Chapter 2

METHODOLOGY

Delineating Areas in Delaware Containing Art Deco Structures

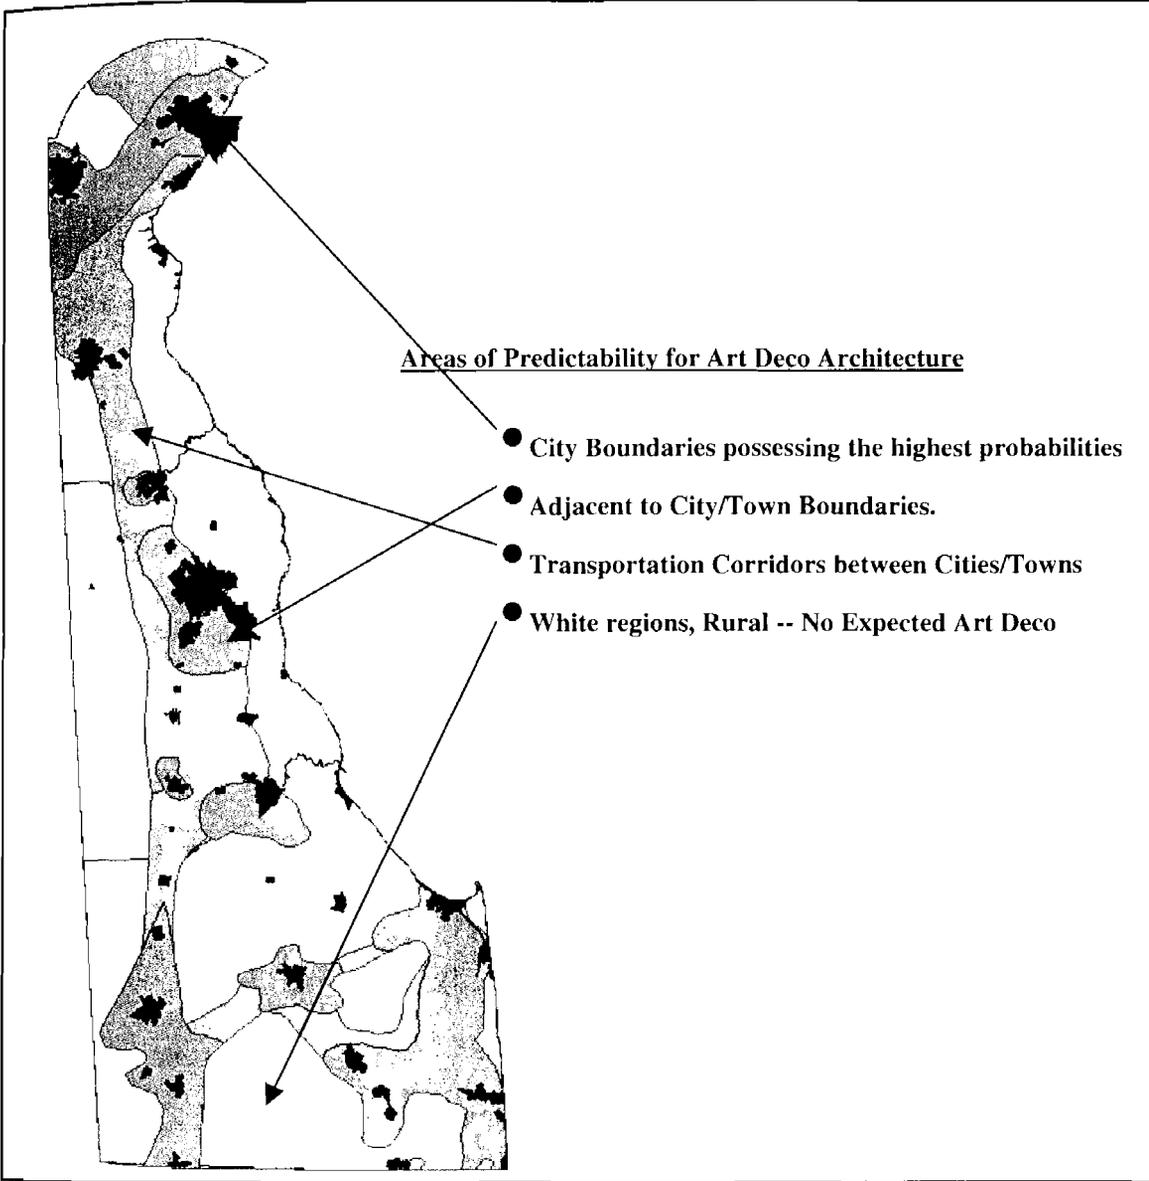
Figure 26: Areas of Art Deco Predictability.

The process of consulting old maps and analyzing where Art Deco might exist allowed identification of areas of predictability (Figure 26). These included areas within municipal and town boundaries, areas adjacent to municipal and town boundaries, and areas encompassing transportation corridors between cities and towns. Mostly excluded from the survey were rural and suburban areas built after the Art Deco era had ended. Some spot canvassing in these areas was performed to confirm that sites of Art Deco architecture were in fact absent.

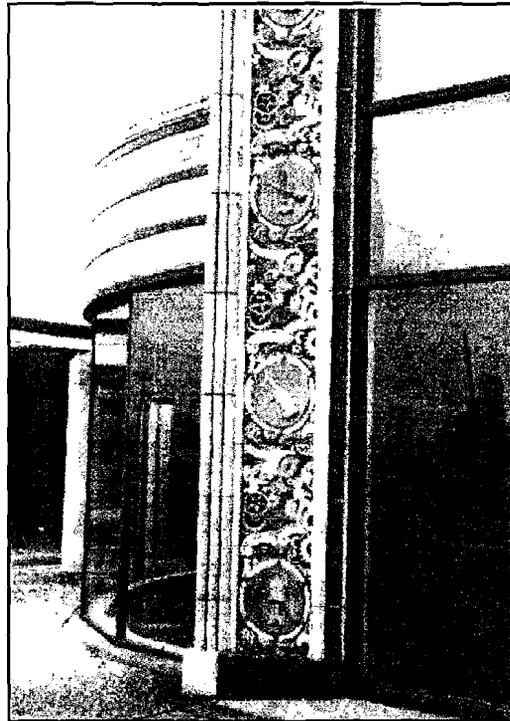
Figure 27: The Art Deco Inventory Template

1. Steel windows? Curved Glass, Glass Block?
0 1 2 3
2. Exterior of light colored brick or stucco?
0 1 2 3
3. Evidence of "Speed Stripes"
0 1 2 3
4. Flat Roofline?
0 1 2 3
5. Rectilinear/Curvilinear motif on building façade?
0 1 2 3

ADF = 15 / 15 = 100%

Excellent example of Streamline Moderne Auto garage motif found in the front facade with bas-relief sculptures showing various themes of an auto dealership and car in general. Oil can, wrench set, tire pump, etc. Excellent speed stripes in dark blue tiles against tan colored brick terra cotta tiles.

Before collecting data, an Art Deco inventory template was created containing vital data to be recorded about each individual structure (Figure 27). Common data

recorded about every site included: the name of the site, a general description, its location, the year the structure was built or designed in the Art Deco style, original purpose of the structure, its present use and condition, and finally a follow up contact for further information.

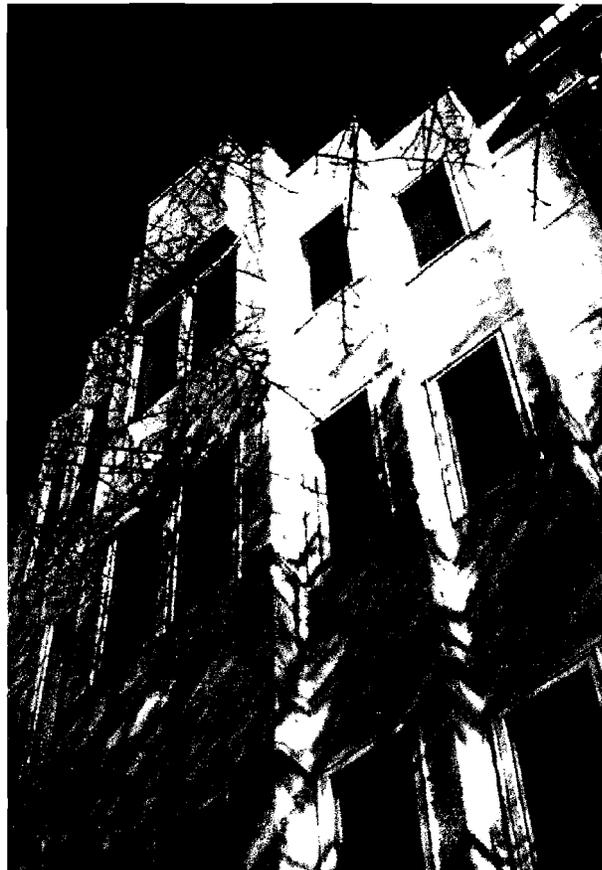
Figure 30: Commercial Office Building. Photo by Author.

The criteria for commercial office buildings, public buildings or large apartment buildings placed more emphasis on the Jazz-age style of Art Deco. The criteria included the following: an ornate entranceway with symmetrical linear details, relief carvings, Art Deco font lettering, rectilinear motif on front façade showing vertical emphasis, and whether the exterior was a light colored brick, concrete, or stucco with contrasting trim colors (Figure 30).

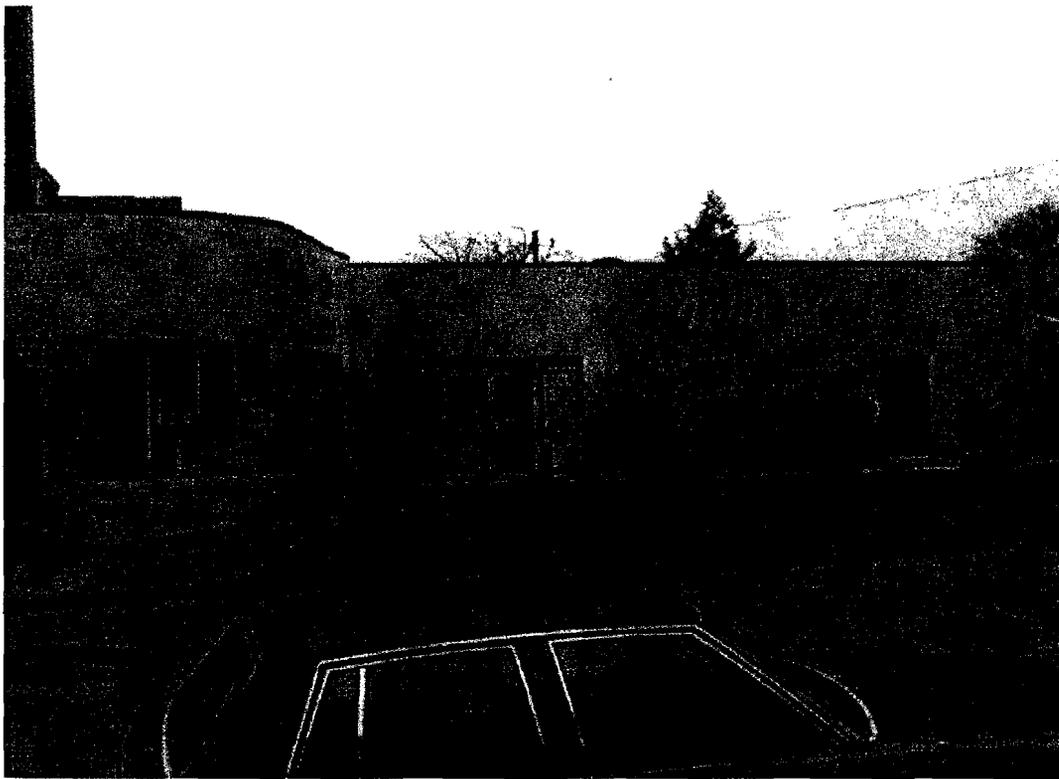
Figure 31: A Former Gas Station. Photo by Author.

Warehouses, factories, service stations, and diners tended to appear later in the diffusion period, and thus most of these buildings exemplified more of the Streamline Moderne features. The criteria list for rating these structures were: the presence of glass block in the exterior, a general curvilinear shape, a stucco or concrete exterior usually in a light color and/or with bright metal trim, emphasis on the horizontal axis, evidence of "Speed Stripes", and finally steel windows (Figure 31).
