PLATES

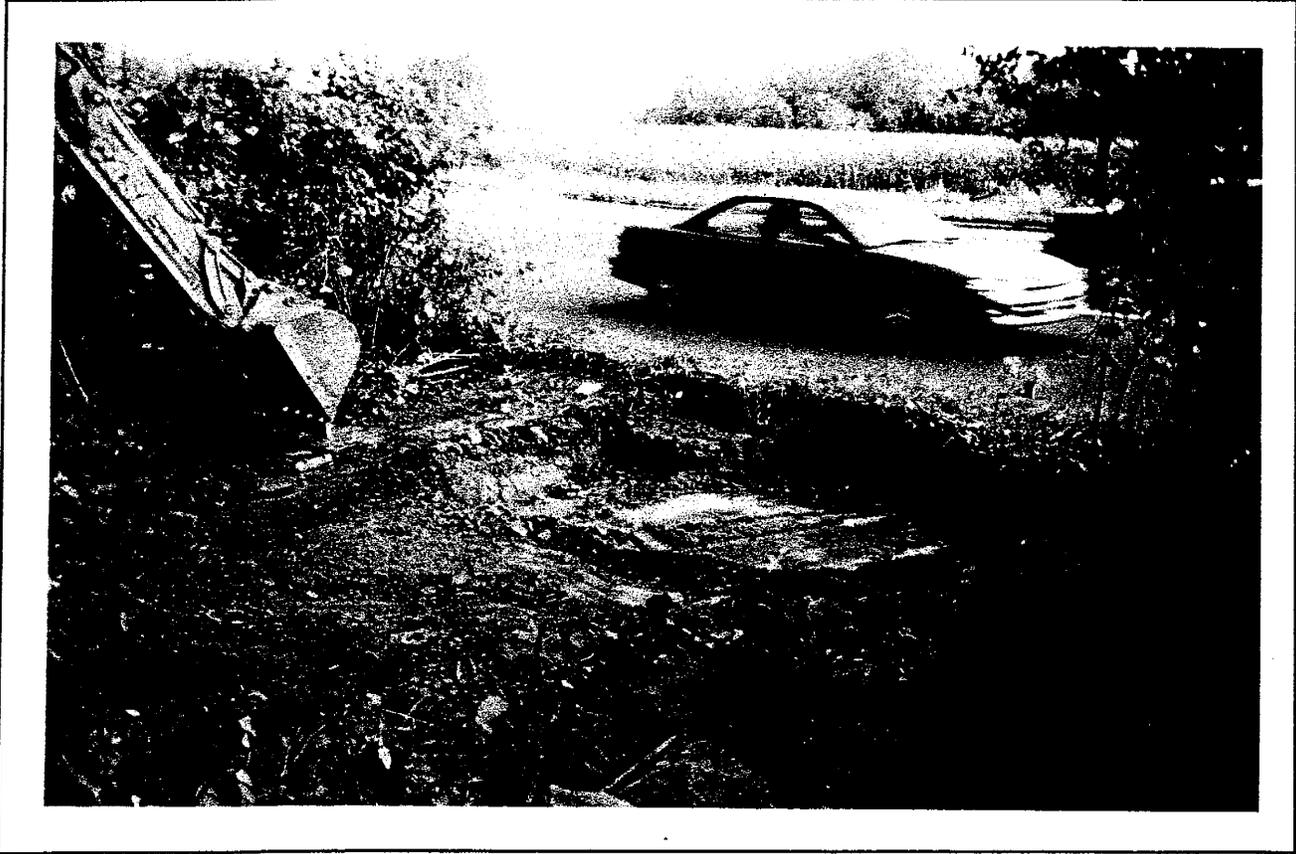
PLATE 7
Excavation of the Tavern/House Foundation

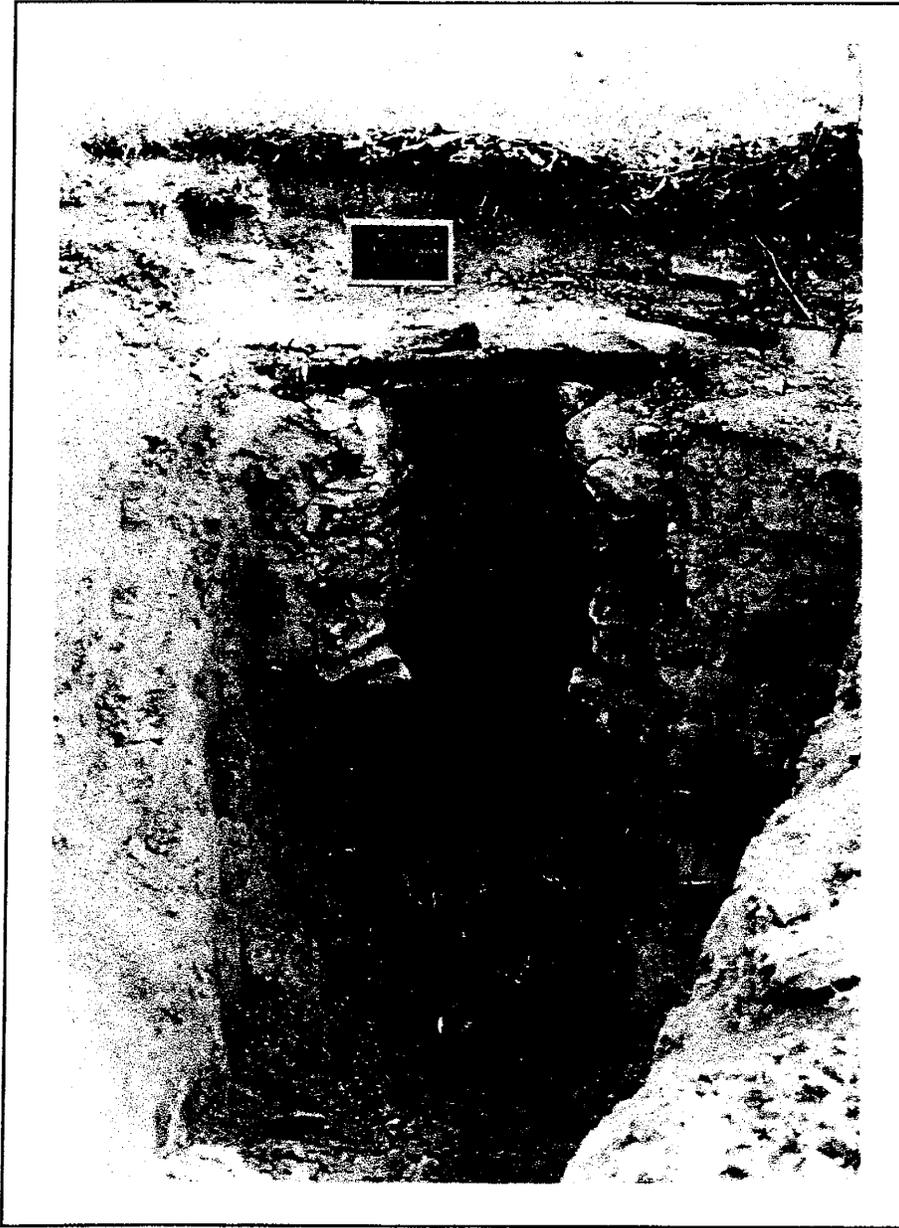
PLATE 8
Cement-capped Stone-lined Well Adjacent to Route 202

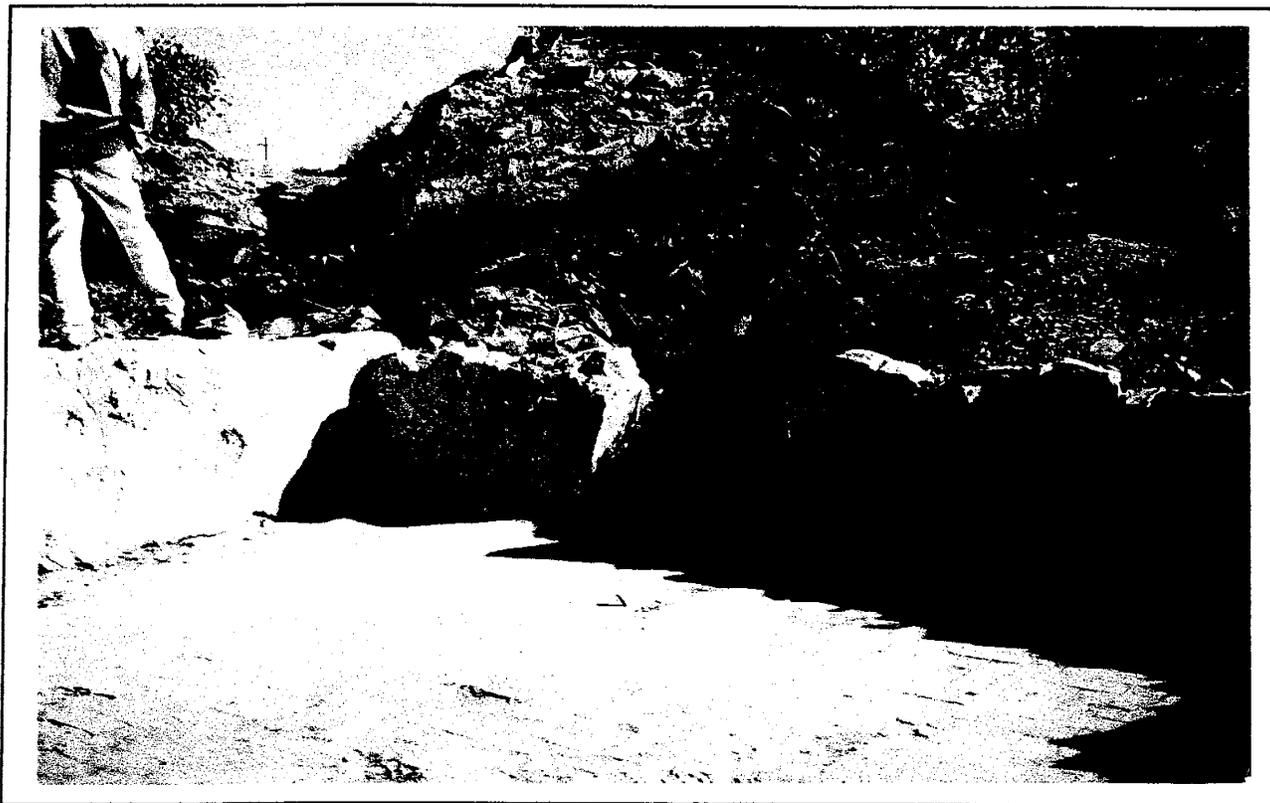
PLATE 9
Stone-Lined Well After Backhoe Trenching

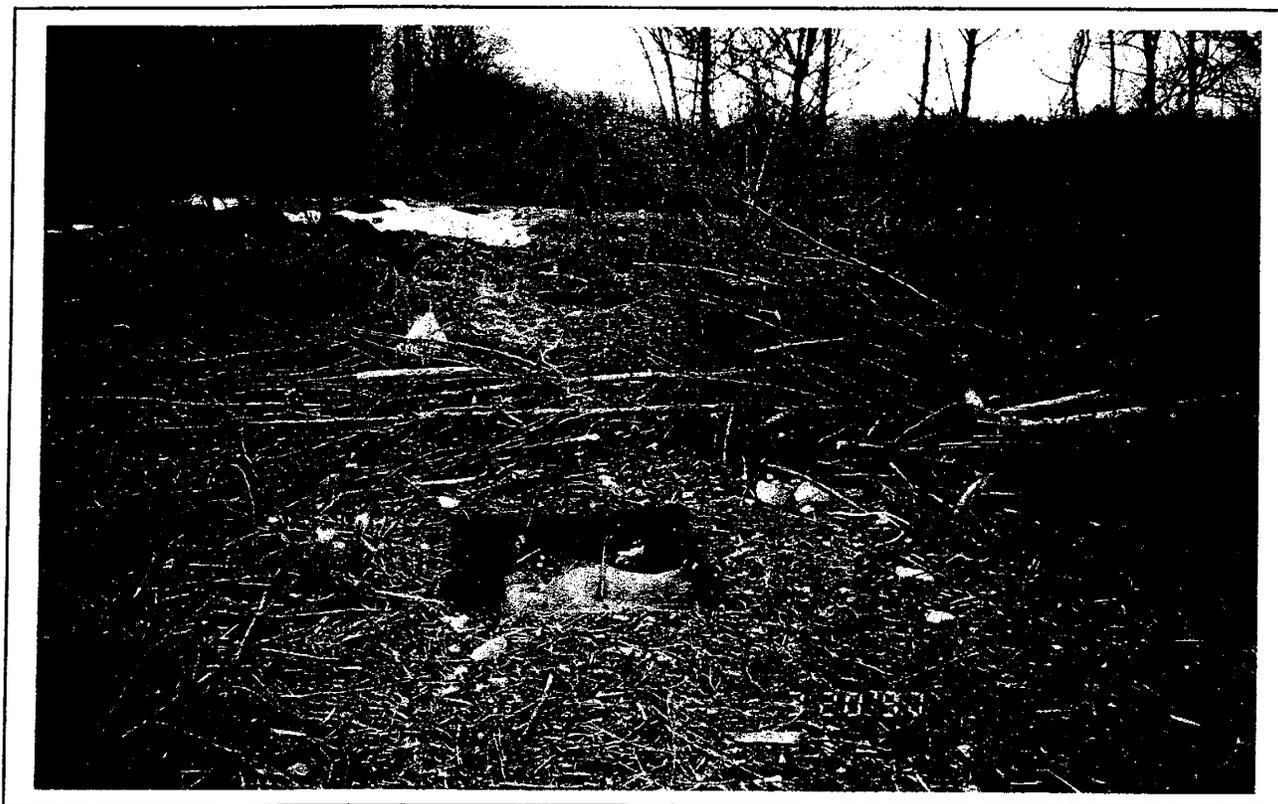
PLATE 10
Tavern/House Foundation with Rubble and Refuse Fill in Background

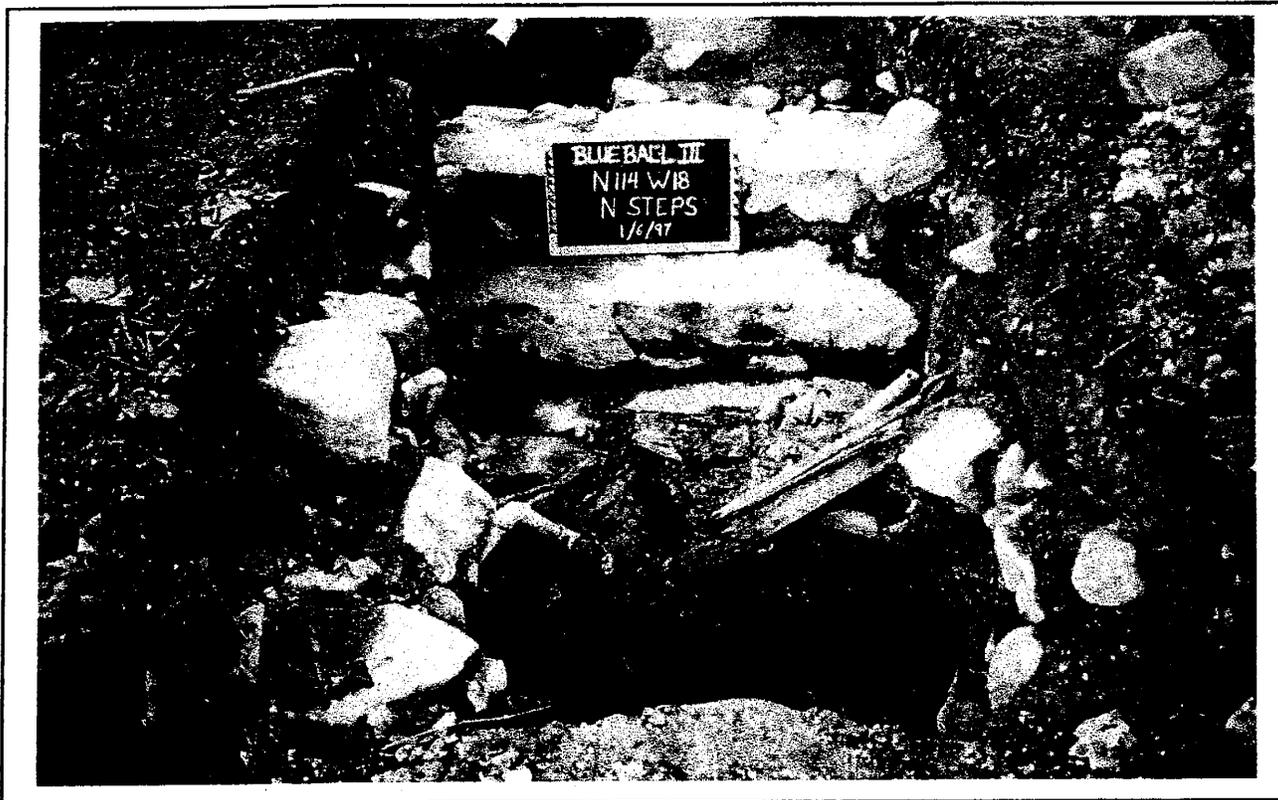
PLATE 15
Dirt Floor Underlying Concrete Floor in North Room

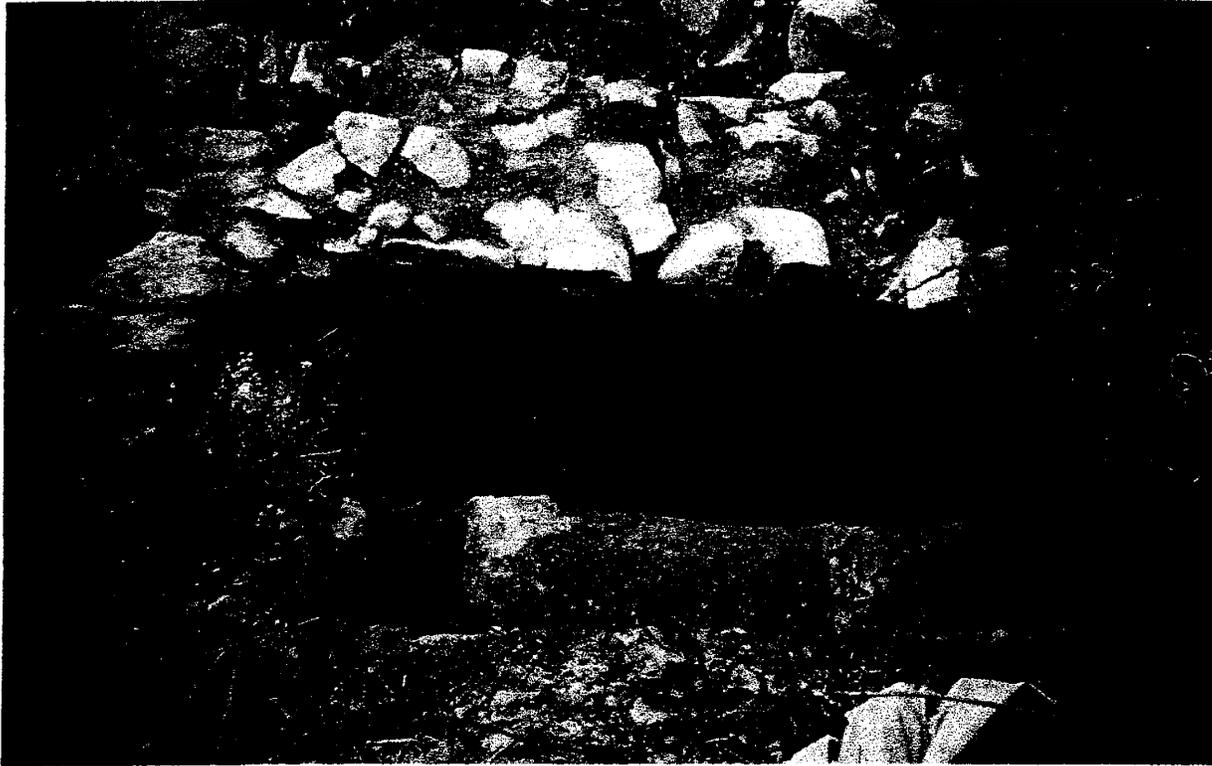
PLATE 16
Stairs in Northwest Corner of the North Room

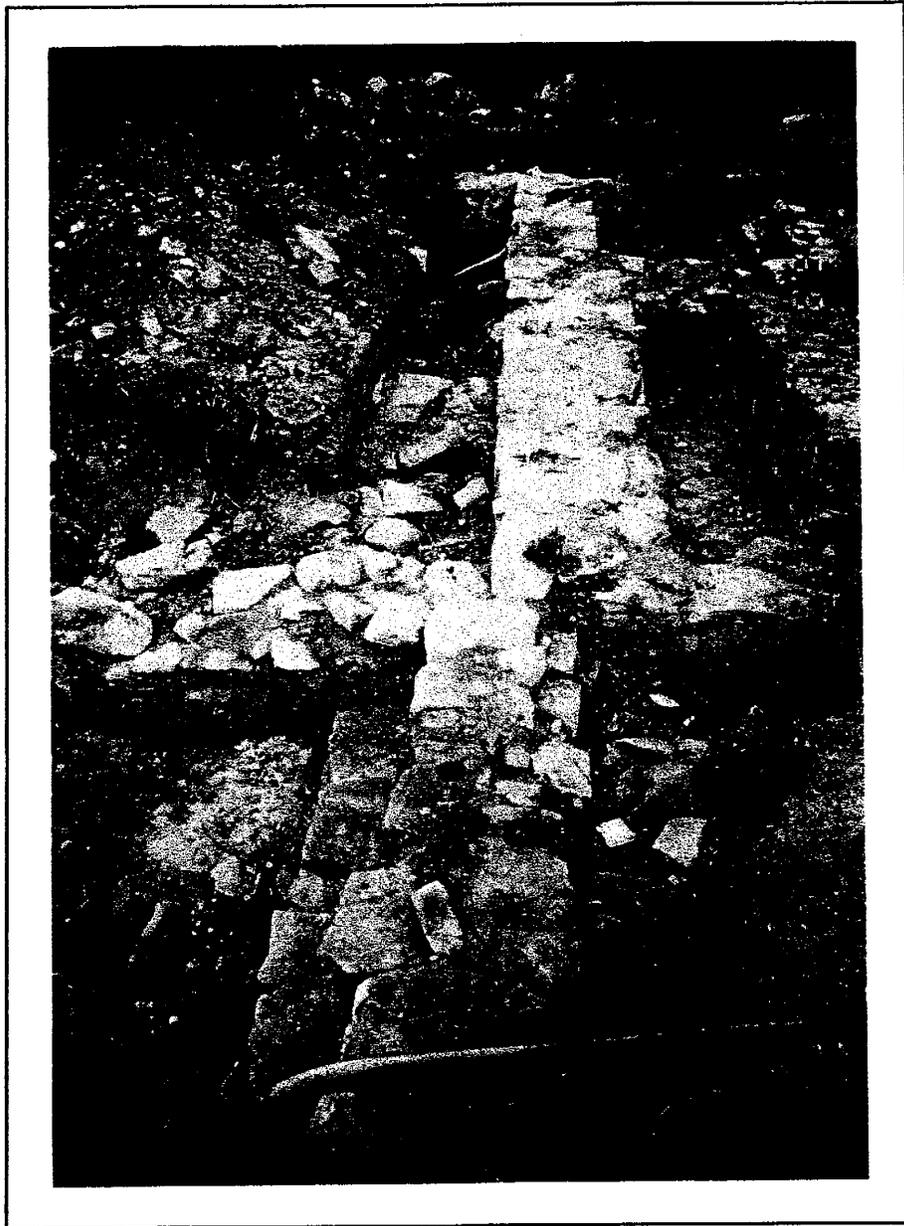
PLATE 17
Remnants of Door in Northwest Staircase

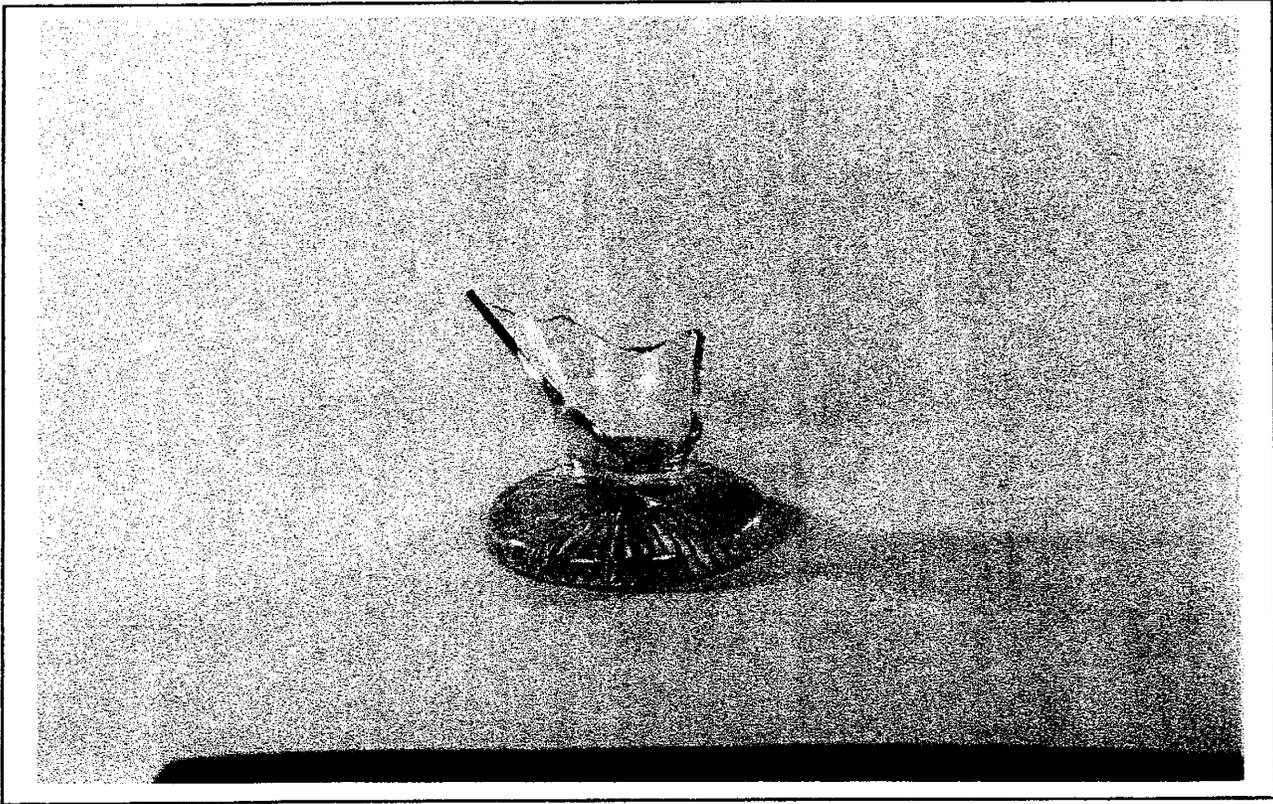
PLATE 26
Feature 91, Profile

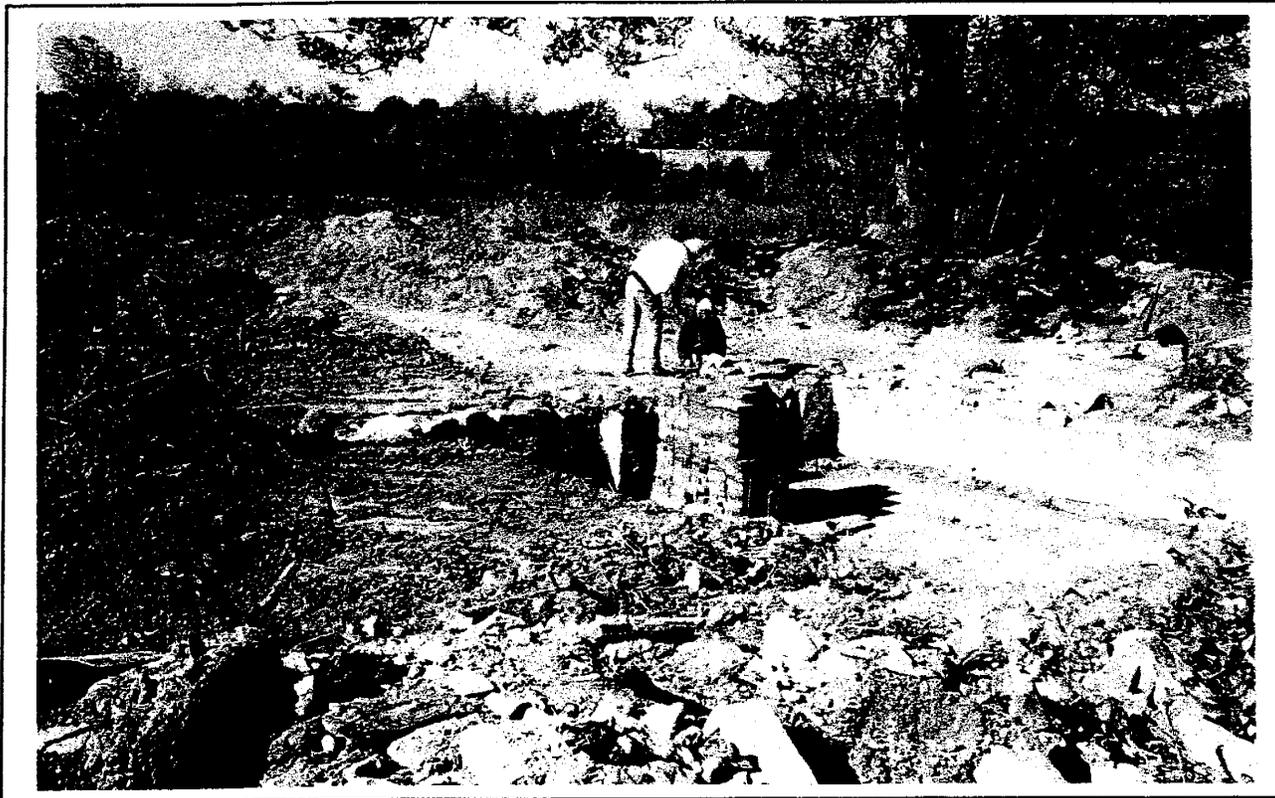
PLATE 32
Wooden Door Sill in Door Between Southeast and Southwest
Rooms of Tavern/House

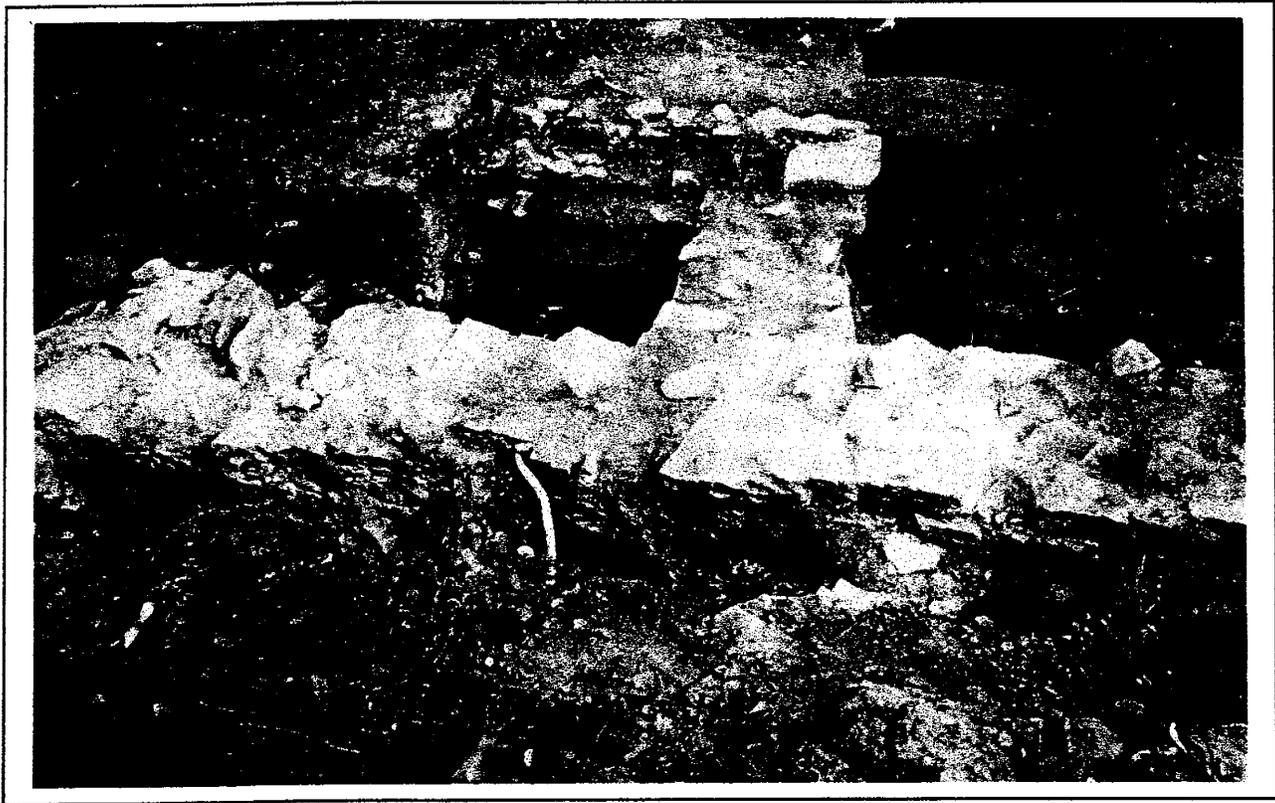
PLATE 33
Partially Removed Brick Floor in Southwest Room Foundation

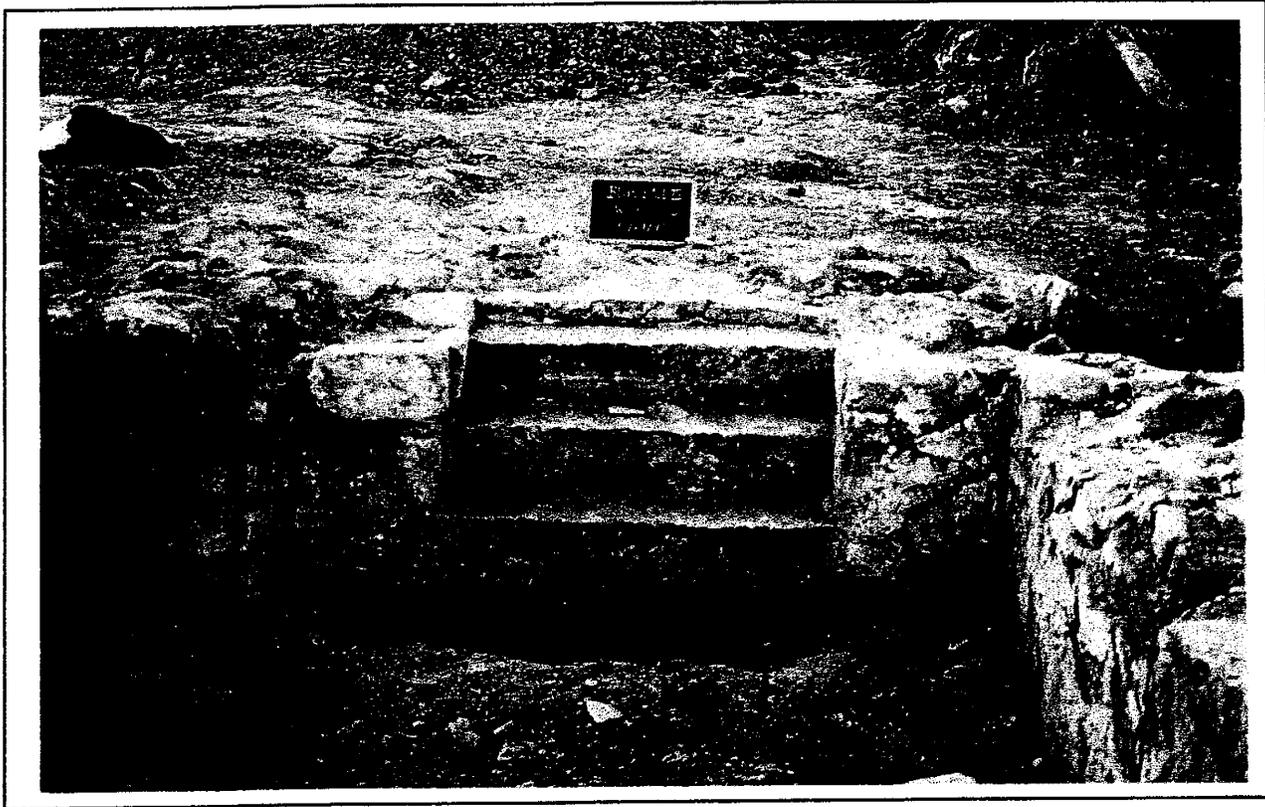
PLATE 35
Sealed Bulkhead Entrance on North Wall of Southwest Room

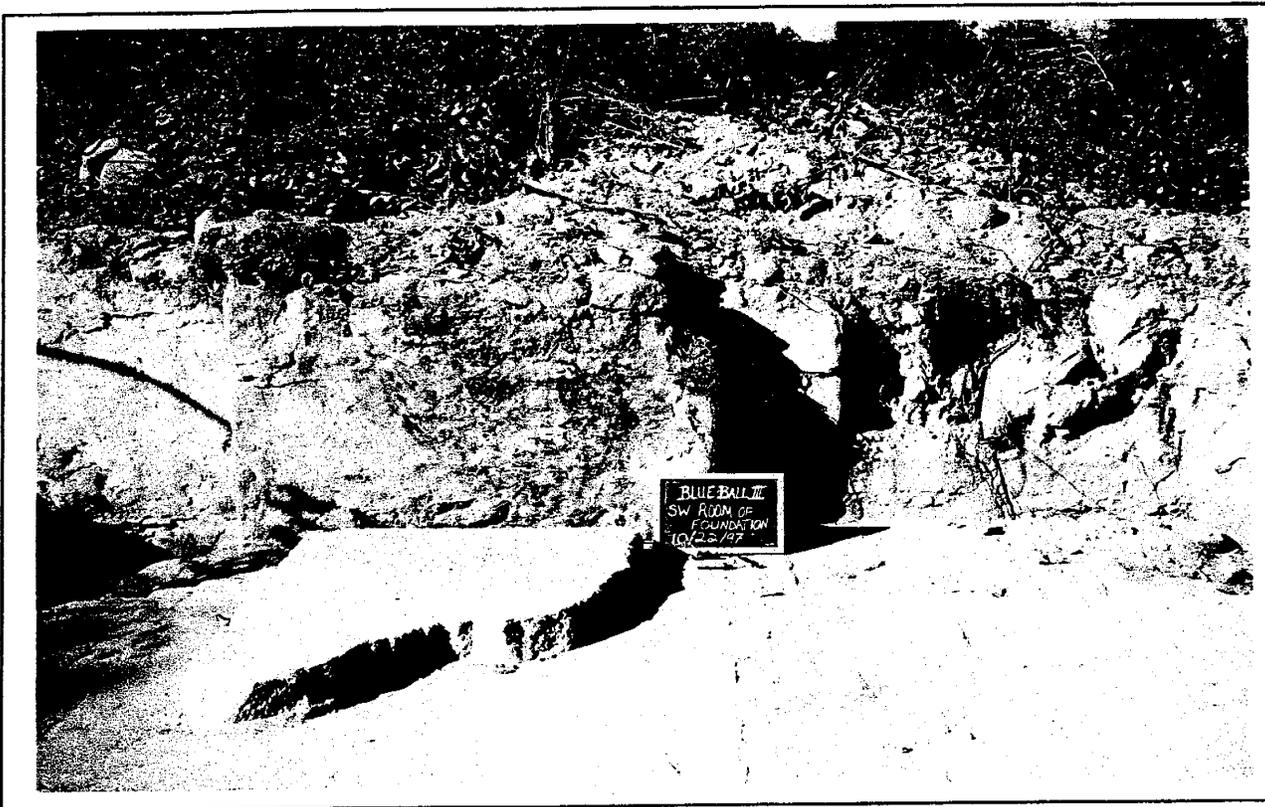
PLATE 36
Blocked Entrance on North Wall of Southwest Room, From Interior

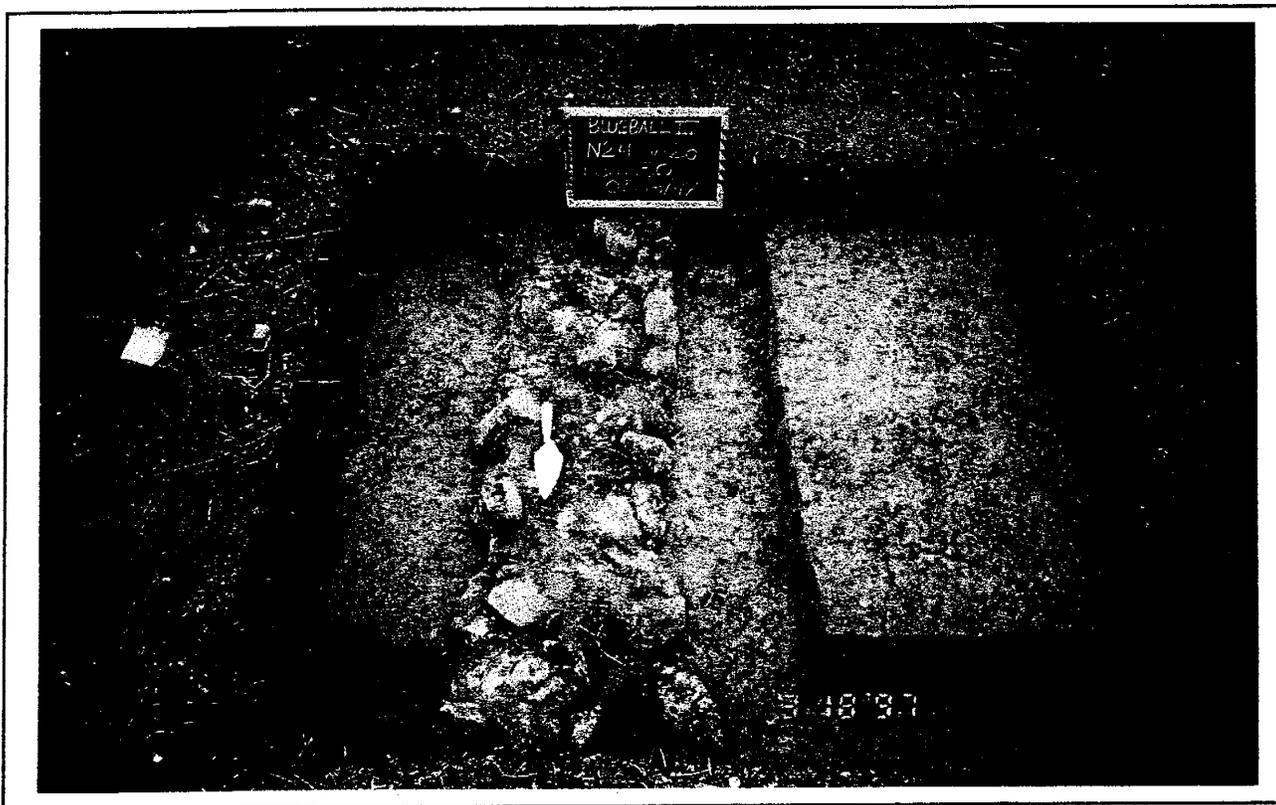
PLATE 38
Stone Column and Concrete Slab in Southwest Room

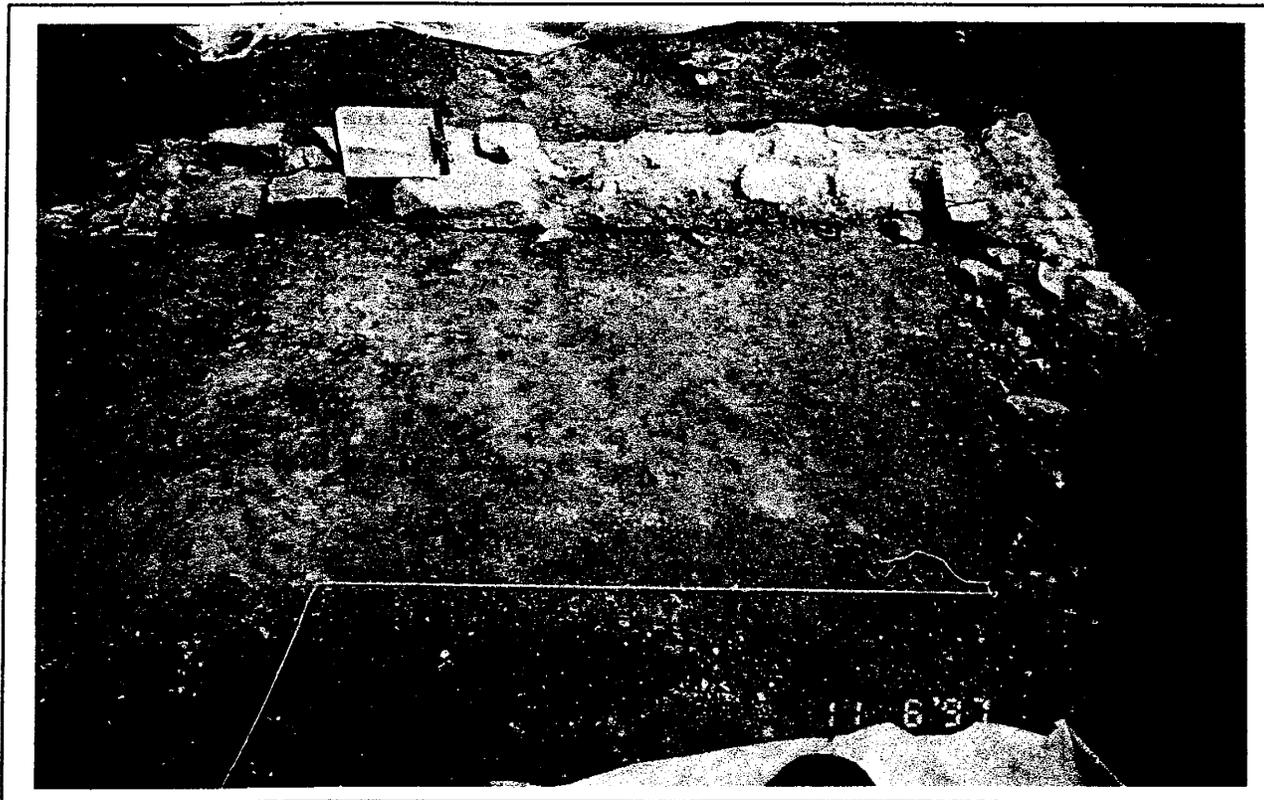
PLATE 39
Trench with Terra Cotta Pipe Along North Wall of Southwest Room

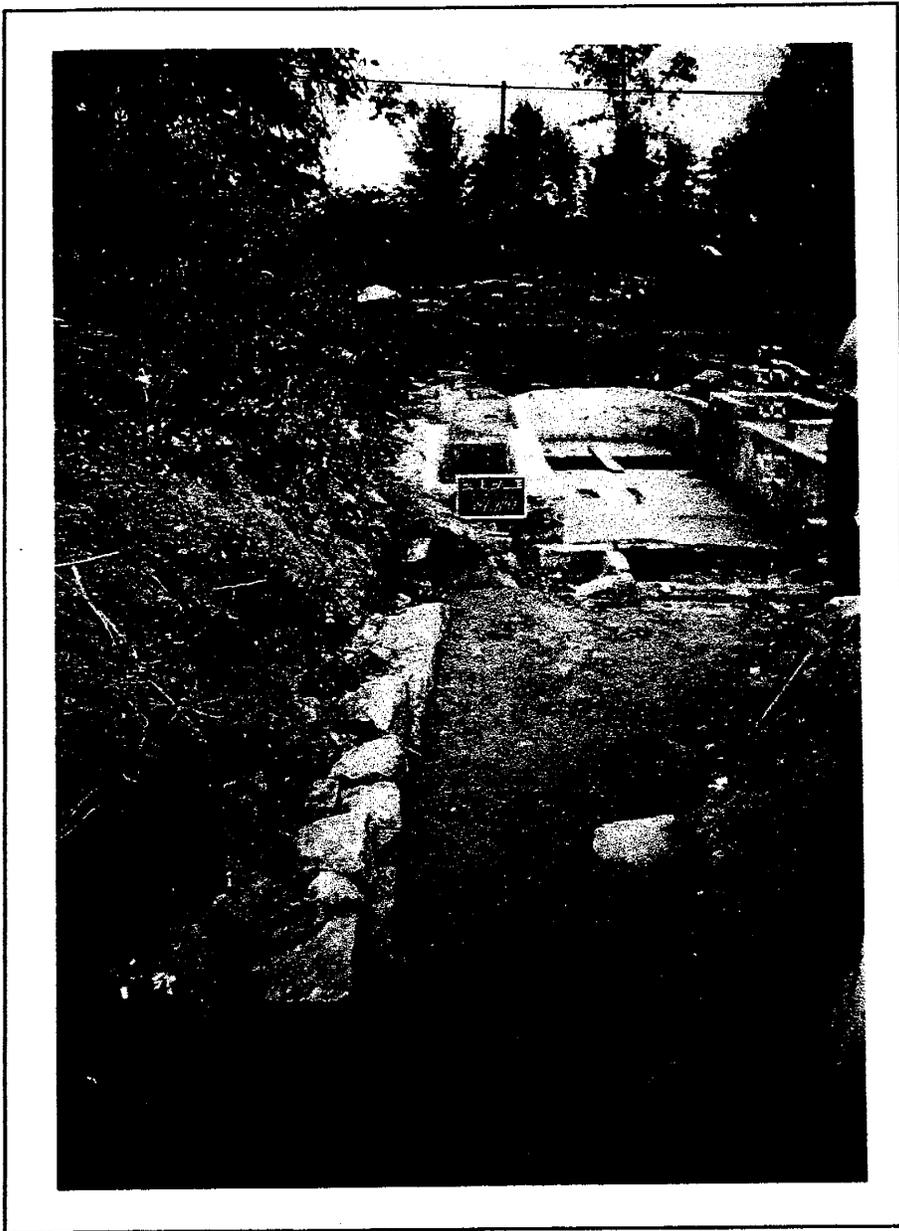
PLATE 44
Steps in Feature 12, Showing Flanking Stone Troughs and
Drain from One of the Plastered Troughs

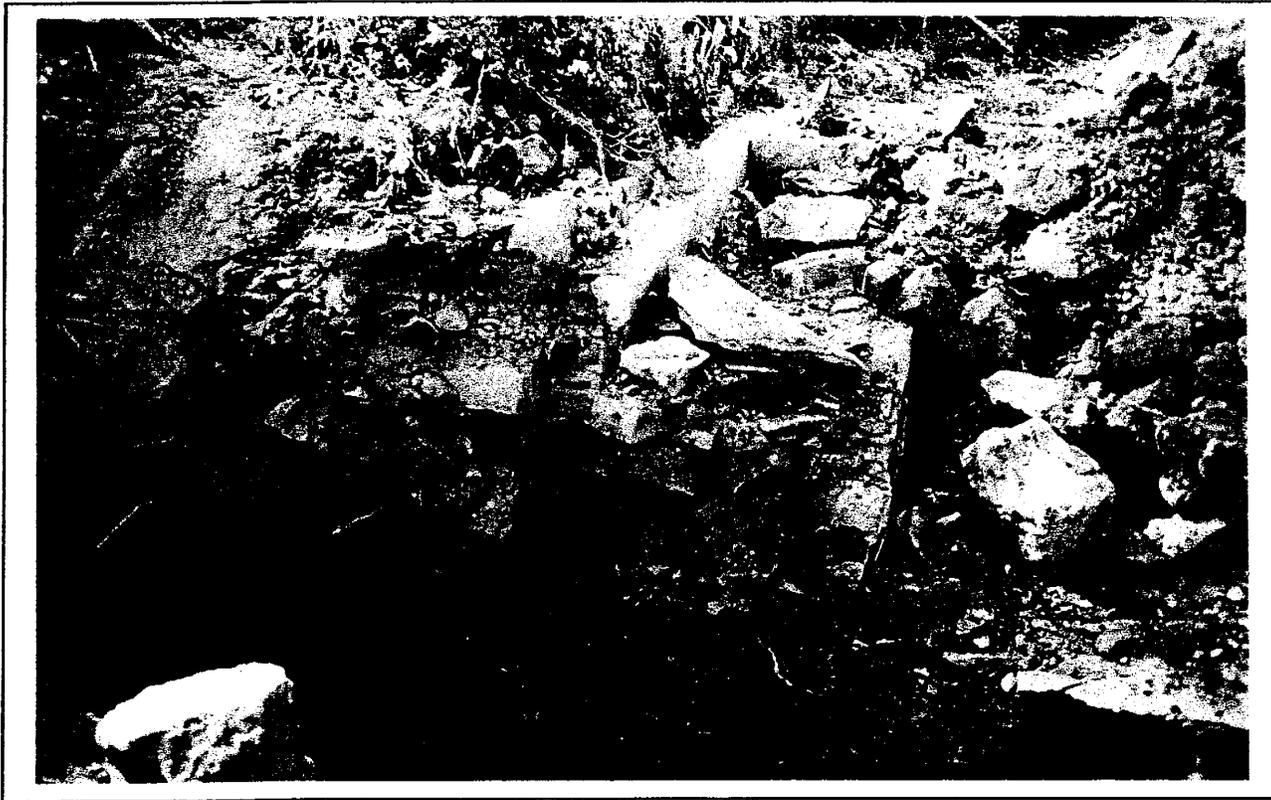
PLATE 45
Trough in Feature 12, Showing Connecting Pipe

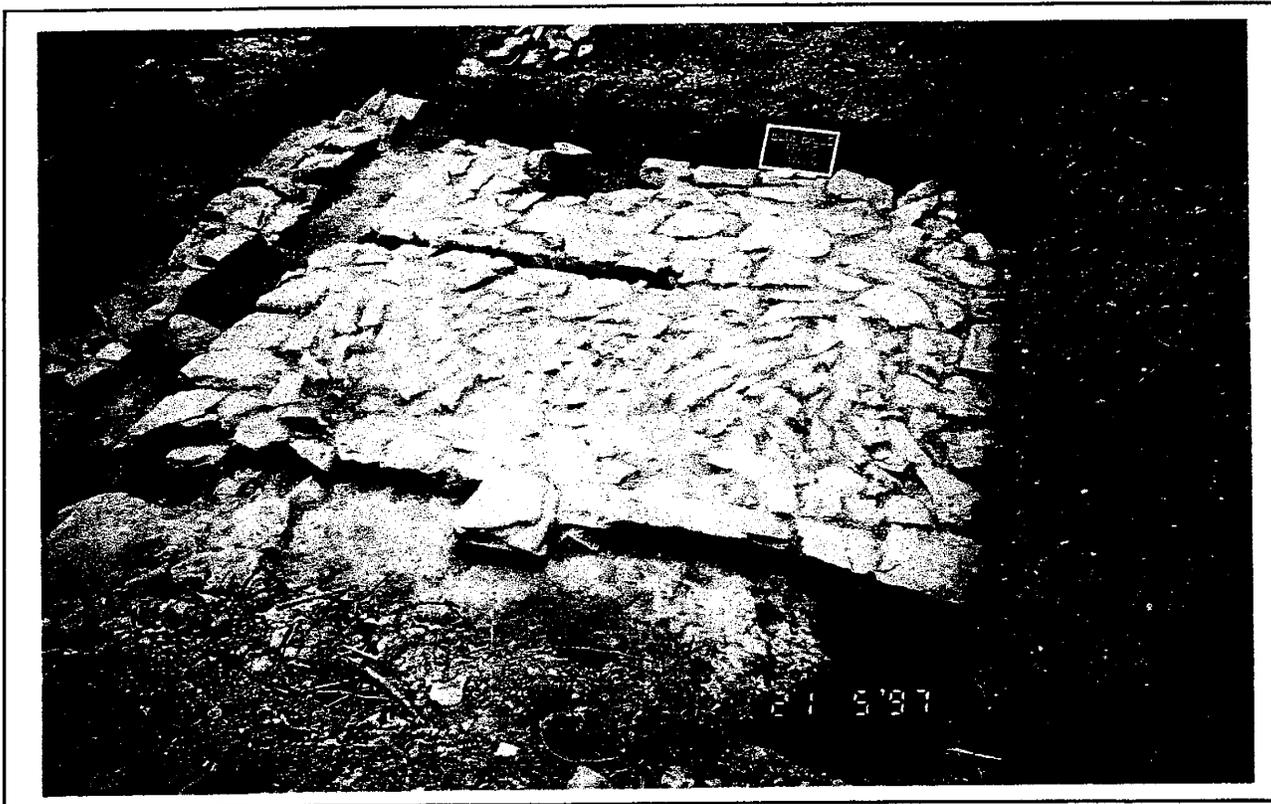
PLATE 47
Backhoe Trench Through Feature 12, Showing
Rubble Fill under Troughs

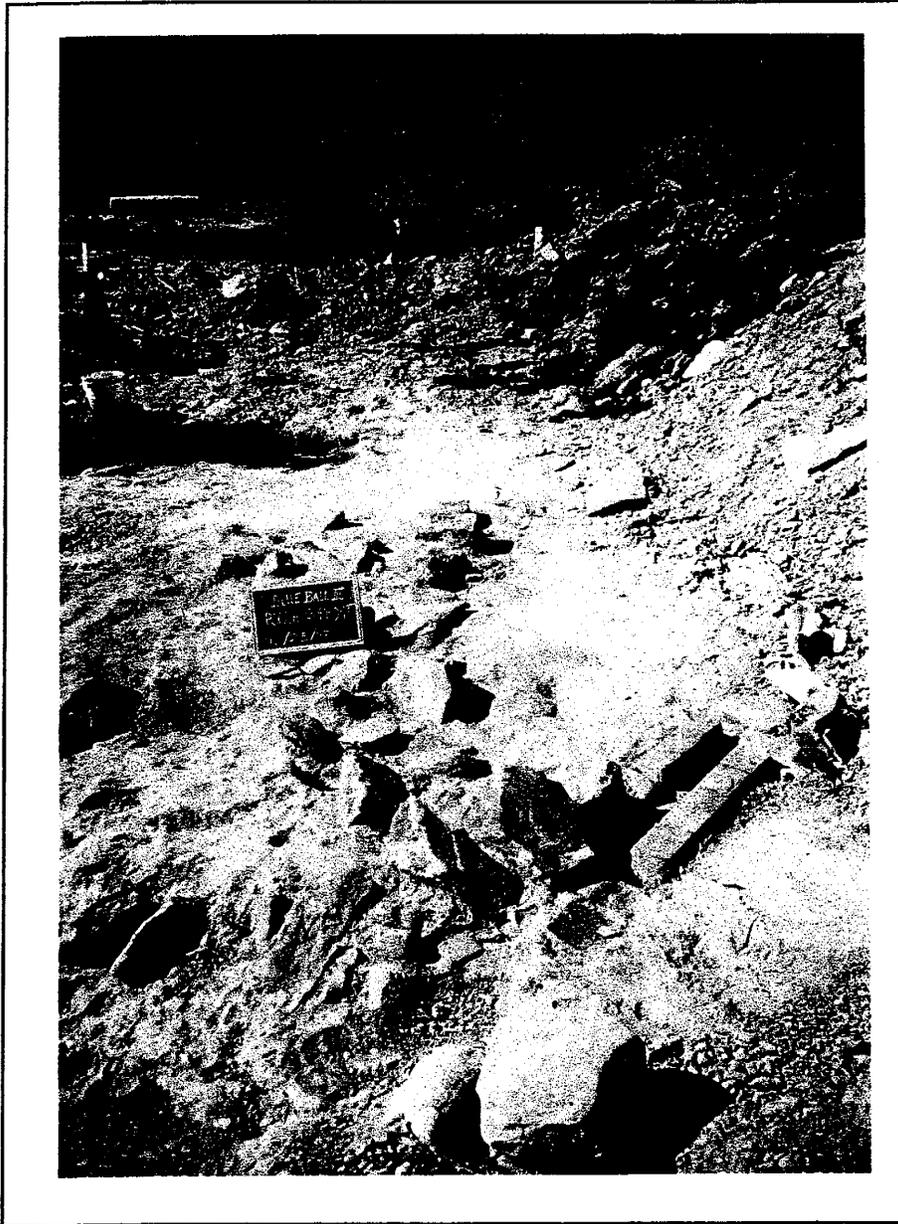
PLATE 52
Feature 32, Mortared Stone Foundation

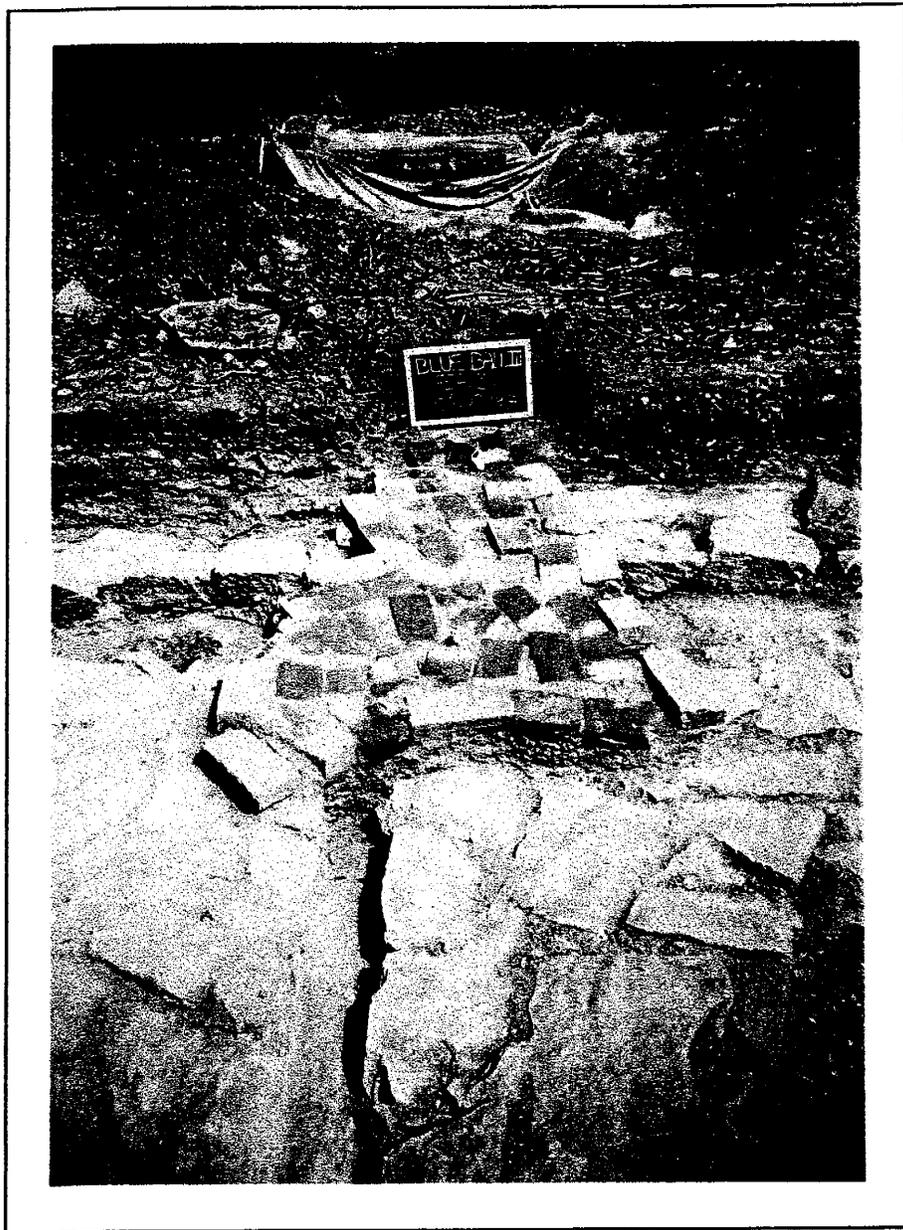
PLATE 53
Feature 66, Dry-laid Stone Floor
in Outbuilding (Feature 32)
