V. ARCHITECTURAL SURVEY

A. INTRODUCTION

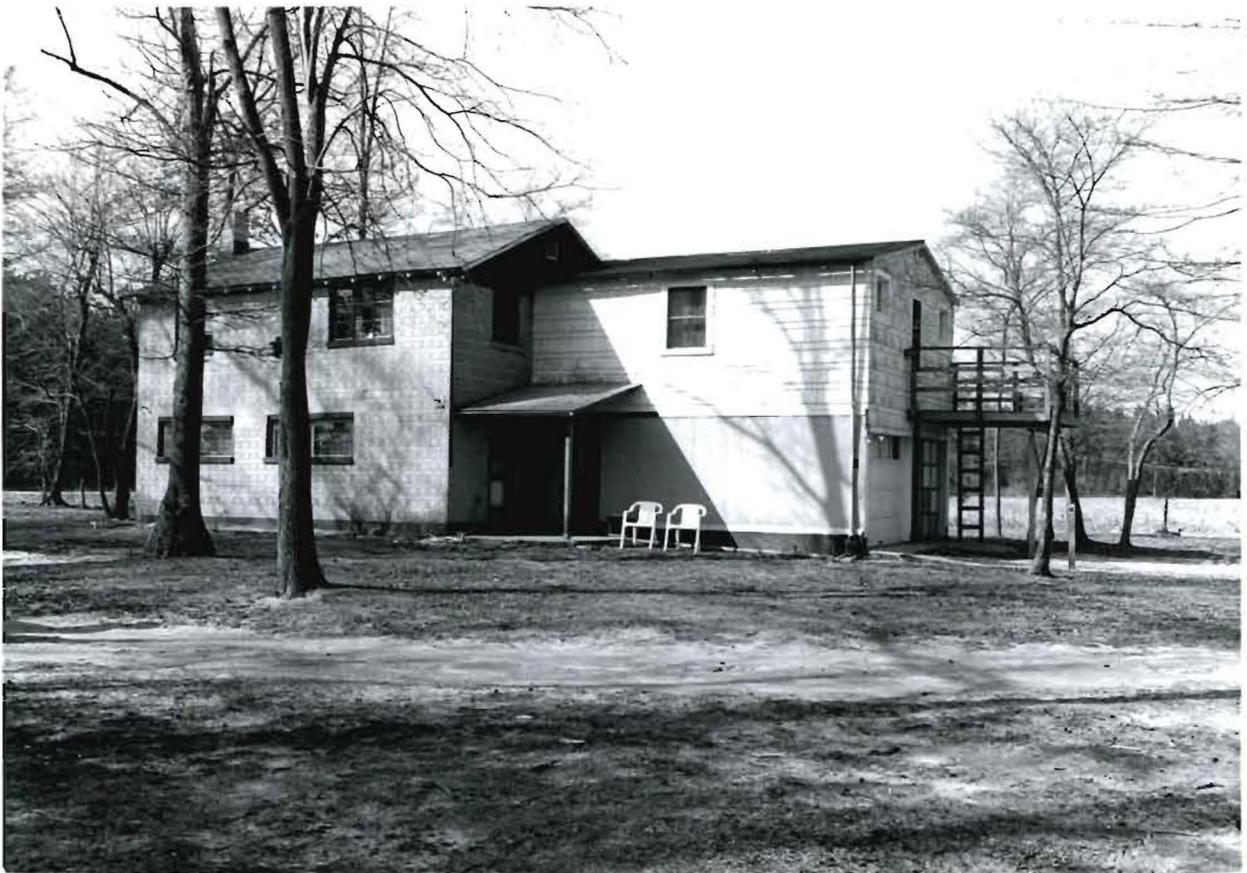
One of the tracts (1-35-10-8), called in the most recent land transfer the "Marshall Tract", is located on the east side of Road 243 (Sussex County (hereinafter SC) Deeds 1079:226). A house and two abandoned outbuildings are present on the property, most of which is under cultivation. The house has a two-story, side-gable main block constructed of concrete block, with circular patterning cast into the exterior face of each block (Plate 2). Off the east end of this section is a slightly lower, two-story wing containing a garage and the main entrance in the first story. The asphalt-shingled roof of the main block has exposed rafter ends. Windows are metal casements. The house appears to date from the 1940s or 1950s.

PLATE 2: CONCRETE BLOCK HOUSE, VIEW TO NORTHWEST

The buildings on the Marshall Tract do not appear to warrant further investigation for National Register eligibility. The dwelling is something of an architectural oddity, due to the patterning in the cast concrete block walls, but does not possess demonstrable qualities of architectural significance or documented association with events or persons of importance in the history of Delaware's Lower Peninsula/Cypress Swamp Zone. The two outbuildings appear to be somewhat older than the house, but the context of their former use is no longer readily apparent. No further work is recommended for this property. It is not eligible for listing in the National Register.

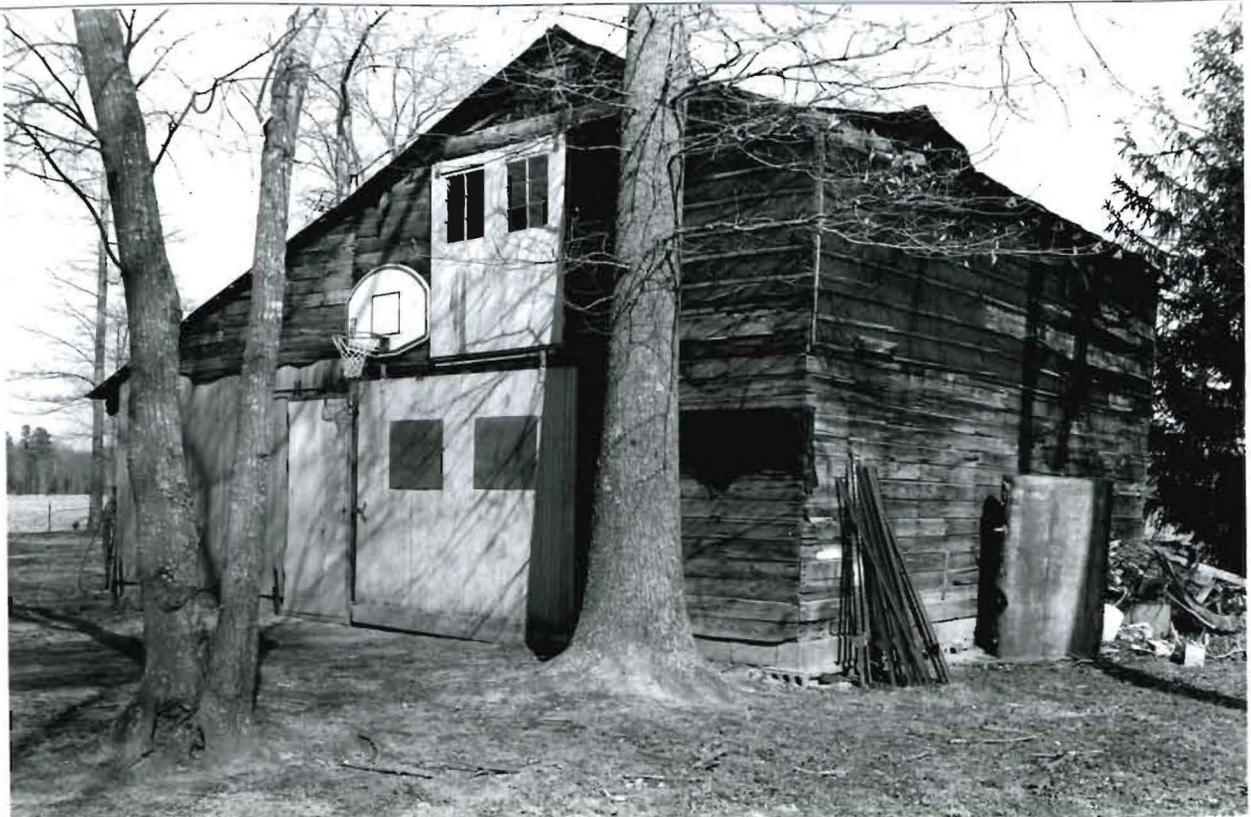
The outbuildings are situated east of the house. Nearest the house is a frame barn or shed on concrete block footings, with exterior walls clad in horizontal planking and battened tarpaper (Plate 3). The gable roof is extended to the north with a lean-to. The two-level structure has a large sliding door in the west elevation, above which is a slightly smaller sliding door to a loft. To the northeast of this structure is a frame poultry shed with lean-to roofs and vertical plank siding (Plate 4).

PLATE 3: FRAME SHED, VIEW TO NORTHEAST

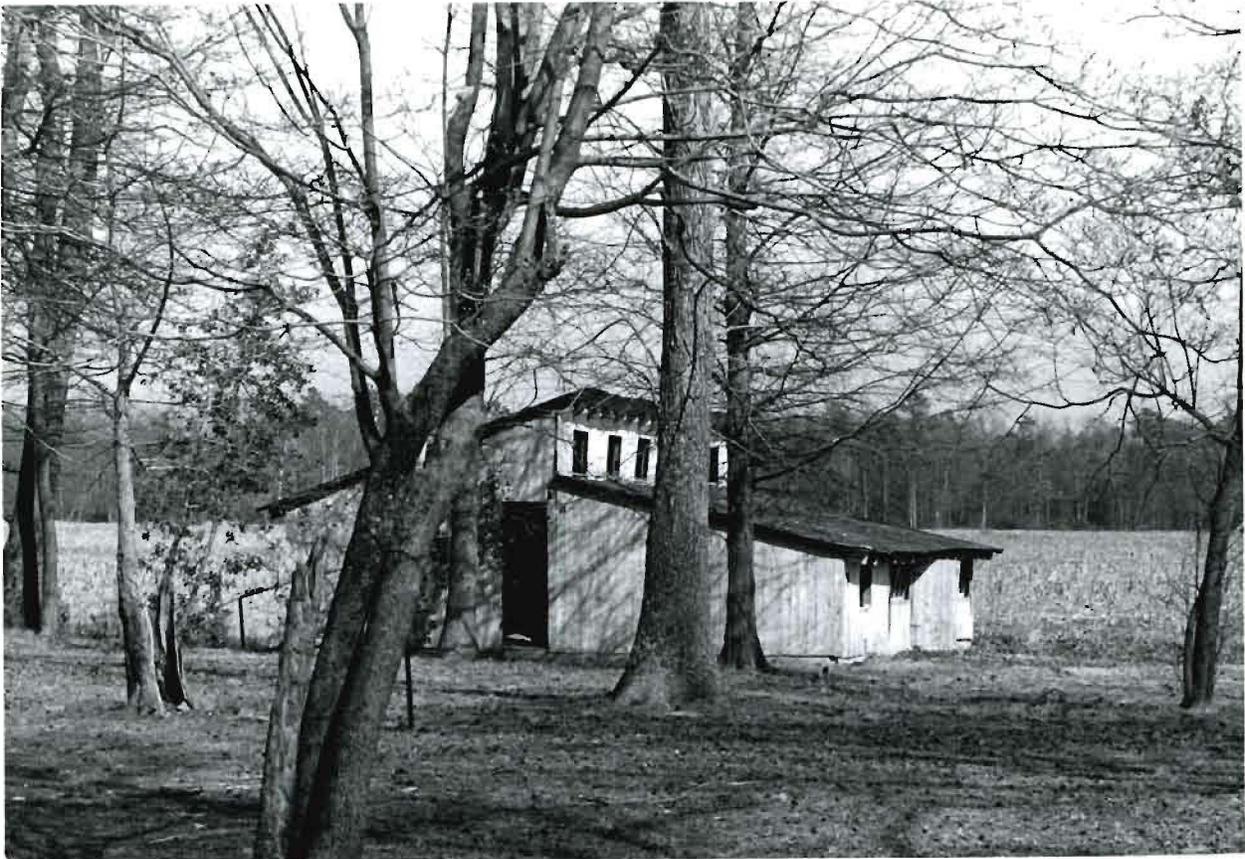
PLATE 4: POULTRY SHED, VIEW TO EAST

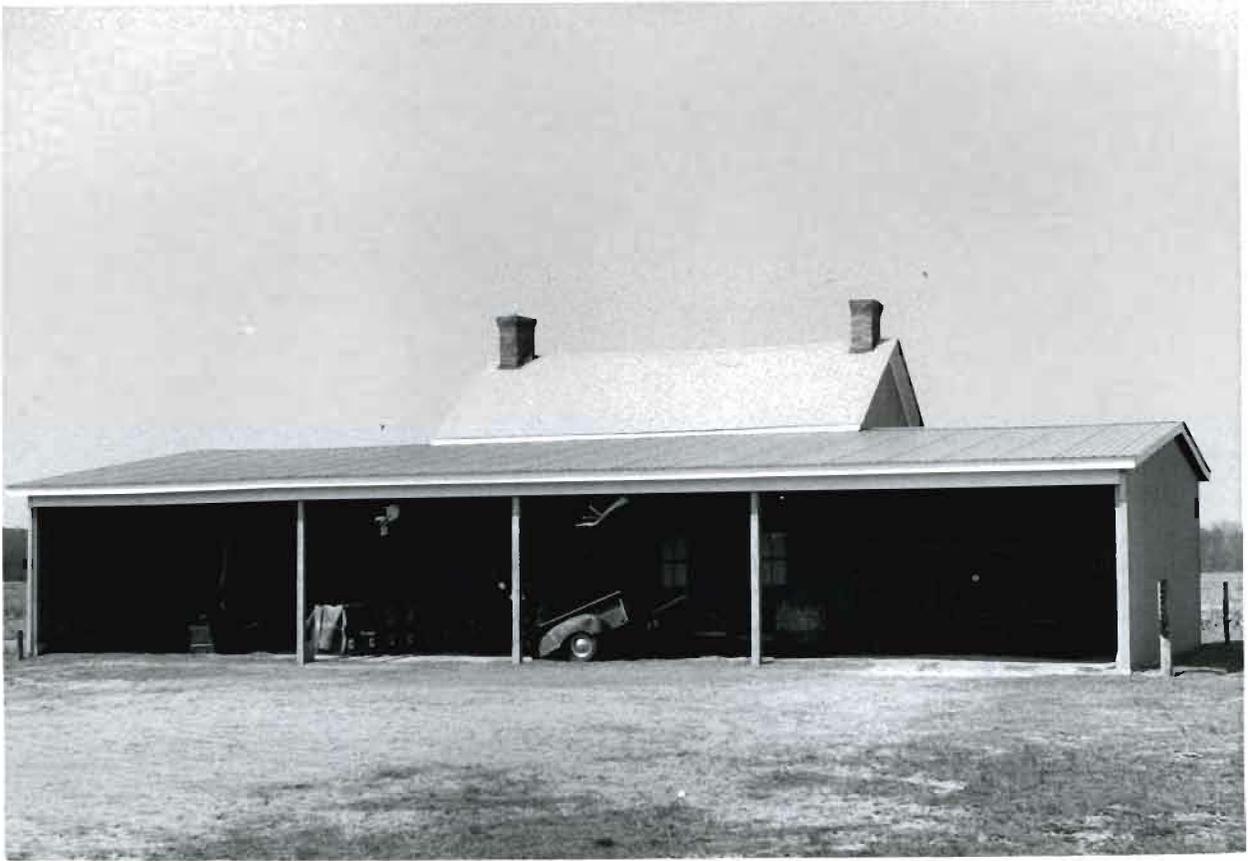
**PLATE 5: WILLIAM H. WARD FARMHOUSE, SHOWING MANNER OF ENCLOSURE
WITHIN EQUIPMENT SHED; VIEW TO NORTHWEST**

The house was occupied as late as the mid-1970s, and is in fairly good condition. The only obvious signs of deterioration are the peeling wallpaper and areas where the plaster has fallen away from the lath. The partial enclosure of the house within the metal equipment shed (and the garage installed in the northeast re-entrant, angle against the parlor wall) has served to protect the facade and lower portions of the side elevations from weather in recent years. The framing for these modern structures consists simply of dimensioned lumber verticals which have been bolted or nailed to the exterior walls of the house.

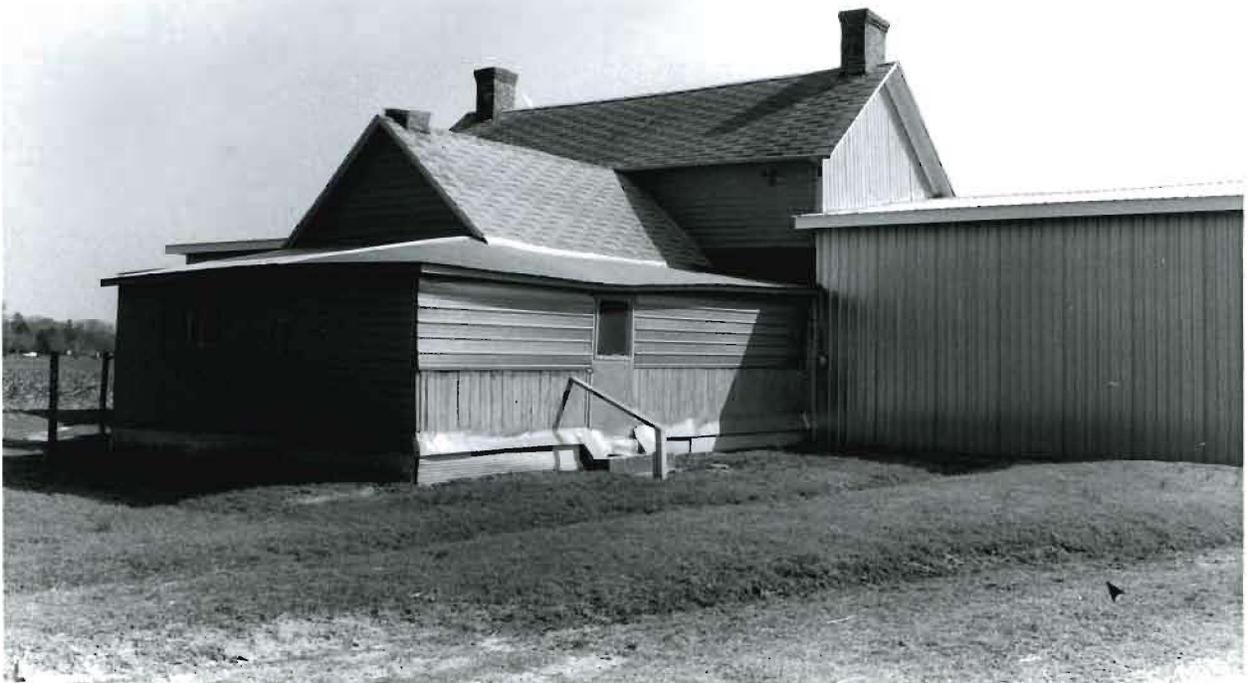
The Ward House (CRS #S-3212) is of frame construction on a brick foundation now enclosed with sheet metal. The house is massed as a 1 1/2-story side-gable main block with a one-story gabled rear wing and lean-to extension that together form a T-shaped plan. A shed-roofed, enclosed porch is located along the southwest wall of the rear wing (Plates 5 and 6). The house is clad in weatherboards painted gray. The roof is covered with patterned asphalt shingles; shaped rafter ends are exposed beneath the roof of the main block. The interior gable end chimneys on the main block are relatively large, terminating in splayed, corbelled caps. The stub of a third smaller chimney is located at the gable end of the rear wing.

**PLATE 6: WILLIAM H. WARD HOUSE, REAR VIEW SHOWING MASSING,
REAR WING AND PORCH/LEAN-TO EXTENSIONS; VIEW TO EAST**

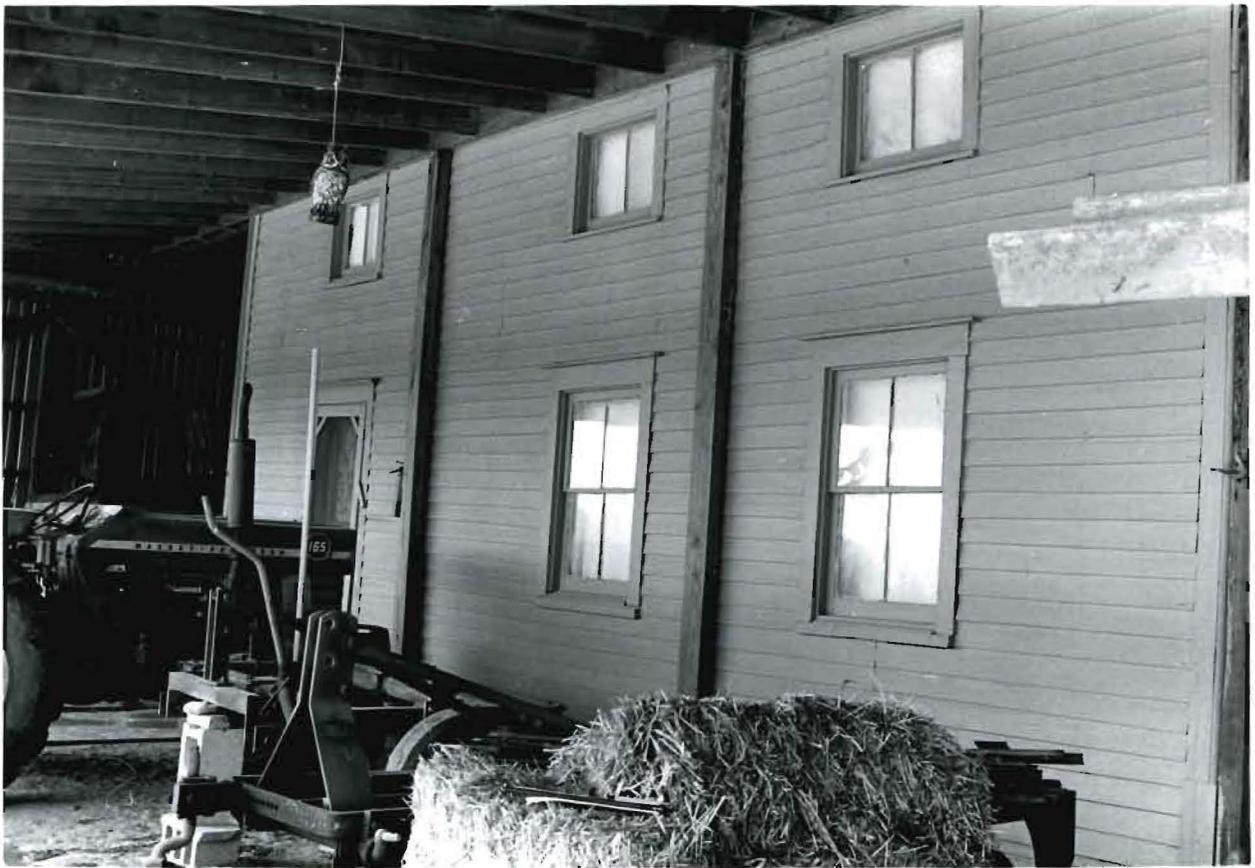
The house has a three-bay facade oriented to face southeast, with the main entrance in the leftmost (southwest) bay (Plate 7). The door has three horizontal panels in the lower half, a single large window in the upper half. Window openings on the first story are fitted with 2/2 double-hung sash in flat plank frames. Some of the frames still retain simple molding strips beneath drip shelves. On the front and rear elevations of the main block are two-light "eyebrow" windows set close beneath the eaves to illuminate the attic level. These windows are nearly square.

PLATE 7: MAIN ELEVATION OF WILLIAM H. WARD HOUSE WITHIN EQUIPMENT SHED

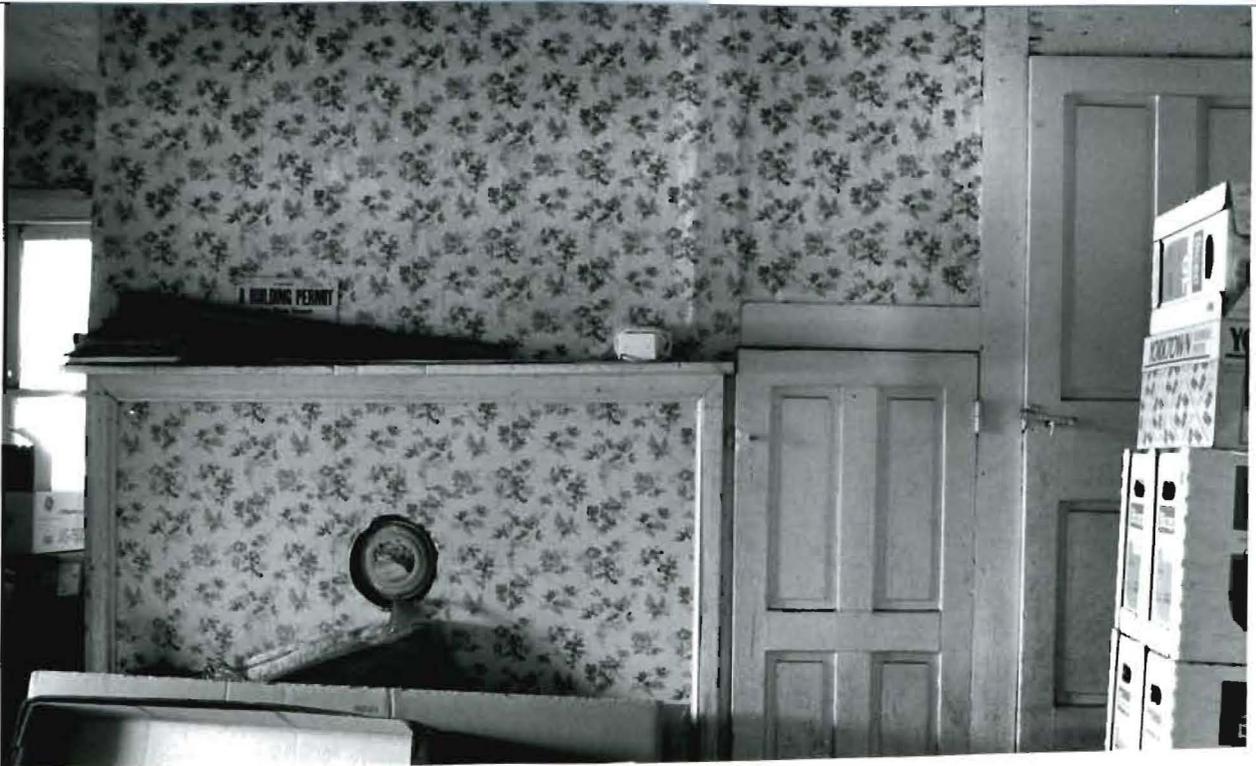
The interior of the main block is arranged in a single-pile, hall-parlor plan (Figure 6). The main entrance opens directly into the "hall", which contains a large brick fireplace against the southwest gable wall (Plate 8). The hearth has been filled in and a stove thimble installed, but the outer edge retains a simple stock molding and mantel shelf set about four feet above the floor. To the right of the fireplace is a small cupboard, and, in the corner, an enclosed winder stair to the attic. Both the cupboard and stair doors have four vertical panels; the latter is also fitted with a simple thumblatch.

PLATE 8: INTERIOR VIEW OF WARD FARMHOUSE "HALL" SHOWING LARGE FIREPLACE AND FLANKING CLOSET AND DOOR TO ENCLOSED CORNER STAIR

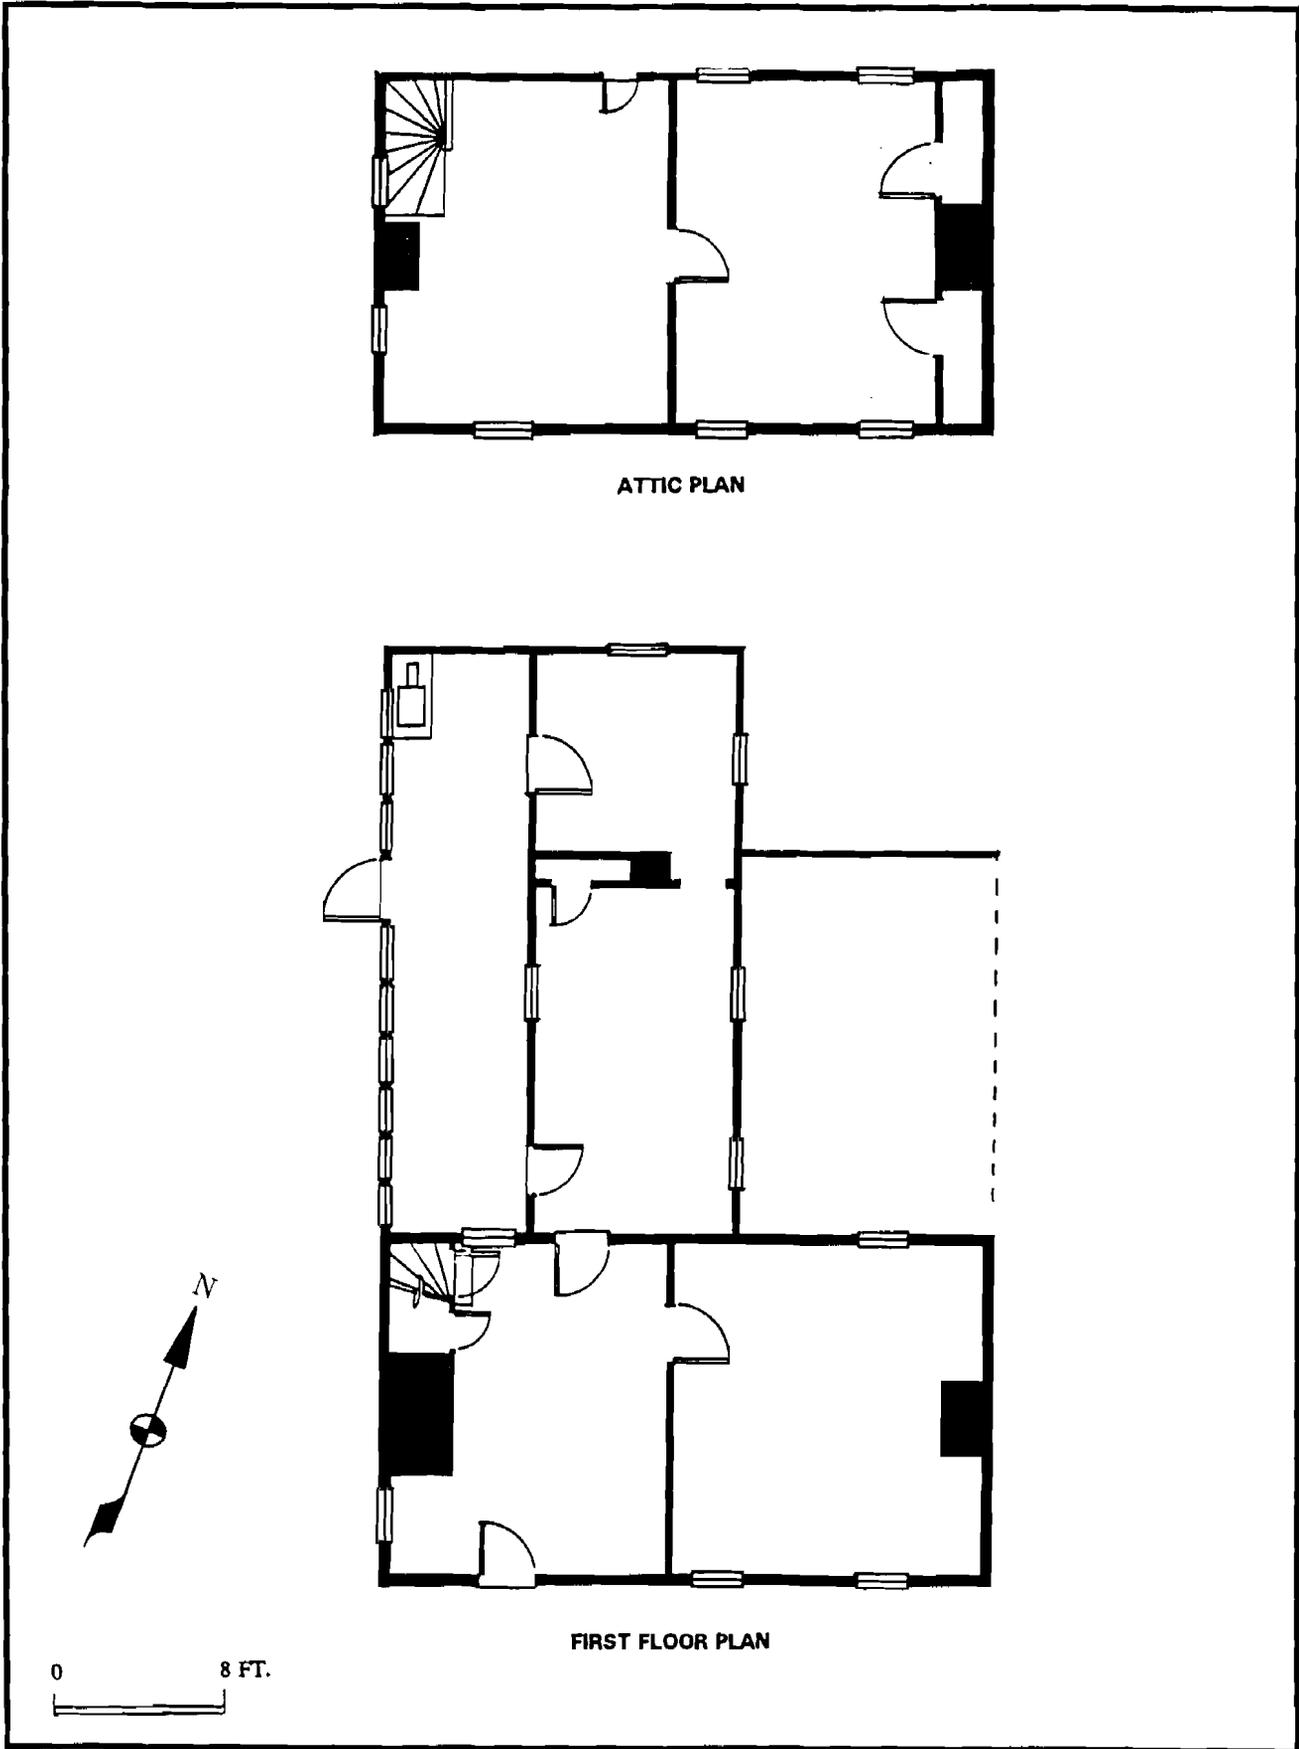
FIGURE 6: WARD HOUSE FLOOR PLANS

Ward House possesses the distinctive characteristics of the type, as described by Herman (1987:20). Its "hall" is entered directly from the outside, and contains a corner stair to the upper floor, and a fireplace larger than that of any other room in the house. The "parlor" is entered only from the hall. The relatively late date of the house (ca. 1880) is indicative of the general conservatism that was characteristic of rural domestic architectural practices in lower Delaware. The subsequent addition of a rear wing is consistent with the relocation of service activities from the front rooms of dwellings to rear areas, permitting a more formalized use of the "hall". Of additional interest is the 1 1/2 story configuration of the main block, since dwellings of two stories are dominant in the nineteenth-century architectural development of rural Delaware. Rear ells of 1 1/2 stories were not uncommon, but the utilization of the half-story for the main body of the house is relatively unusual. At least two other examples of the 1 1/2 story configuration from the same general time period have been recorded in the area, one on Road 244 west of the Ward House (CRS # S-3213) and the Jacob Sharp house on U.S. Route 113 north of Georgetown (CRS # S-8449).

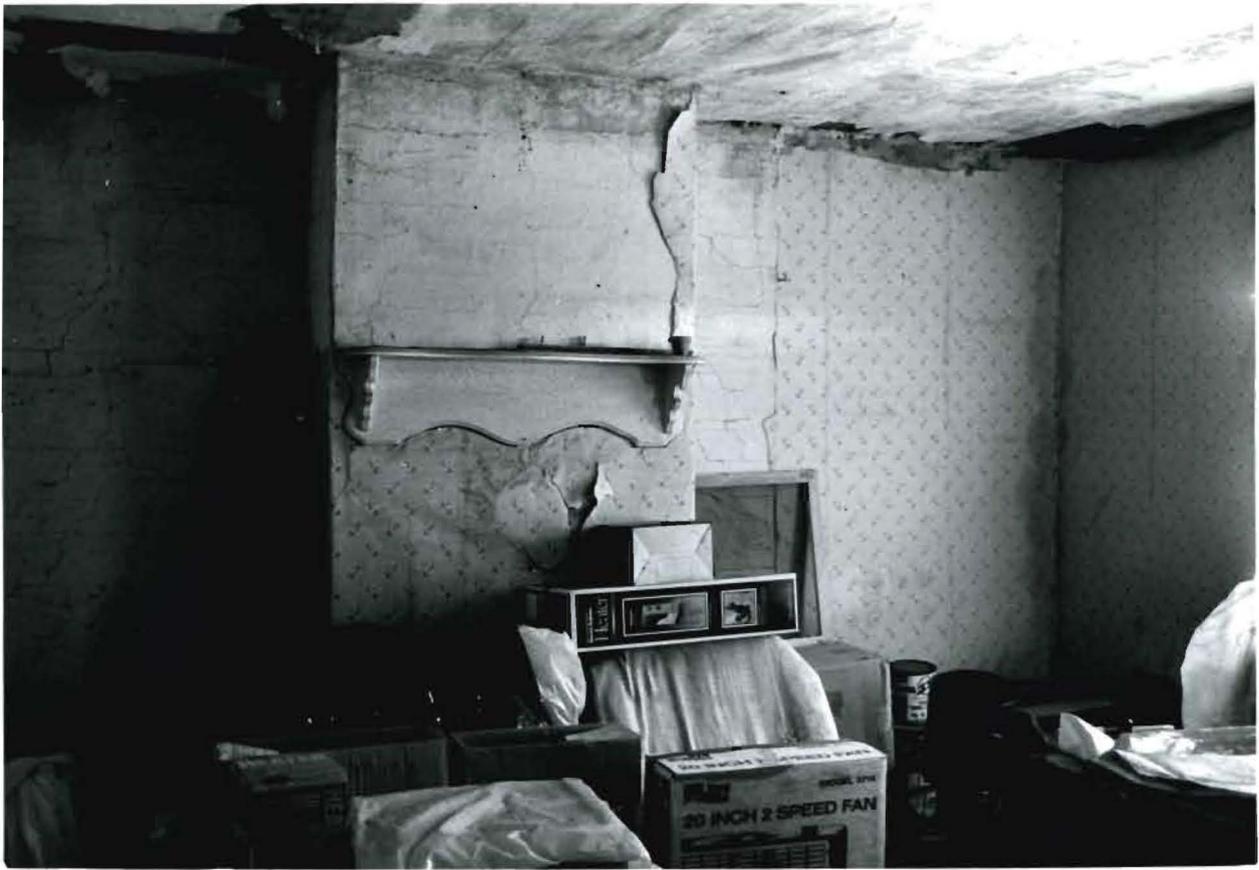
The "parlor" features a somewhat smaller chimney breast ornamented with a simple mantel shelf supported on shaped brackets (Plate 9). A thimble indicates prior use with a stove. Whether a hearth is enclosed beneath the paper and plaster could not be determined without destructive investigation.

PLATE 9: INTERIOR VIEW OF WARD FARMHOUSE "PARLOR" SHOWING CHIMNEY BREAST AND APPLIED MANTEL SHELF

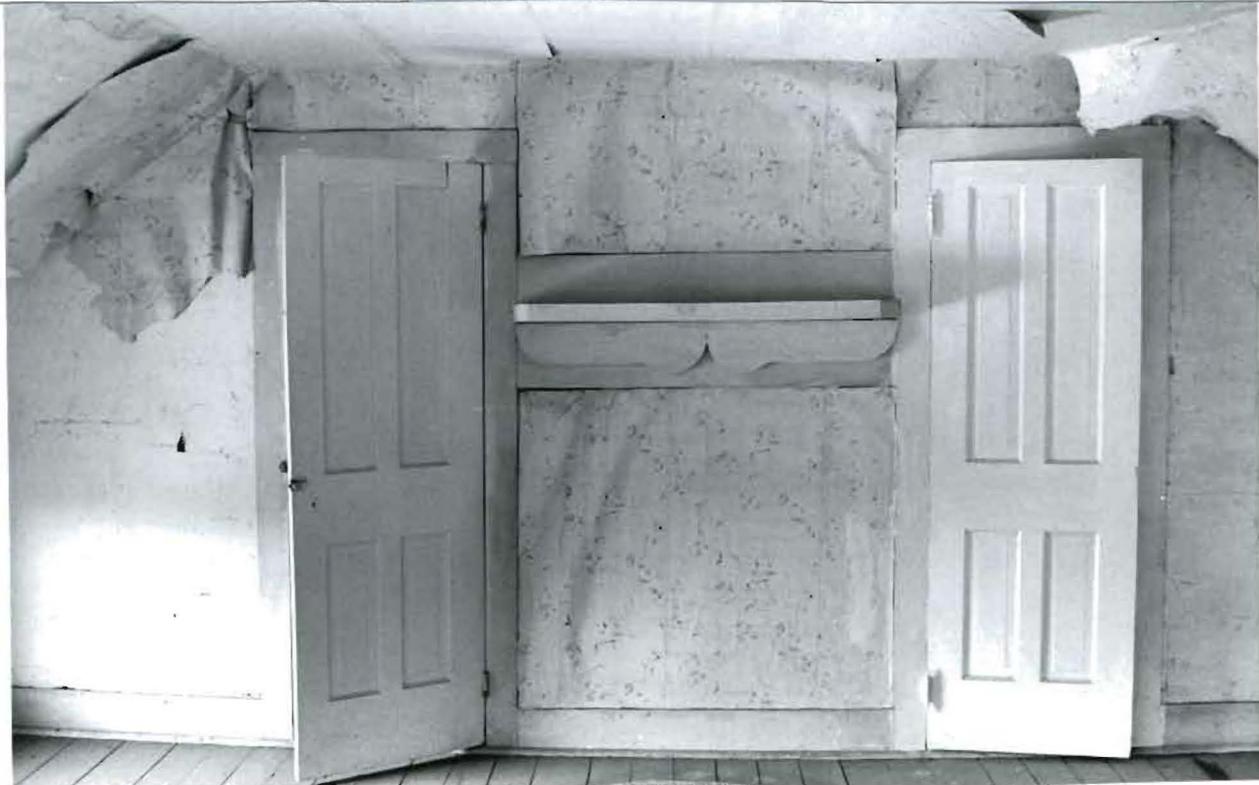
The attic is also divided into two rooms, the flooring and wall treatment essentially the same as that of the hall and parlor below. In the northeast room, the chimney breast features an applied mantel shelf and is flanked by closets with four-panel doors (Plate 10).

PLATE 10: INTERIOR VIEW OF WARD HOUSE, NORTHEAST ROOM ON UPPER FLOOR SHOWING CHIMNEY BREAST WITH MANTEL SHELF AND FLANKING CLOSETS
