3.0 RESULTS

3.1 Geomorphology

BRIDGE 146 RETAINING WALL
BRIDGEVILLE
SUSSEX COUNTY

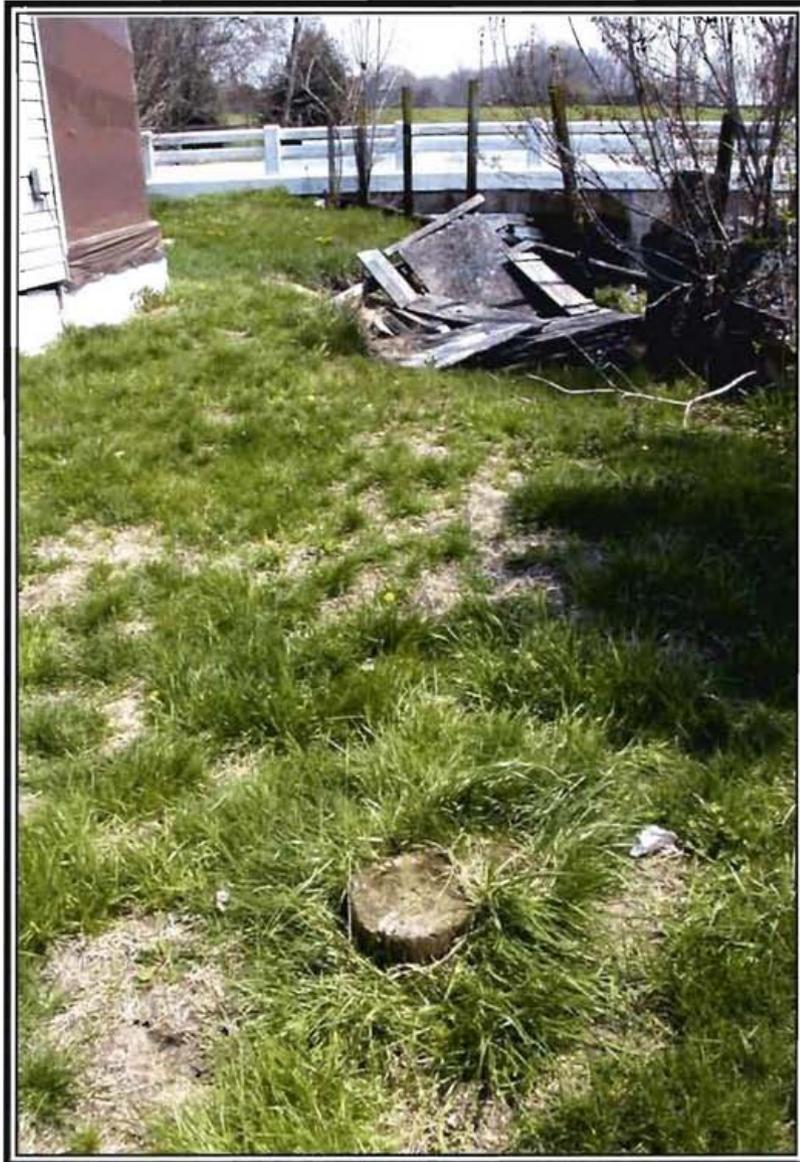
Photograph 5. View of one of two pilings located in the south yard of the house (S-4387), facing east.

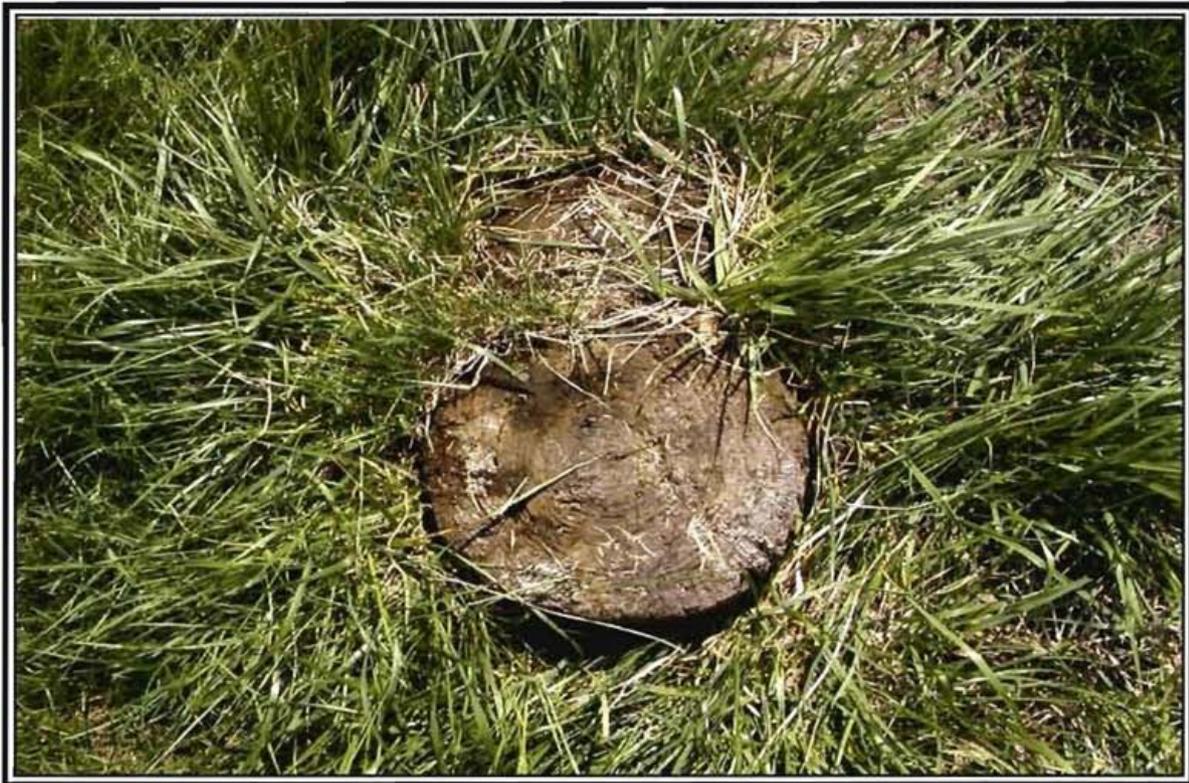
Photograph 6. Close view of one of the two pilings located in the south yard of the house (S-4387), facing south.

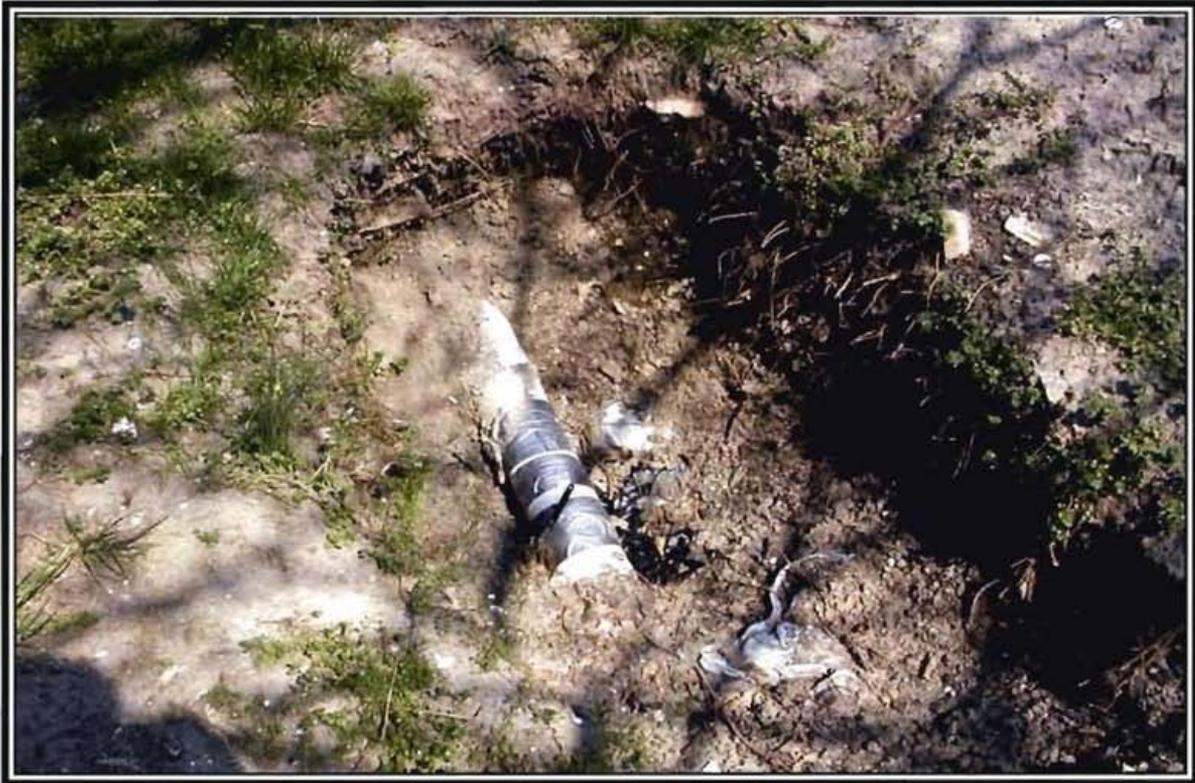
Photograph 7. View of the hole containing PVC piping located southwest of the house (S-4387), facing southwest.

The results of the expedient auger borings indicate that there is no potential for intact soils of appropriate age to contain precontact period archaeological deposits within the Bridge 146 Retaining Wall project APE. Four somewhat distinct but discontinuous fill layers were found within the stratigraphic profiles of the project APE. Fill Layer 1 is a 10YR 3/3 dark brown loamy sand with modern debris and an accumulation of organic matter (darkening the soil) from exposure at the present ground surface. Fill Layer 2 is a 7.5YR 4/4 brown sand mixed with 10YR 6/1 gray sand with brick and cinder fragments. Fill Layer 3 is a 10YR 6/1 gray sand mixed with 7.5YR 4/4 brown sand and ash fragments. Fill Layer 4 is an N 2/0 black sand with ash and brick fragments. These fill layers appear to be mixed, not directly deposited, and subsequently buried and preserved. Mixing of the fill may be the result of a combination of factors, including flooding, animal burrows, subsequent fill placement, and excavations for utility lines and poles, as well as the construction of stream erosion control structures such as the existing retaining wall. The presence of at least two large pilings set into the yard midway between the existing retaining wall and the house(S-4387) seem to confirm that filling of the site, in conjunction with maintenance of some sort of retaining wall, was a continual effort at this lot (Photographs 5 and 6). Therefore, the majority of the side yard, south of the house (S-4387), has been constructed with fill subsequent to the construction of the second retaining wall. In addition, to the southwest of the house (S-4387), a hole containing PVC

pipings was noted (Photograph 7). This appears to be a buried sewage/drainage pipe coming from the house (S-4387) to the stream.

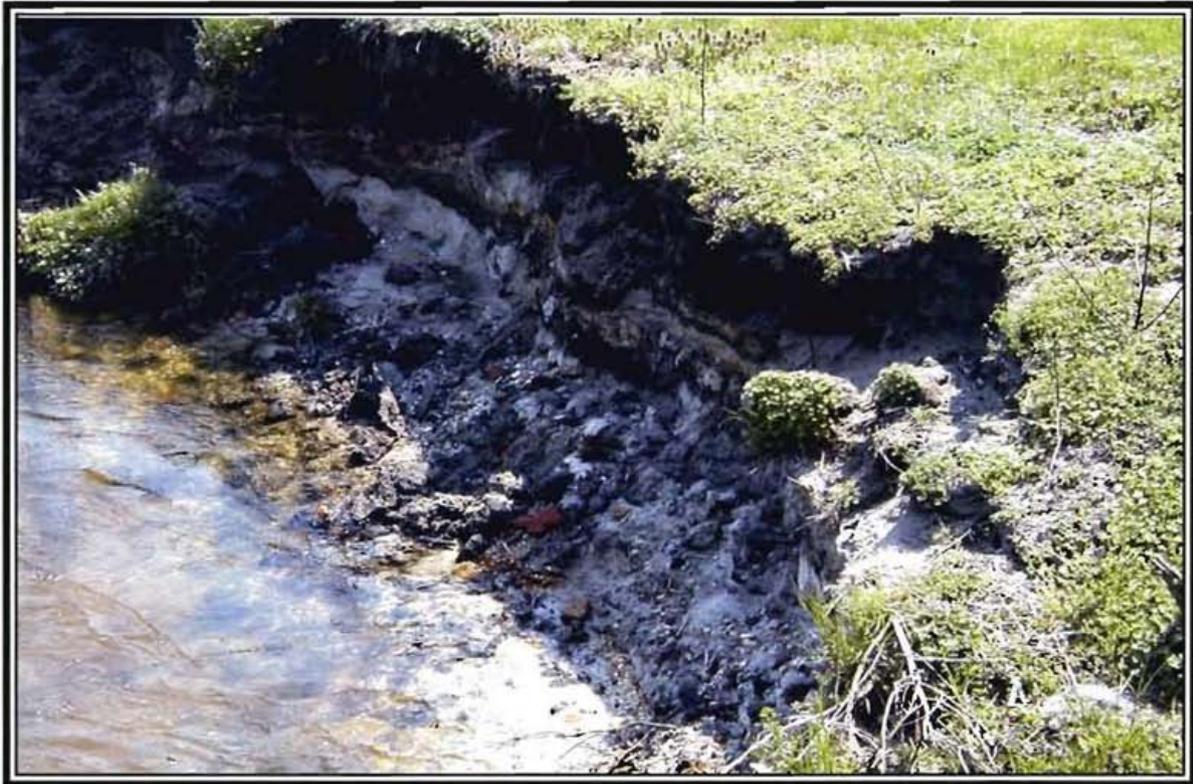
Photograph 8. View of the south stream cut bank located southeast of the project APE, facing north.

In the late nineteenth and early twentieth century, a brick manufacturing plant was operating within the area located across the creek and to the south of the project APE. The 1912 Sanborn maps of Bridgeville show F.L. Willey's brickyard located there (Sanborn Map Company 1912:Sheet 1). The brickyard produced bricks between 1897 and 1914 (Kurtze 1993a:4). It appears from the amount of brick fragments and coal and ash within the auger boring profiles that waste materials from the brick manufacturing process were used as fill throughout the area. This material, particularly when deposited across a floodplain landform, would have been eroded by naturally occurring floodwaters and lateral migrations of the creek. Placement of this manufacturing waste close to the creek bed would have resulted in flow restrictions within the channel bed and floodwater chutes, increasing the amount of scouring and redeposition of fill or sediment along banks and/or across the floodplain. This sequence is confirmed in the stream's southern cut banks where the stream bank profile can be seen (where the retaining wall is not located) (Photograph 8).

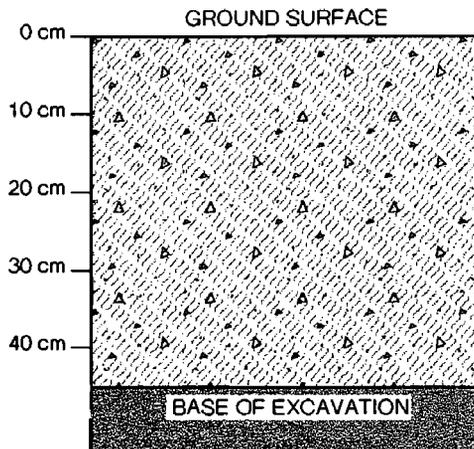
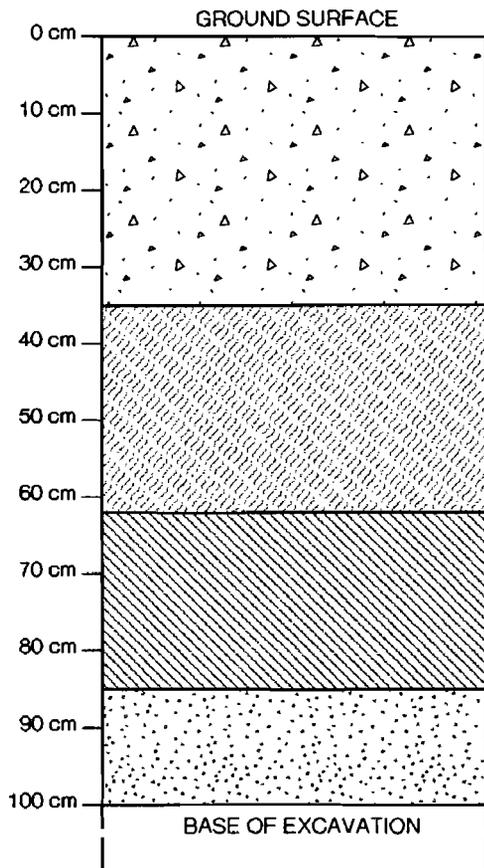
FIGURE - 4

SOIL PROFILE AUGER BORING 1

**Mixed
Fill Layers
1 & 2**

10YR 4/3 Brown and 7.5YR 4/4 Brown mixed sandy fill, with ash, brick, and coal fragments.

Auger refusal: coarse fill.

SOIL PROFILE AUGER BORING 2

Fill 1

10YR 3/3 Dark brown loamy sand, with fine glass and plastic fragments.

Fill 2

7.5YR 4/4 Brown sand, mixed with 10YR 6/1 Gray sand and brick and cinder fragments.

Fill 4

N 2/0 Black sand with ash and brick fragments.

C

N 8/0 White coarse sand.

SOIL PROFILES
AUGER BORINGS 1 AND 2

Specific descriptions of typical auger borings follow and are also presented in tabular format in Appendix B. Auger Boring 1 was taken east of the existing house (S-4387), within the front yard. This boring exhibits sandy fill mixed with ash, brick, and coal fragments, a combination of Fill Layers 1 and 2 (Figure 4). Auger refusal was encountered at a depth of 45.0 cm (17.7 in) below the modern ground surface. Additional borings within the front yard of the house (S-4387) were refused at this same depth or shallower, indicating fill across the area.

Auger Boring 2 was taken northwest of the house (S-4387), within the backyard. This auger boring exhibits Fill Layers 1, 2, and 4, underlain by the coarse white sand of the C horizon (Figure 4). Taken from a location southwest of the house (S-4387) and also in the backyard, Auger Boring 3 contained all four of the fill layers, and was also underlain by the white sand of the C horizon

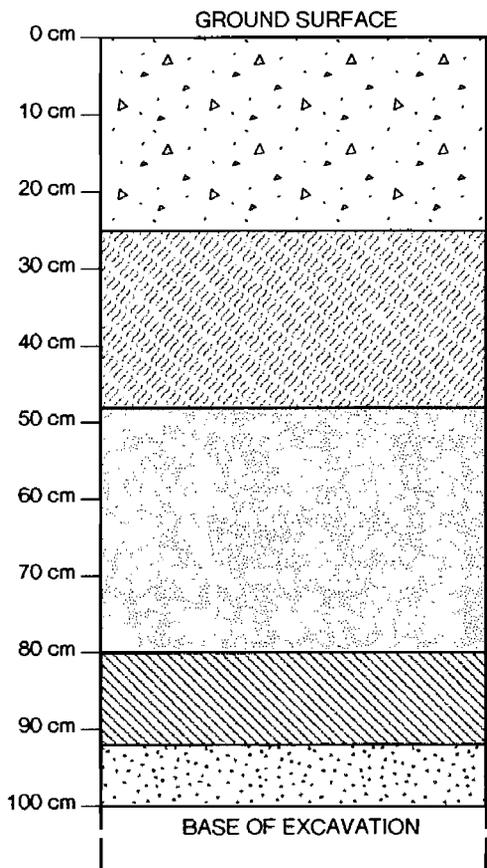
FIGURE - 5

Fill 1 10YR 3/3 Dark brown loamy sand, with fine glass and plastic fragments.

Fill 2 7.5YR 4/4 Brown sand, mixed with 10YR 6/1 Gray sand and brick and cinder fragments.

Fill 3 10YR 6/1 Gray sand, mixed with 7.5YR 4/4 Brown sand and ash fragments.

Fill 4 N 2/0 Black sand with ash and brick fragments.

C N 8/0 White coarse sand.

SOIL PROFILE
AUGER BORING 3

(Figure 5). Auger Boring 4, taken in the front yard southeast of the house (S-4387), exhibits Fill Layers 1 and 2, underlain by the white sand (Figure 6).

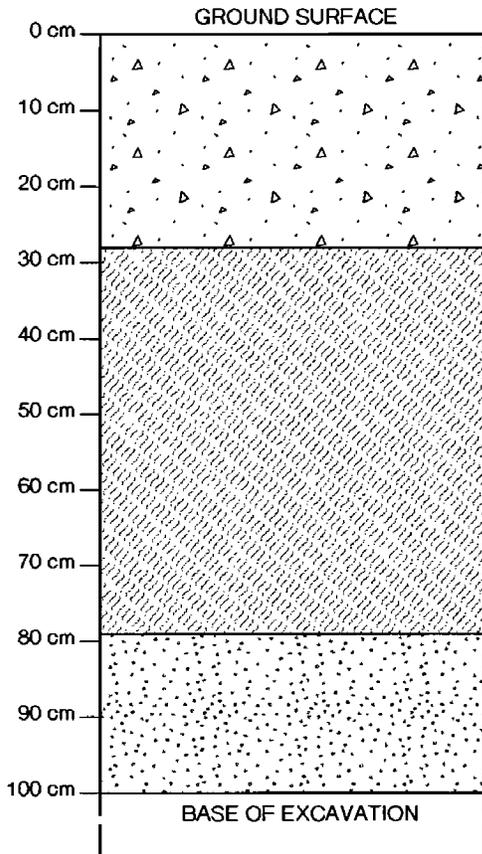
FIGURE - 6

Fill 1 10YR 3/3 Dark brown loamy sand, with fine glass and plastic fragments.

Fill 2 7.5YR 4/4 Brown sand, mixed with 10YR 6/1 Gray sand and brick and cinder fragments.

C N 8/0 White coarse sand.

SOIL PROFILE
AUGER BORING 4
