IV. ARCHEOLOGICAL INVESTIGATIONS

BRIDGE 305 OVER LITTLE CREEK
REPRESENTATIVE STP PROFILES

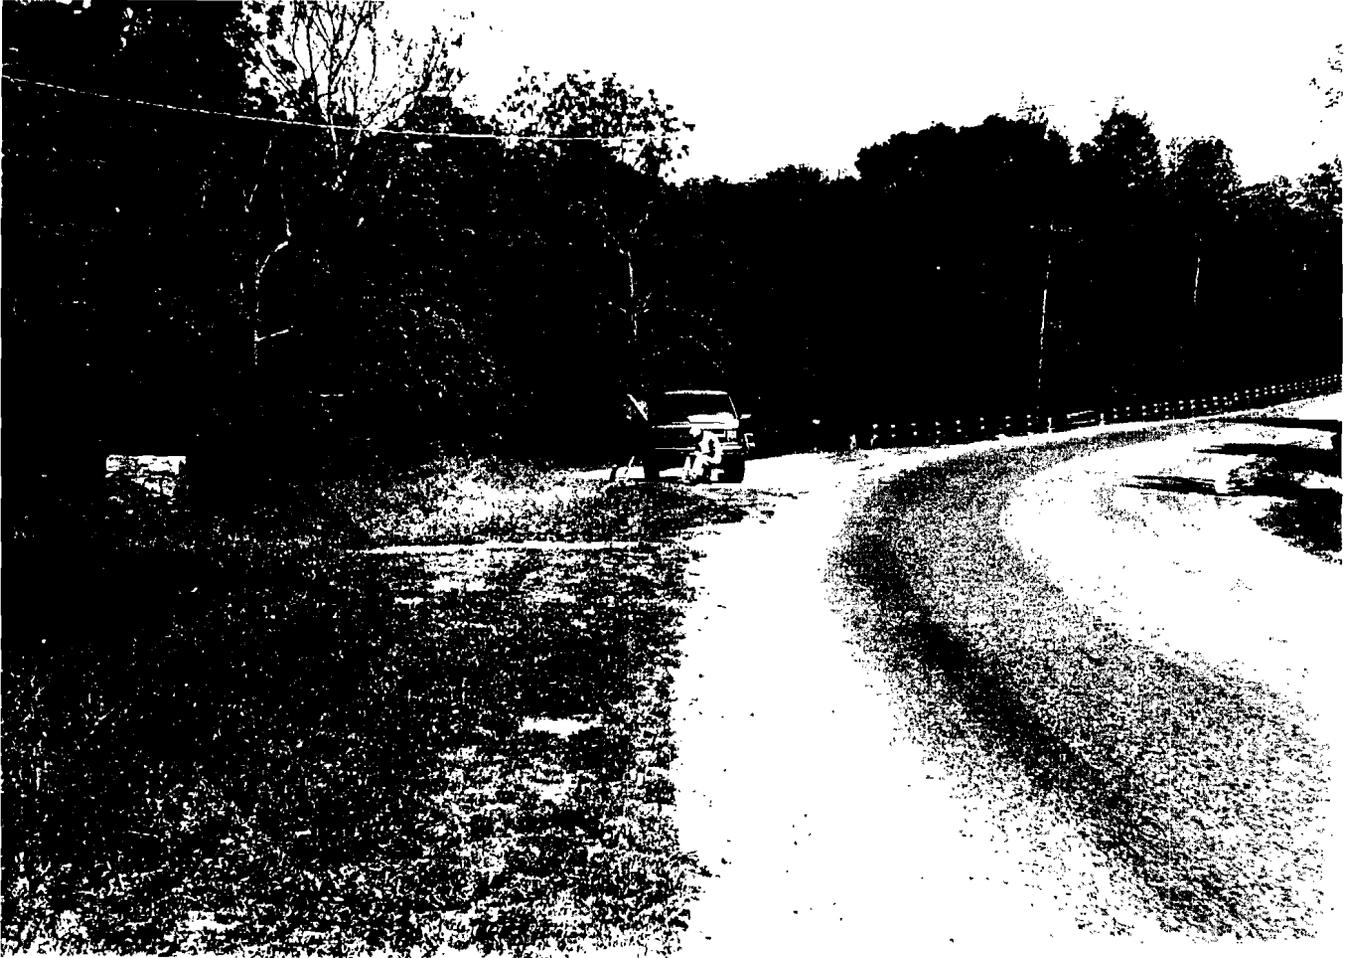
Ten systematic shovel test pits were excavated between Stations 0+180 and 0+230 (Figure 6) (Photograph 3). Three of these STPs were placed at 15-meter (49.2 feet) intervals along the south side of 6th Street. The remaining shovel tests were placed at 5-meter (16.4 feet) intervals in close proximity to the mill ruin on the north side of the road. Shovel testing consistently exposed deep modern fill deposits along both sides of the road within the project corridor. Representative profiles consisted of shallow topsoil deposits of dark grayish brown loamy sand fill overlying thick fill deposits measuring no less than 70 centimeters (2.3 feet) to one meter (3.3 feet) in depth (Figure 7). Occasionally, these deposits contained road gravel and modern artifacts. Four artifacts were collected during fieldwork, all from Shovel Test A-1 (Figure 6). These included one glass fragment, one brick fragment, and two unidentifiable metal fragments from fill soils and do not constitute significant cultural resources. The artifacts were discarded in the field.

Photograph 3. Area Selected for Shovel Testing at the Western Terminus of the Project Area. Looking East.

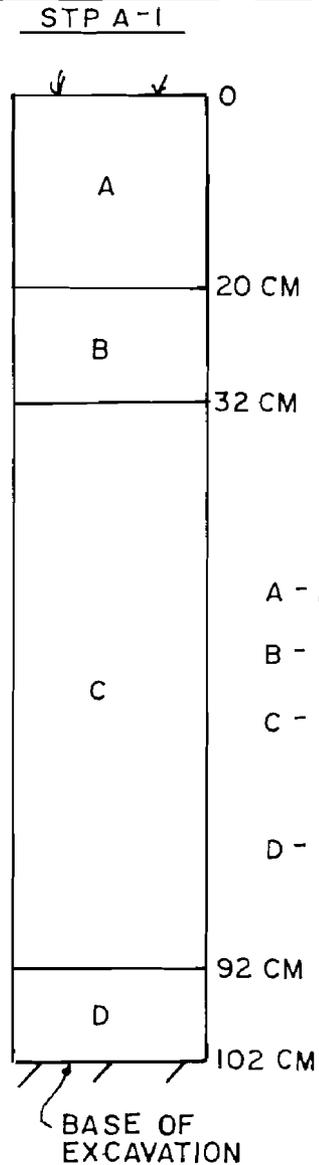
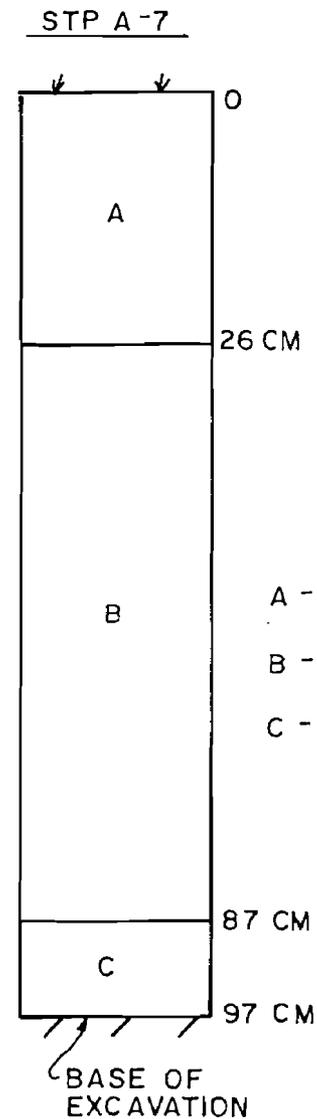
FIGURE 7

- KEY
- A - 10YR 4/2 DARK GRAYISH BROWN LOAMY SAND; FILL
 - B - 10YR 7/1 VERY PALE BROWN SAND; FILL
 - C - 10YR 5/3 BROWN SAND MOTTLED WITH 10YR 3/1 VERY DARK GRAY SAND; FILL
 - D - 10YR 7/6 YELLOW SAND; FILL

- KEY
- A - 10YR 4/2 DARK GRAYISH BROWN LOAMY SAND; FILL
 - B - 10YR 5/6 YELLOWISH BROWN SAND; FILL
 - C - 10YR 8/3 VERY PALE BROWN CLAYEY SAND; FILL
