III. PHASE I ARCHEOLOGICAL SURVEY

GAI conducted the Phase I archeological survey of the Bridge 4A project area from May 4 to 6, 1998. This work included a pedestrian reconnaissance, followed by subsurface survey to identify potentially significant archeological resources that could be affected by the project construction.

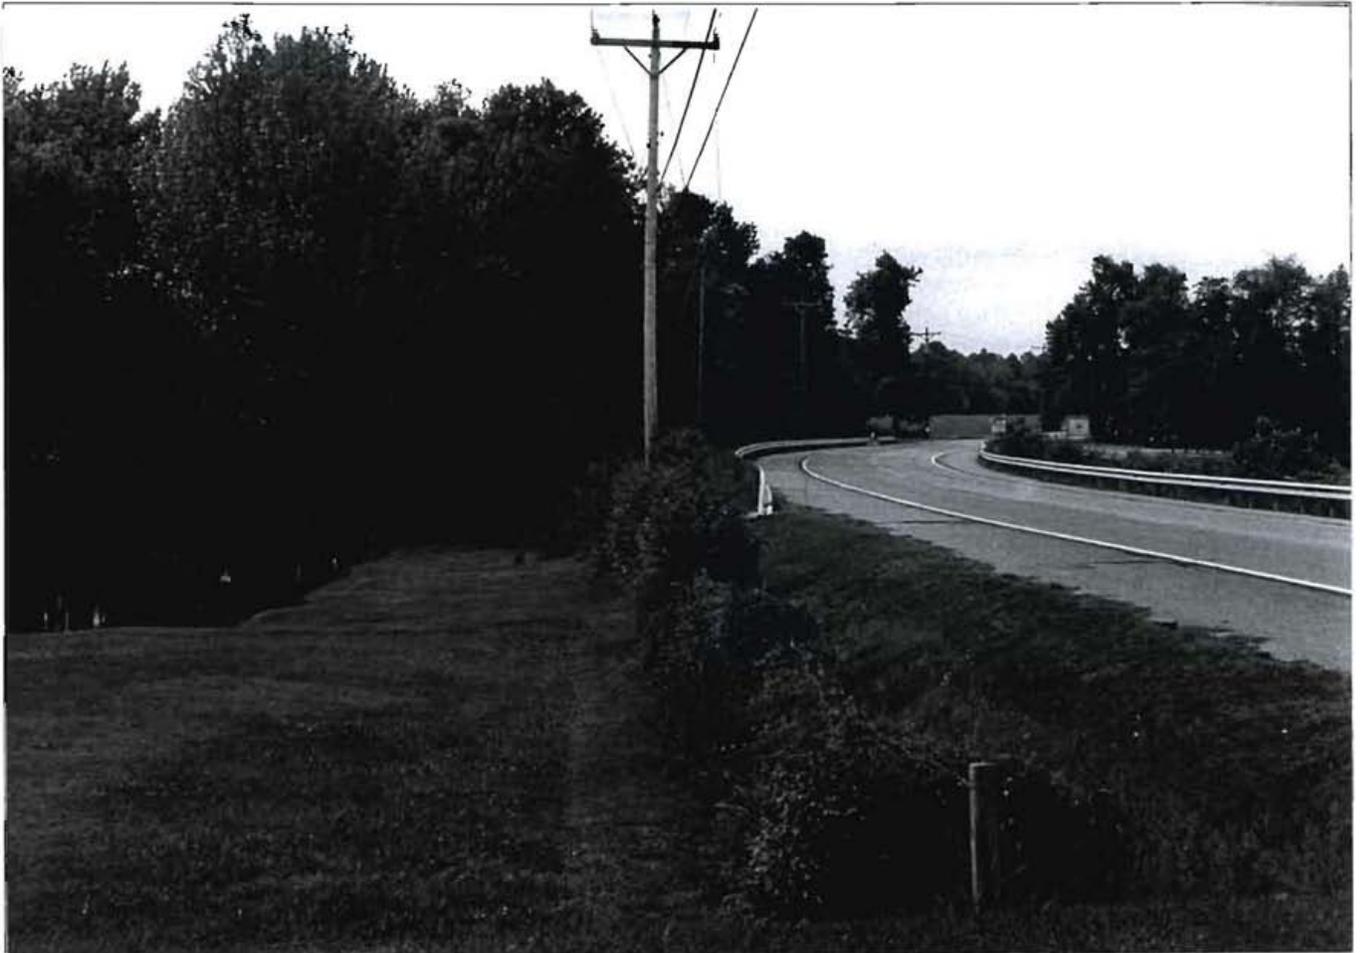
Photograph 1. Road prism along east side of Route 13A, northern terminus of the project corridor. Looking south.

The preliminary inspection revealed a number of locations that could be omitted from further survey due to recent disturbance or poor drainage. The project corridor crosses the shallow valley of Tidbury Creek immediately below Derby Pond. The margins of the creek are low and marshy, and the roadbed supporting Bridge 4A and the roadway approaches on Route 13A consists of a prism that measures 1.0 meter deep or more, particularly north of the bridge (Photograph 1).

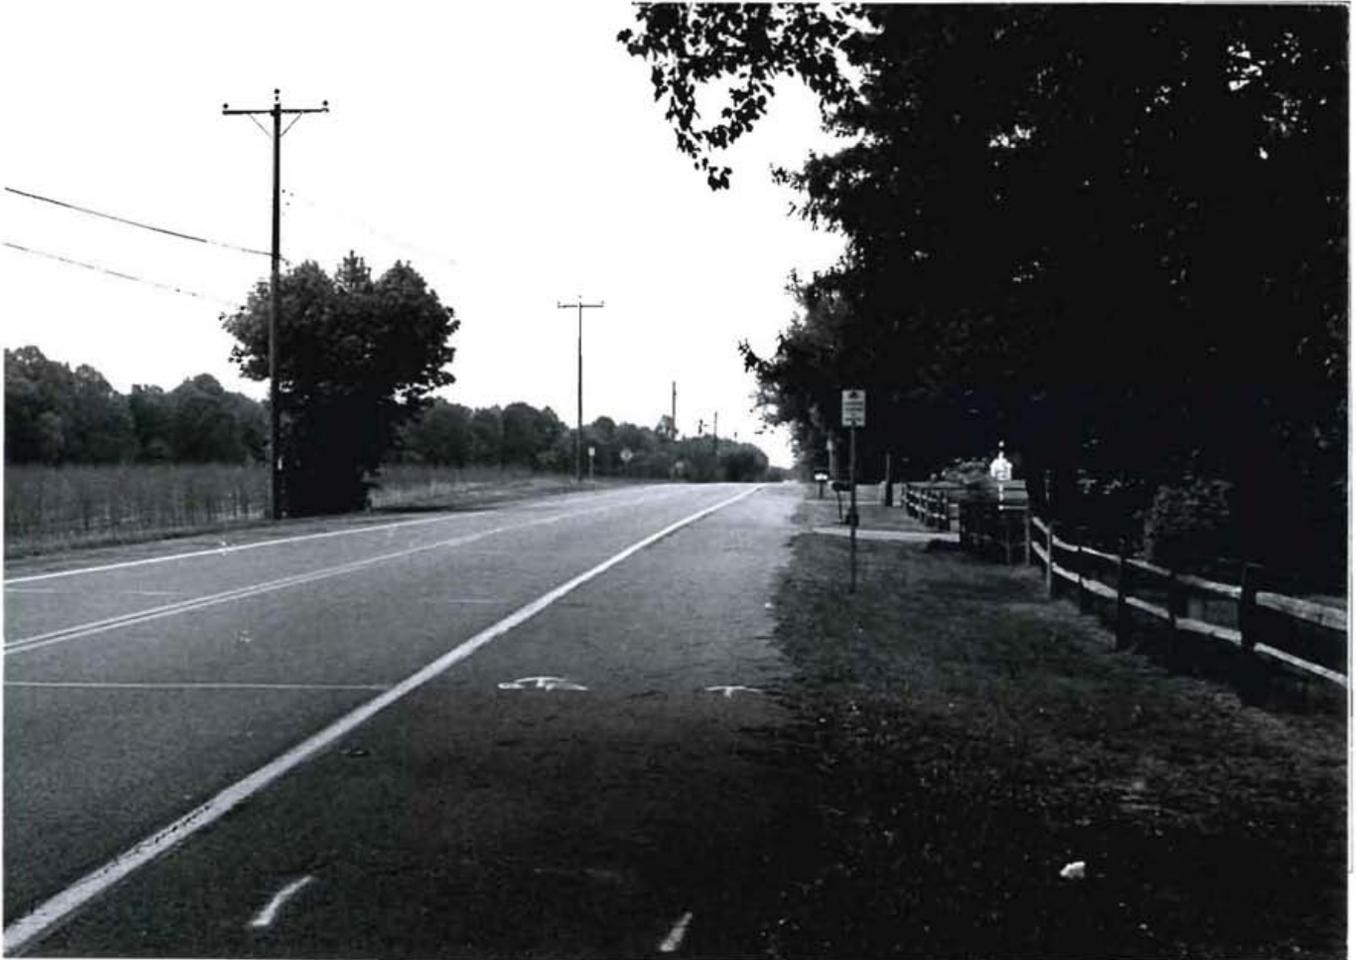
Here, much of the road apron extends to the margins of the ROW, leaving few undisturbed or unfilled areas for testing except in locations where the road grade lies close to the natural grade. Such locations were present only in the southern portion of the survey corridor on the east side of Route 13A, between Stations 1+000 and 1+170. This area lay in an agricultural field (Figure 4; Photograph 2).

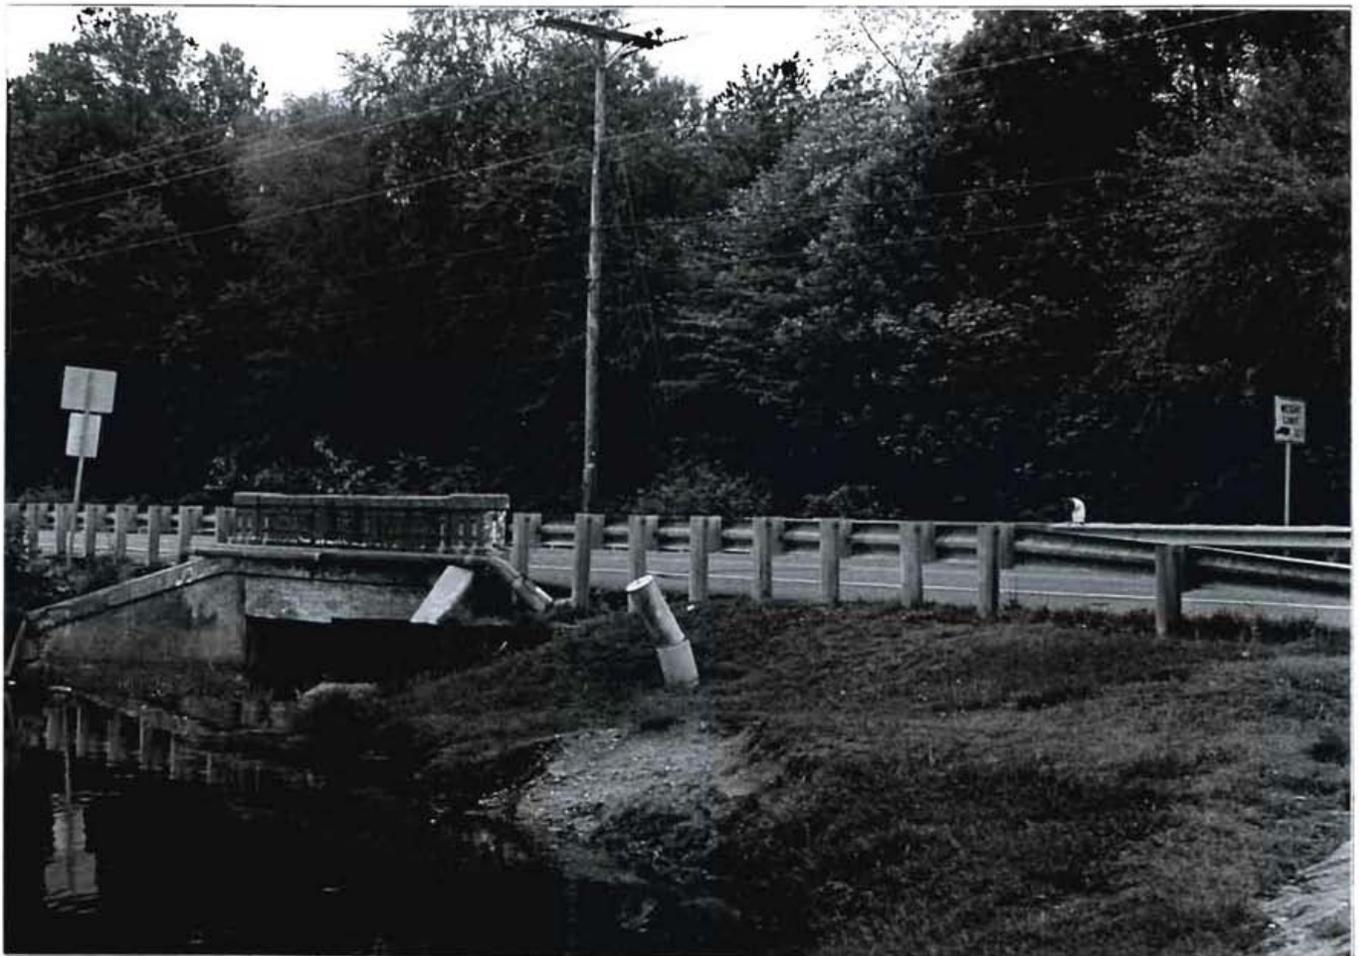
Photograph 3. Eastern shoreline of Derby Pond and adjoining western margin of the project area at Bridge 4A, showing the artificial embankment. Looking northeast.

On the west side of Route 13A, from Bridge 4A north to Station 1+270, the APE consists of road fill prism fronting Derby Pond, and wetlands (Photograph 3). South of Bridge 4A and west of Route 13A, between Stations 1+000 and 1+100, areas inside the ROW exhibited disturbance from residential and recreational development: a paved parking lot adjacent to the south shore of Derby Pond, and south of this lot, a residential yard (Photograph 4). From Stations 1+270 to 1+290, areas on the west side of the road were poorly drained and stagnant. Low terrain and poorly drained soils flanking Tidbury Creek were also found east of Route 13A between Stations 1+175 and 1+280. An artificial pond centered at Station 1+230 and a gravel driveway north of the pond at Station 1+280, indicated recent disturbance (see Photograph 1). A second artificial pond lay 30 meters east of the project ROW at approximately Station 1+160.

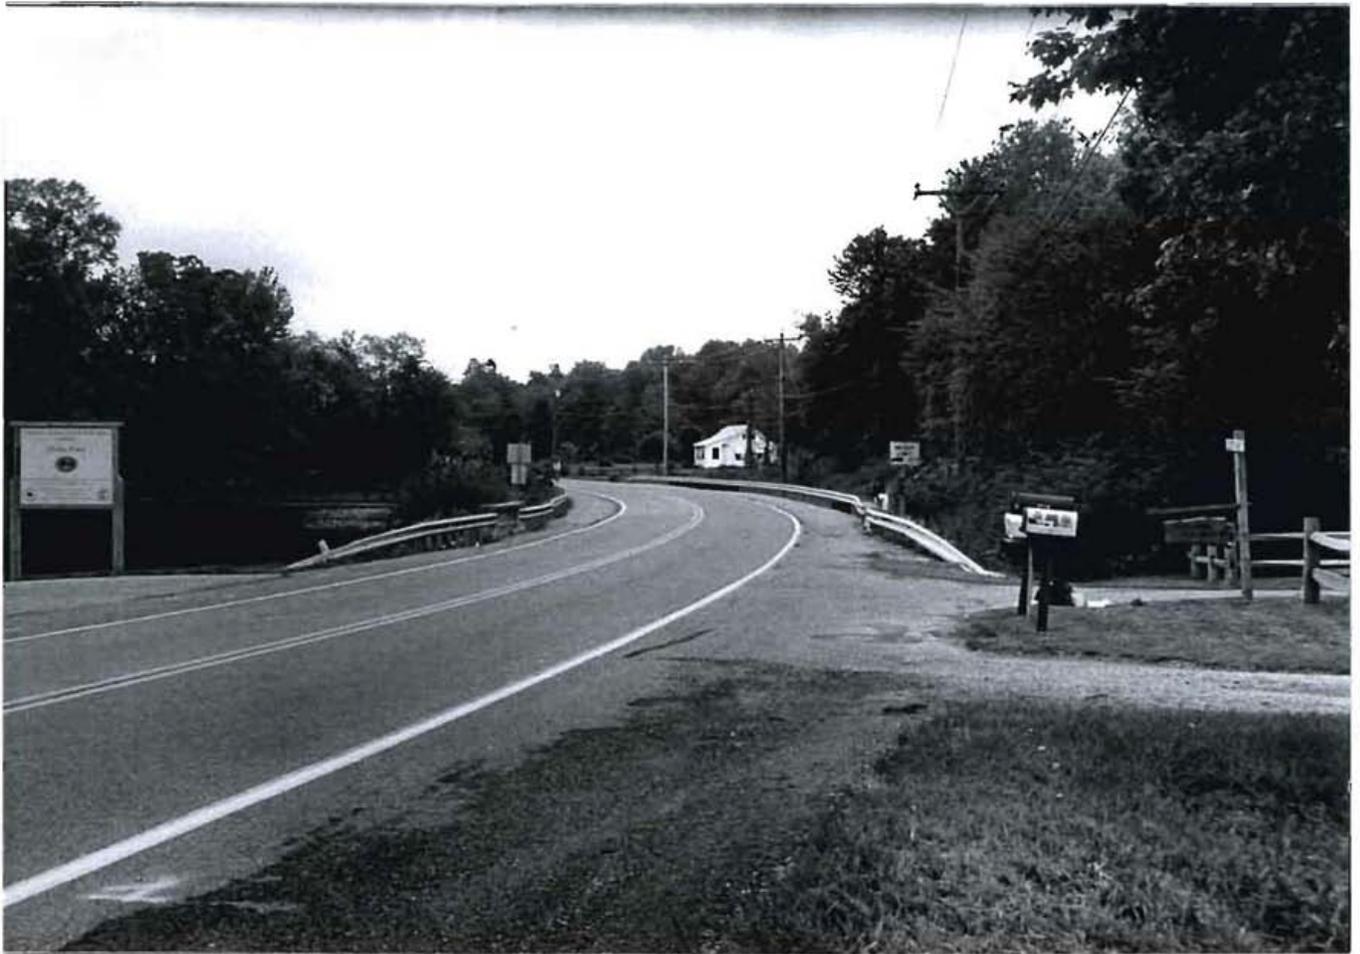
Photograph 4. Recreational and residential land use south of Bridge 4A. Looking south.

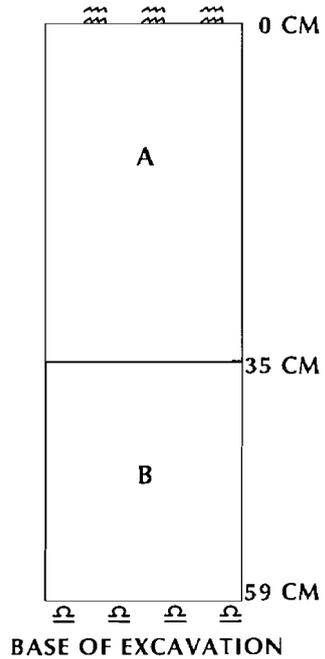
STP A-1

- A = 10YR 3/2 VERY DARK GRAYISH BROWN SANDY LOAM (FILL)
- B = 10YR 5/6 YELLOWISH BROWN SAND (B OR C HORIZON)

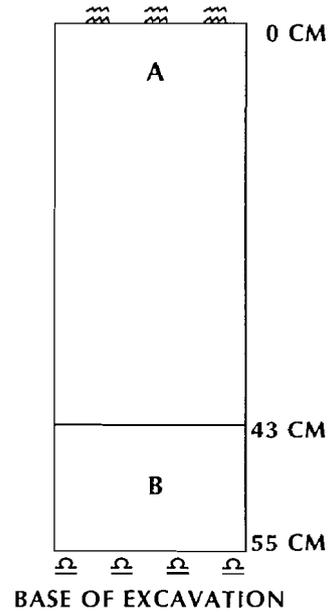
STP C-1

STPs excavated at the berm that extends east of the project area exposed very dark grayish-brown sandy loam above yellowish-brown sand. The upper deposit probably represents fill or a mixture of fill and natural A-horizon topsoil. The lower stratum, encountered at 35 centimeters below surface, appeared to reflect B- or C-Horizon soils (Figure 5, STP A-1). Testing in the area north of the berm and adjacent to the road prism exposed a 43-centimeter thick deposit of dark grayish-brown sandy loam that probably constitutes mixed fill and A-Horizon soils. This material lay above light yellowish-brown sand that represents a B or C Horizon (Figure 7, STP C-1).

- A = 10YR 4/2 DARK GRAYISH BROWN SANDY LOAM (FILL AND/OR A HORIZON)
- B = 10YR 6/4 LIGHT YELLOWISH BROWN SAND (B OR C HORIZON)

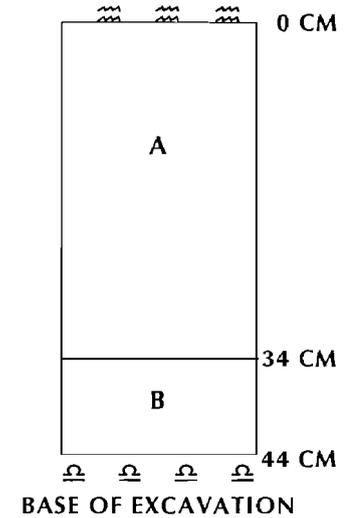
STP C-2

In general, the shovel testing revealed disturbed or truncated stratigraphic profiles along the project ROW. Typically, STP profiles along the road exhibited a plowzone of dark grayish-brown sandy loam above truncated, often gleyed C-horizon soils of dark gray sand (Figure 7, STP C-2). In some instances, further disturbance or redeposited soil was noted as a result of road or driveway construction. Artifacts from these STPs came from the uppermost soil deposits and consisted of modern materials. A total of five items were recovered from four STPs (C-8, C-9, C-10, and C-11): one wire nail, one fragment of non-diagnostic brown glass, one plastic wrap fragment, and two pieces of Styrofoam. These items were interpreted as casual discard, and were not retained for laboratory processing. They do not constitute archeological resources.

- A = 10YR 3/2 VERY DARK GRAYISH BROWN SANDY LOAM (A OR Ap HORIZON)
- B = 2.5Y 4/1 DARK GRAY SAND (Cg HORIZON)

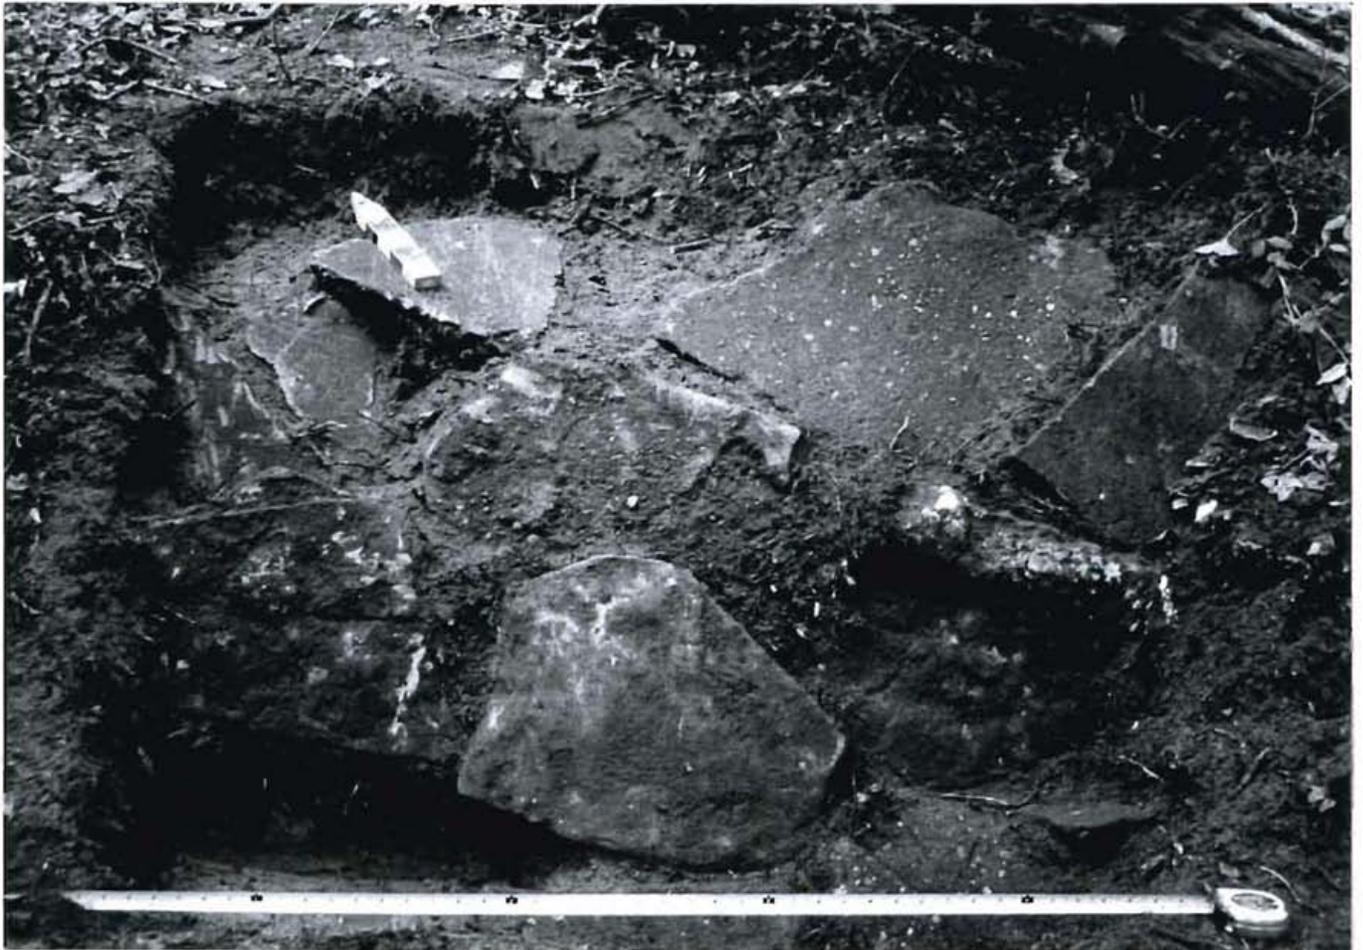
Test Unit 2, located at the berm's southeastern corner, encountered a 50-centimeter-deep deposit of light yellowish-brown sand containing concrete and stone rubble (Photograph 5). This stratum comprised a fill deposit that lay above a gray sand gleyed C Horizon. Probing of the adjacent area indicated that this deposit of rubble extended roughly 1.5-meters to the west (toward Route 13A) and continued east into the streambed where additional rubble deposits were visible. The total area covered by this rubble measures roughly 5x 5meters.

Photograph 5. Stone and concrete fill, exposed in Test Unit 2. Looking northeast.

The distribution of this rubble suggests a discrete deposition event. The stratigraphy within the berm exposed by shovel testing and TU 1 further indicates that the overall berm landform probably represents a natural levee. The rubble encountered at its eastern terminus may represent an attempt to enhance this natural landform with rubble spoil to divert the stream flow for the former mill site. However, no verification of this interpretation was found in the historic map data or in informant interviews. The rubble may instead relate to road construction activities in the 1970s, as reported by Mr. Sam Cronus.

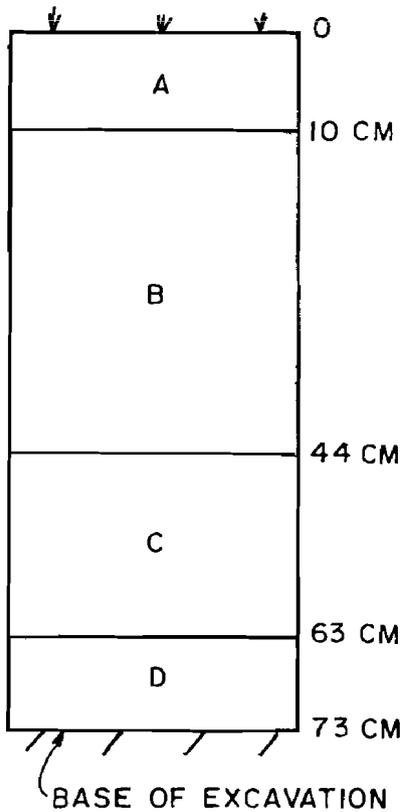
FIGURE 8

The test units on the berm generated similar stratigraphic data as the shovel tests. Test Unit 1, on the north flank of the berm, exposed a shallow, recent A horizon above a 34-centimeter thick deposit of brown loamy sand that probably represents a mixed fill and A/C Horizon. This material capped yellowish-

brown sand that graded down to a mottled deposit of light yellowish-brown sand, grayish-brown sand, and yellowish-brown sand. These last two strata appeared to represent C Horizon soils (Figure 8).

- A - 10YR 3/2 VERY DARK GRAYISH BROWN SANDY LOAM (A HORIZON)
- B - 10YR 4/3 BROWN LOAMY SAND (AC HORIZON)
- C - 10YR 5/6 YELLOWISH BROWN SAND (C1 HORIZON)
- D - 10YR 6/4 LIGHT YELLOWISH BROWN SAND MOTTLED WITH 10YR 5/2 GRAYISH BROWN SAND AND 10YR 5/6 YELLOWISH BROWN SAND (C2 HORIZON)

BRIDGE 4A PROJECT,
PROFILE OF TEST UNIT I
