## 2.0 HISTORY OF RESEARCH

### **2.3 Construction Monitoring and Archaeology at the Reynolds Mill Site (7S-C-99)**

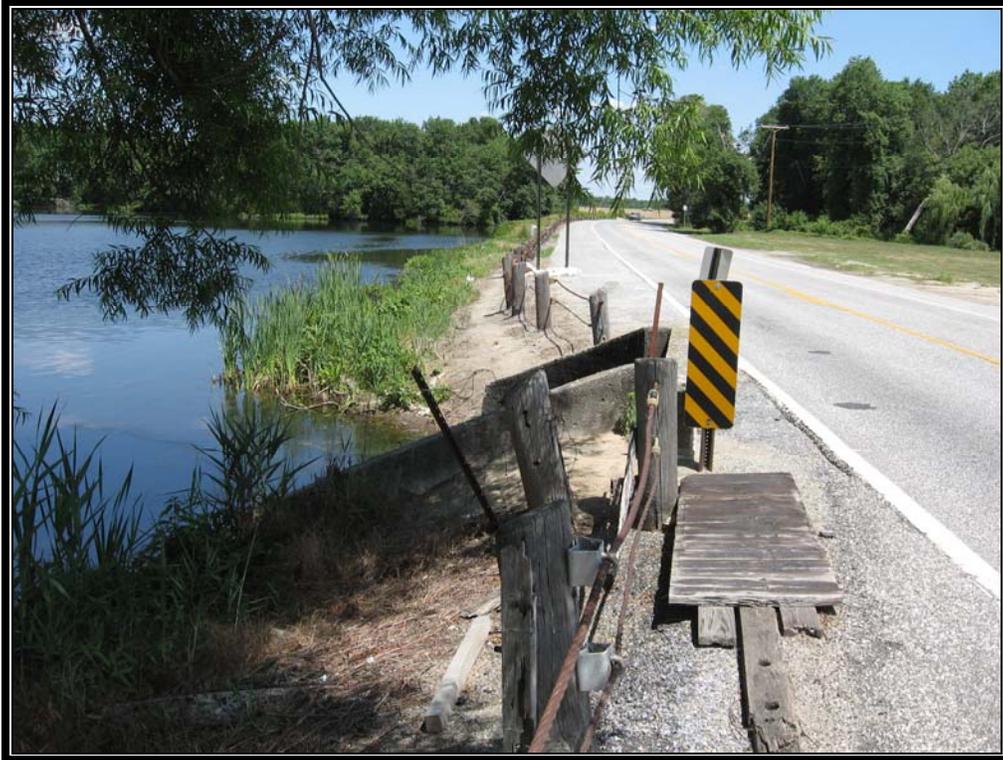
*Photograph 4. View of west side of Bridge 918 at gate, facing north.*

The Bridge 918 project Area of Potential Effects (APE) includes all areas in which potential ground disturbance related to the proposed construction may occur. FHWA/DelDOT and SHPO established the proposed project's APE to include those areas within the limits of construction (LOC), temporary construction easements (TCE)/permanent easements (PE), right of way (ROW), and/or wetland mitigation sites as well as adjacent or contiguous properties where visual effects occurred. Skelly and Loy was advised of the APE boundaries both verbally and on mapping provided by DelDOT. The entire APE, including the existing gate, bridge, and outlet, was considered during the cultural resources investigations and all of Skelly and Loy's cultural resources investigations were completed within the defined APE (Photographs 4, 5, 6, 7, and 8).

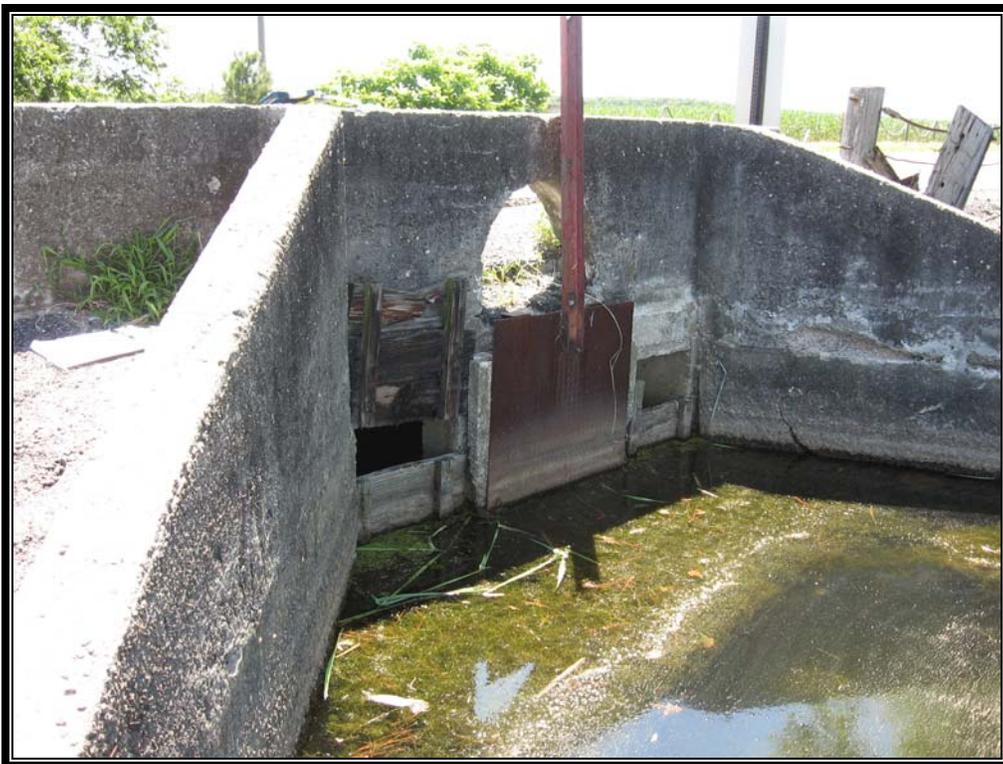
*Photograph 5. View of gate and culvert, facing southeast.*

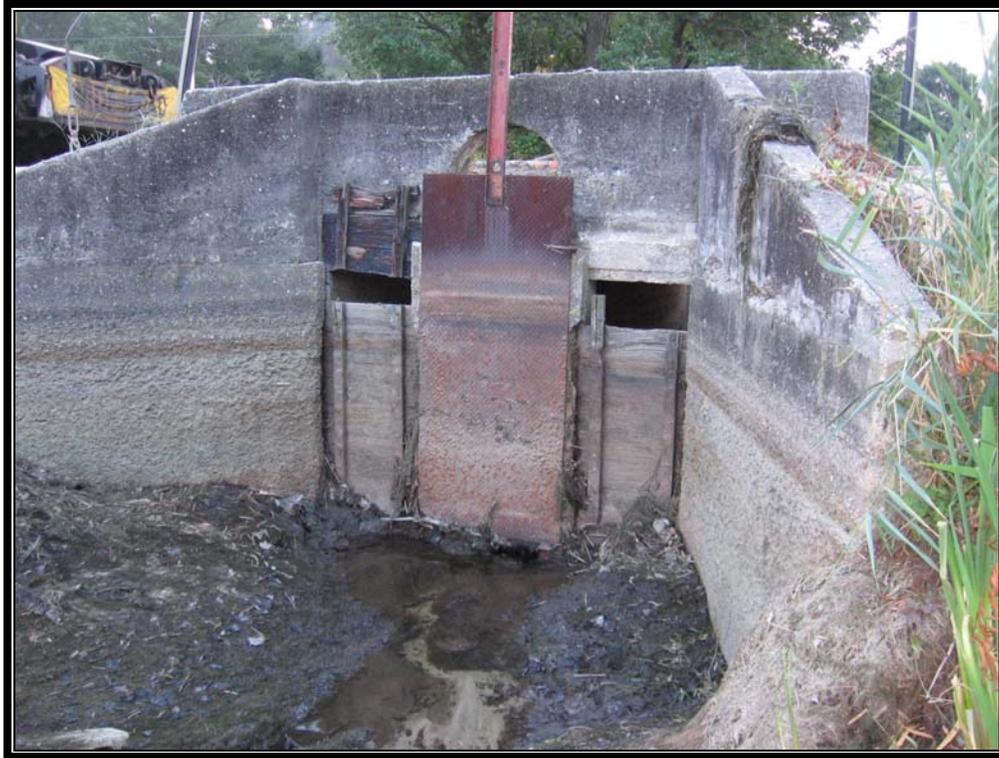
*Photograph 6. Close-up view of gate with water drawn down, facing north/northeast.*

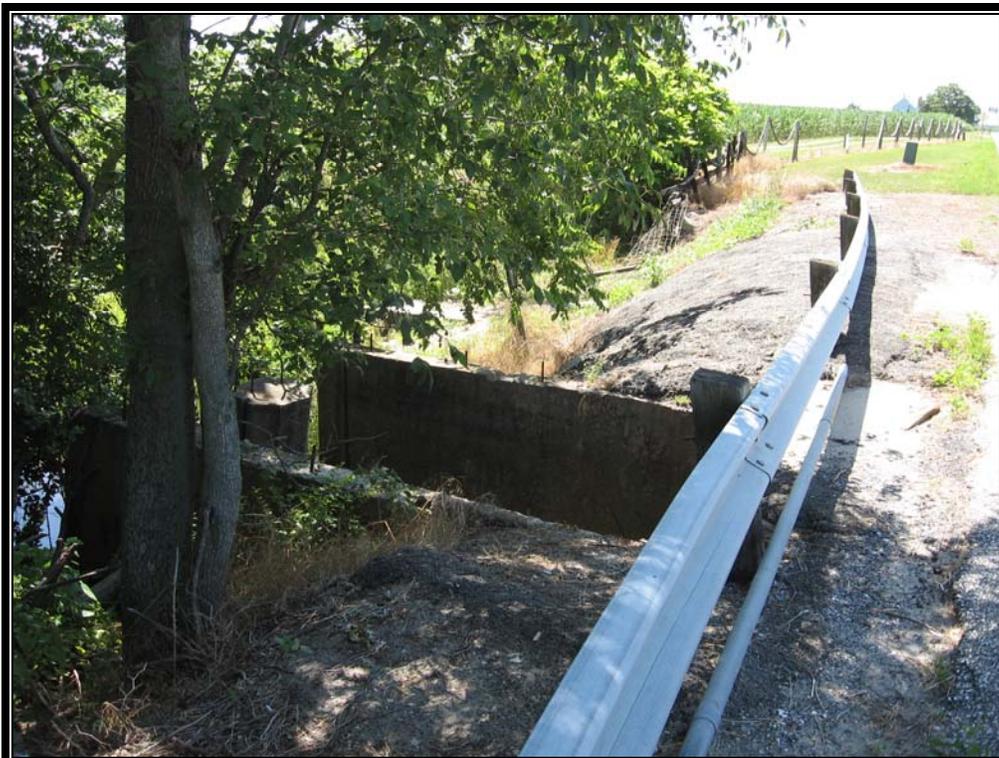
*Photograph 7. View of east side of Bridge 918 at outflow, facing south/southeast.*

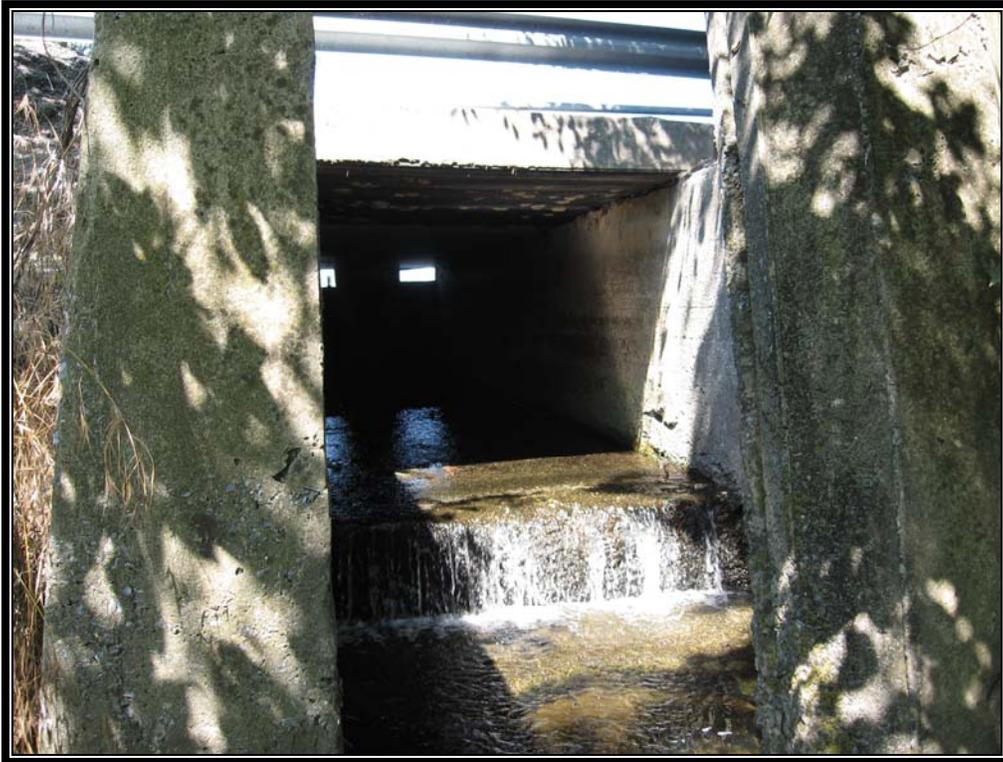
*Photograph 8. Close-up view of interior of culvert and outflow, facing west.*

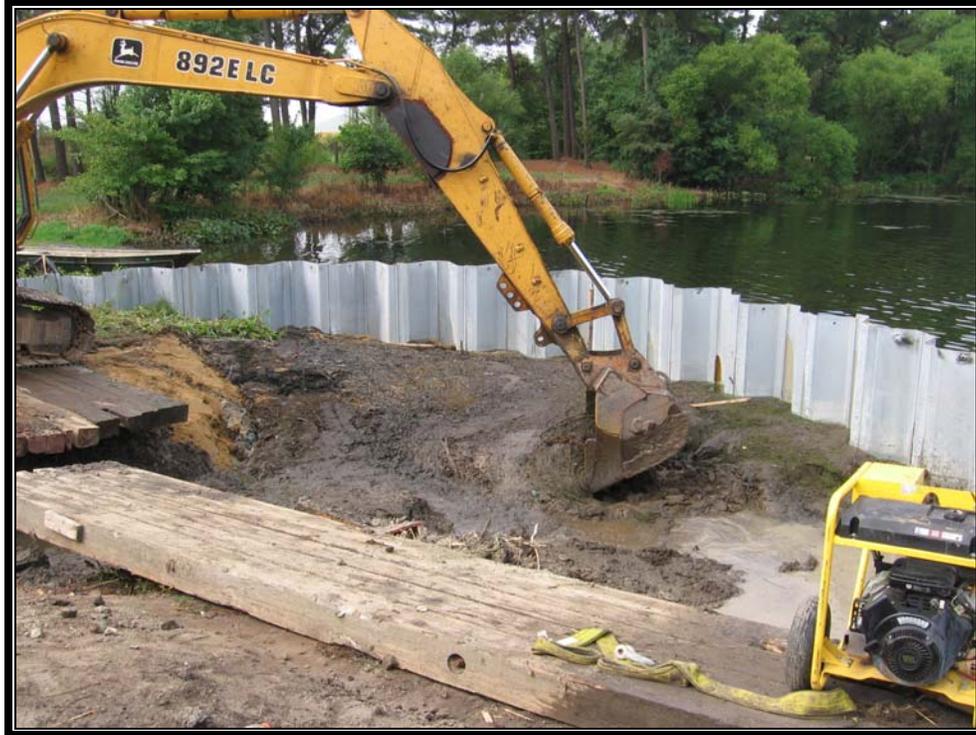
*Photograph 9. Building the coffer dam prior to removal of the bridge and culvert, facing west/southwest.*

Due to the construction techniques, which had to be used during demolition of the ca. 1925 structures and emplacement of the new box culvert, the documentation of the archaeological resources located at the bridge site had to be done concurrently with the demolition/construction (Photographs 9, 10, 11, 12, 13, and 14). As per the MOA, after consultation with the SHPO, the archaeological remains were presumed to be significant and eligible for listing in the National Register of Historic Places (NRHP) for the purposes of Section 106. This allowed the archaeological research, which started as demolition monitoring, to expand into full-scale data recovery, as per the treatment plan, with no delays to the construction schedule.

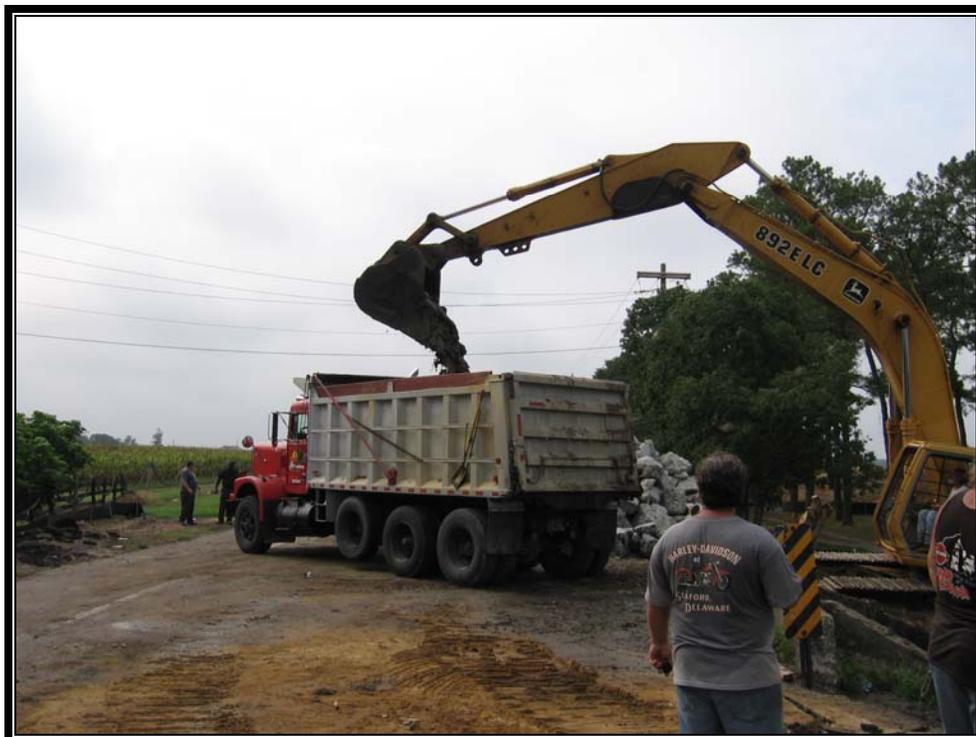
*Photograph 10. Loading the dump truck with debris as demolition of the bridge and culvert continues, facing south.*

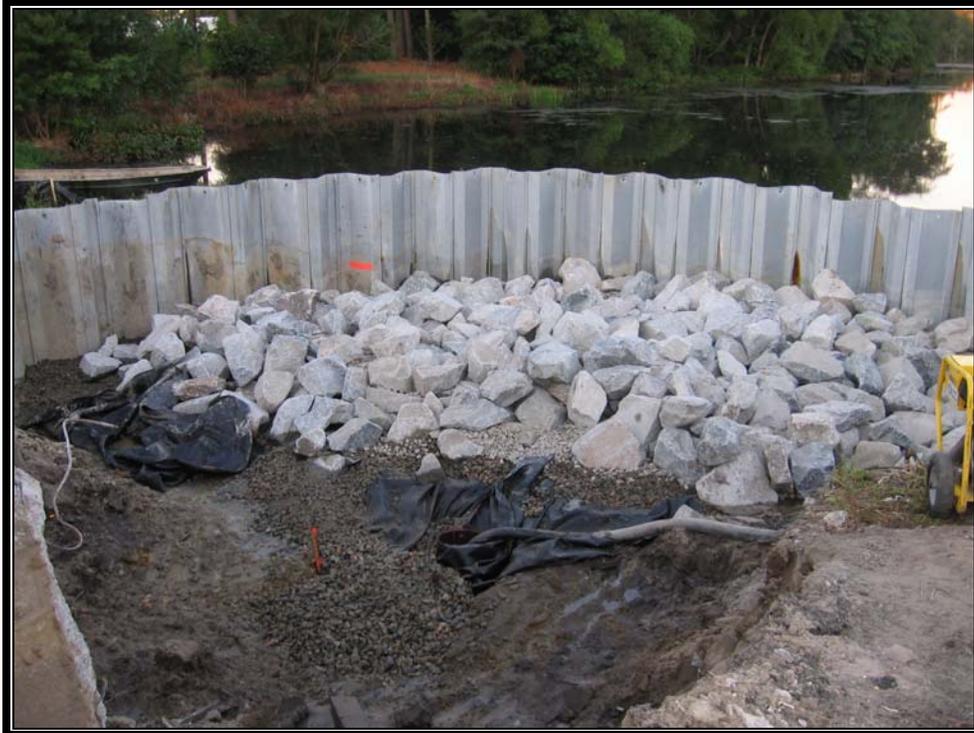
*Photograph 11. Finished coffer dam used to prevent water from inundating the project site and to manage water flow, facing west.*

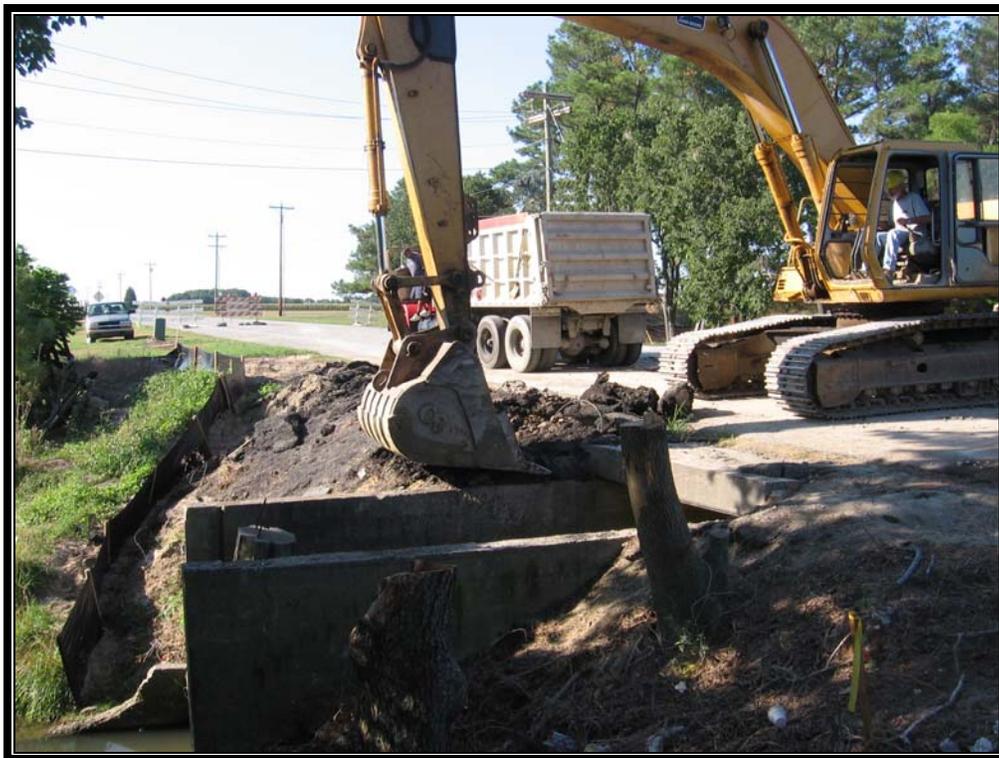
*Photograph 12. Beginning demolition on bridge, roadway, and culvert, facing north.*

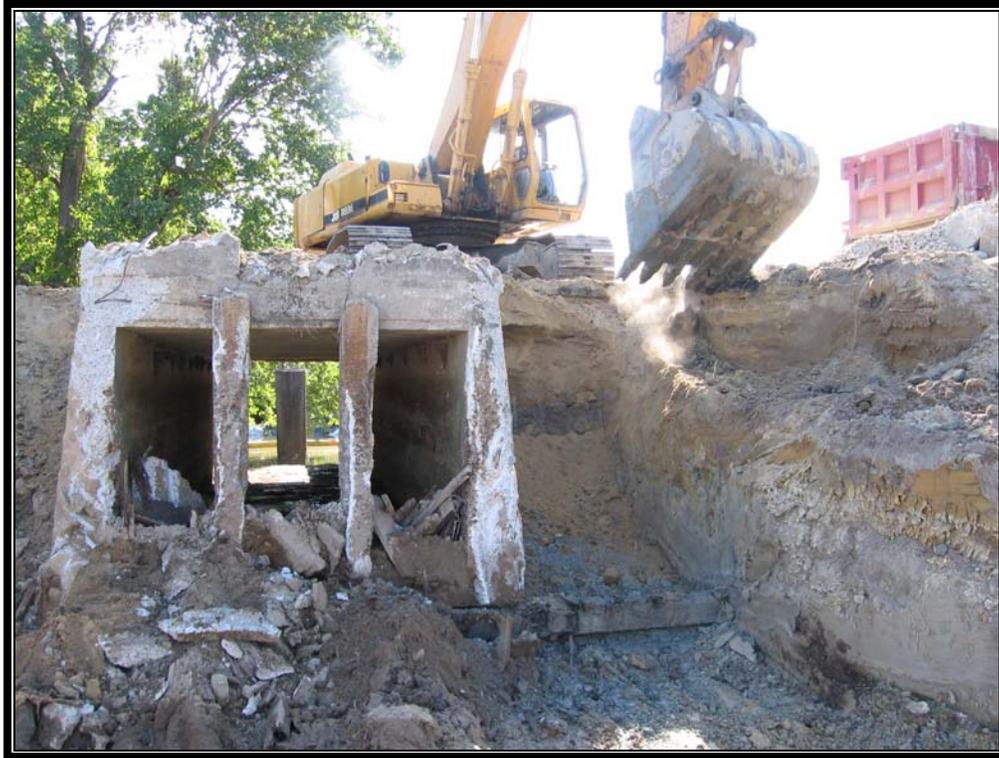
*Photograph 13. Demolition on culvert, facing east.*

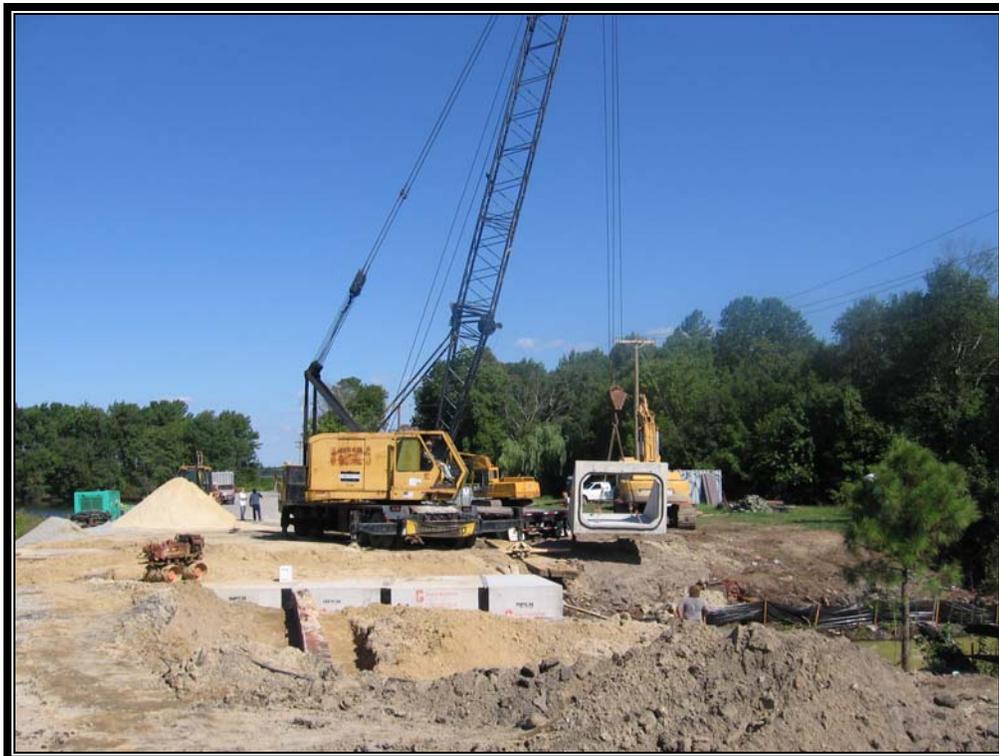
*Photograph 14. Preparing to emplace the new culvert, facing north.*
