DELAWARE DEPARTMENT OF TRANSPORTATION	
BRIDGE 362 AT CHIPMANS POND BROAD CREEK HUNDRED SUSSEX COUNTY	
PROJECT AREA IN 1955	
FIGURE - 8	SKELLY and LOY Inc. CONSULTANTS IN ENVIRONMENT ENERGY ENGINEERING - PLANNING

4.2.7 Bridge 362 Over Chipmans Pond (S-11421)

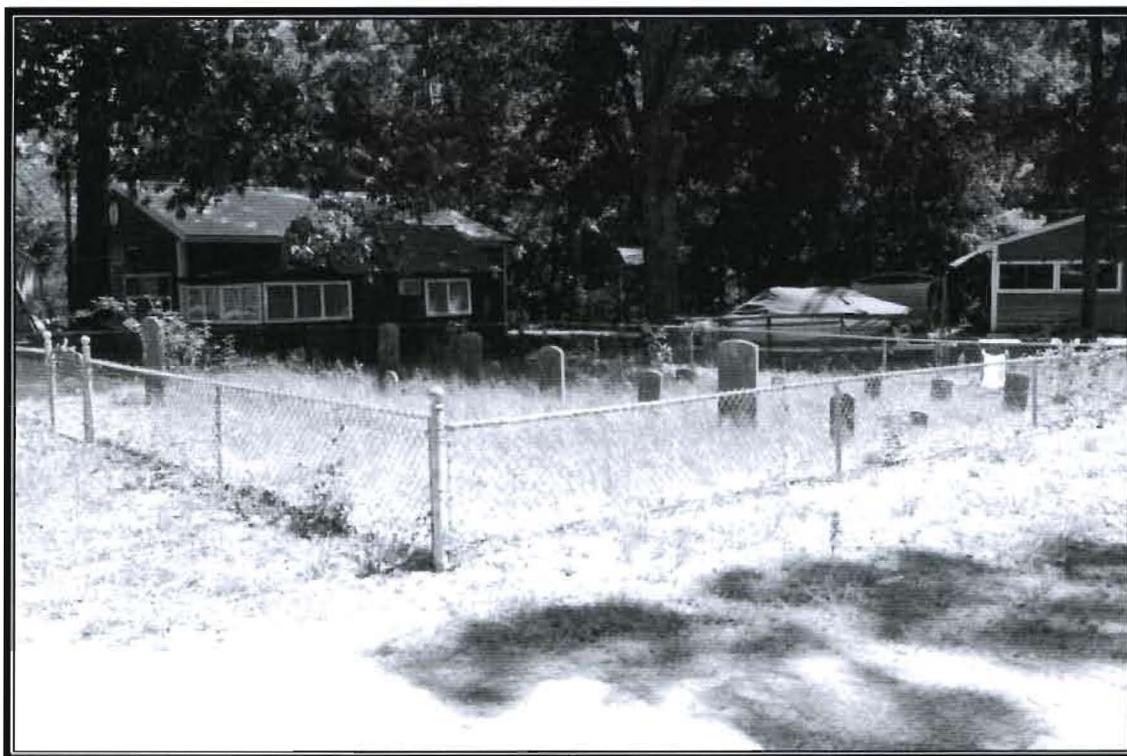
Photograph 12. Chipman Family Cemetery (S-11420), facing northeast.

The Chipman Family Cemetery is located on the grounds of Lowe's Lakeview Campground, but it is not associated with the campground's operation. The cemetery, a family burial plot surrounded by a chain link fence of relatively recent vintage, contains approximately 20 head and foot stones, most illegible (Photograph 12). All are related to the Chipman family, the owner of most of the surrounding land from the early nineteenth through the mid-twentieth centuries.

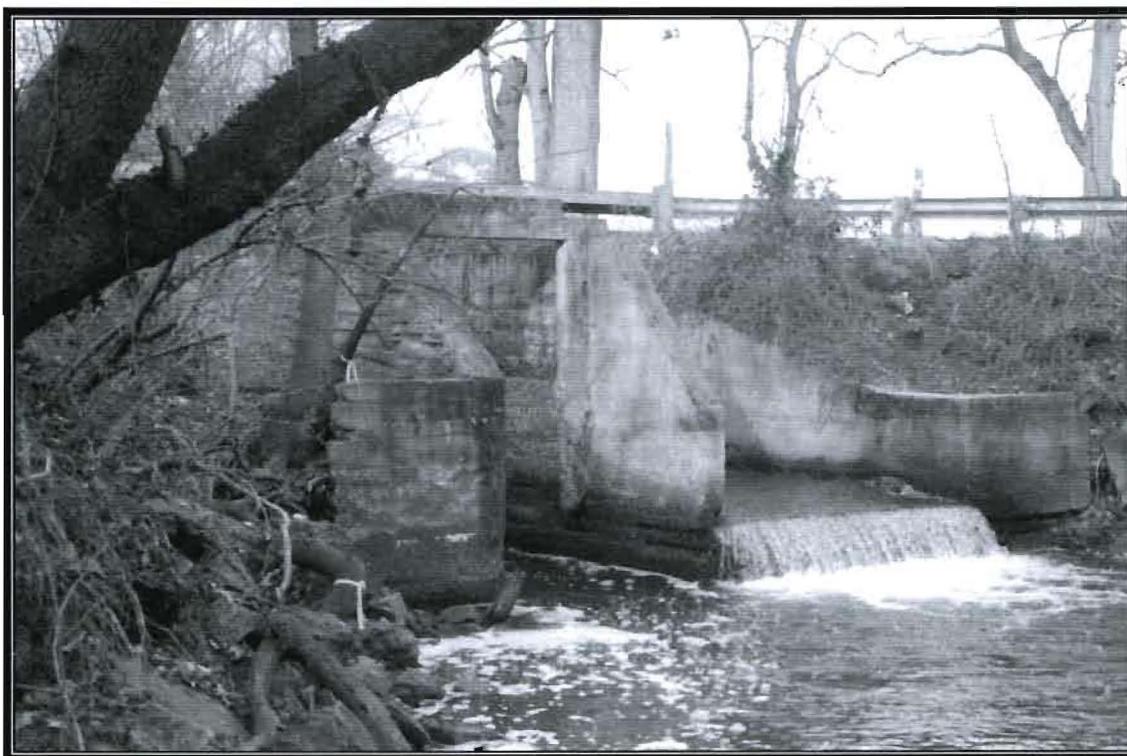
Photograph 13. Millrace and overflow spillway of Chipmans Mill (S-400), facing northeast.

Chipmans Mill, built in 1884, was listed in the NRHP in 1978. The listing included only the mill and millrace, which was located under the mill. In 1987, the mill building was destroyed by fire, with only the foundation remaining (Photograph 13). However, other resources related to the mill remain, including the mill foundation, spillway and overflow, bridge over the spillway, and millpond.

The bridge over the millrace and spillway seems to have been constructed ca. 1934, following the Laurel flood. Supporting this conclusion are the slab bridge itself, types which were commonly built in Delaware at this time (Lichtenstein Consulting Engineers, Inc. 2000:191) and the WPA photograph of the bridge from 1936 (Willard Stewart Collection ca. 1936) (see Plate 1).

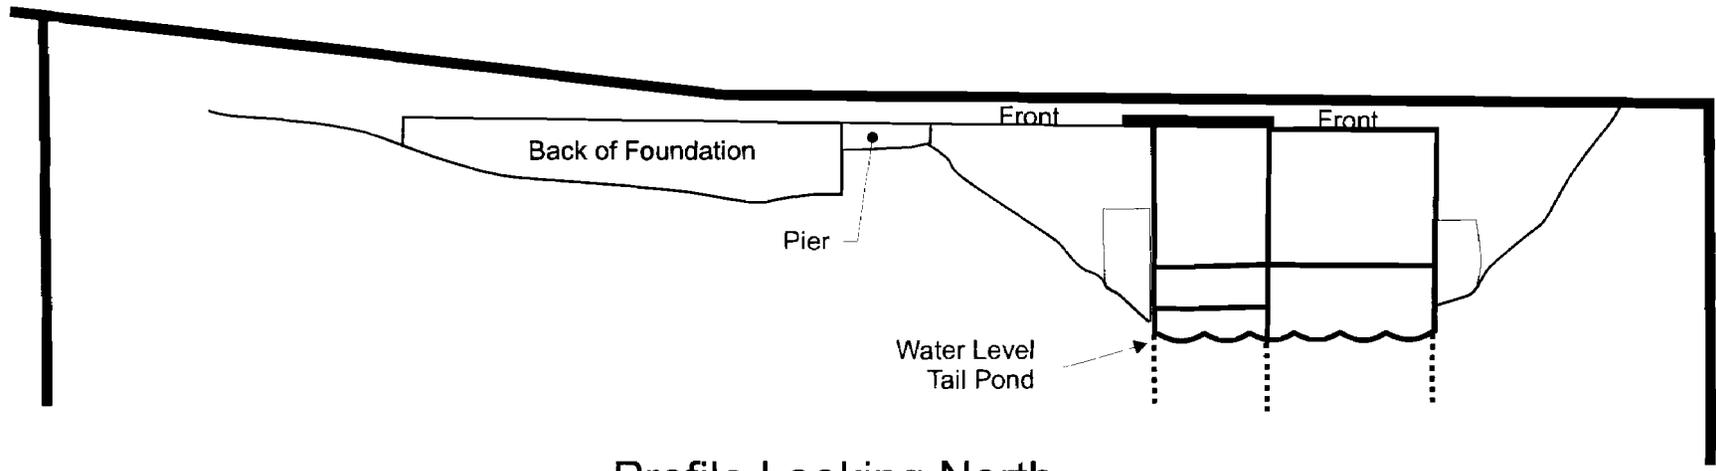
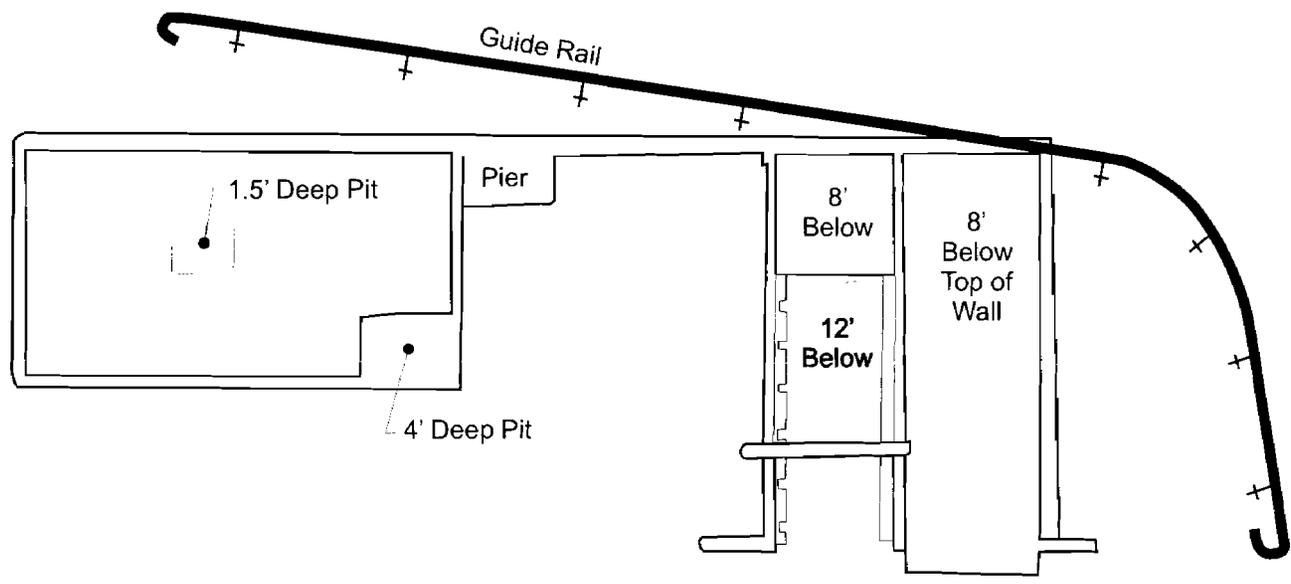
DELAWARE DEPARTMENT OF TRANSPORTATION	
BRIDGE 362 AT CHIPMANS POND BROAD CREEK HUNDRED SUSSEX COUNTY	
SKETCH MAP OF CHIPMANS MILL REMAINS	
FIGURE - 9	SKELLY and LOY Inc. CONSULTANTS IN ENVIRONMENT - ENERGY ENGINEERING - PLANNING

A sketch of the mill's foundation remains is shown on Figure 9. Dating the mill's foundation is difficult. The remains appear to be unreinforced concrete. Concrete construction in the United States predates 1884, when Chipman's Gristmill was erected, but a concrete foundation in rural Delaware at that time seems unusual (Condit 1960:223-231). According to the NRHP nomination for the mill, the western portion of the mill was reportedly moved from another location. Perhaps the concrete foundation supported a later expansion, or was placed following the 1933 flood.

Profile Looking North

Plan View

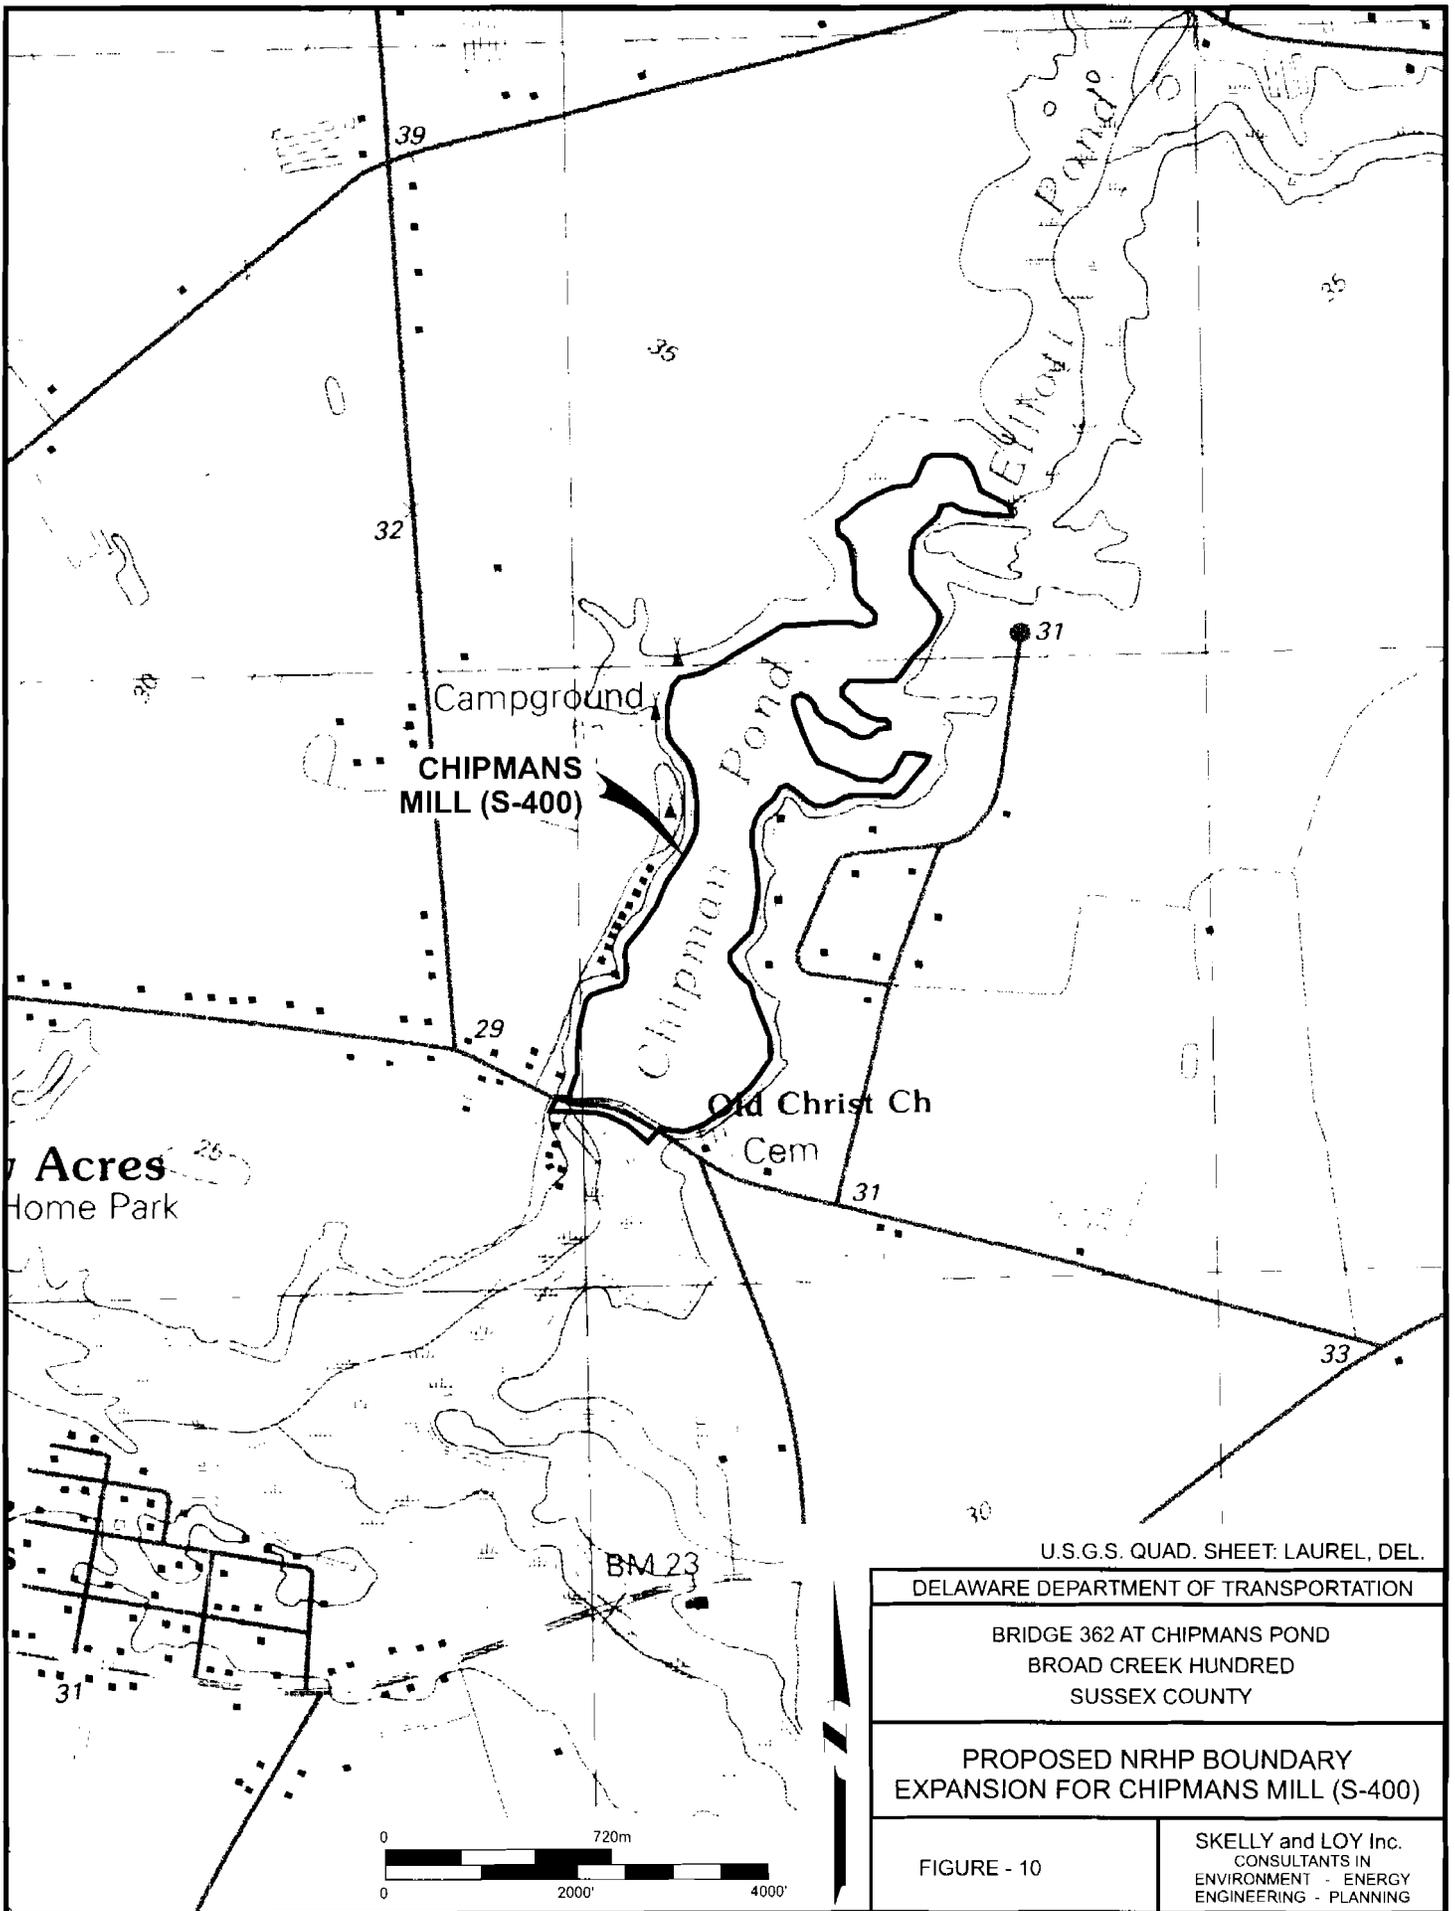
FIGURE - 10

It is recommended that the existing NRHP nomination for Chipmans Mill be revised to explain the loss of the mill building and to expand the NRHP boundary. The proposed boundary is found on Figure 10. It includes the millpond, mill remains, concrete spillway and overflow, and the combination dam and bridge.

PROPOSED NRHP BOUNDARY
 EXPANSION FOR CHIPMANS MILL (S-400)

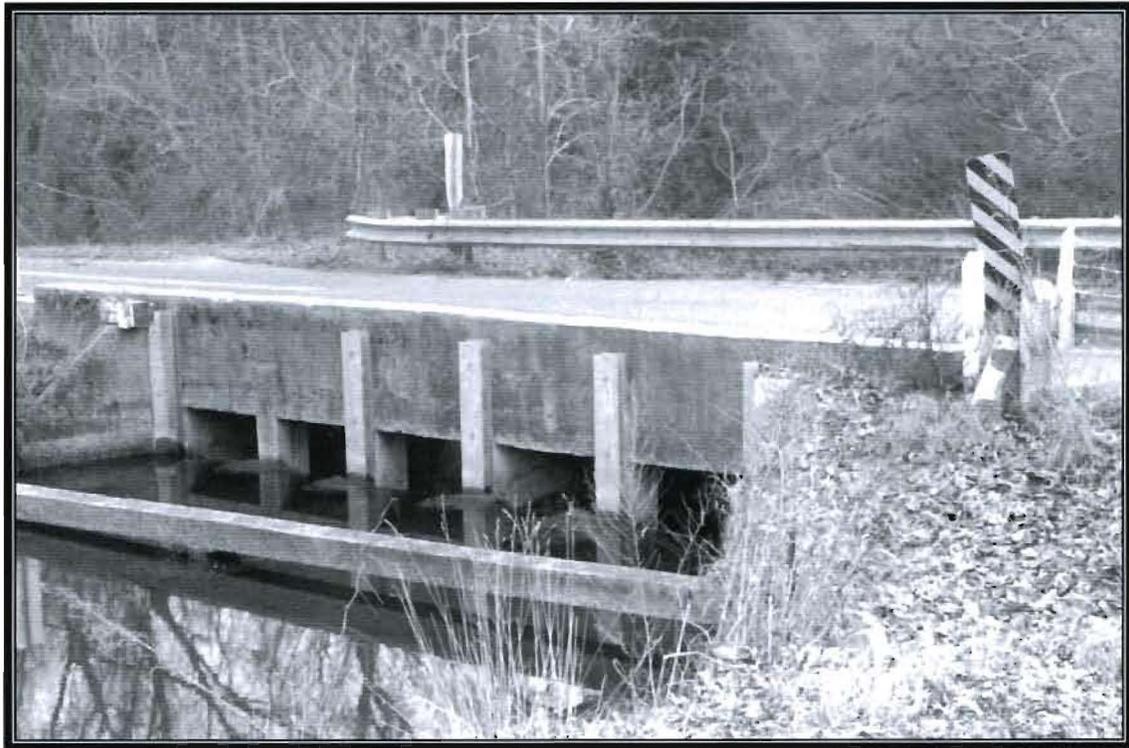
Photograph 14. Elevation view of Bridge 362 Over Chipmans Pond (S-11421), facing southeast.

As noted above, Bridge 362 Over Chipmans Pond is NRHP-eligible under Criterion A as a contributing resource to the proposed Chipmans Mill Historic District. Because it is the subject of the replacement project, the bridge is also being assessed for individual NRHP eligibility. Bridge 362 is a two-span, reinforced concrete slab bridge (Photograph 14). The west span over the millrace is 2.1 m (7.0 ft) long; the east span over the overflow is 3.1 m (10.0 ft) long. Due to the angle of the former mill site to the road, the west end of the bridge is wider than the east end, 7.2 m (23.5 ft) versus 6.4 m (21.0 ft). Steel gate frames are attached to the upstream side of the bridge. They once supported the gates that regulated water flow to Chipmans Mill. The gates have been removed.

Bridge 362 is evaluated as not individually eligible for NRHP listing. It is not significantly associated with Delaware transportation history, as is required under NRHP Criterion A. The bridge is part of a mill dam. Such combination mill dams and bridges were common due to a state law that required the county to build and maintain bridges over mill spillways crossed by public roads (Heite 1991). There is nothing historically noteworthy about this example. No evidence was uncovered linking this bridge to a historically significant person; consequently, the bridge is not eligible under Criterion B. The bridge is also not significant for its engineering or architecture. It is an undistinguished example of a common bridge type built with great frequency in Delaware beginning in the 1920s. This bridge, constructed ca. 1933, is not an early example, a

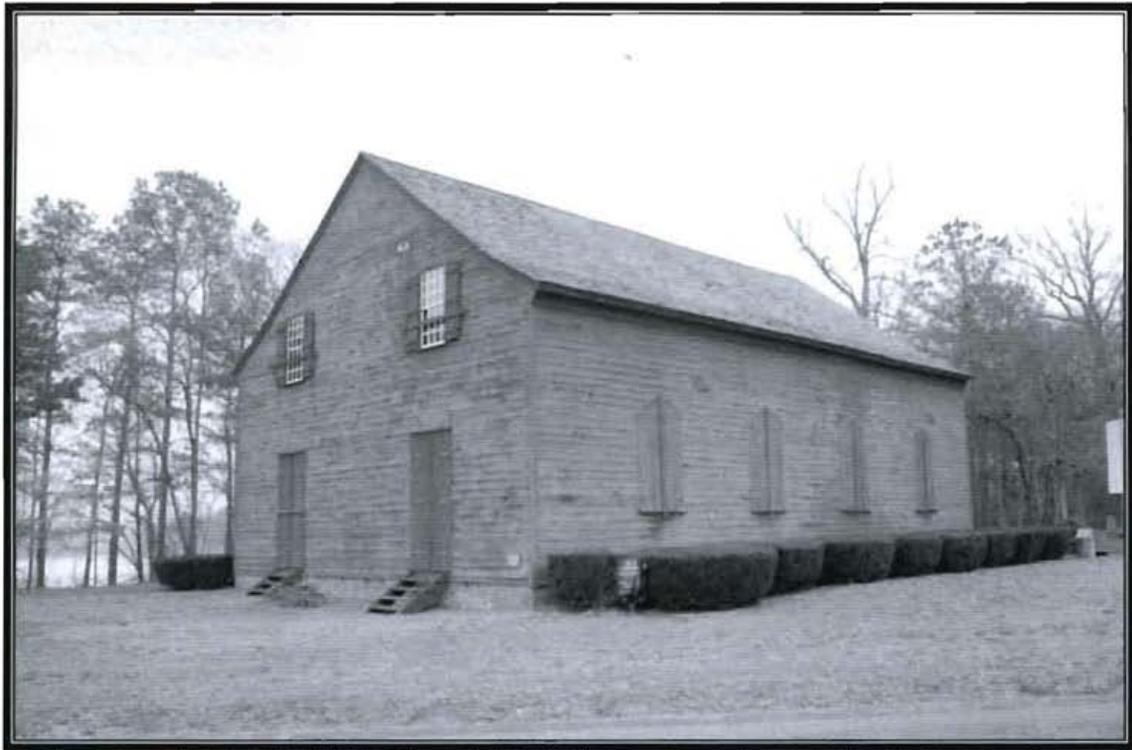
Photograph 15. Old Christ Church (S-188) facade and east side, facing northwest.

Old Christ Church (Photograph 15), a “Chapel-of-Ease” built between 1770 and 1772, is an outstanding example of “eighteenth century native workmanship successfully adapting Georgian ecclesiastical to a worthy expression in wood” (Wilkie 1971). The church was listed in the NRHP in 1971. The nomination references only the church, and makes no mention of the cemetery located to the building’s rear (Photograph 16). The NRHP boundary should be expanded to include this feature.

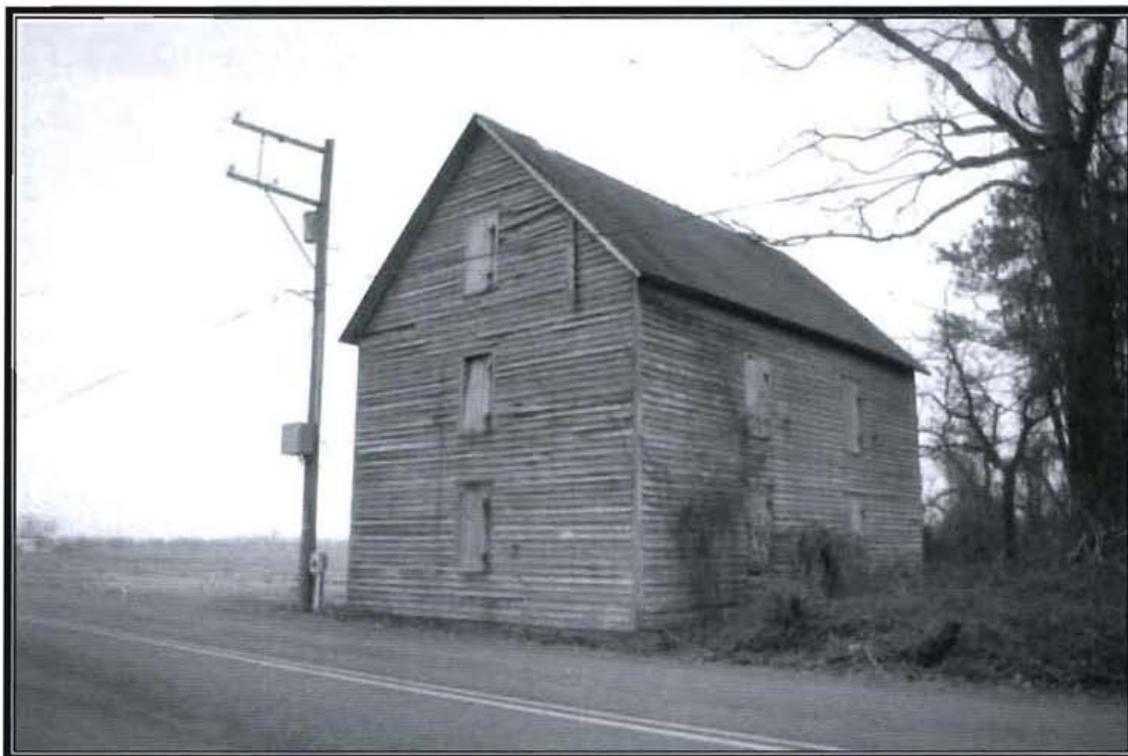
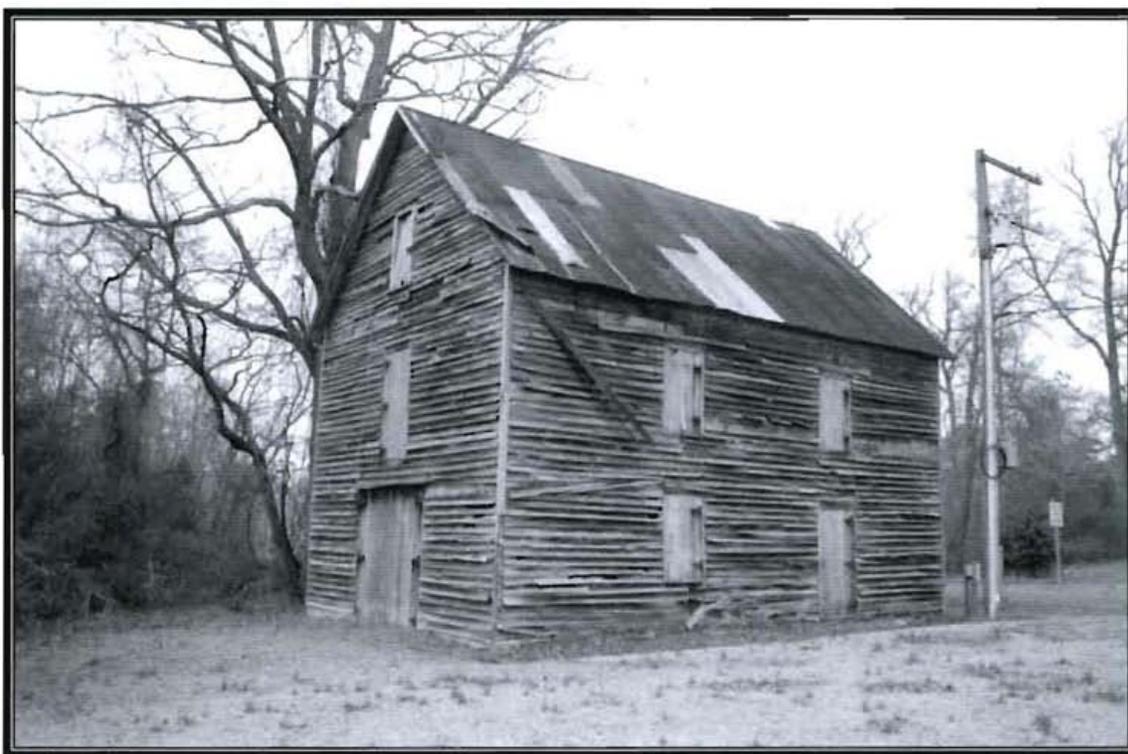
Photograph 17. Chipman Potato House (S-5873) north and west sides, facing southeast.

Photograph 18. Chipman Potato House (S-5873) facade and east side, facing northwest.

The Chipman Potato House is located on the south side of Chipman Pond Road. The exterior of the building is not as well preserved as when it was listed in the NRHP in 1990, but it retains integrity. Some of the roofing material has come off, and the weatherboard siding is detached in places. The owner has had to secure the building due to theft and vandalism.

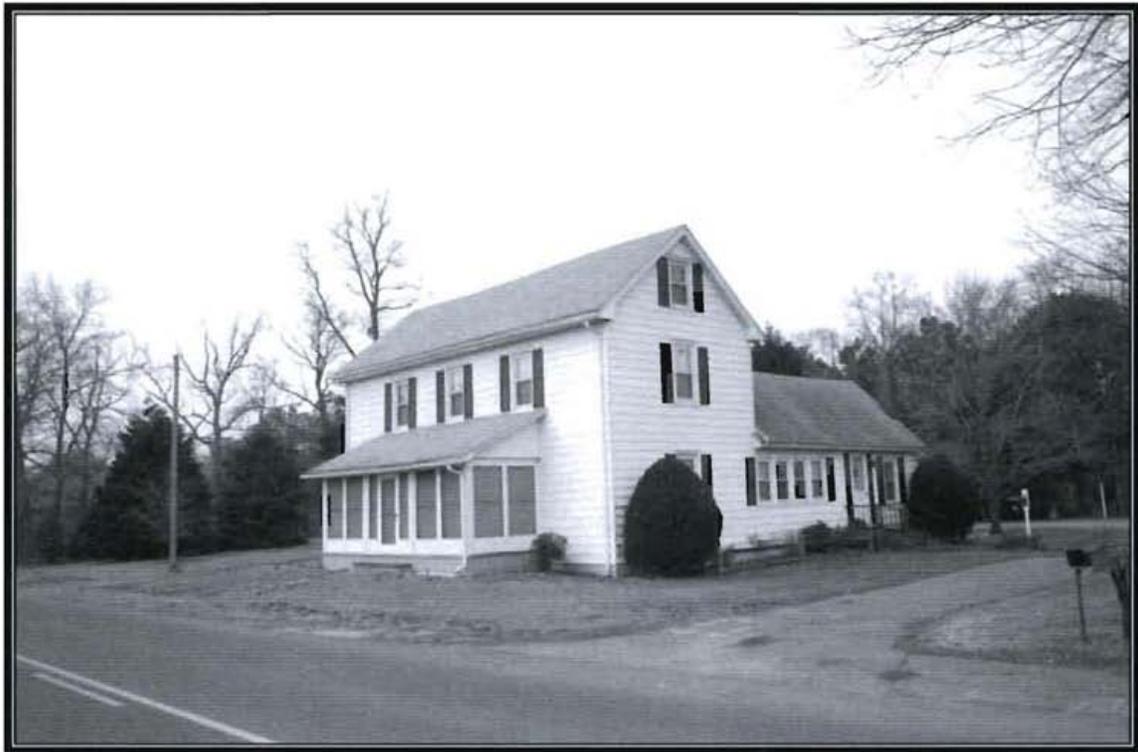
Photograph 19. Facade and east side of the Joseph Chipman Farmstead (S-5873) farmhouse, facing northwest.

The farmhouse (Photograph 19) does not appear on the 1868 map of Broad Creek Hundred (Beers 1868). According to the current owner, the farmhouse dates to ca. 1880 (Sturges Lowe, personal communication 2005). It is an example of “the dominant house” type from the agricultural areas of Sussex County in the late nineteenth and early twentieth centuries: a two-story, three- or five-bay, single pile dwelling with a kitchen wing (De Cunzo and Garcia 1993:189). The house has been fundamentally altered, however. Originally, a colonnade separated the house and the kitchen wing. In 1953, this area was filled in to create a dining room and the roof of the new wing was

raised (Sturges Lowe, personal communication 2005). The front porch is not original, and the house now sports vinyl siding and replacement windows.

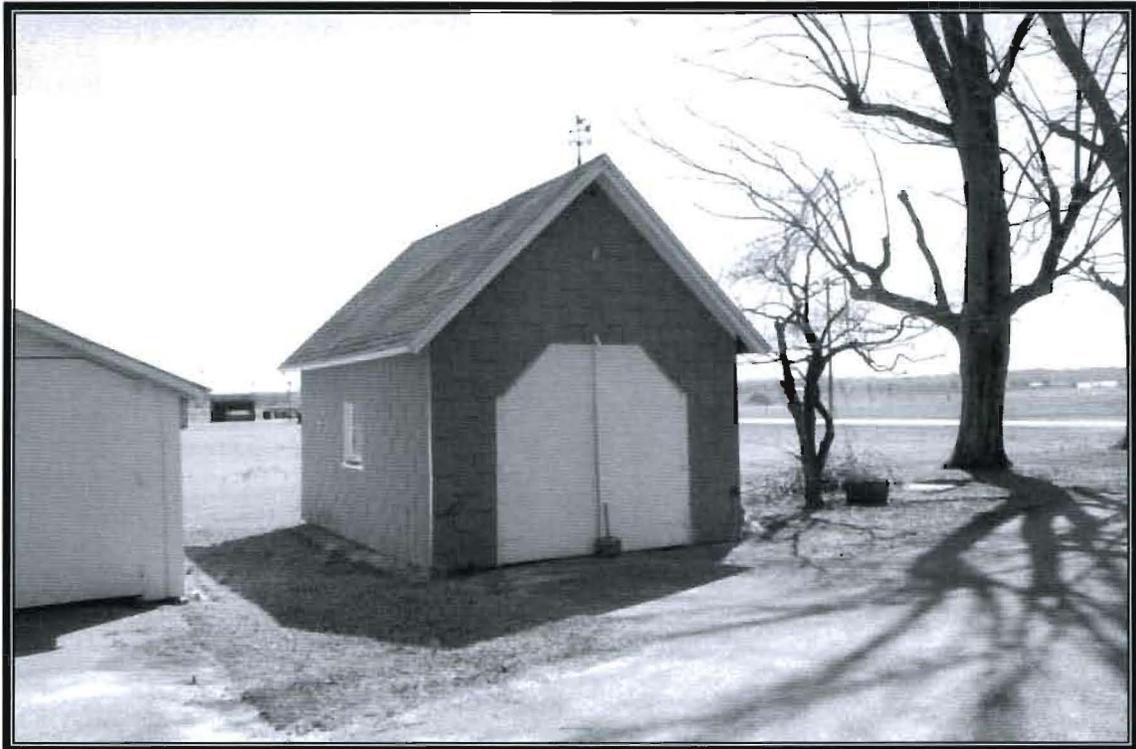
Photograph 20. Facade and north side of the Joseph Chipman Farmstead (S-5873) facing southeast.

The property has seen other changes as well. A large barn once found on the farmstead was removed in the 1960s. The garage now located on the property was moved from across the road (Photograph 20). The garage is a frame, one-story, gable end building with double wood doors and asphalt siding. Next to it is the former carriage barn, a two-story frame building with two shed-roof, one-story wings on each side (Photograph 21). The building has a metal roof and asbestos siding.

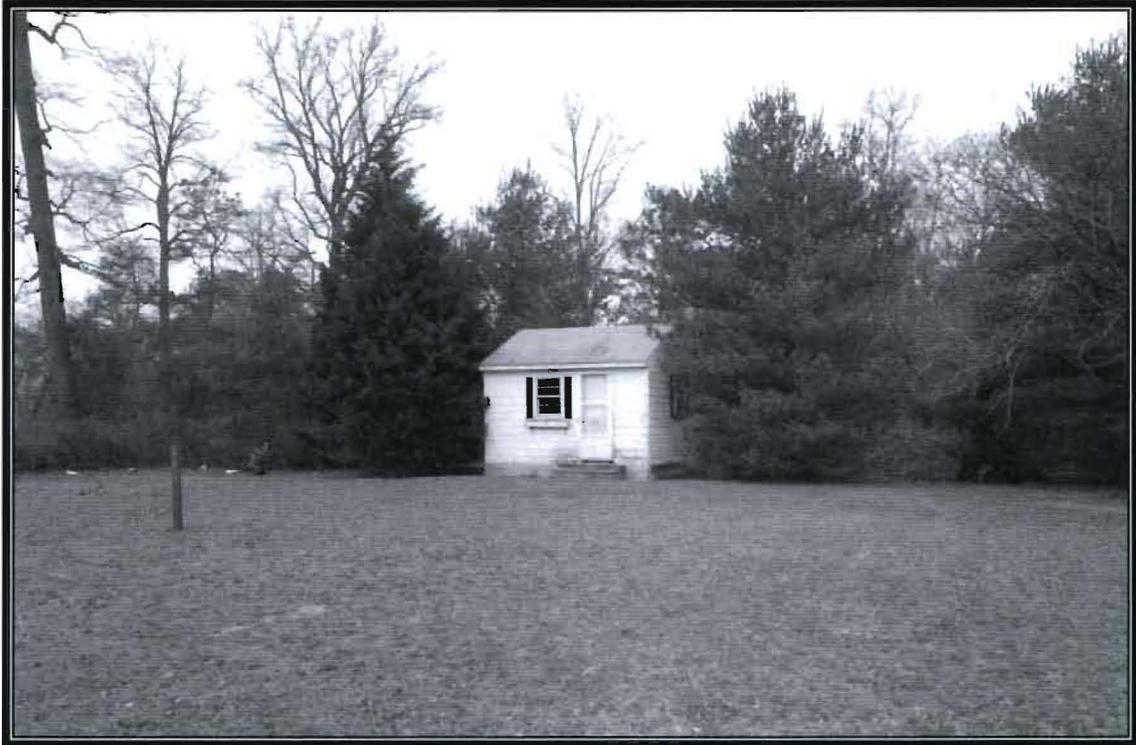
Photograph 22. Facade and east side of the Joseph Chipman Farmstead (S-5873) office, facing north.

To the northwest of the house is a one-story, one-bay frame building that the current owners used as an office to refinish furniture. It has clapboard siding and replacement windows (Photograph 22).
