**New Castle County, Delaware
New Castle Hundred
Church Road (Wynnefield to S.R. 71) Improvements**

Geomorphology Report

November 2003

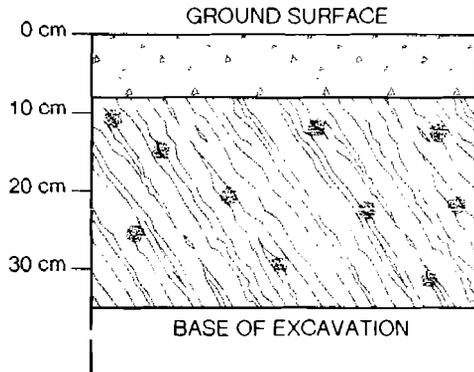
SOIL PROFILE AUGER BORING 1

All soil auger borings exhibit a truncated profile of Coastal Plain sediment covered with a shallow layer of roadside fill. Soil profiles within Auger Borings 1, 2, and 3 are typical of this type of disturbance (Figures 8 and 9). In each profile, the original surface and upper subsoil have been replaced by a layer of loose loamy fill with road gravels, asphalt fragments, and debris. A well developed argillic horizon, normally found deep within the

- Fill 10YR 5/3 Brown fine road gravels, asphalt fragments, and debris mixed with loose loam.
- Bt 10YR 5/4 Yellowish brown sandy clay loam, with few fine road gravels.

Auger Boring 1

Horizon/Depth	SOIL COLOR		Texture	Structure	Consistence	Boundary	Comments
	Matrix	Mottling					
fill / 0-8.0 cm (0-3.2 in)	10YR 5/3 Brown		fine road gravels, asphalt fragments, and debris mixed with loose loam	single grained	loose	clear	
Bt / 8.0-35.0 cm+ (3.2-13.8 in+)	10YR 5/4 Yellowish brown		sandy clay loam, with few fine road gravels	weak fine subangular blocky	firm

Additional Notes: Broad uplands position; well developed, well drained profile of coastal plain sediments. Original soil profile has been truncated (topsoil removed), and the subsoil has been covered with loose gravelly fill.

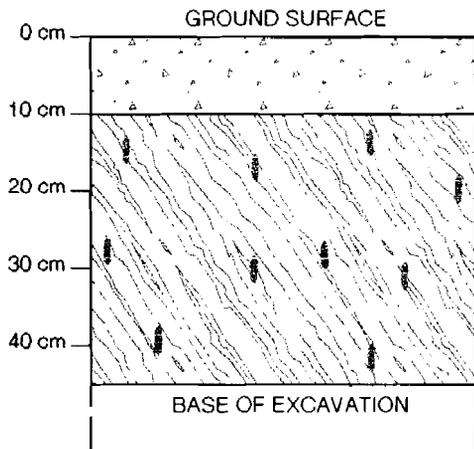
SOIL PROFILE AUGER BORING 2

- Fill 10YR 5/3 Brown fine road gravels and asphalt fragments mixed with loose loam.
- Bt 10YR 5/4 Yellowish brown sandy clay loam, with few fine road gravels and quartz pebbles.

Auger Boring 2

Horizon/Depth	SOIL COLOR		Texture	Structure	Consistence	Boundary	Comments
	Matrix	Mottling					
fill / 0-10.0 cm (0-3.9 in)	10YR 5/3 Brown		fine road gravels and asphalt fragments mixed with loose loam	single grained	loose	clear	
Bt / 10.0-45.0 cm+ (3.9-17.7 in+)	10YR 5/4 Yellowish brown		sandy clay loam, with few fine road gravels and quartz pebbles	weak fine subangular blocky	firm

Additional Notes: Broad uplands position; well developed, well drained profile of coastal plain sediments. Original soil profile has been truncated (topsoil removed), and the subsoil has been covered with loose gravelly fill.

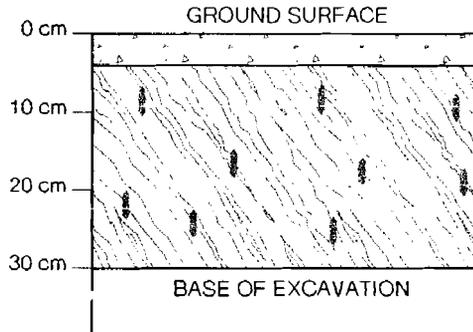
SOIL PROFILE AUGER BORING 3

Fill 10YR 5/3 Brown fine road gravels, debris, quartz pebbles, and asphalt fragments mixed with loose loam.

Bt 10YR 5/4 Yellowish brown sandy clay loam, with few fine quartz pebbles.

Auger Boring 3

Horizon/Depth	SOIL COLOR		Texture	Structure	Consistence	Boundary	Comments
	Matrix	Mottling					
fill / 0-4.0 cm (0-1.6 in)	10YR 5/3 Brown		fine road gravels, debris, quartz pebbles, and asphalt fragments mixed with loose loam	single grained	loose	clear	
Bt / 4.0-30.0 cm+ (1.6-11.8 in+)	10YR 5/4 Yellowish brown		sandy clay loam, with few fine quartz pebbles	weak fine subangular blocky	firm

Additional Notes: Broad uplands position; well developed, well drained profile of coastal plain sediments. Original soil profile has been truncated (topsoil removed), and the subsoil has been covered with loose gravelly fill.

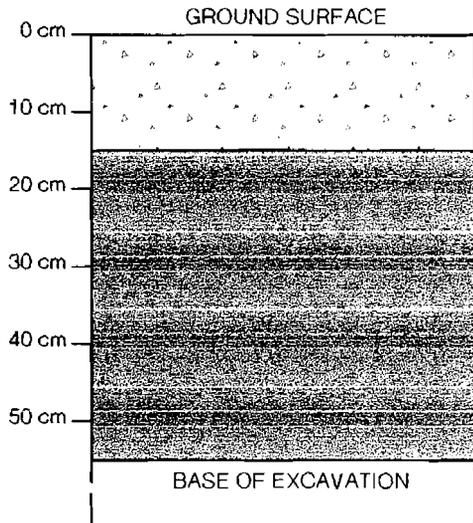
SOIL PROFILE AUGER BORING 4

Fill 10YR 4/1 Dark gray loose sandy clay loam, with fine road gravels and quartz pebbles.

Cg N5/0 Gray sandy loam.

Auger Boring 4 was located along a small stream within the project APE. Flow within this drainage has been placed into an artificial channel. The profile of Auger Boring 4 is comprised of undeveloped, gleyed, sandy sediment covered with 15.0 cm (5.9 in) of fill (see Figure 9). Gleyed conditions (gray, often mottled soil) occur when a soil profile is saturated for the majority of the growing season. This area appears to have been a broad wetland with minor flow and no distinct stream channel before development of the area. Water flow was collected into a defined channel to accommodate the width of the culvert under the roadway. The wetland was then covered with fill, most likely to raise the elevation of the wetland surface and contain the flow, now concentrated within the artificial channel. The gleyed sandy sediments in Auger Boring 4 are the deep, saturated subsoil of the former wetland profile. No intact former wetland surface or upper subsoil horizons were found within auger borings taken along this drainage.

Auger Boring 4

Horizon/Depth	SOIL COLOR		Texture	Structure	Consistence	Boundary	Comments
	Matrix	Mottling					
fill / 0-15.0 cm (0-5.9 in)	10YR 4/1 Dark gray		loose sandy clay loam, with fine road gravels and quartz pebbles	single grained	loose	clear	
Cg / 15.0-55.0 cm+ (5.9-21.7 in+)	N 5/0 Gray		sandy loam	massive	plastic, slightly flowing		wet

Additional Notes: Drainageway with channelized creek bed; gleyed coastal plain sediments. Former wetland soil, truncated of original surface. Exposed subsoil sediments covered with fill from channelization and road construction.
