THE MURPHY HOUSE

The following description of the Murphy House has been taken from the HABS document prepared in 1993 and 1994 by the KFS Historic Preservation Group. This document may be found in Appendix III and will offer greater detail than does the summary presented below. The photographs included within this section of the report were taken during the late summer of 1996; the house has been unoccupied for a number of years and is gradually decaying. Plates 3, 4, 5 and 6 show the four sides of the building in its current state.

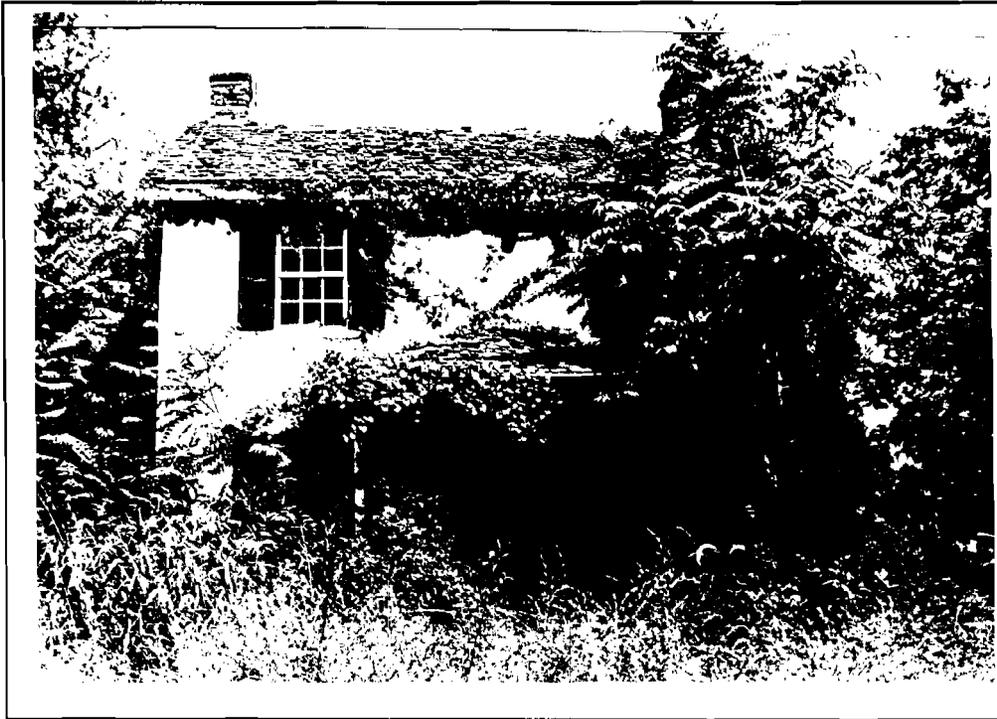
PLATE 3

View of the front of the Murphy House from Rockland Road

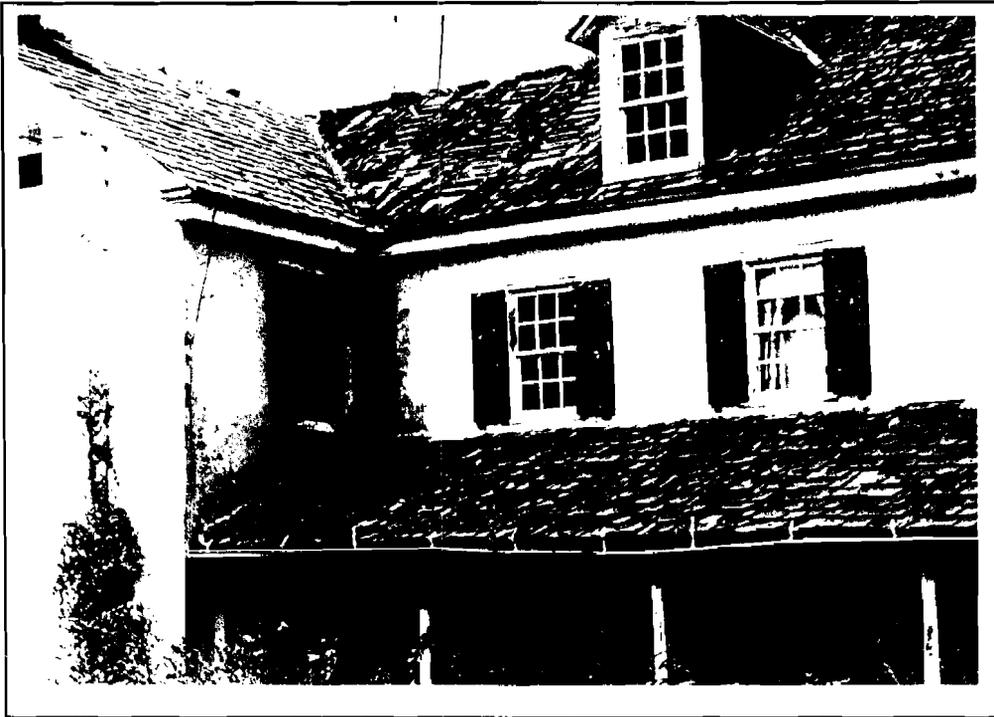
PLATE 7

**View of the east side showing cornice with dentil detailing
against rear addition**

- 3] physical evidence in the form of basement walls and supports and first story joists reveals that the one story rear wing was centrally located between the two first story windows of the front section's rear wall.
- 4] the cornice and dentil molding visible in Plate 7 once ran across the entire rear wall of the building and is now partially obscured by the rear wing.
- 5] the door surround facing into the wing is very plain in its detailing, indicating that it was most likely meant to function as an interior, not an exterior, surround, and was intended from the initial construction to face into another interior space--such as a rear kitchen wing.

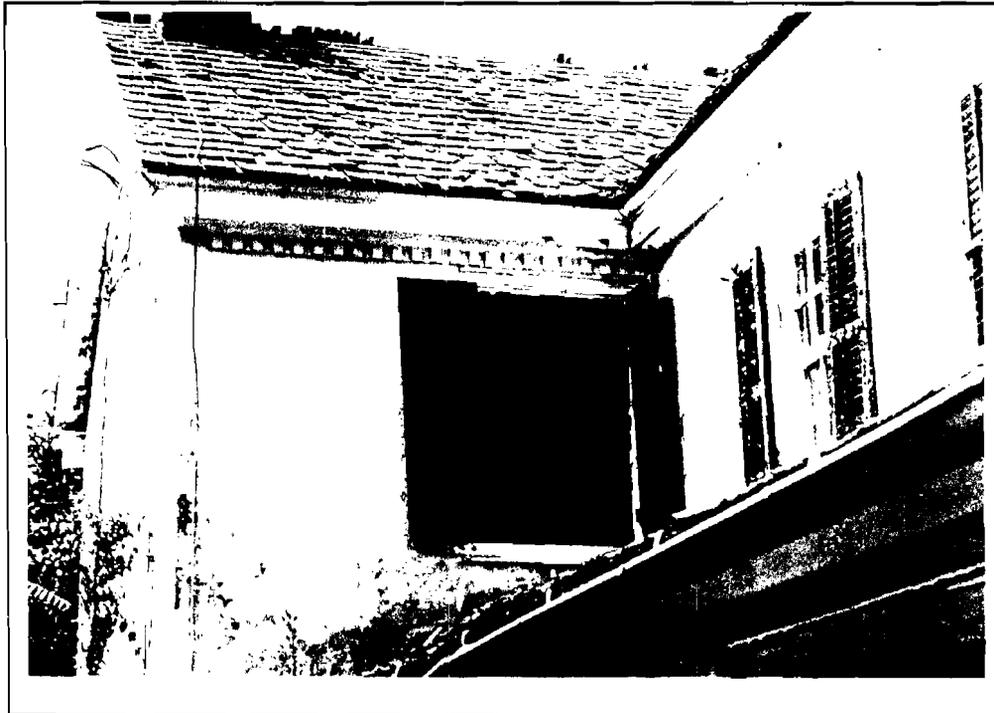
PLATE 8

**Dentil detailing runs into rear wing and shutter cannot lie flat
against the house wall**

The frame two and a half story rear wing and a rear, two-sided wraparound porch was added to the original stone house at an unknown date. A full basement extends under the porch as well as under the wing area. This is the current location of the kitchen (first floor) and two bedrooms and a bathroom (second floor). The first and second story west-bay windows at the rear of the house, originally double-hung sash windows, have been altered: the first story is now a cupboard and the second floor window is a closet. The second floor closet still displays the original window reveals, indicating that it was at one time an exterior wall window. The awkwardness of attachment of the rear wing to the front section is another indication; because the east wall of the wing nearly abuts the west edge of the window frames, the shutters cannot lie flat against the rear wall of the original section (Plate 8).
