4.0 FIELD RESULTS

4.1 Parcel 1

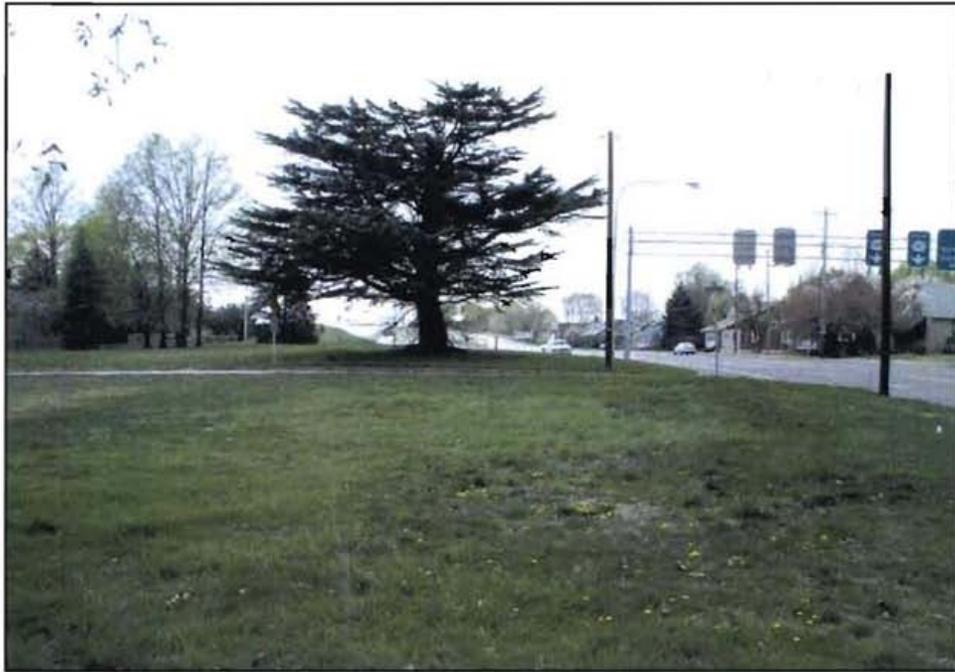
Photograph 1: Parcel 1, view south (April 2005).

The landform in Parcel 1 yielded a stratigraphic profile indicative of a once-active plowed agricultural setting converted into a manicured yard area (Photograph 1) (Figure 7). The test pit excavations produced a 4.0- to 9.0-centimeter thick very dark grayish brown (10YR 3/2) silt loam sod horizon capping a 16.0- to 26.0-centimeter thick brown (10YR 4/3) silty clay plowzone horizon. Beneath the plowzone, the excavations exposed a dark yellowish brown to yellowish brown (10YR 4/6 to 5/6) silt loam to silty clay subsoil (E) horizon (Appendix D). Pockets of fill deposits were recorded in Parcel 5. STP 1-3, Stratum II (5.0 to 1.0 centimeters below surface [cmbs]) produced a dark yellowish brown (10YR 4/4) silt loam fill deposit overlying the plowzone horizon. A mottled dark yellowish brown (10YR 4/4) and yellowish brown (10YR 5/6) clay loam fill horizon was noted in Stratum II, 4.0 to 30.0 centimeters below surface in STP 1-5. STP 1-4+25E produced a yellowish brown (10YR 5/8) sand fill deposit 24.0 to 31.0 centimeters below surface in Stratum II.

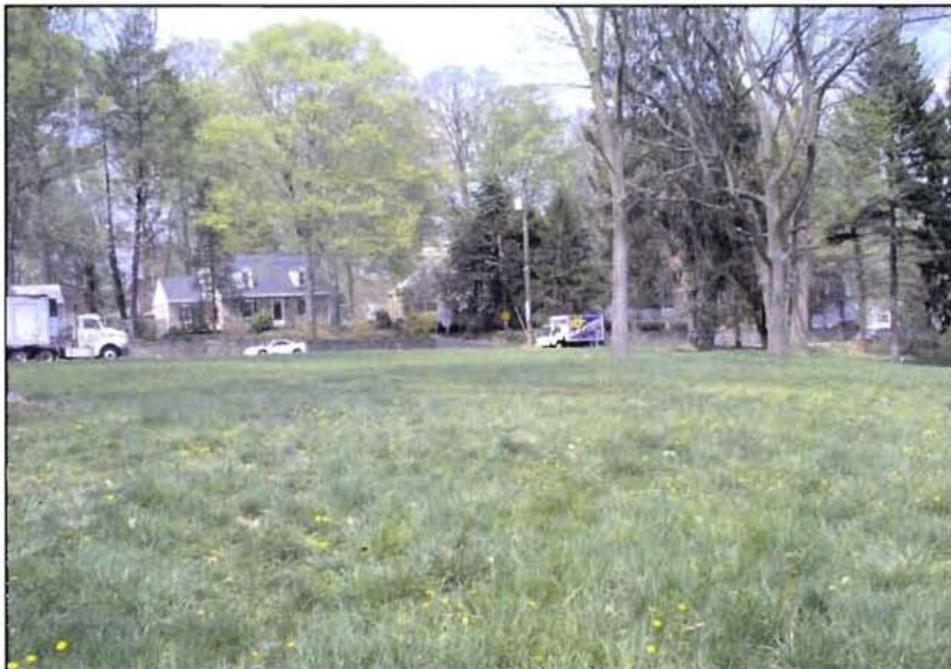
Photograph 2: Parcel 2, view west (April 2005).

Archaeological testing in Parcel 2 exposed an intact landform supporting minor fill episodes (Photograph 2; Figure 7). STP 2-1 and STP 2-5 revealed a 25.0- to 29.0-centimeter thick dark brown to dark grayish brown (10YR 3/3 to 4/2) silty clay Ap-horizon overlying a strong brown to yellowish brown (7.5YR 4/6 to 10YR 5/8) silty clay subsoil horizon (B). STP 2-2 and STP 2-3 revealed the Ap- and B-horizon stratigraphy as well, but these natural horizons were capped with

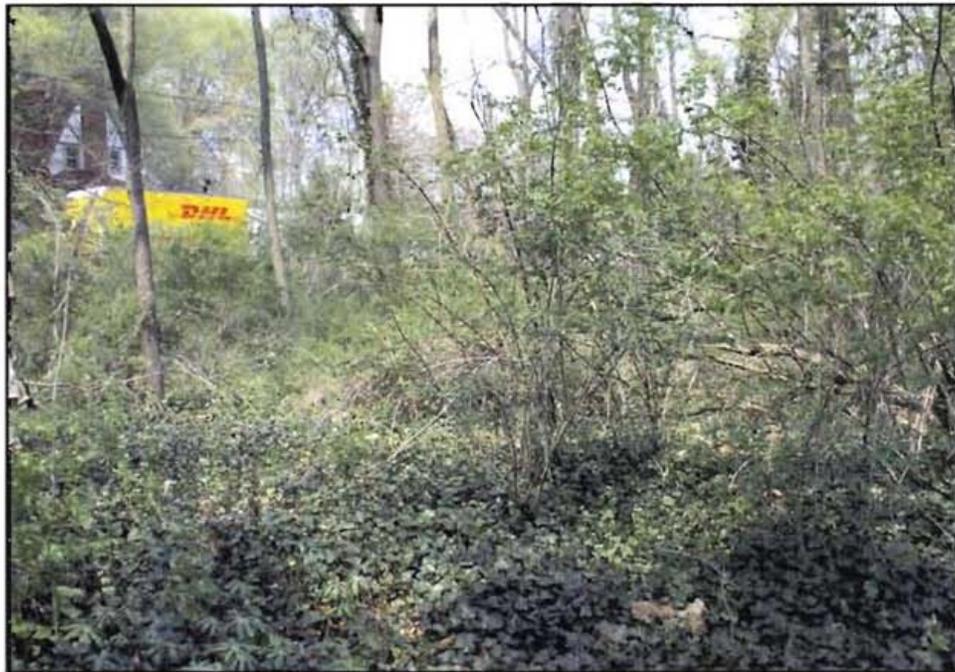
Photograph 3: Parcel 3, view northwest (April 2005).

Parcel 3 consists of an approximately 76.2-meter long by 39.6-meter wide area east of SR 141 comprising the wooded uplands adjacent to the south side of Little Mill Creek (Photograph 3). The test pits excavated in Parcel 3 revealed evidence of disturbance, varying from minor episodes of fill at the southern end of the lot to prominent rubble deposits at the northern end (Figures 7 and 8). Recent deposits of concrete and asphalt rubble were noted along the eastern edge of the APE in Parcel 3. Excavations of STP 3-2 and STP 3-3 were discontinued when asphalt was discovered at 32.0 and 40.0 centimeters, respectively, below surface. The excavation

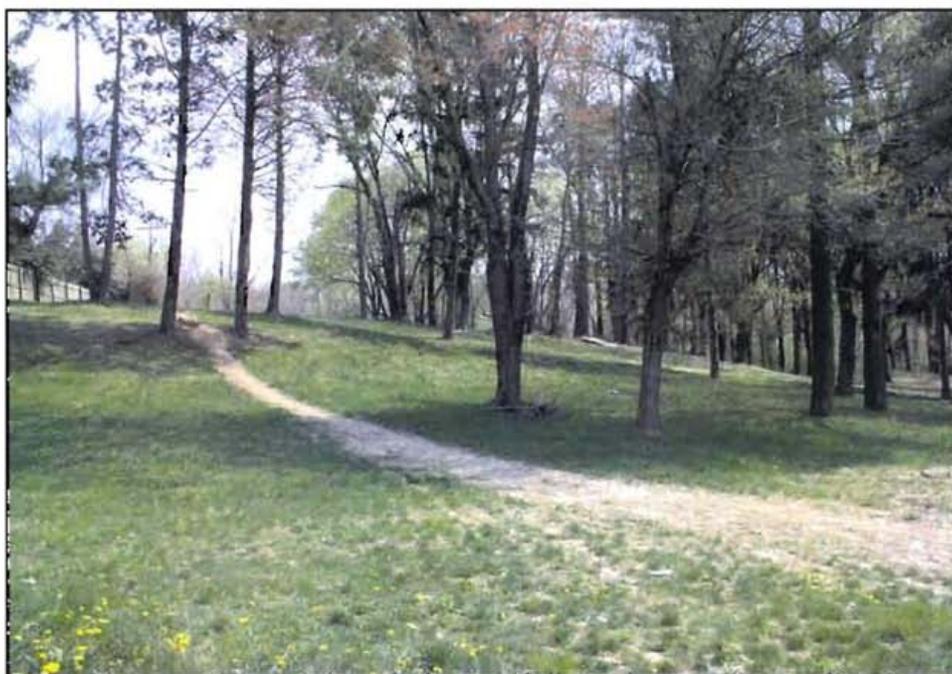
Photograph 4: Parcel 4, view east (April 2005).

Parcel 4 consists of a 83.8-meter long by 167.6-meter wide area east of SR 141 comprising the wooded uplands adjacent to the floodplain on the north side of Little Mill Creek (Photograph 4; Figure 8). This section of ground resides just north of a large sanitary sewer line running parallel to Little Mill Creek. A total of 58 STPs were excavated within Parcel 4.

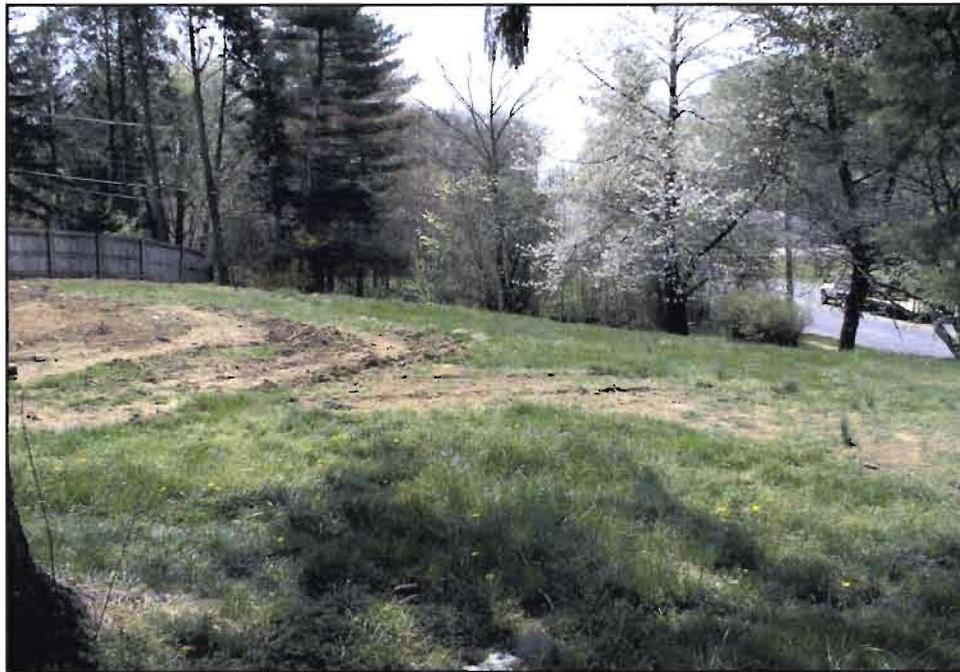
Photograph 5: Parcel 5, view south (April 2005).

Parcel 5 consists of a 126.5-meter long by 18.3-meter wide parcel of ground comprising the backyards of several structures in the Eton Court residential development (Photograph 5; Figures 8 and 9). Of the five STPs excavated in Parcel 5, four revealed relatively intact soils. STP 5-1, 5-3, 5-4, and 5-5 comprised a 13.0- to 21.0-centimeter thick dark yellowish brown (10YR 3/4 to 4/4) silt loam A-horizon overlying a strong brown (7.5YR 4/6 to 5/6) silt loam to silty clay B-horizon. A 10.0- to 49.0-centimeter thick brown (10YR 4/3) silt loam fill episode was noted above the intact soils of STP 1 and STP 5. STP 2 was comprised of five separate 10.0- to 18.0-centimeter thick silt loam to silty clay fill episodes extending to 75.0 centimeters below surface, at which point an impenetrable layer of rock rubble was encountered (Appendix D).

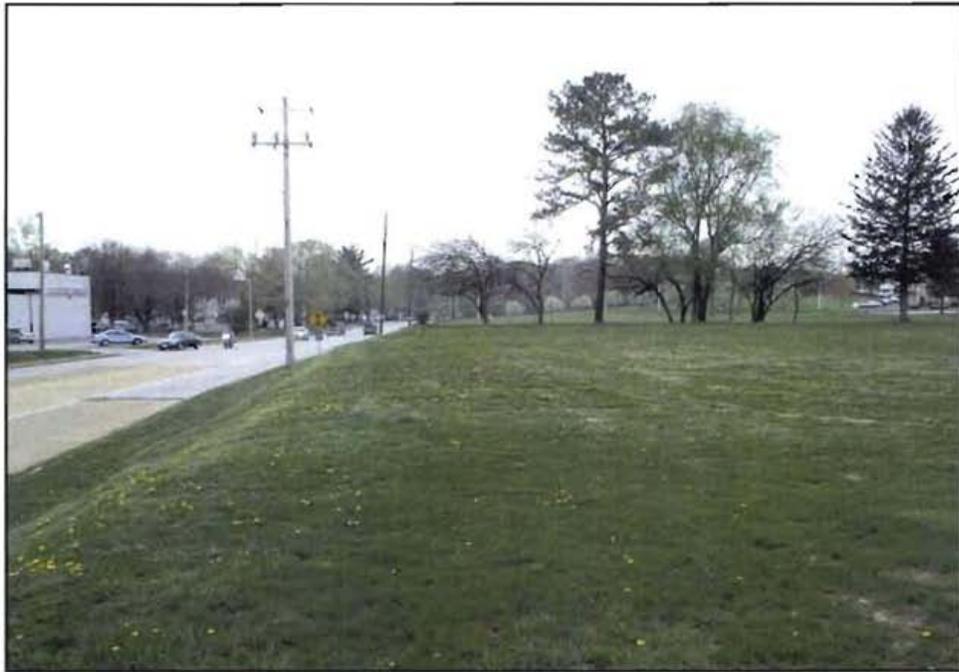
Photograph 6: Parcel 6, view west (April 2005).

Parcel 6 is comprised of an approximately 487.7-meter long by 30.5-meter wide parcel of ground bordered by SR 141 to the east, Faulkland Road to the south, an entry road into the Ferris Center to the west, and the Ferris Center grounds to the north (Photograph 6; Figures 10 and 11). STPs in Parcel 6 generally revealed disturbed soils at the eastern end of the parcel, adjacent to SR 141. STP 1 through STP 3 exhibited three to four 10.0- to 20.0-centimeter thick silt loam to clay loam fill horizons overlying a strong brown (7.5YR 4/6 to 5/8) to yellowish brown (10YR 5/6) clay loam to silty clay subsoil horizon (B). Concrete chunks were noted in Stratum II of STP 6-2, 10.0 to 35.0 centimeters below surface, indicating that construction rubble was utilized as part of the fill mixture for certain horizons. The fill episodes noted within the STP 6-1 through 6-3 are consistent with the construction of a raised berm along the north side of Faulkland Road, evident in Photograph 6.

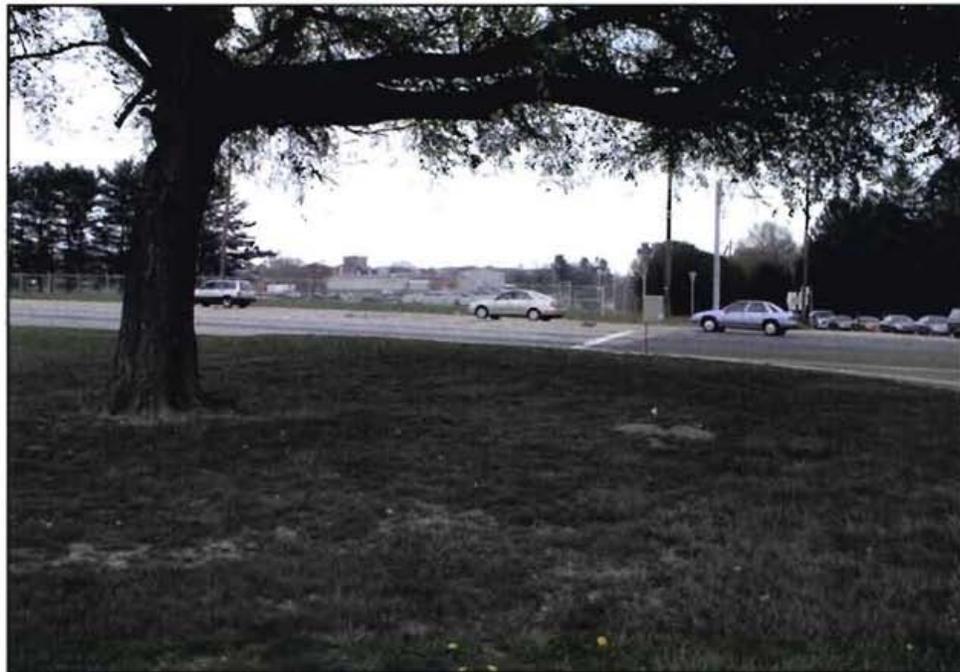
Photograph 7: Parcel 7, view east (April 2005).

Parcel 7 consists of an approximately 167.6-meter long by 30.5-meter wide corridor along the north side of Faulkland Road extending from the east side of SR 141 to an unnamed drainage (Photograph 7; Figures 10 and 12). The soil stratigraphy of this landform consisted of a 24.0- to 36.0-centimeter thick brown to dark yellowish brown (10YR 4/3 to 4/4) silt loam plowzone

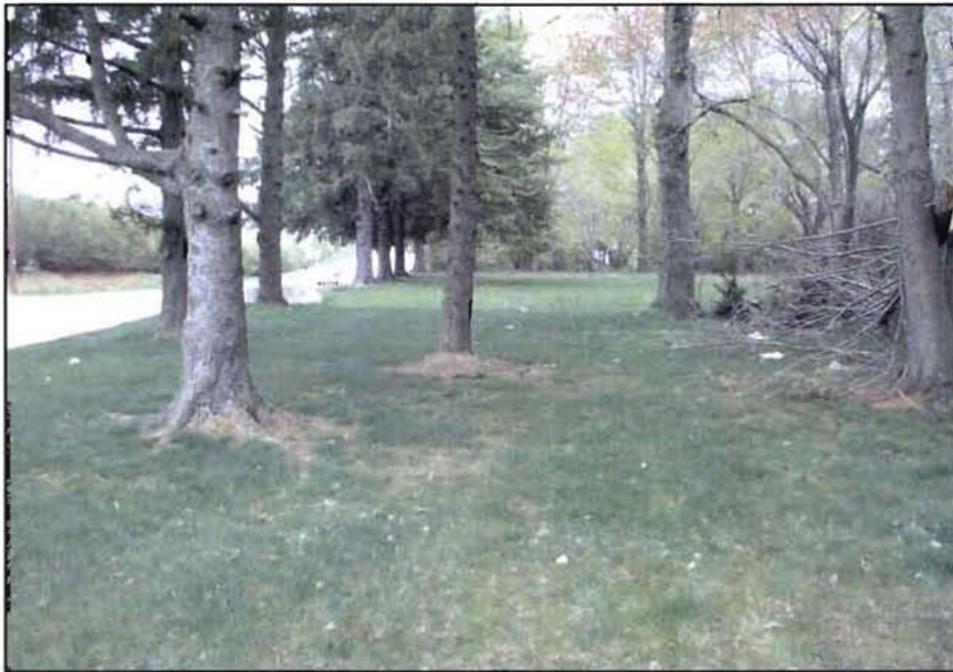
Photograph 8: Parcel 8, view east (April 2005).

Parcel 8 consists of an approximately 121.9-meter long by 30.5-meter wide corridor along the south side of Faulkland Road extending from the east side of SR 141 to an unnamed drainage (Photograph 8; Figures 10 and 12). All excavated soils in Parcel 8 appeared intact. Three separate stratum were noted. Soils consisted of a 17.0- to 33.0-centimeter thick brown (10YR 4/3) silty clay A-horizon overlying an 8.0- to 14.0-centimeter thick yellowish brown (10YR 5/6) silty clay E-horizon. A third stratum, a B-horizon, was comprised of a strong brown (7.5YR 5/6) silty clay (Appendix D).
