**Former Jennie Aaron dwelling, 444 Water Street
Tax ID ED-05-077.13-1-3; 50' X 150' parcel
Detached Bungalow, circa 1937**

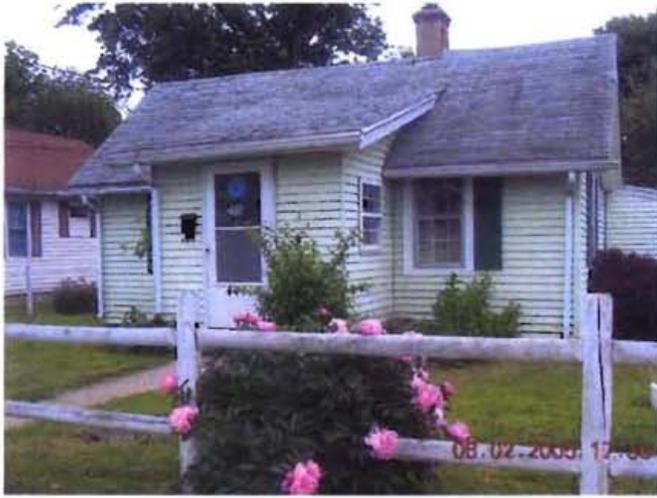
On the far left, the lot formally contained a single story three-bay side gabled, concrete block building with an enclosed central front porch. The roofing was covered with asphalt shingles and a central shed roof projection continues to extend from the roof to form the front porch (enclosed and updated). The corbelled chimney rises from the gable peak off center towards the west.

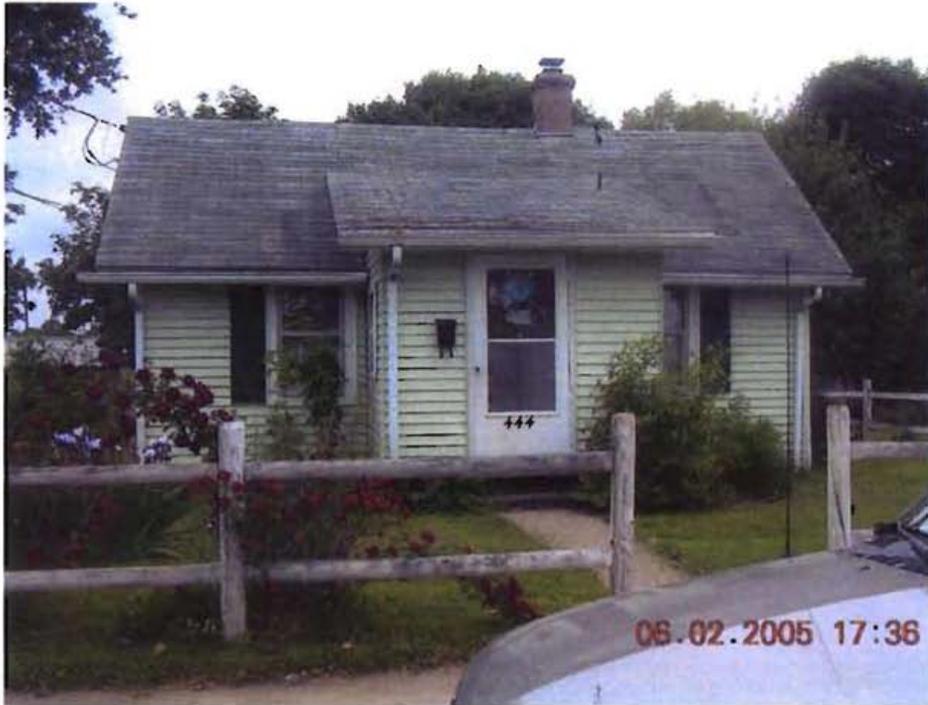
The two front windows were 6/6 double hung sash with a single vinyl (or aluminum) end shutter at each outside end. The side windows within the enclosed front porch were also smaller renditions of 6/6 double hung sash, but were vinyl treatments. Other windows treatments were unavailable, but interior photos and asbestos testing records suggest a smaller fixed casement bay in the kitchen (rear) and a window bay in the rear bedroom. The west end is marked by a single bay window towards the front bedroom and the east consisting of a single bay window in the towards the rear bedroom. A set of paired double hung towards the front den were also evident. It is speculated based on typical trends that they would have been 6/6 double hung window treatments as they served both bedrooms and the den.

Font of dwelling looking south

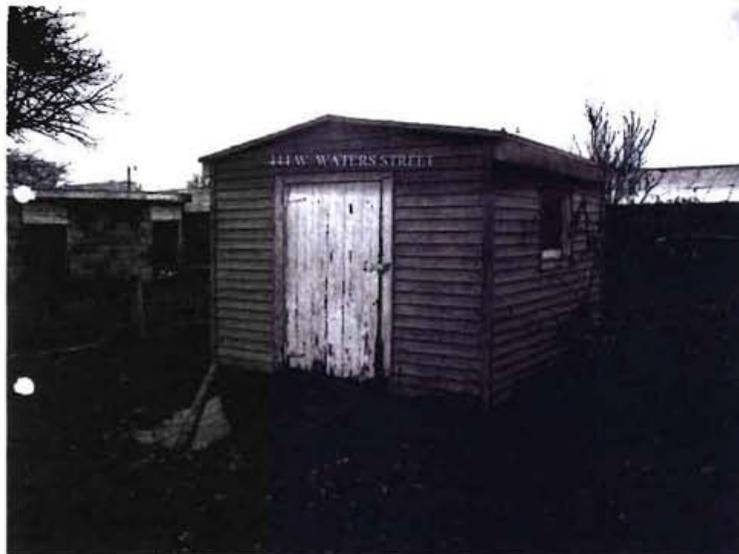
Towards the rear of the property lot a 9' by 9' storage shed existed. Raised on concrete blocks, the front gable shed had a central vertical board door (timber) and sheathing covered with modern vinyl siding. Casement modern windows were located on each side.

Storage shed in rear of property

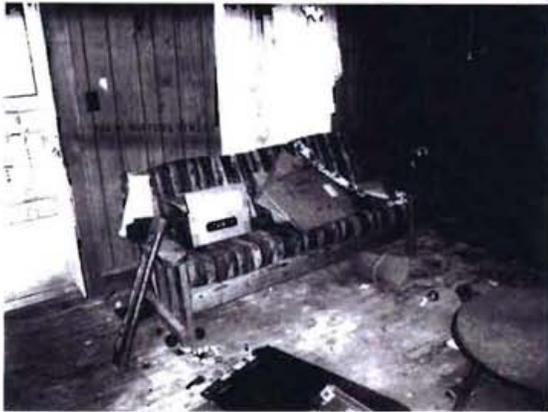
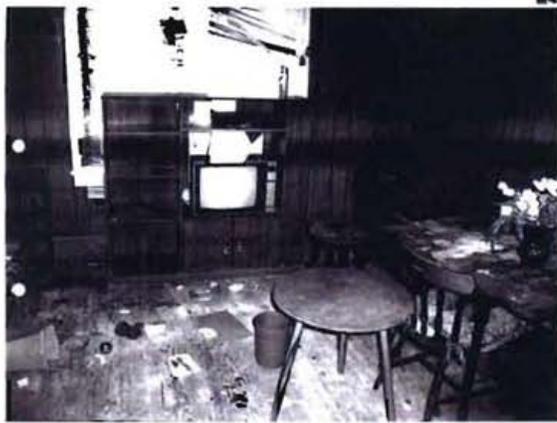
Approximate layout from asbestos report. The interior photos are within living room
