# CULTURAL RESOURCES SURVEY & EVALUATION

## *PYLES FORD ROAD (ROAD 239) CULVERTS*

Prepared for: Environmental Studies Section  
Delaware Dept. of Transportation

- FINAL -  
April 2008

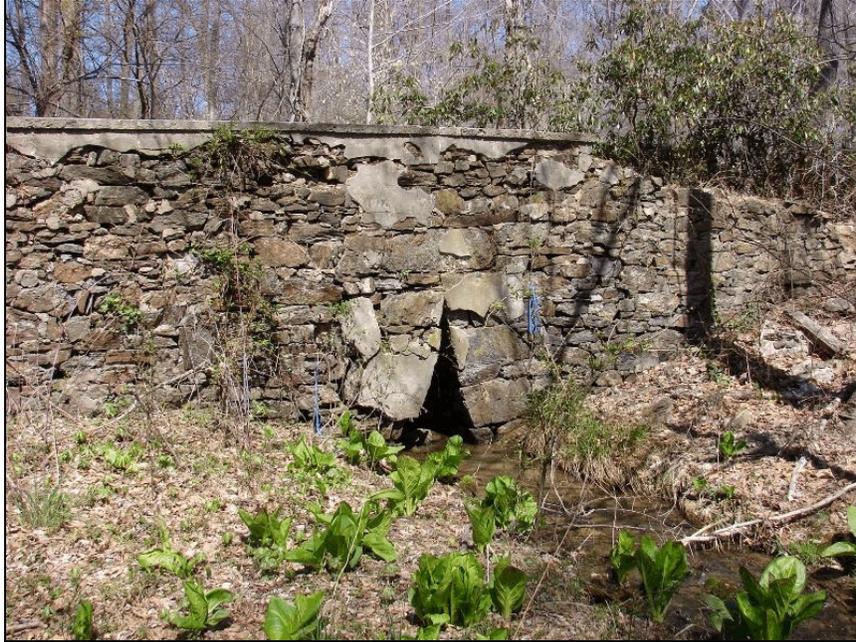
Figure 2. Stone culvert with triangular-shaped opening, built in 1817. Downstream elevation.

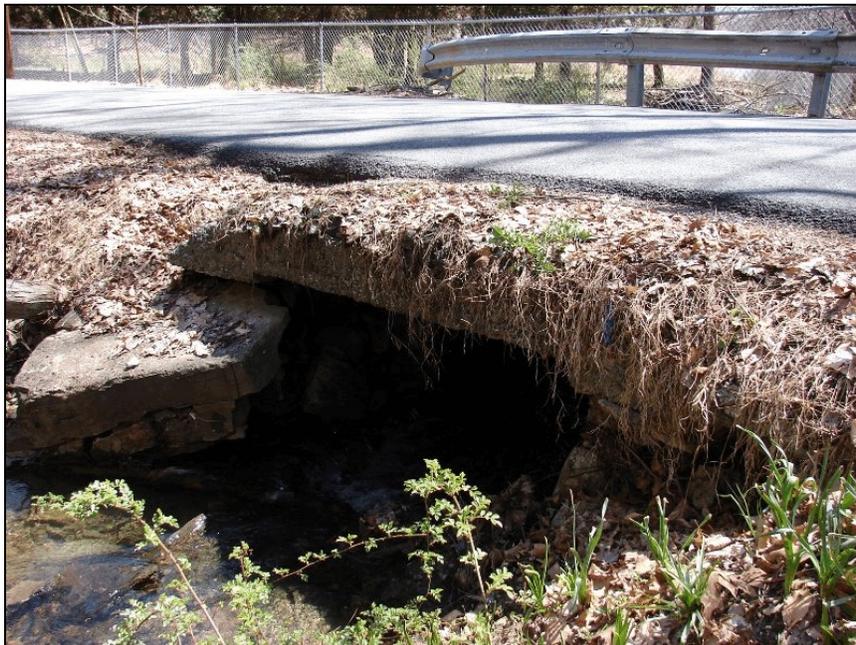
Figure 3. Concrete slab culvert, built ca. 1910. Upstream elevation.

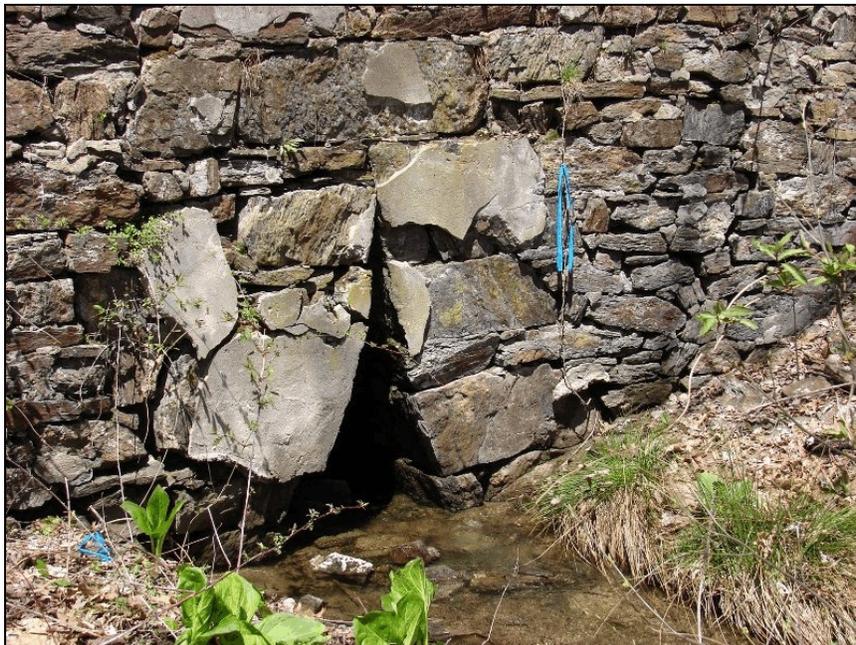
Physical Description. The stone culvert is dated to 1817 and was widened to the upstream side with a steel pipe extension prior to 1981. The original stone section has a triangular-shaped opening that measures approximately 30" at the base, 5' in height, and 17' wide (out-to-out) (Figure 7). The stone is a locally quarried gneiss, known as "blue rock" for its dark, grayish-blue appearance. It is the same stone found in many vernacular buildings, walls, and other structures throughout much of northern New Castle County. A May 17, 1921 photo of the culvert (the earliest known photo attached to the county bridge card) shows that the culvert had been coated with a cementitious material sometime in the early 20th century (Figure 8). Some of that coating remains today but most of it has fallen away. The stone parapet remaining on the downstream side has a non-original concrete coping that also dates to before 1921 (Figure 9).<sup>5</sup>

Figure 7. Detail of culvert opening.

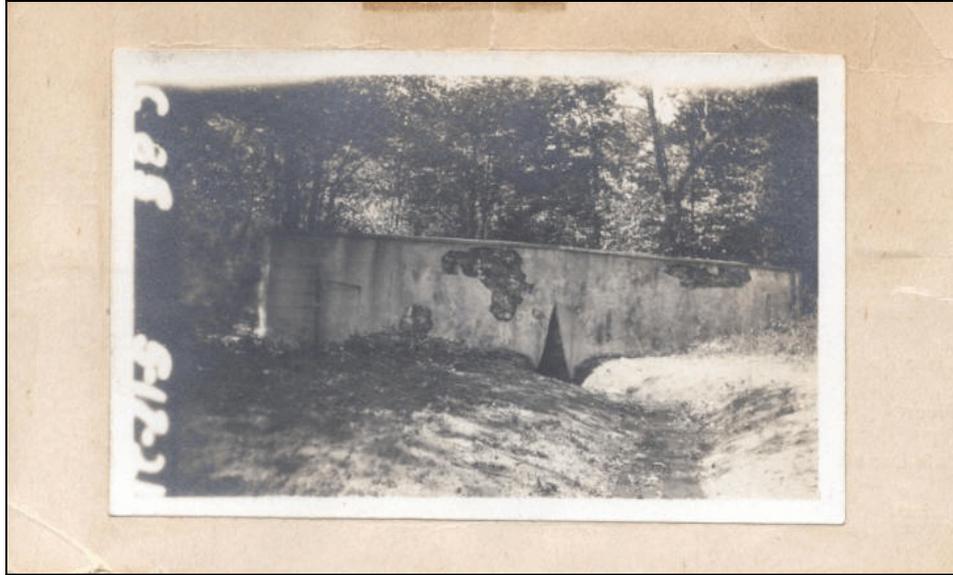
Bridge No.	C-85
Location	Near Centerville
Description	Stone culvert, triangular. Built 1817
Clear Span	3'0"
Abutments	masonry
Floor to W. L	6'8" water 6"
Clear Roadway	14'0"
Floor	road on fill
Safe Load	Indeterminate. C-12
Details

Figure 8. New Castle County Bridge Card, 1921.

Historical Context. The earliest documentation for the culvert is a New Castle County bridge card and photo dated May 17, 1921 (Figure 8). That card lists the culvert as county culvert No. C-85, "Stone Culvert, Triangular, Built in 1817." The source of the 1817 date is not documented. The 1981 NAER card also references the county card and adds as a source, "Inscription in stone indicating date of 1817." Unfortunately, the NAER surveyor did not note the inscription's location and didn't photograph it. Field work in 2007 did not locate the inscription or any additional documentation of it. A possibility is that the inscription has been removed, covered by repointing, or lays in the rubble of the southeastern parapet. Inscriptions would have typically been found on the roadway faces of the parapets, usually at one corner or at mid-span. In any event, the 1817 date is appropriate based on the culvert's style. No other evidence withstanding, 1817 is believed to be the correct date.

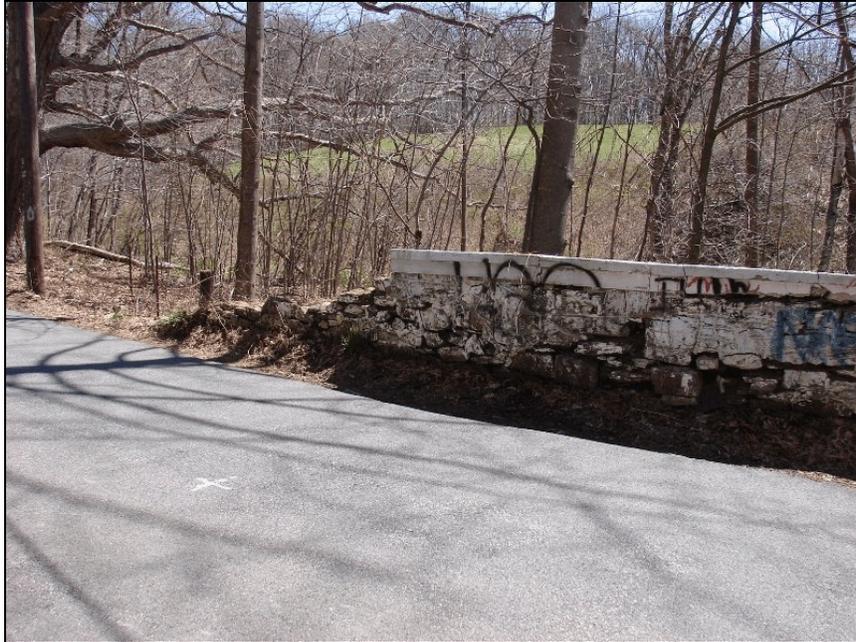
Figure 9. Parapet detail, looking southeast.

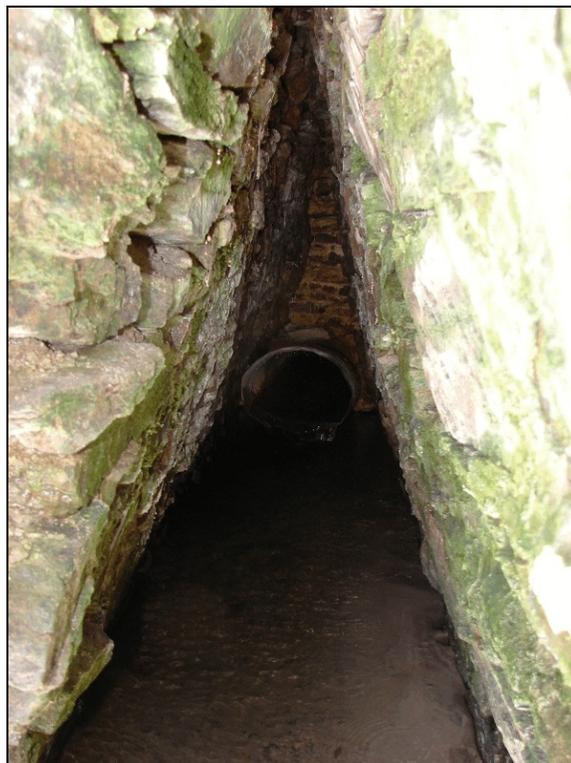
The roughly coursed, corbeled stones forming the triangular opening were worked to provide a relatively uniform triangular-shaped inner surface (Figure 10). The culvert opening (intrados) is not stepped, it is truly triangular in shape. A lintel-like stone much larger than the other stones is located one course above the apex of the triangle (Figure 7). It is presumed that if the fill over the opening were removed that the outer walls (extrados) are stepped. The wingwalls and parapets are of uncoursed fieldstone. The culvert appears to have been built using mortar (it was not dry laid) but the original soft lime-based mortar has completely weathered away.<sup>6</sup>

Figure 10. Inside the stone culvert looking upstream. Note the pipe placed in the upstream opening.

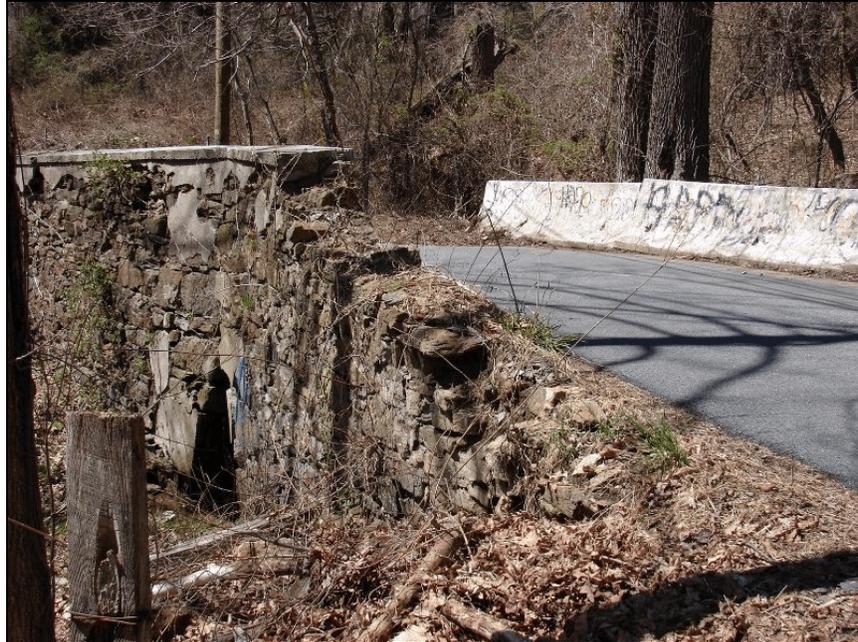
The triangular-shaped opening is at the junction of the two flared wingwalls. The wingwalls measure approximately 19' long to the east of the opening and 22' to the west of the opening for a total out-to-out length of approximately 41' (as measured along the tops of the parapets on the downstream side). The wingwalls flare at an oblique angle to one another, thus conforming with the curvature of the roadway (Figure 11). The parapet measures approximately 40" high (as measured from the roadway surface to the top of the parapet) and 20" wide. Several generations of repointing are evident, but most of the exposed surfaces on the outside face of the wingwalls have little to no mortar remaining with loose, shifting, or missing stones. The parapet and wingwall at the southeastern corner have failed and collapsed for a length of about 15' (Figure 11)

Figure 11. Oblique view of stone culvert looking west. Note the collapsed parapet and wingwall at the southeast corner.

The original culvert had an approximately 14'-wide roadway, but it has been widened to its upstream side with a corrugated-steel pipe culvert to make for an approximately 18'-wide roadway (Figures 10, 12). The 1981 NAER survey reported that the widening was "recent" but does not provide an exact date; there are no available records for the widening at DeIDOT. It is believed that state maintenance forces probably widened the culvert sometime in the 1960s or 1970s to achieve a wider roadway and/or repair the upstream side of the culvert because of a failing parapet or wingwalls. The pipe is set into the upstream side of the triangular opening at a skew. The triangular opening above the pipe has been filled with mortared stone (Figure 10). The pipe is under earth fill that also covers the remains of the stone culvert's upstream side. The original stone parapet on the upstream side is gone; temporary Jersey barriers now serve as the upstream railing (Figure 11).

The culvert's deteriorated condition and environment, including poor alignment and location in a setting with increasing development pressures, threatens its survival. Currently, it is possible to pull stones out of the culvert walls by hand and it will not take much to further collapse them. It is believed that the weakened southeastern wingwall

and parapet were ultimately lost to impact damage from a motor vehicle. In addition to poor geometry and physical condition, the culvert's upstream side is clogged with heavy debris and silt, suggestive that the current opening has become inadequate to the hydraulics of the site.

If the culvert is replaced, it will be an adverse effect. Given that the culvert is being recommended eligible under Criterion D, there is justification to approaching the culvert as an archaeological resource. When archaeological sites cannot be left undisturbed, data recovery is the goal for mitigating effects. Such data recovery from the culvert would likely include the following items:

- Removing the roadway fill from the culvert to allow for complete examination and documentation of the extrados, upstream walls, and construction technique. This should be done with the assistance of a backhoe operator experienced with this type of archaeological work. Documentation should include photography and measured drawings.
- A thorough search should be made for the missing inscription stone. The inscription was referenced but not adequately documented by a cultural resources survey of the culvert in 1981. This may include looking among the loose stones that have fallen from the bridge and checking with state maintenance crews to determine if the stone happens to be stored off-site. Removal of the overburden may also reveal the stone, especially if it is located near the parapet's roadway level and has been covered over by pavement.

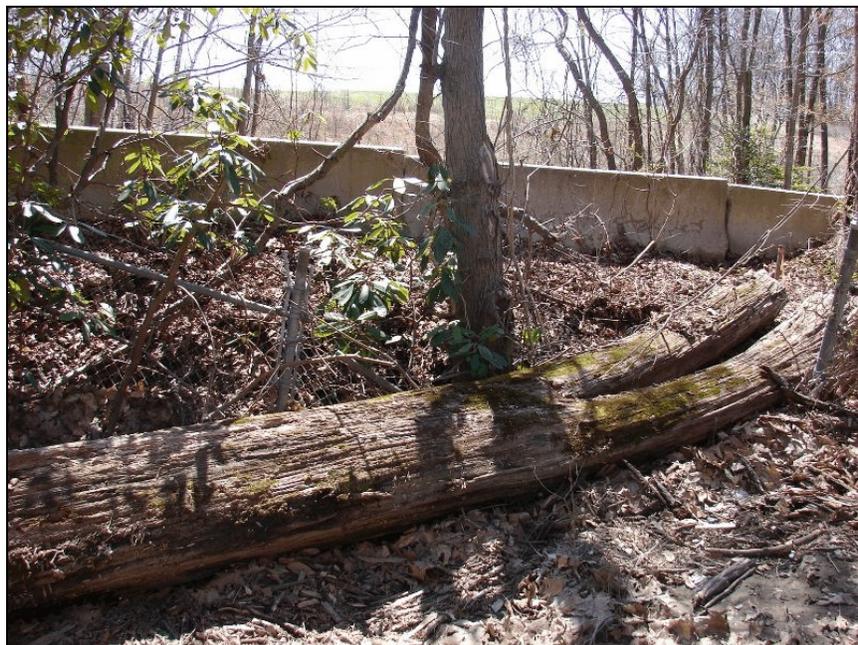
Figure 12. Upstream elevation. The upstream opening has been covered by debris and silt.

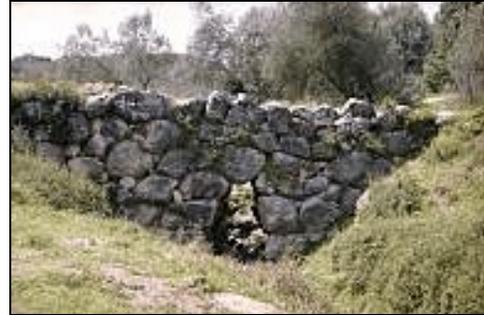
Figure 13. A Mycenaean culvert with triangular-shaped opening near Epidauros, Greece (1,300 B.C.). Source: Scholar Resource Web site.

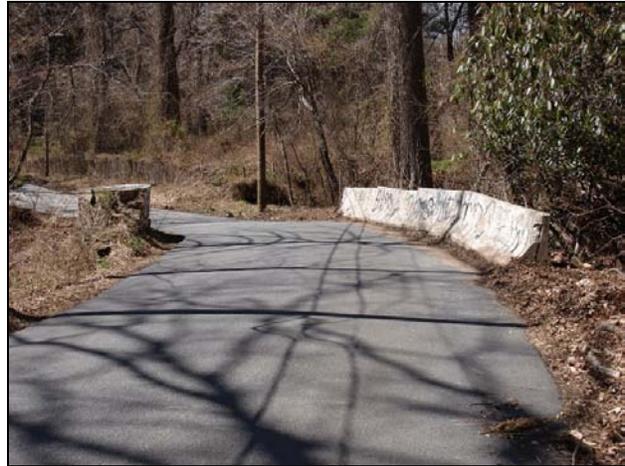
The lack of documentation makes any interpretation of the culvert speculative. An observation made by LCE professional engineer Michael C. Cuddy is that the topography may have required that the culvert be built on a curve in the road. A triangular shape would definitely have been easier for a less skilled mason to build than a skewed arch, which is more complex and requires formwork and abutment. Thus, this simple culvert could be merely a local solution to a site-specific problem (Figure 14).

Figure 14. The stone culvert is at a curve in the road with the stream's course crossing at a skew. The triangular-shaped opening may have been a site-specific solution avoiding difficulties associated with building an arch.

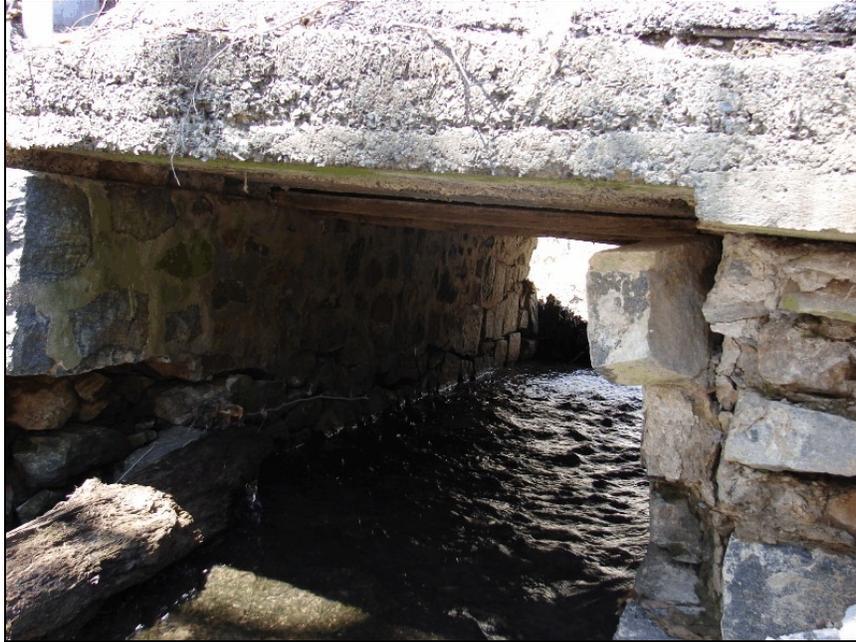
Physical Description: The skewed, 5'-long (clear span) and approximately 18'-wide, concrete slab culvert is supported on roughly coursed fieldstone abutments (Figures 3, 15). The culvert has lost its original railings, which consisted of two-high steel pipes over the opening and concrete parapets over the wingwalls as shown by the New Castle County bridge card photo dated May 17, 1921. A section of the pipe railing and parapet is still visible where it fell downstream of the culvert (Figures 16-17). A modern steel beam guide rail has been added to the south elevation, but there is currently no railing on the north elevation. The 8"-deep concrete slab is spalled at its fascia with no visible reinforcing bars; it is presumed that the slab, given its short length, is probably un-reinforced. The stone abutments and wingwalls have been undermined at all four corners and have partially collapsed.

Figure 15. Concrete slab culvert on stone abutments. Note the undermined abutment (left) and failed and shifted abutment corner (right). Looking upstream.

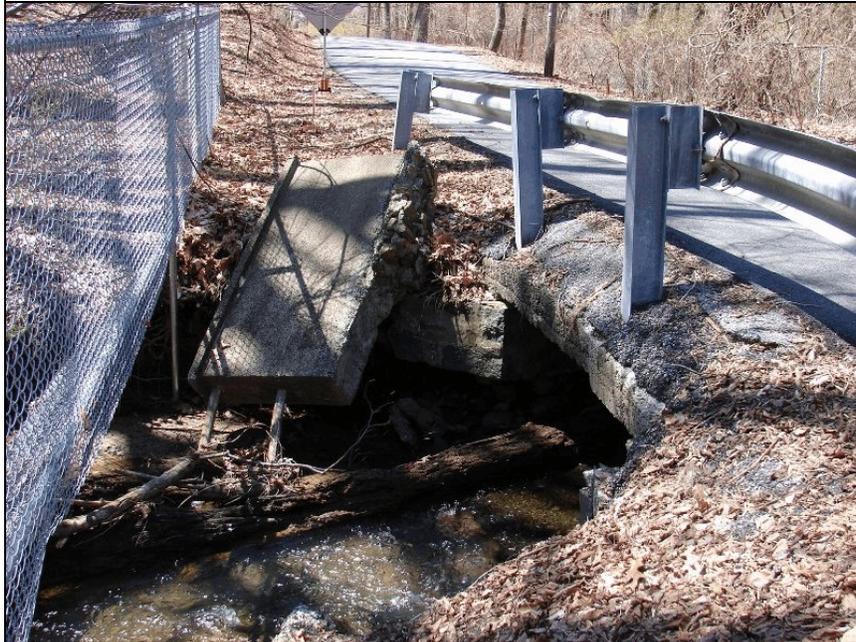
Figure 16. Oblique view of slab culvert, downstream side looking west. Note the section of concrete parapet laying on its side.

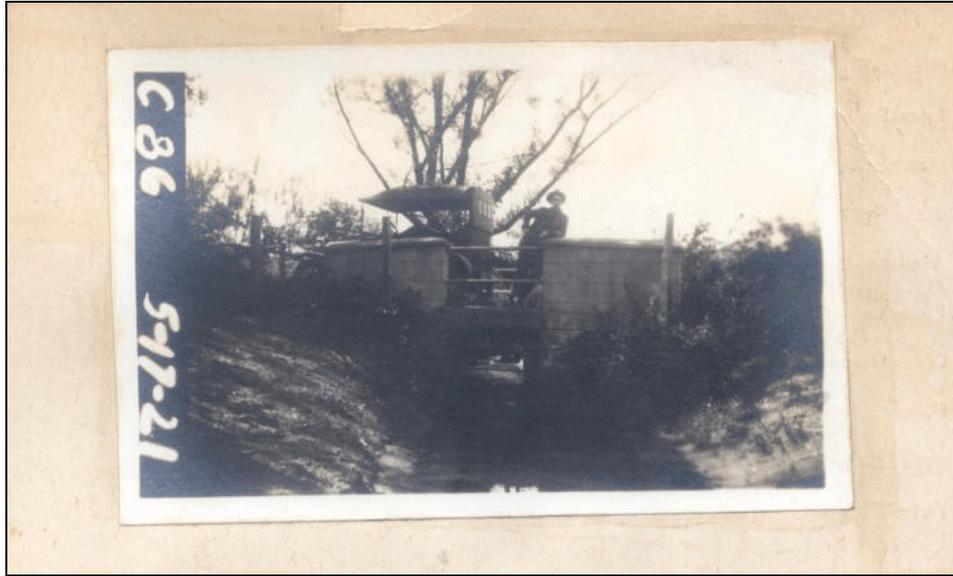
Historical Context. DeIDOT has no plans for the culvert and no documentation for its date of construction. It is dated ca. 1910 based on style and that it was in place by 1921 as documented by a New Castle County bridge card. The card lists it as county culvert No. C-86, but does not provide a date of construction.

Bridge No.	C-86
Location	near Centerville
Description	culvert, conc. slab & walls, pipe rail
Clear Span	5' 0"
Abutments	masonry
Floor to W. L.	3' 9"      water 6"
Clear Roadway	about 16' 0"
Floor	road surface
Safe Load	<i>Indeterminate</i>
Details	<i>None.</i>

Figure 17. New Castle County Bridge Card, 1921.

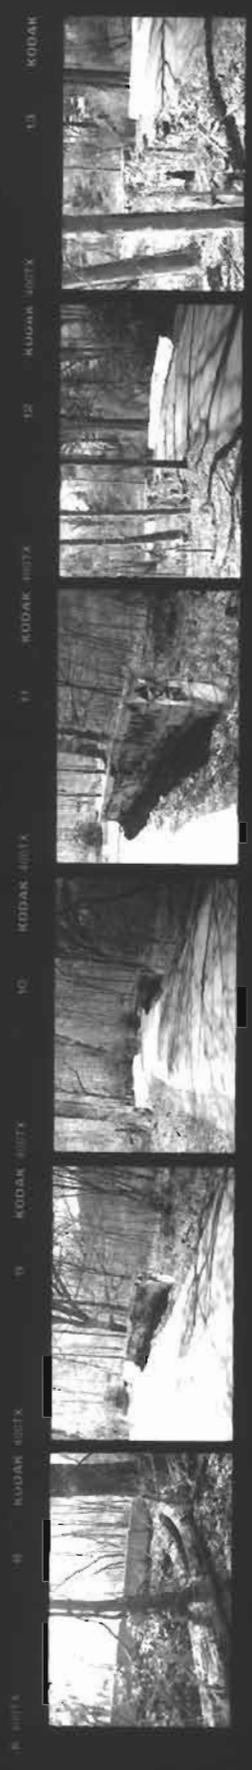
8 9 10 11 12 13

Frame #	CRS #	Description of view
8	N-4283	Upstream elevation - debris covers opening
9	"	Looking NE at stone parapet
10	"	Roadway view, looking NE
11	"	Detail of stone parapet, SW corner
12	"	Roadway view, looking SW
13	"	Oblique view of downstream elevation, looking SW
14	"	Downstream elevation, looking NW
15	"	Downstream elevation, looking N
16	"	Downstream elevation
17	"	Triangular opening detail
18	"	Detail of SW wingwall
19	"	Oblique view of downstream elevation, looking NE
20	N-13673	Roadway view looking E
21	"	Upstream elevation looking SE
22	"	Upstream elevation looking SE
23	"	Roadway view looking W
24	"	Downstream elevation looking NE
25	"	Downstream elevation looking NW
