**IV. HISTORIC ARCHITECTURAL SURVEY
and EVALUATION**

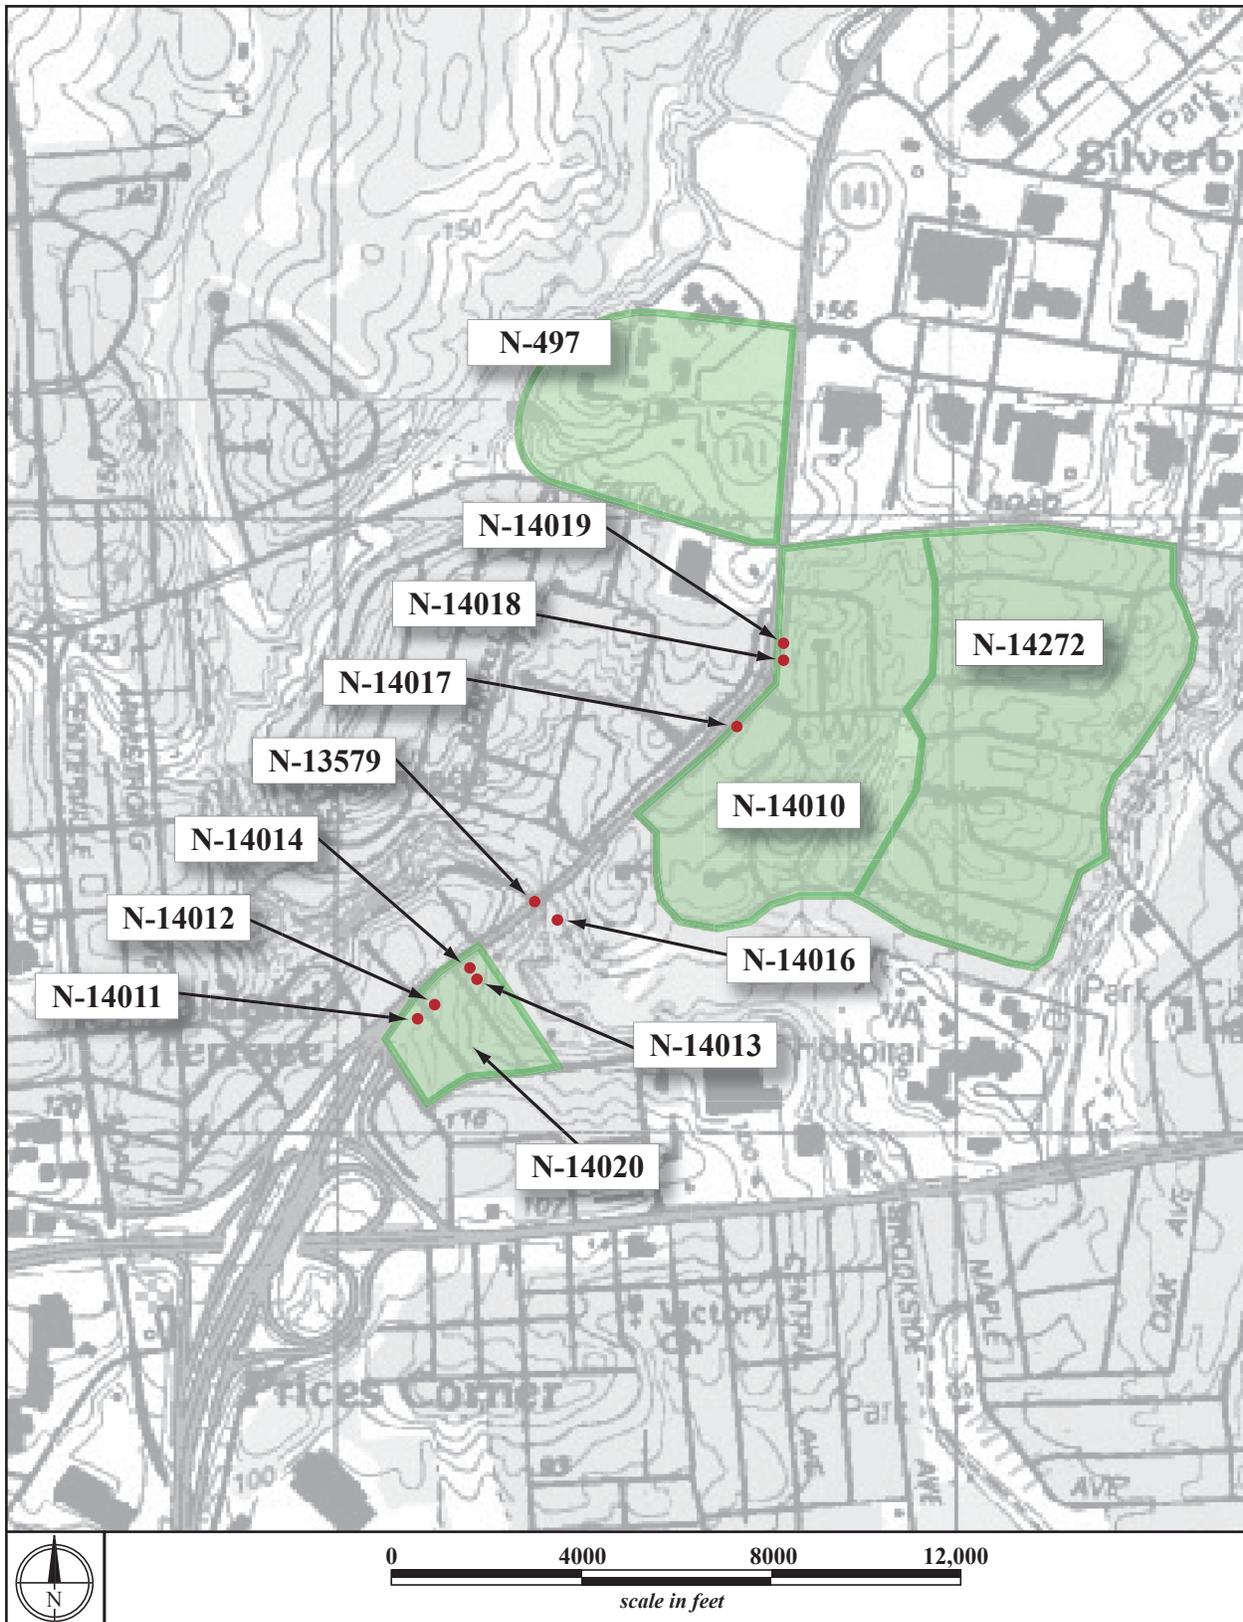
Figure 6. Previously identified architectural resources. (Source: United States Geological Survey, 7.5' Topographic Series Quadrangles, *Wilmington North, DE*, and *Wilmington South, DE*, 1997, <http://www.topozone.com>).

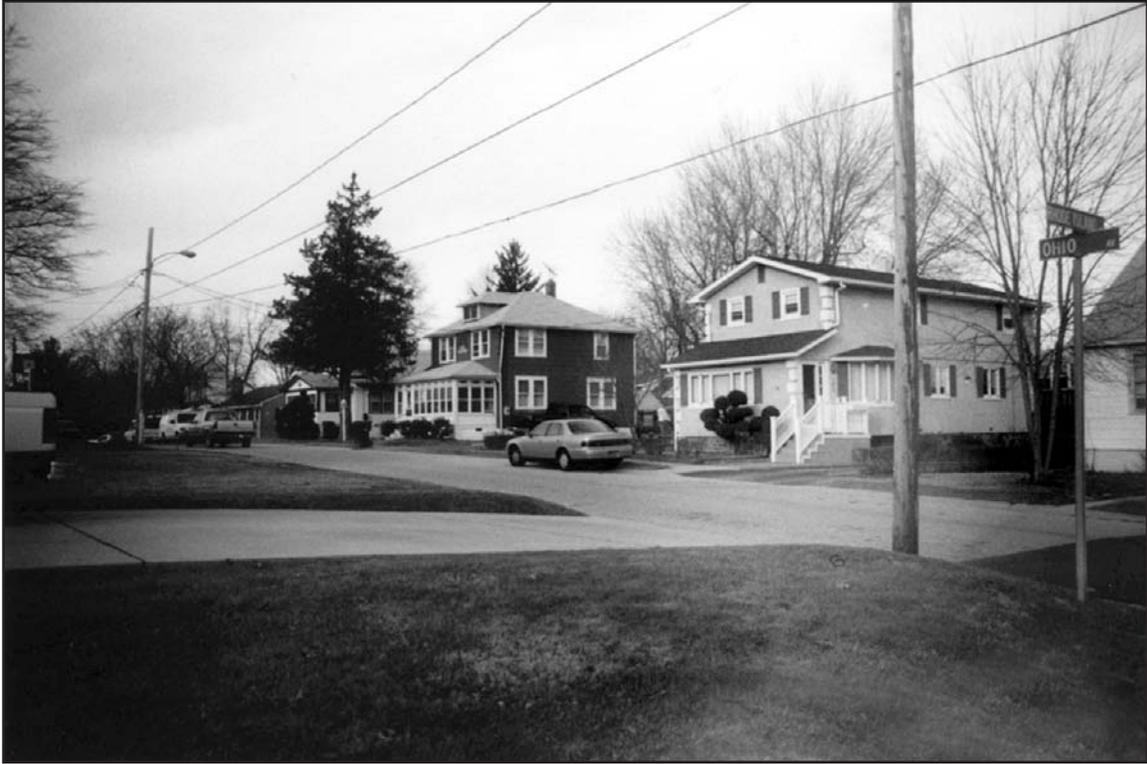
Plate 6. Brookland Terrace, intersection of Ohio and Rhode Island streets, view southwest.

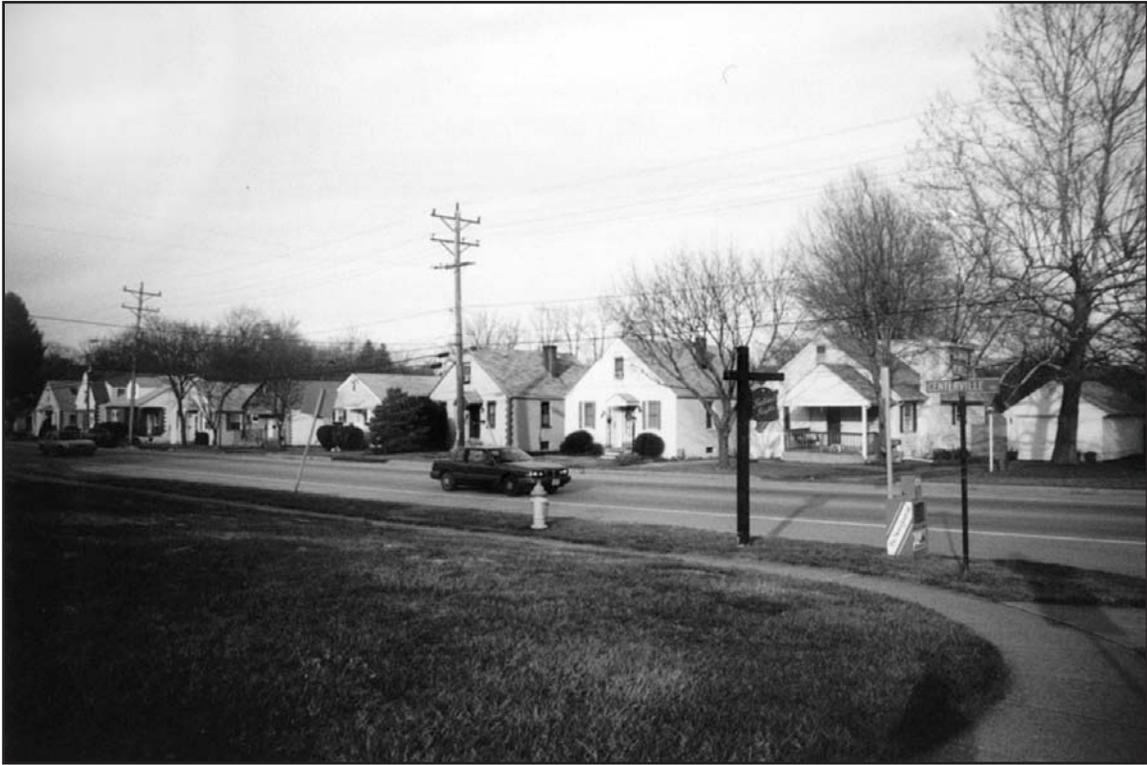
Plate 7. Brookland Terrace, intersection of Newell Street and Centerville Road, view south.

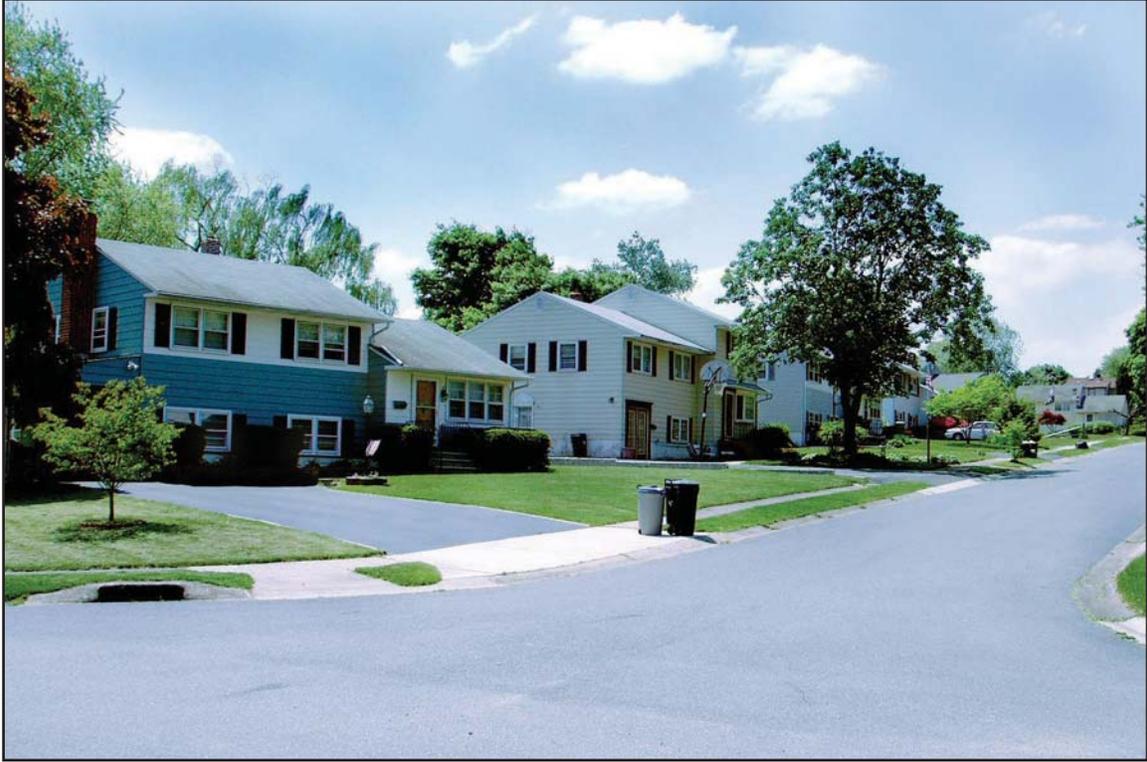
Plate 8. Woodland Heights, Britton Place, view southwest

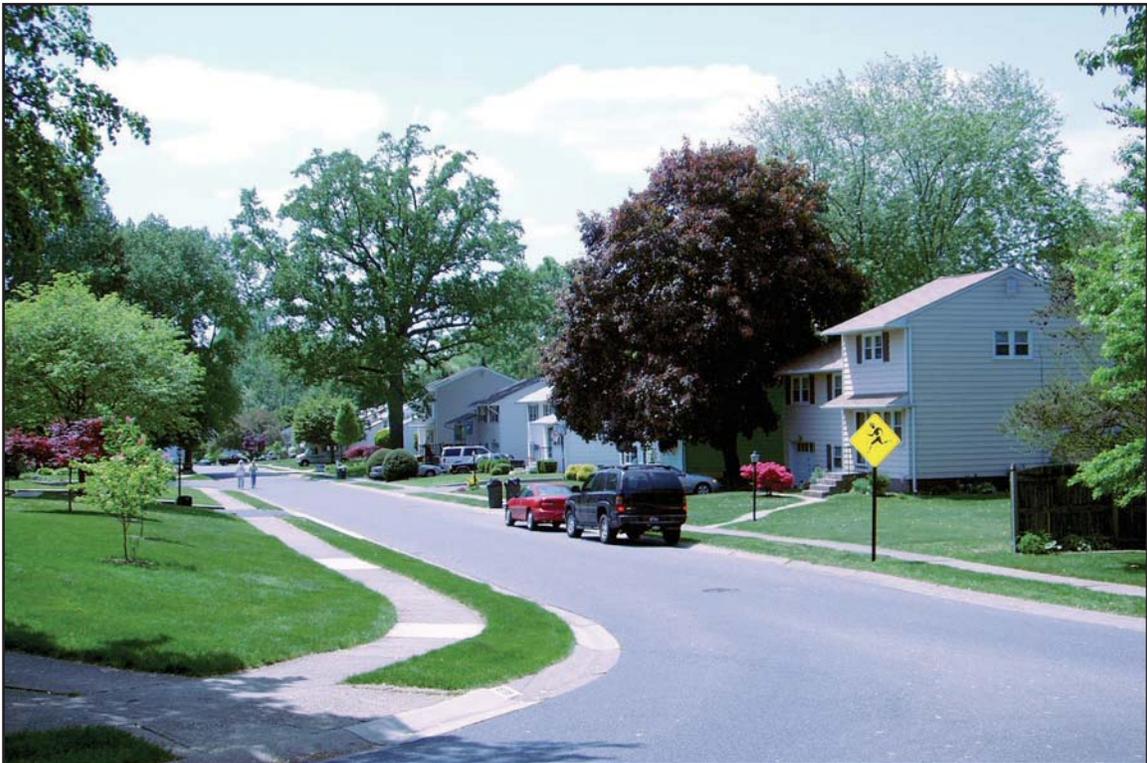
Plate 9. Woodland Heights, Wagoner Drive, view southwest

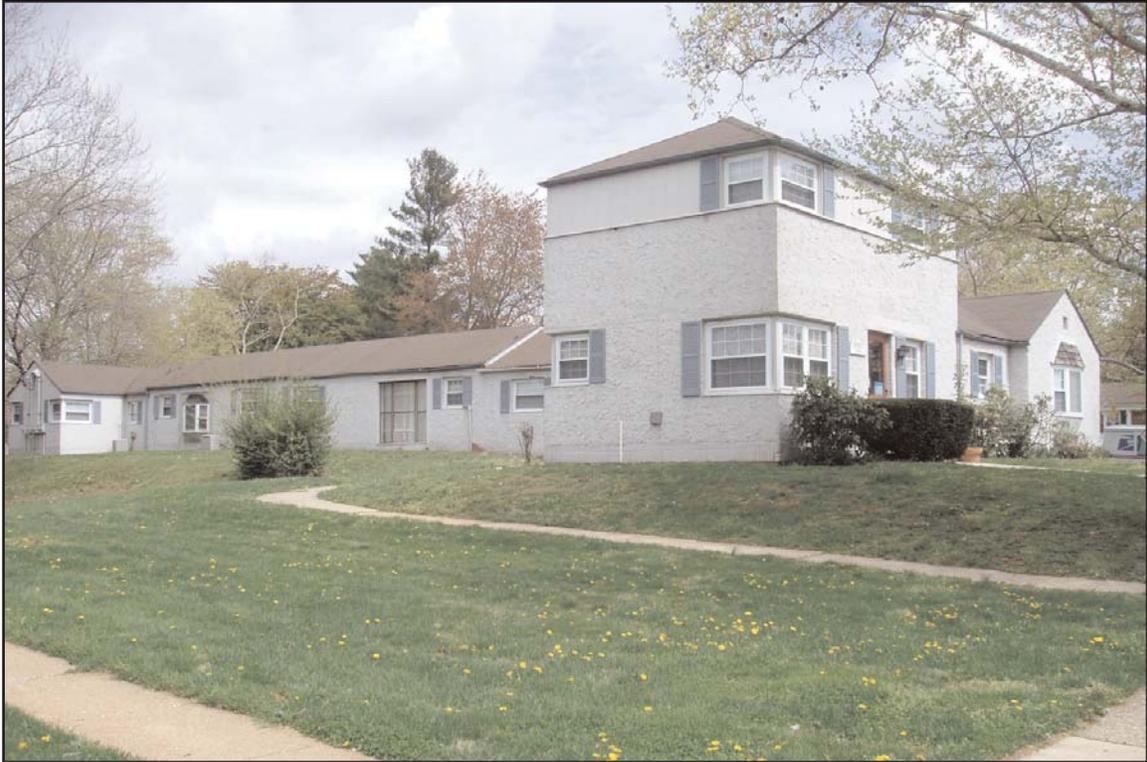
Plate 10. Woodland Apartments Building Type A, view north.

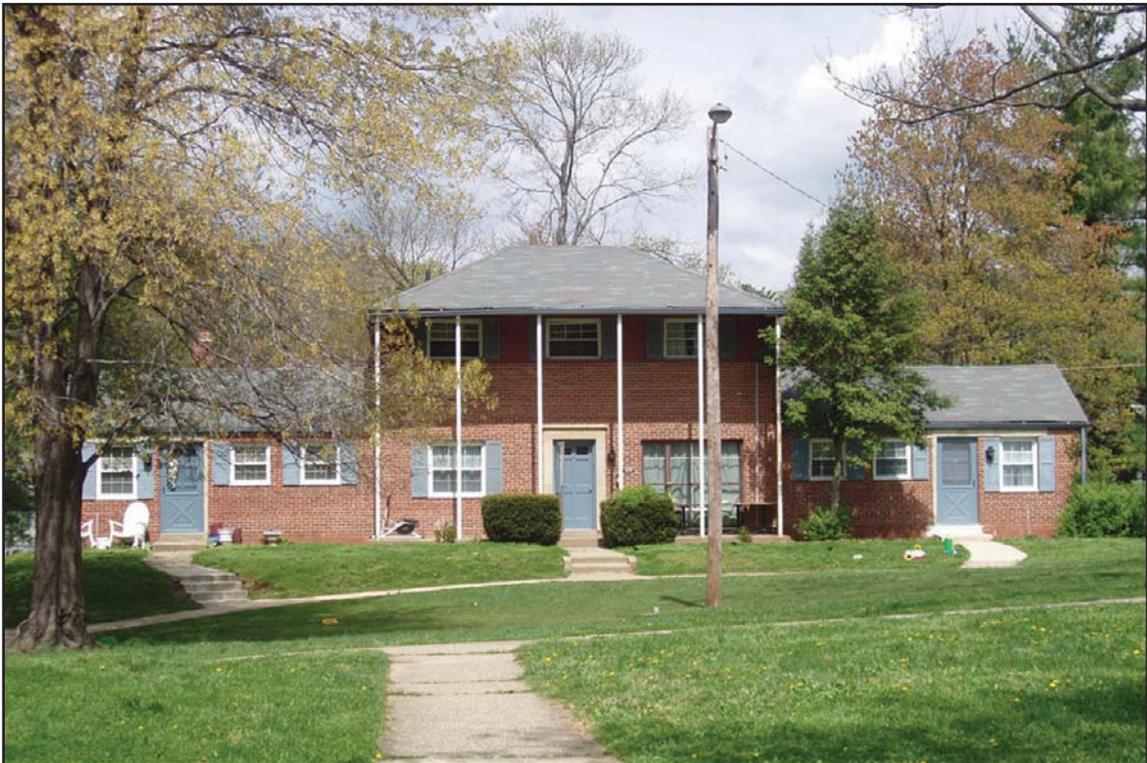
Plate 11. Woodland Apartments Building Type B, view northwest.

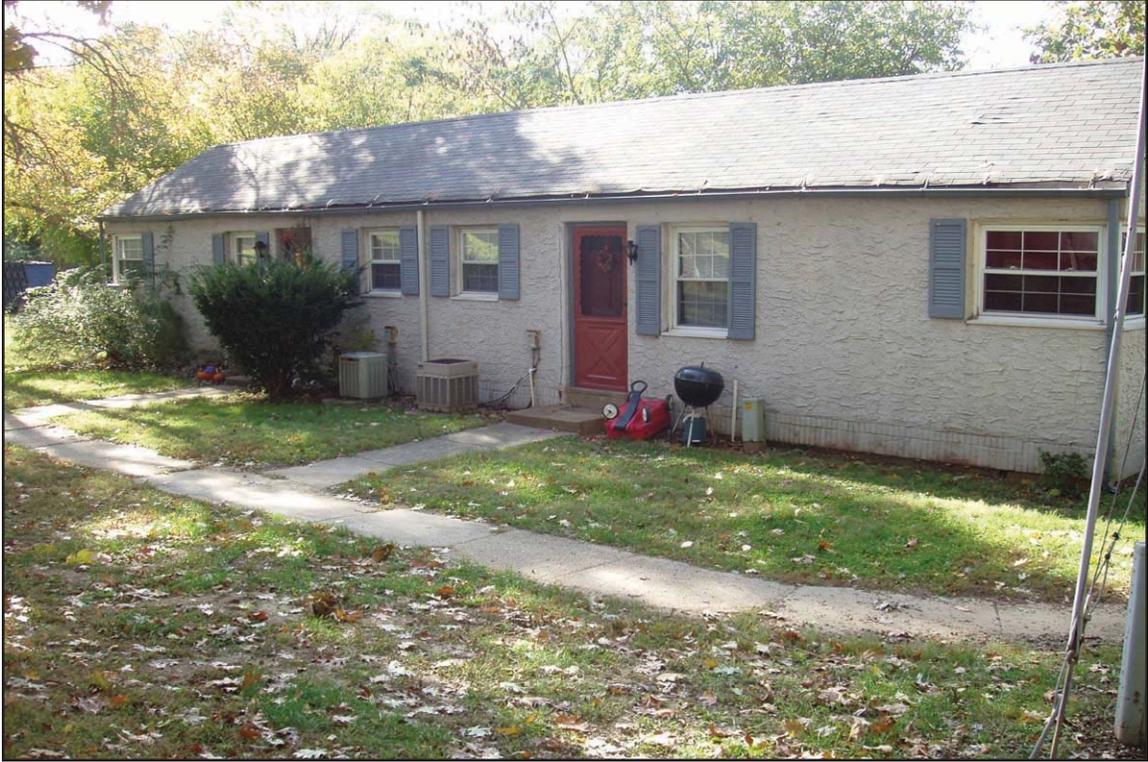
Plate 12. Woodland Apartments Building Type C, view south.

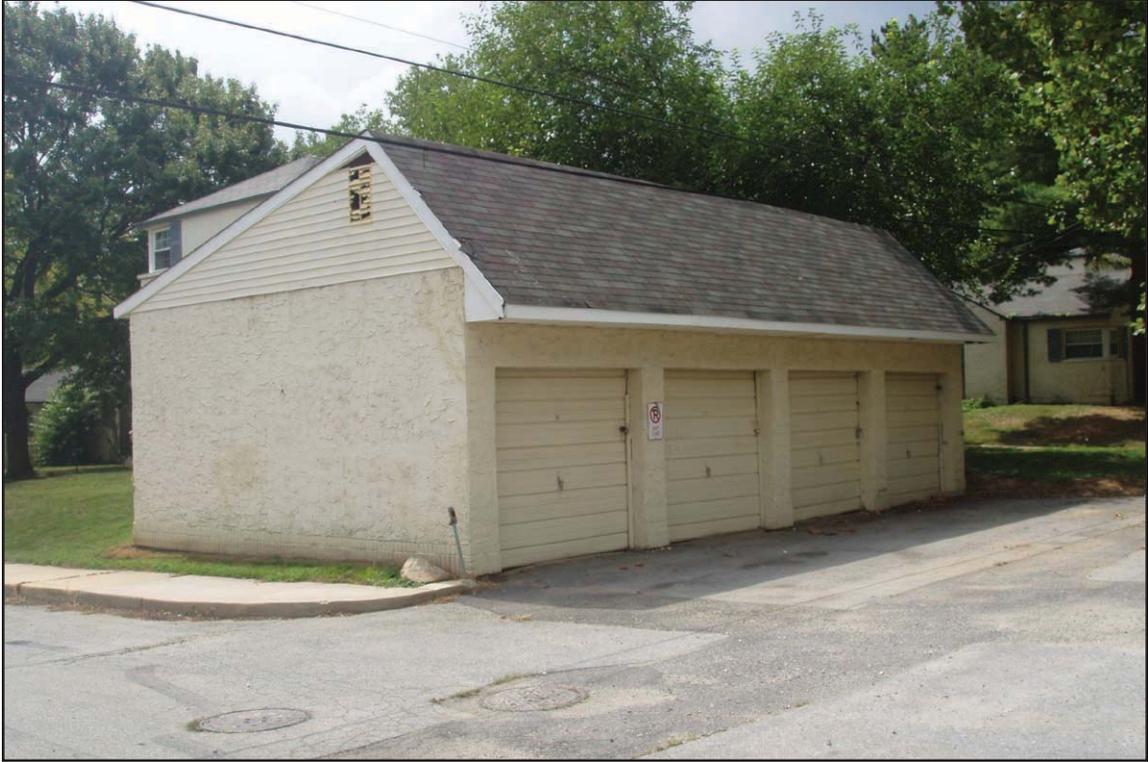
Plate 13. Woodland Apartments Building Type D, view south.

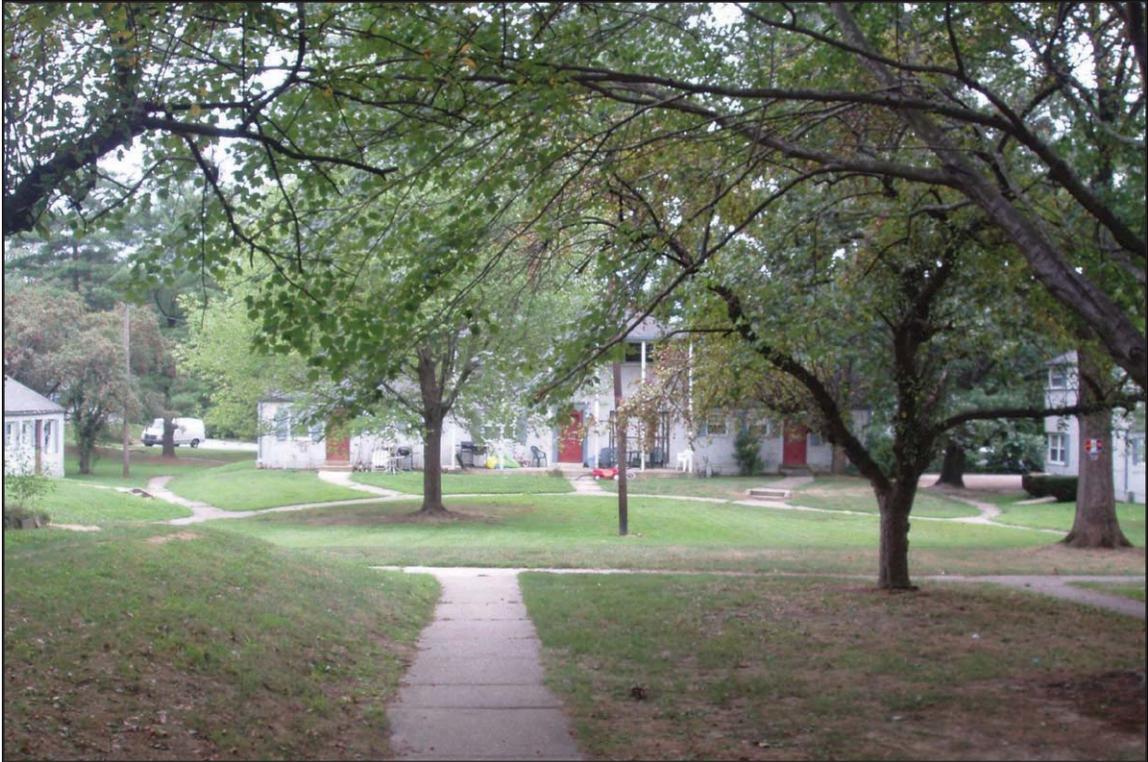
Generally, three to four buildings surround a central courtyard, with concrete walkways linking the buildings to this green space (**Figure 9**). Concrete sidewalks surround each block in the subdivision, encouraging pedestrian activity. These walkways have had sections replaced, but the new paths follow the original alignment. Walkways leading to the entrances of the individual apartment units are also concrete, and have stairs with wrought iron railings where necessary. A service road is located between Woodlawn Apartments and Centre Road (Route 141). The general landscape consists of mature pine, crabapple, mulberry, and sycamore trees. Some shrubs and plantings are adjacent to the buildings, and for an additional charge, residents may maintain a private flower garden. There are also asphalt pads in the rear of the three-unit U-shaped apartment buildings. These contain permanent metal pipe supports for clotheslines, and are slightly overgrown with vegetation.

Plate 14. Woodland Apartments, landscape features, view south.

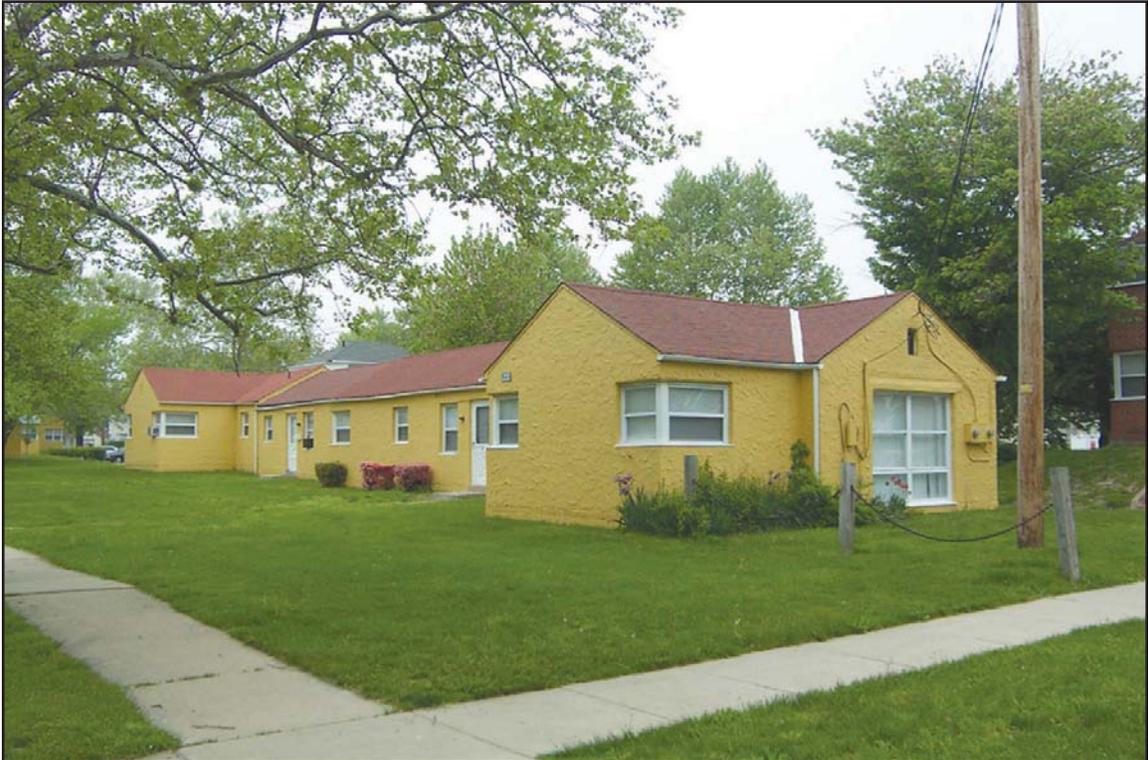
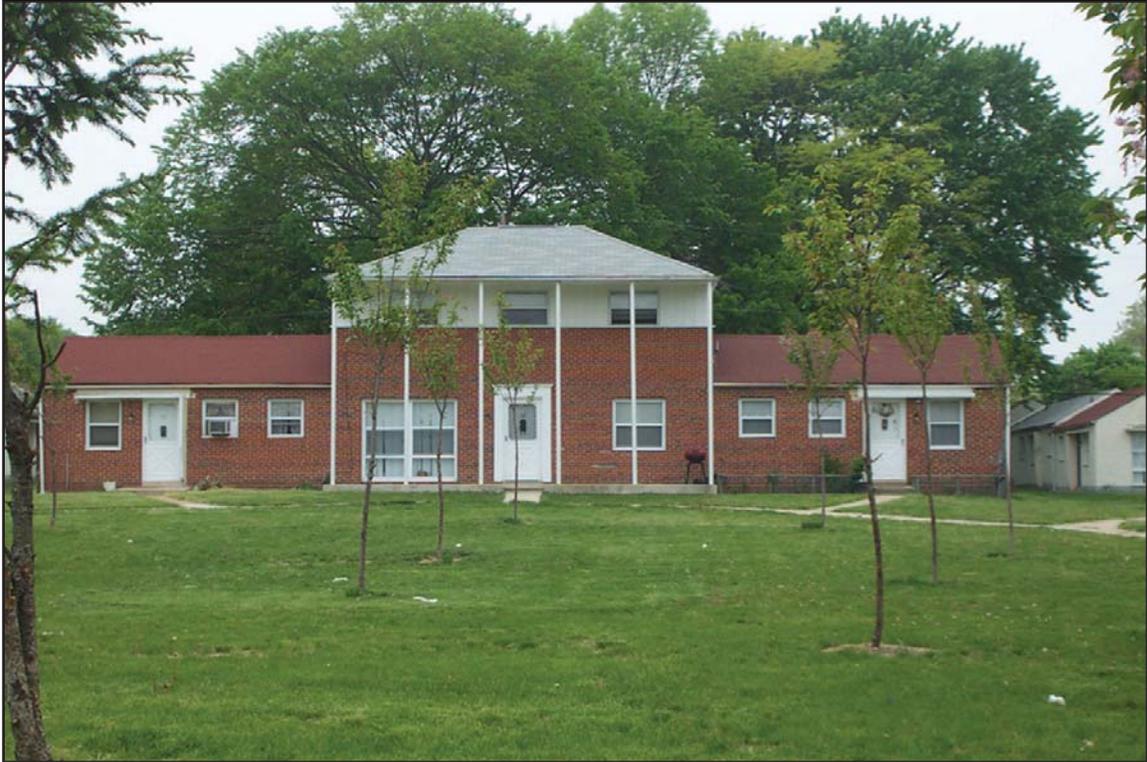
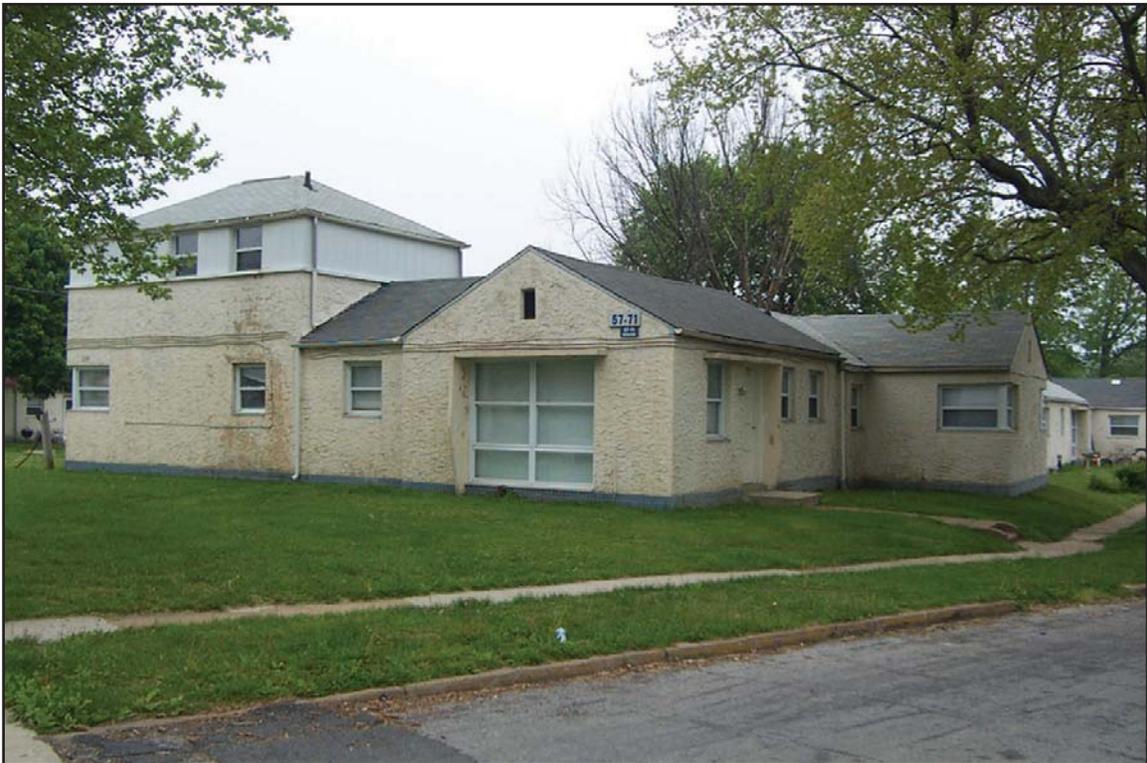
Plate 17. Brookview Apartments, view north.

Plate 18. Brookview Apartments, view northwest.

Plate 19. Brookview Apartments, view southeast.

During this period, Anthony P. Miller, Inc. was also building a similar complex, the Brookview Apartments, in Claymont, Delaware. This land was conveyed to the Anthony P. Miller Company as part of lands willed to the company, in fee, by James C. McComb.⁴⁹ The company transferred ownership to Brookview Apartments, sections 1, 2, and 3. The Brookview Apartments was also an FHA-sponsored rental housing project (No. 032-42021) for which Anthony P. Miller, Inc. was the contractor. In a loan consolidation document dated 1968, Mr. Anthony P. Miller is noted as the President of Brookview Apartments Corp. (subsequently a partnership).⁵⁰ Mr. Miller maintained a similar relationship at Woodland Apartments, and was also noted as their President in 1968.⁵¹ The Anthony P. Miller, Inc. Company worked throughout the region, also participating in projects in Pennsylvania and New Jersey.⁵² Only three apartment complexes built by this firm are currently known.⁵³

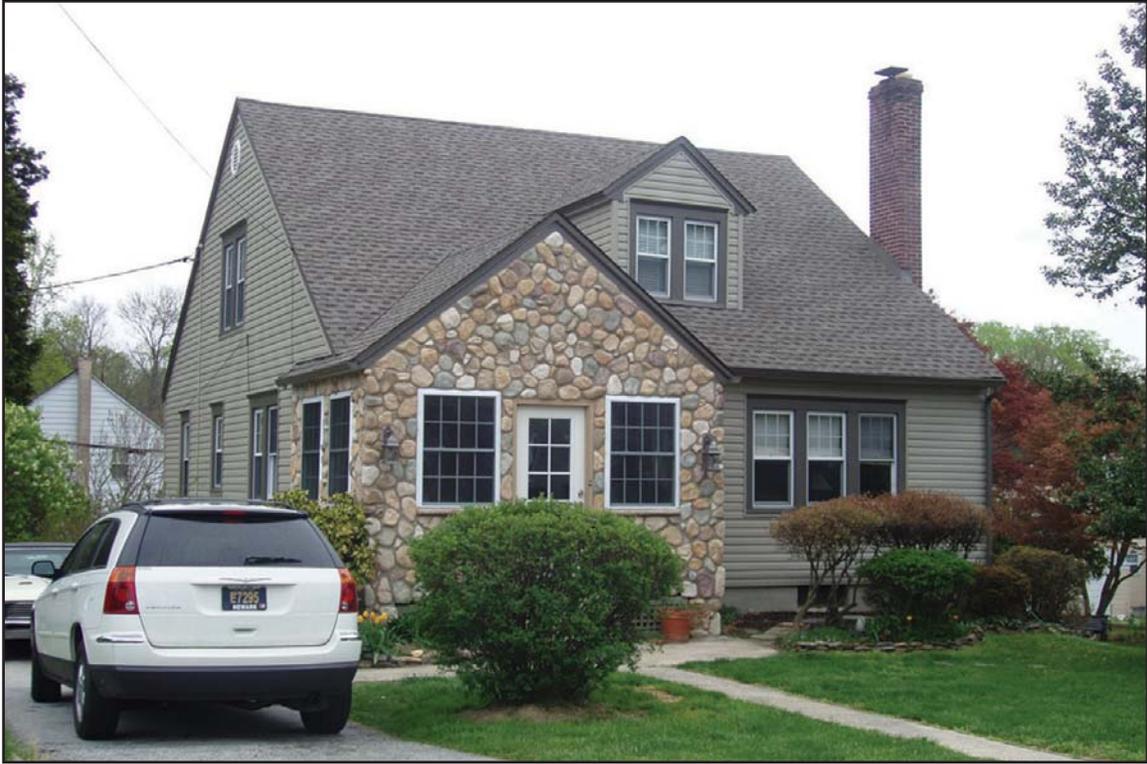
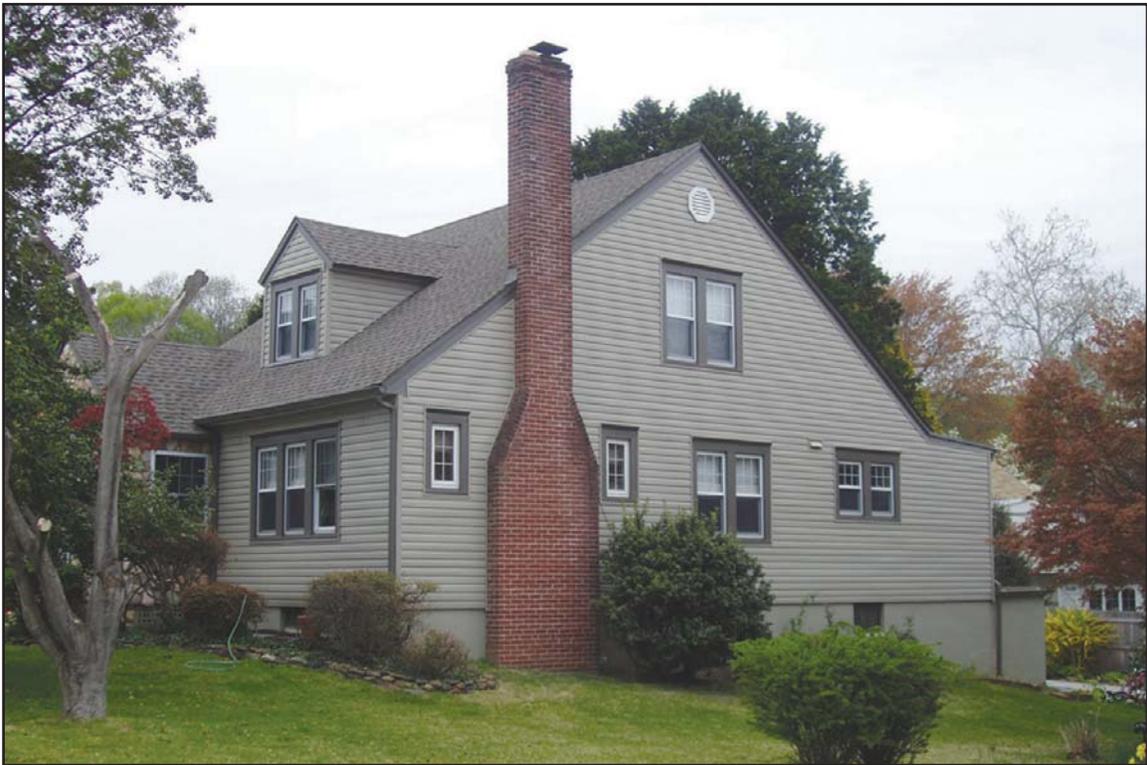
The William Frederick Property subdivision was platted in 1931 and developed into the 1950s. Lot sizes included 25 feet of frontage and either 100 or 125 feet of depth. Although by that time the widespread use of the automobile was leading to progressively more park-like subdevelopments, with curved streets, limited access, and a growing use of cul-de-sacs, the Frederick landscape design reflects the earlier gridded plats and small dwellings of simple, conservative design. This property combines three lots to form its 75 by 100-foot parcel. The changes to the fenestration and siding on the dwelling appear to date to circa 2000.

Plate 20. 7 Cedar Avenue, view east.

Plate 21. 7 Cedar Avenue, view north.

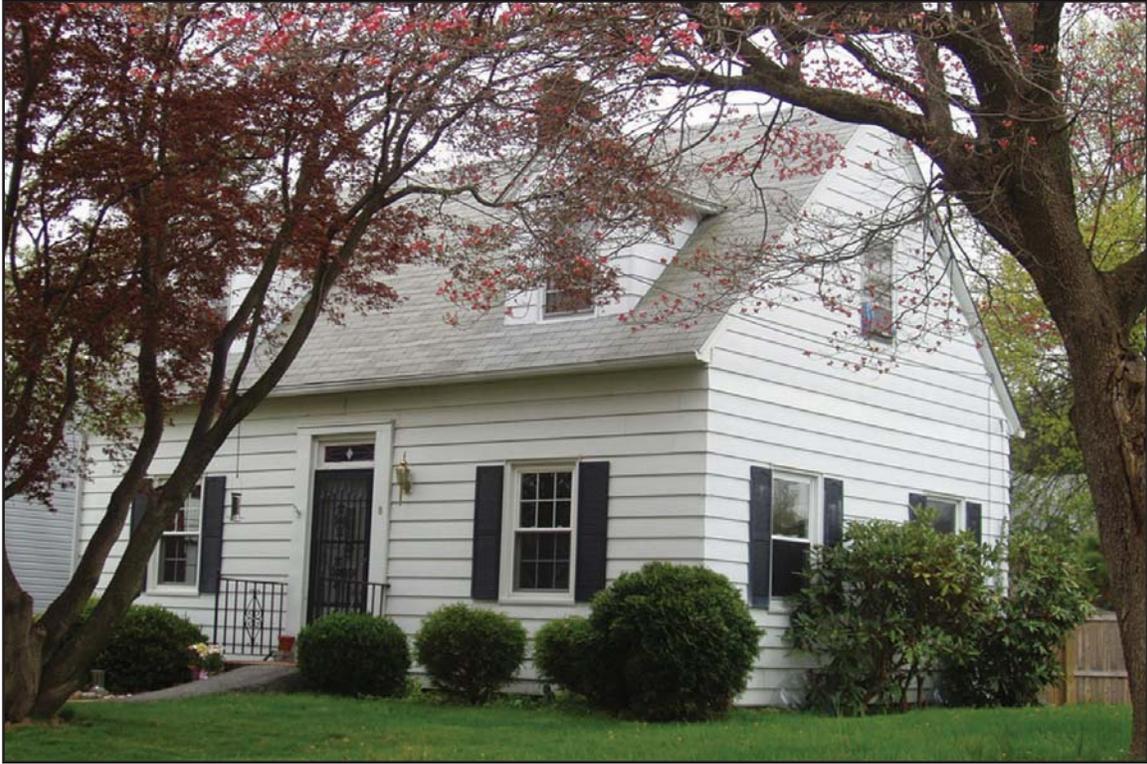
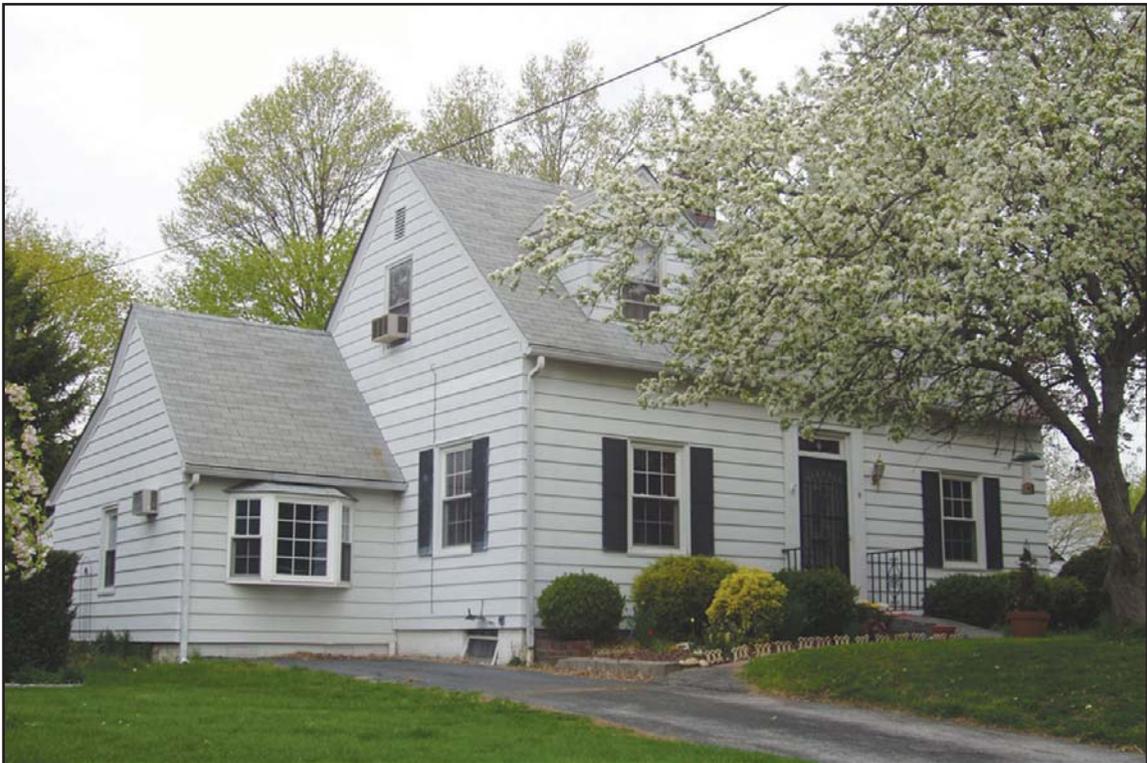
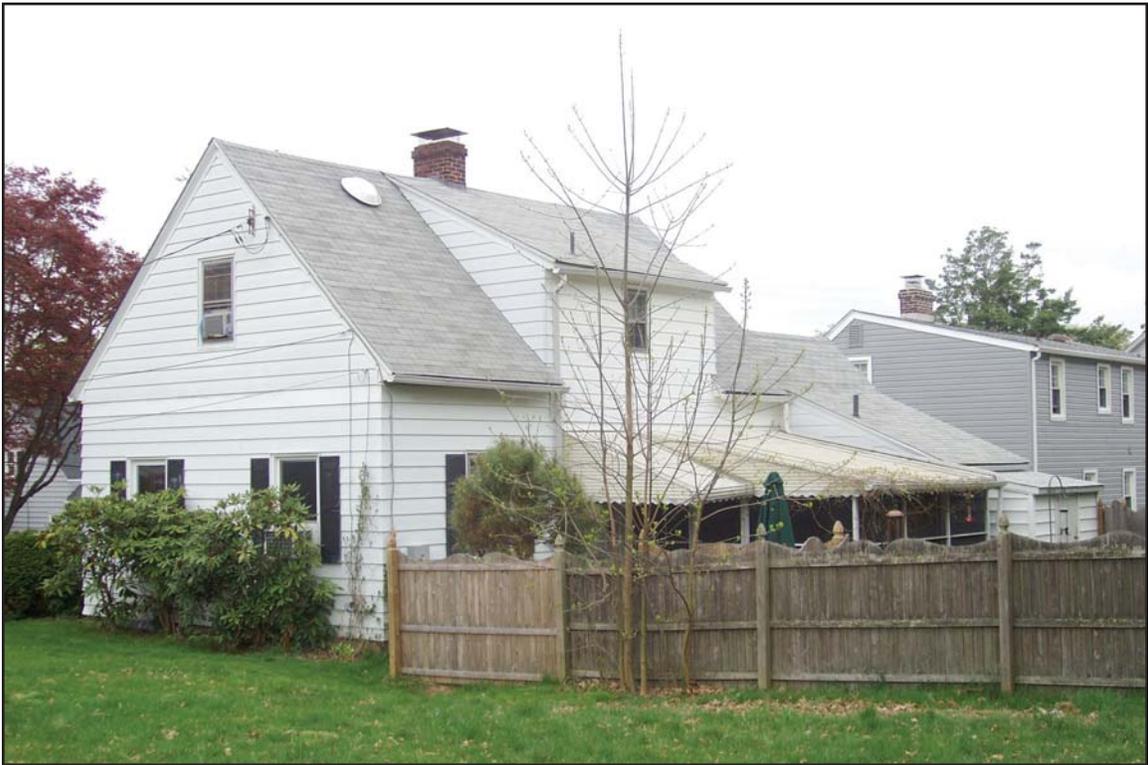
Plate 22. 8 Cedar Avenue, view south.

Plate 23. 8 Cedar Avenue, view west.

Plate 24. 8 Cedar Avenue, view east.

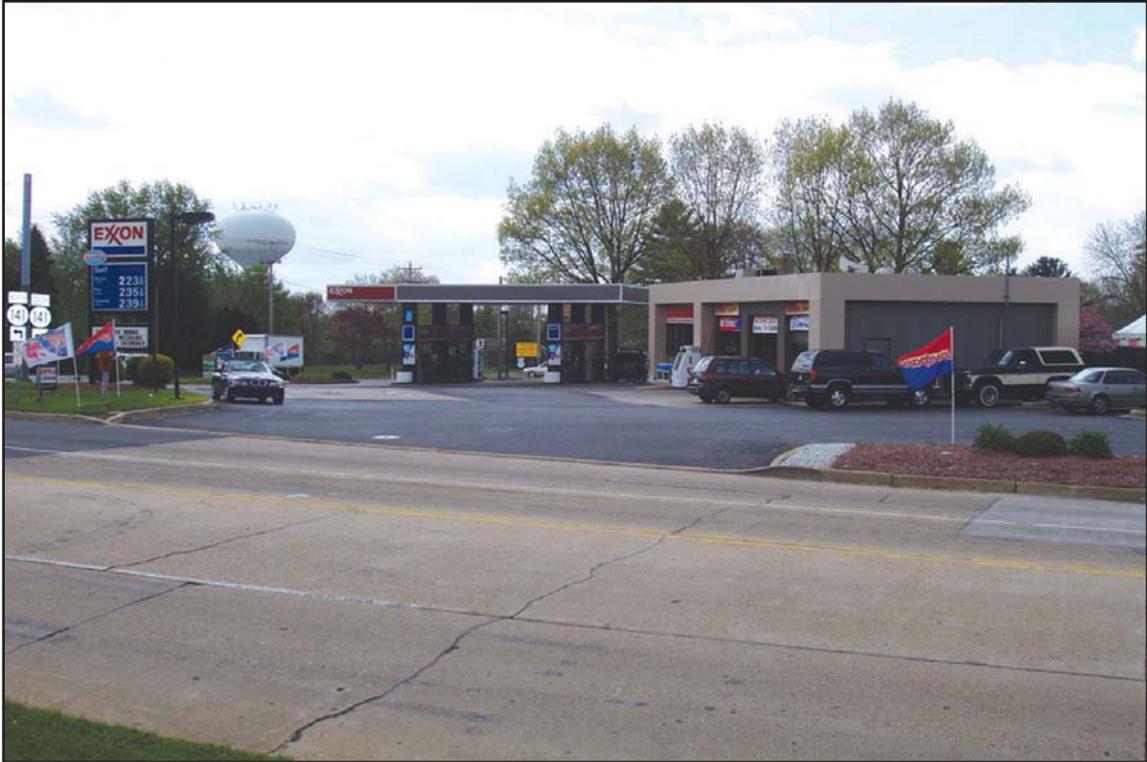
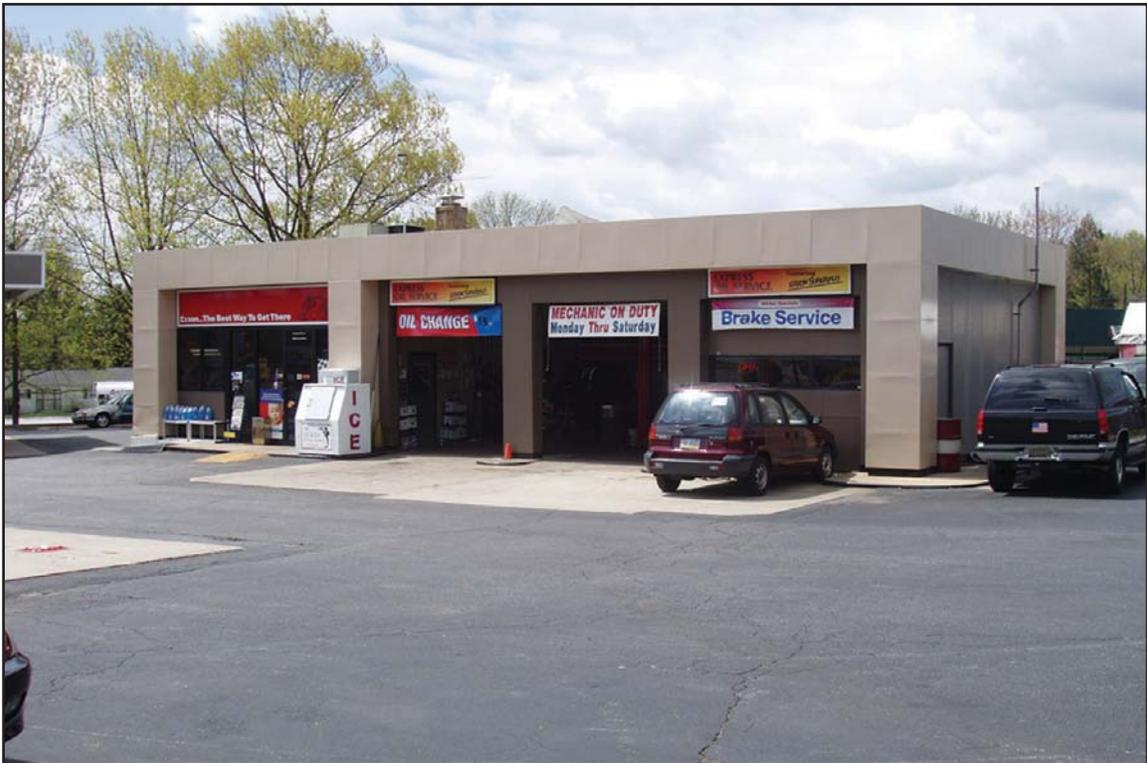
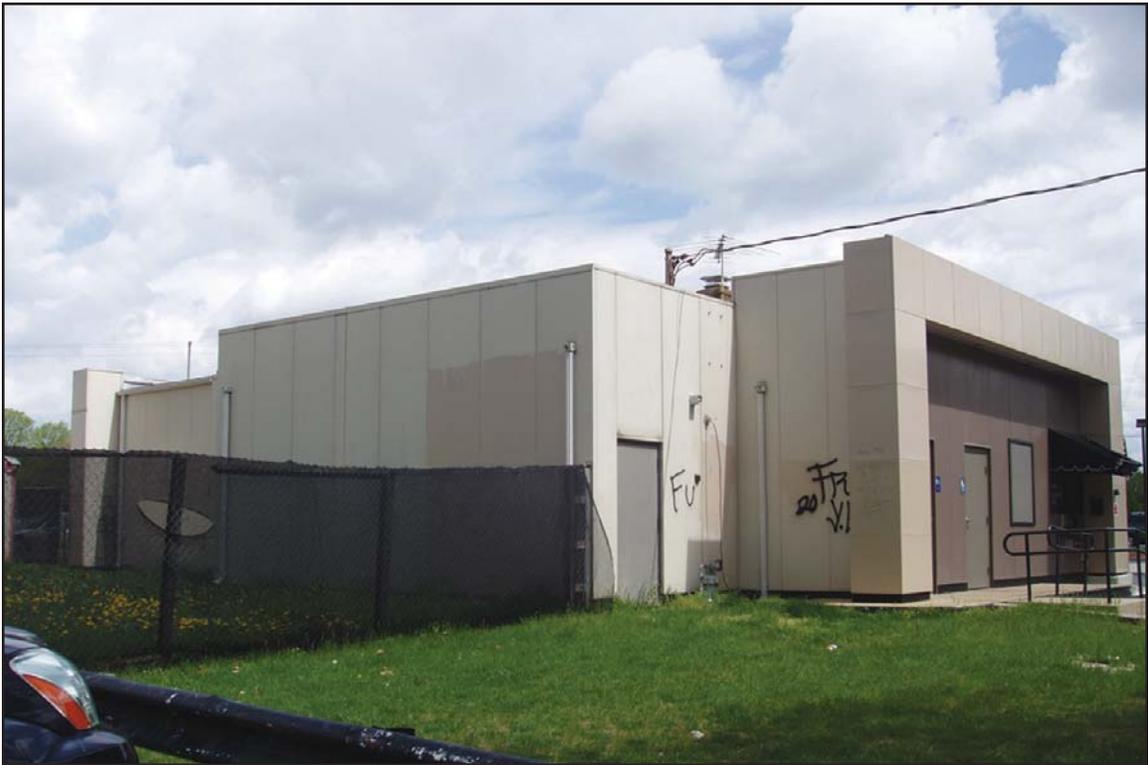
This gas station was constructed a few years after the completion of the nearby Woodland Apartments. As residents continued to move from the city to the suburbs, as well as from rural areas to the suburbs, service industries began to move in to serve the new residents. The increasing reliance on automobiles, an instigator of increasing suburban development, led to a need for fueling facilities nearby. This gas station was constructed in the mid-1950s with three service bays and a retail space. A fueling island was located in front of the building. This fuel island has been removed, and a new fueling facility installed southeast of the building. The building's retail/cashier area has also been renovated.
- **Evaluation**

Plate 25. 1001 Centre Road, view southwest.

Plate 26. 1001 Centre Road, view southwest.

Plate 27. 1001 Centre Road, view northeast.
