**IV. HISTORIC ARCHITECTURAL SURVEY
and EVALUATION**

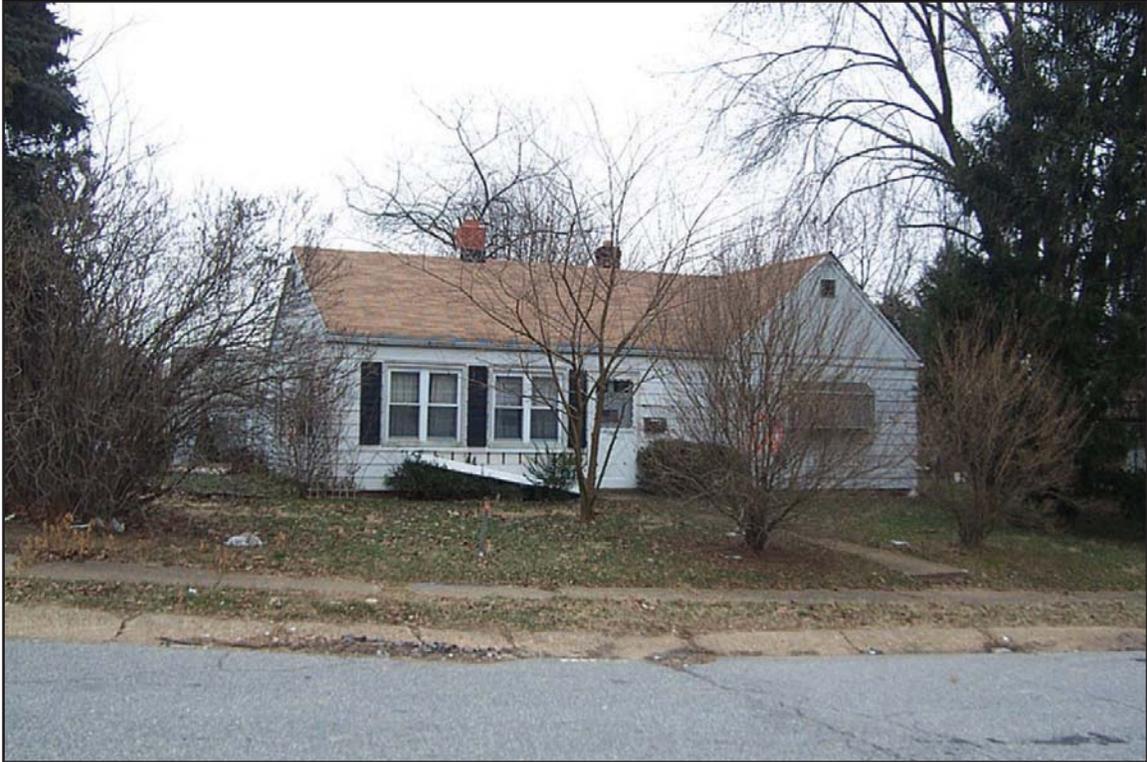
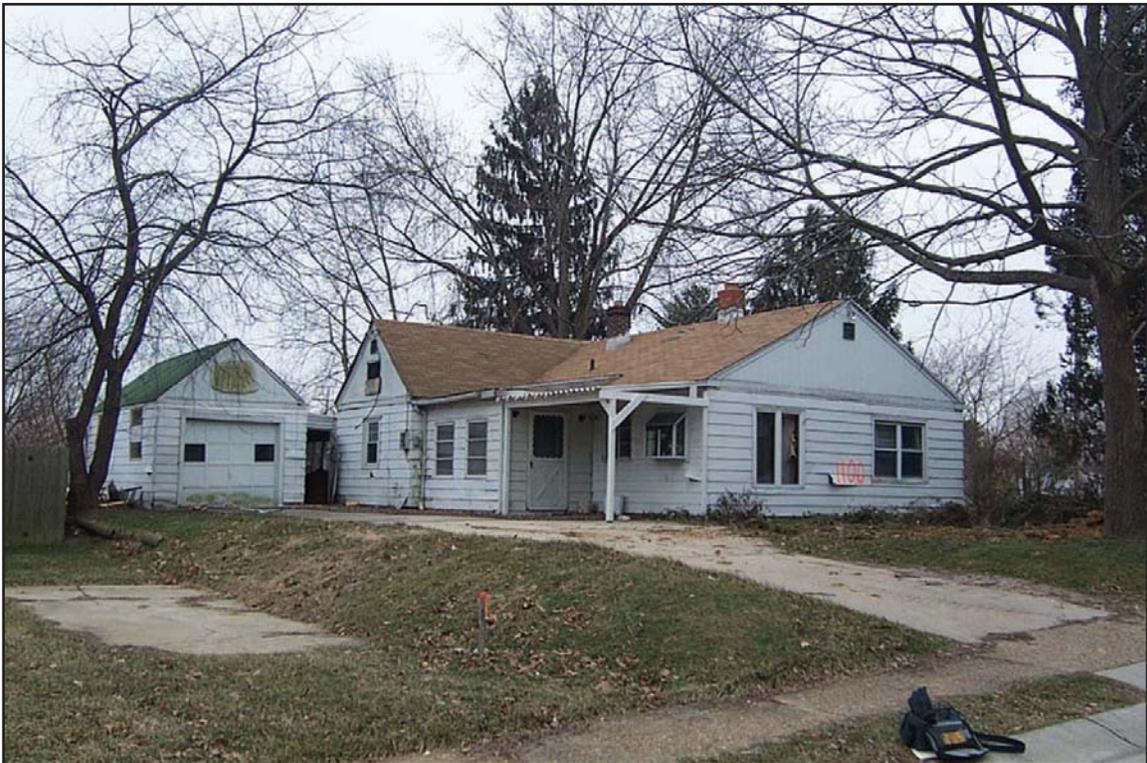
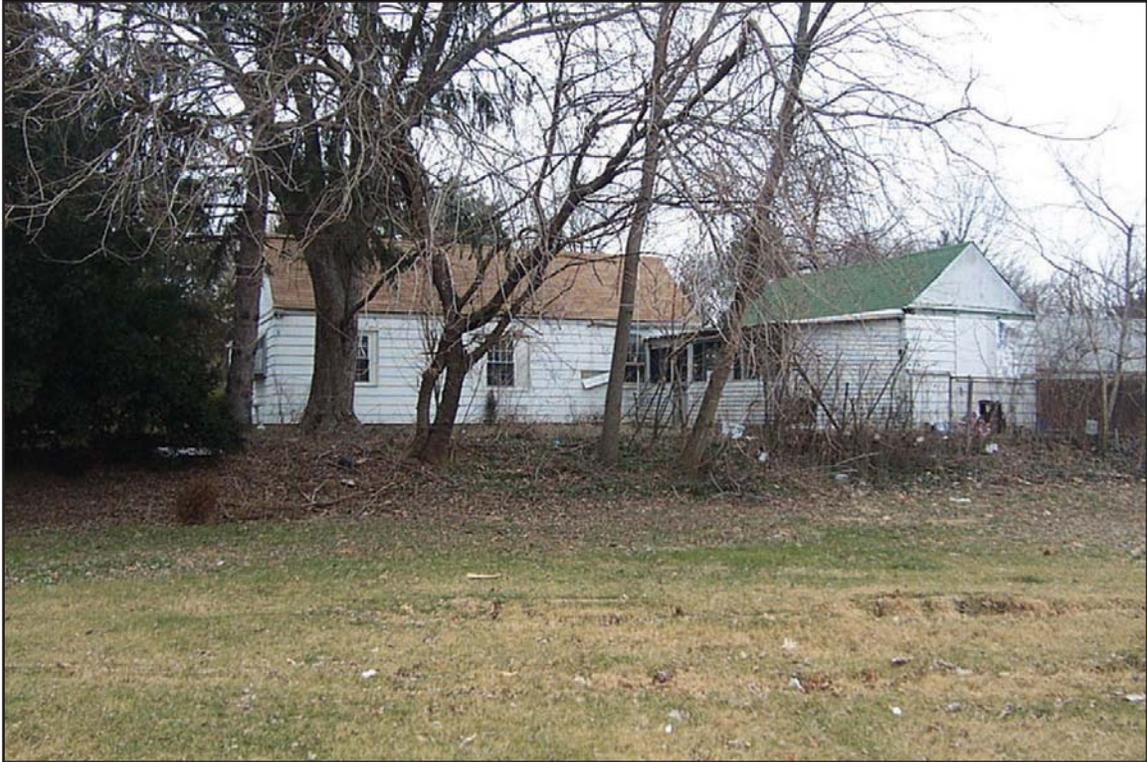
1100 Centre Road (N-14234) (Plates 28-30)

Plate 28. 1100 Centre Road, view southeast.

Plate 29. 1100 Centre Road, view southwest.

Plate 30. 1100 Centre Road, view northeast.

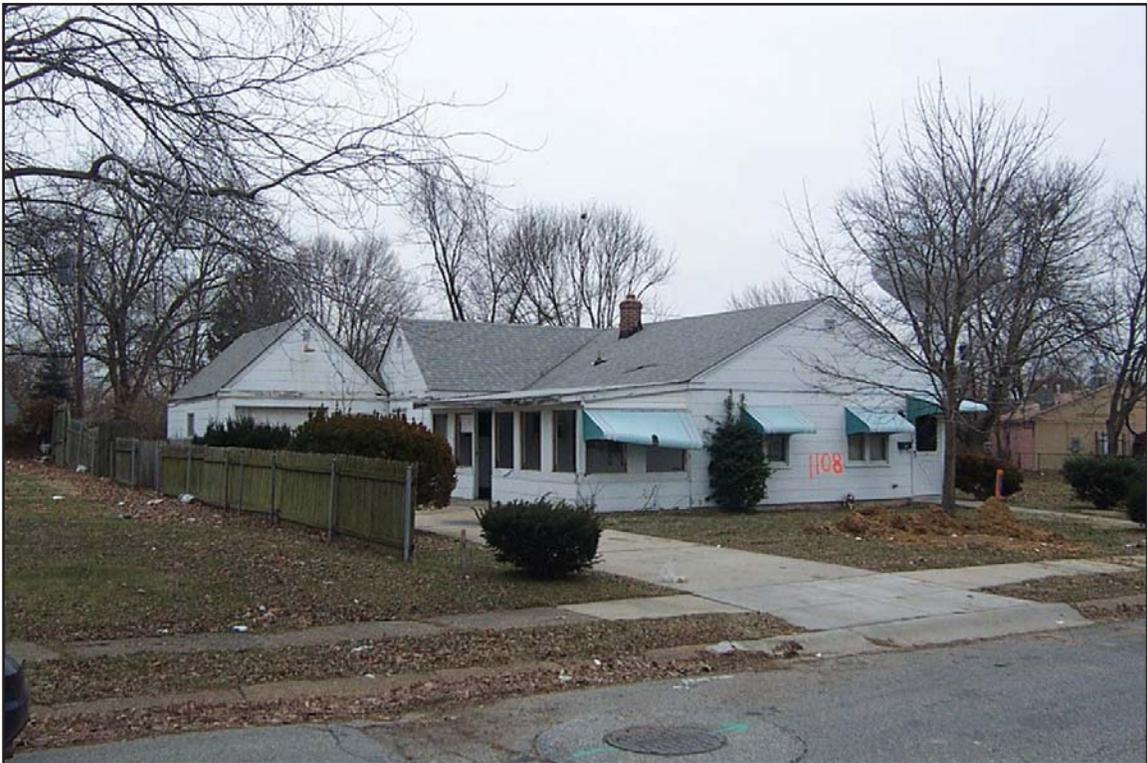
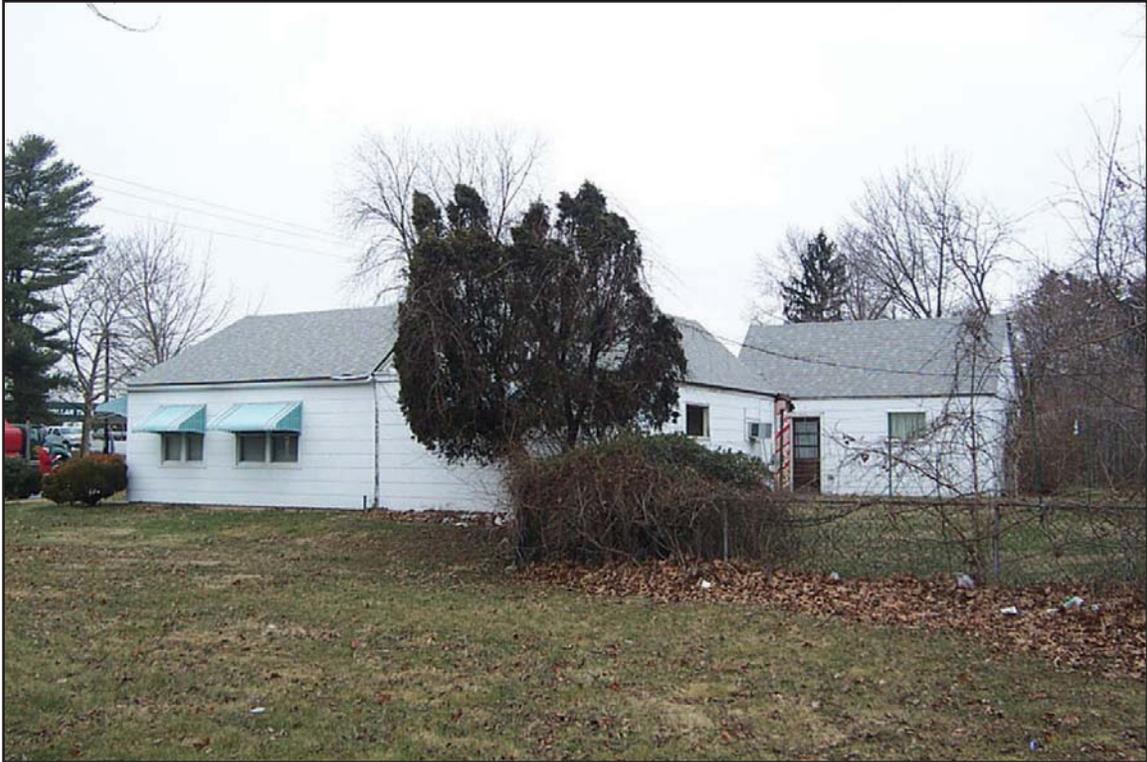
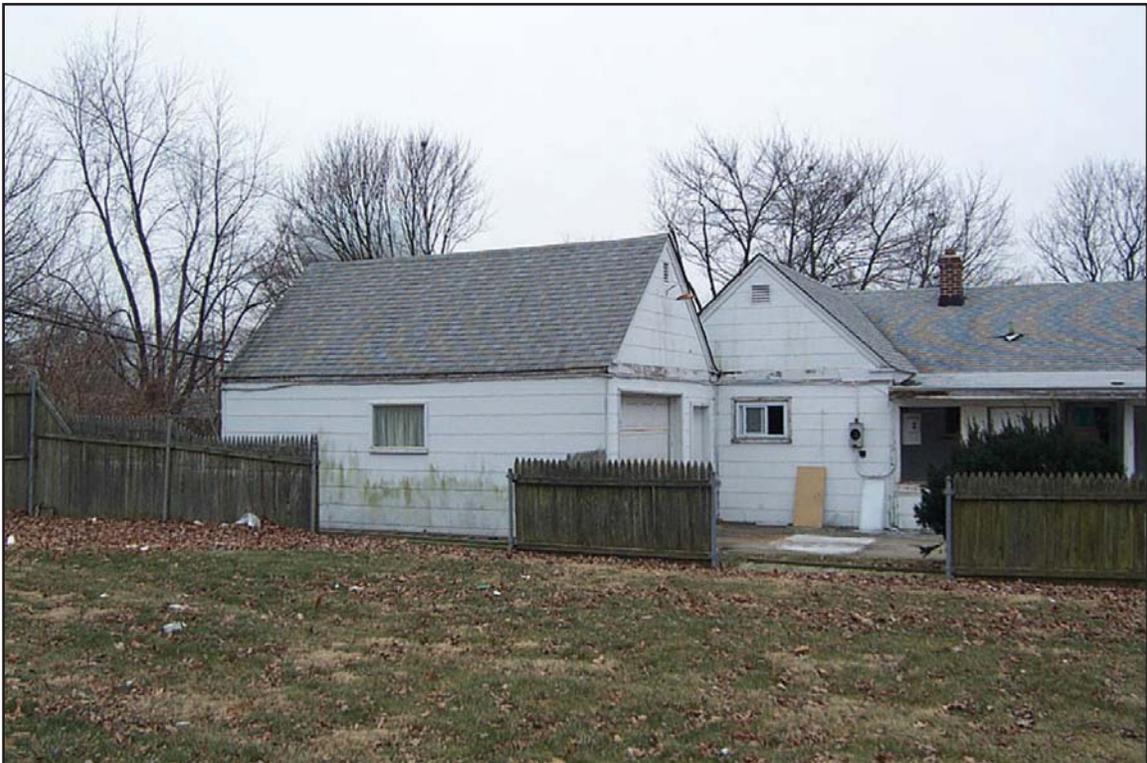
This .15-acre property is located in the Willow Run I subdivision outside of Wilmington, Delaware. The design of this building is similar to others in this subdivision. The building is a one-story, three-bay aluminum-clad dwelling with a cross gable roof, enclosed porch, and attached garage. The roof is clad in asphalt shingles, and a brick chimney is located in the northern roof slope near the ridge. The main entry is located at the southern end of the main (west) façade; the door is missing, but an aluminum storm door remains. Windows are paired vinyl 1/1 double-hung sash shaded by corrugated metal awnings, with the exception of a sliding two-light vinyl window on the north façade and single-light fixed window on the rear elevation. Formerly an L-shape plan, the building now has

Plate 31. 1108 Centre Road, view south.

Plate 32. 1108 Centre Road, view north.

Plate 33. 1108 Centre Road, garage, view southwest.

a rectangular plan with the enclosure of a porch on the north (side) elevation. A door is centrally located on the northern elevation of this enclosure. A one-story front gable roof garage is attached to the northeast corner of the dwelling. The garage is clad in asbestos siding, and its roof is clad in asphalt shingles. The garage features a folding overhead panel garage door and wood slab door on the main façade, and a wood pane and panel door on the southern elevation. Single-light fixed windows are located on each side elevation.

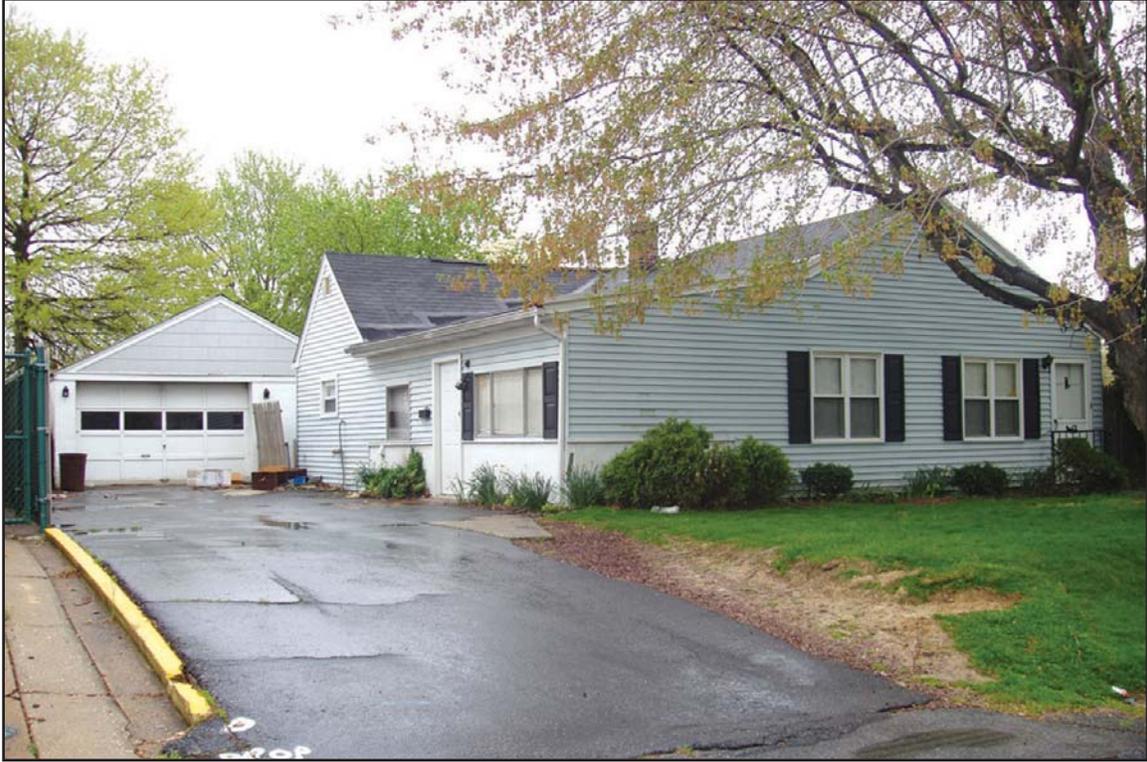
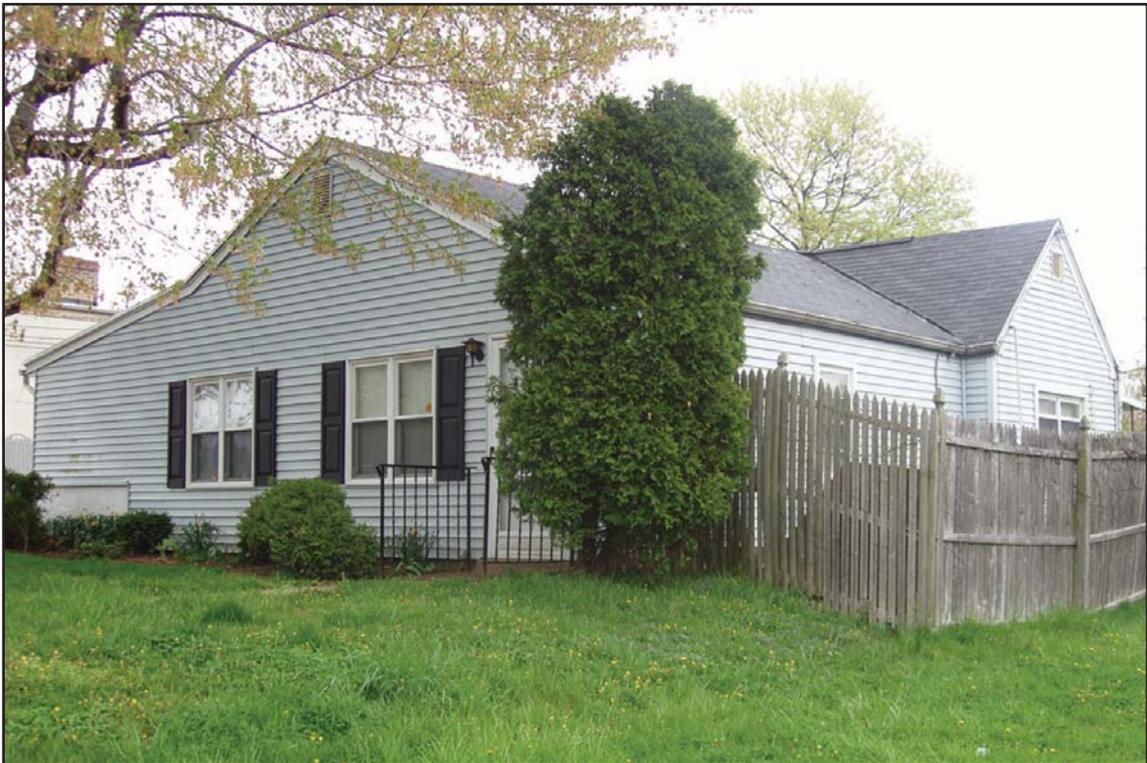
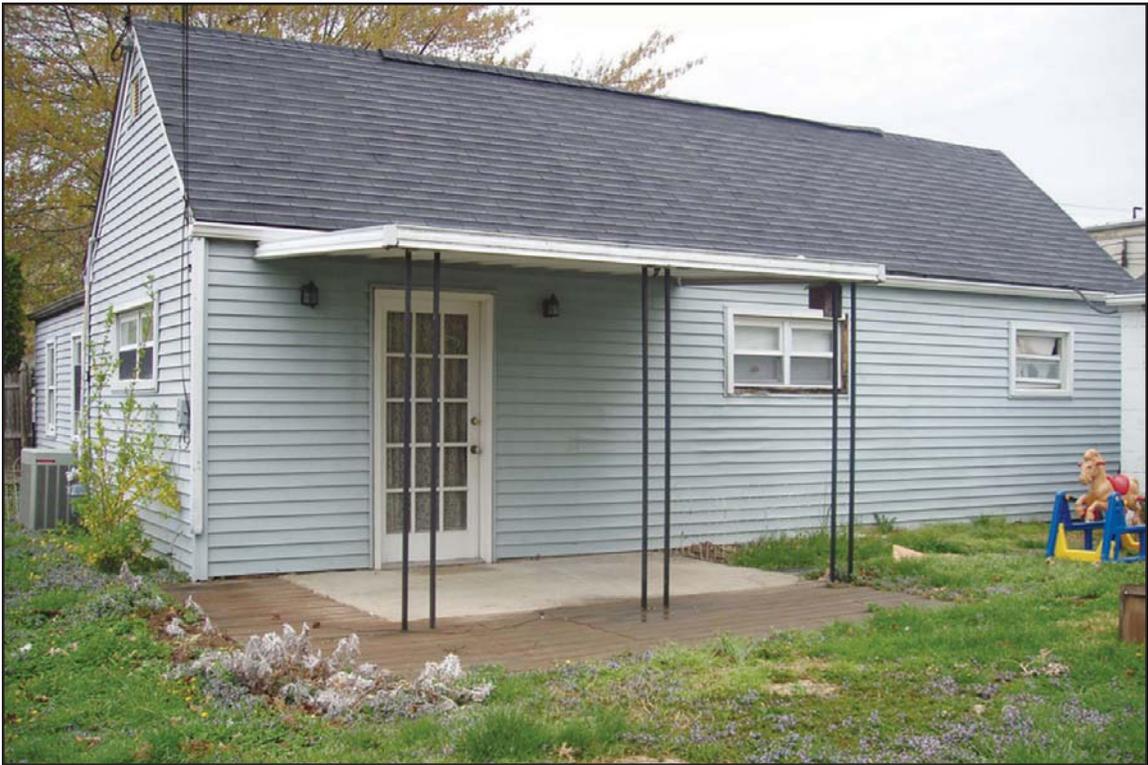
This .15-acre property is located in the Willow Run I subdivision outside of Wilmington, Delaware. The design of this building is similar to others in this subdivision. The building is a one-story, three-bay, vinyl-clad dwelling with a cross gable roof, enclosed porch, and detached garage. The roof is clad in asphalt shingles, and a brick chimney is located in the northern roof slope near the ridge. The main entry is located at the southern end of the main (west) façade, and it is a panel door with an aluminum storm door. Windows are paired 1/1 vinyl double-hung sash with inoperable louver shutters with the exception of a large picture window on the north elevation of the enclosed porch. Formerly an L-shape plan, the building now has a rectangular plan with the enclosure of a porch on the north (side) elevation. A slab door is centrally located on the northern elevation of this enclosure. A one-story front gable roof detached garage is located near the northeast corner of the dwelling; when compared to other garages on similar properties, this appears to have been expanded or re-built. The garage is clad in vinyl, and its roof is clad in asphalt shingles. The garage features a folding overhead pane and panel garage door on the main façade, and a wood pane and panel door on the southern elevation.

Plate 34. 1202 Centre Road, view south.

Plate 35. 1202 Centre Road, view east.

Plate 36. 1202 Centre Road, view north.

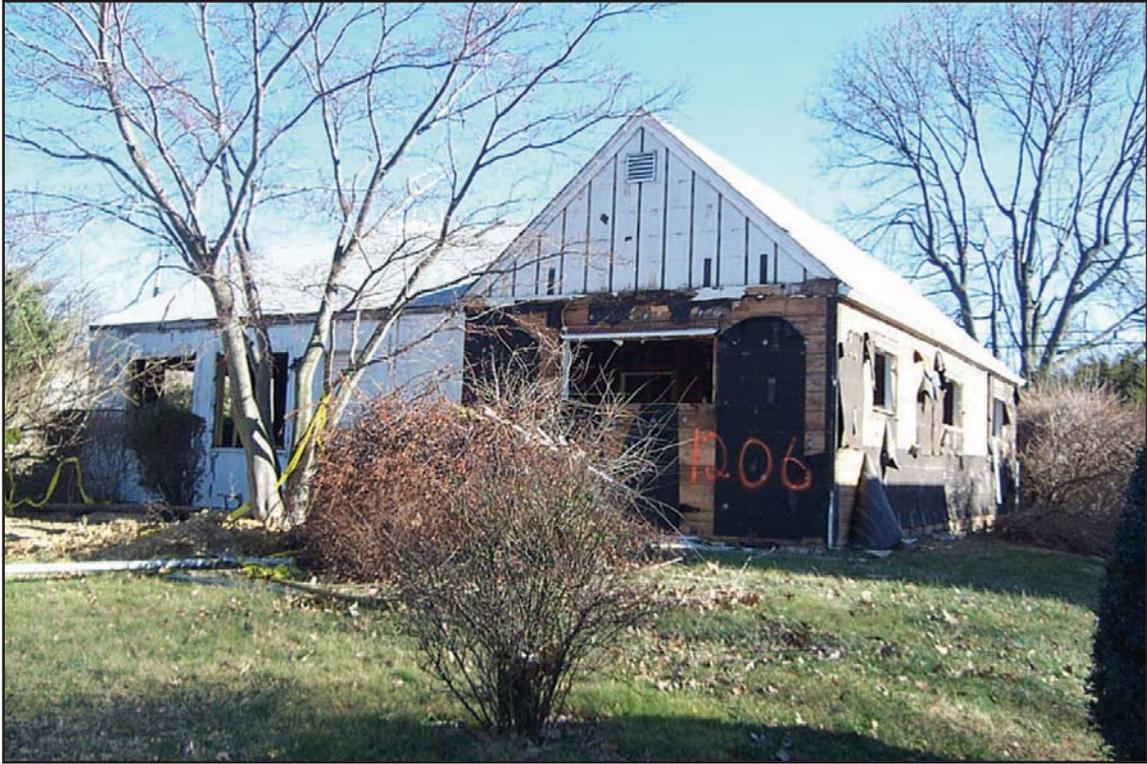
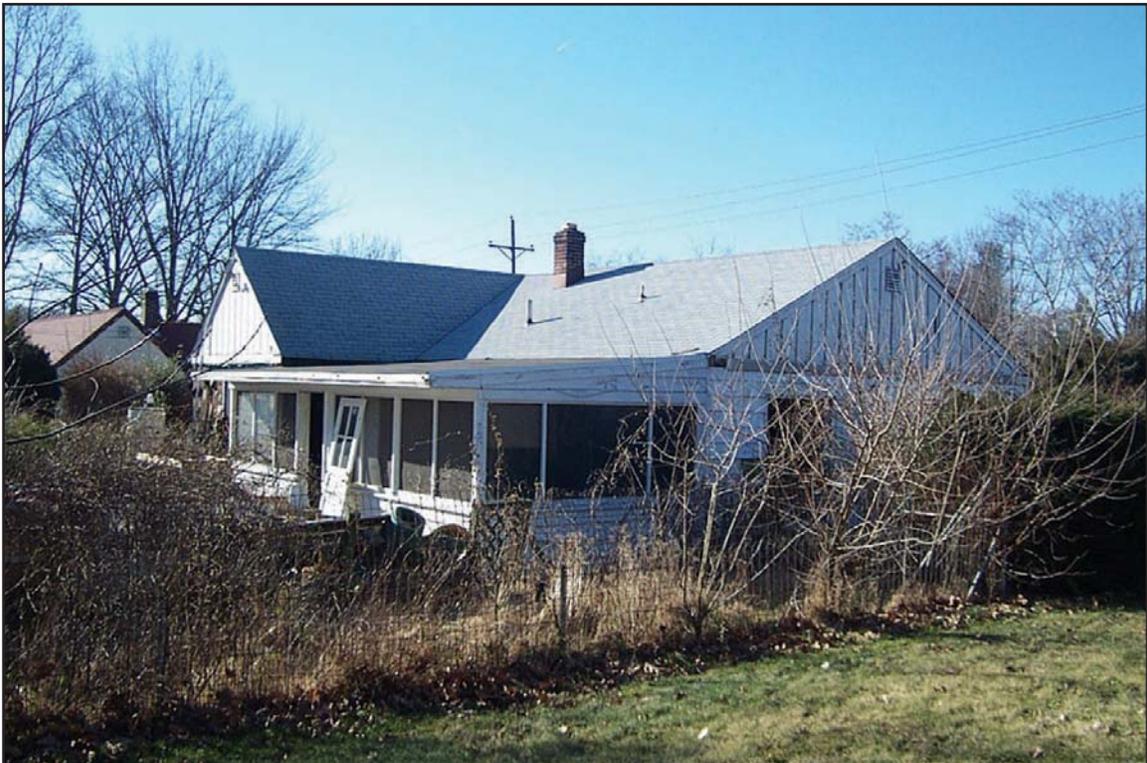
Plate 37. 1206 Centre Road, view southeast.

Plate 38. 1206 Centre Road, view southwest.

its method of construction or architecture (Criterion C). This building is considered Minimal Traditional in style, which is not discussed in the *Suburbanization* context, or in the NR Bulletin *Historic Residential Suburbs*. 1206 Centre Road is not a significant example of its type or style. The integrity of this property has been severely compromised by the removal of interior and exterior cladding materials and fenestration. Because the property lacks individual historical and architectural significance, 1206 Centre Road is recommended not eligible for the NR.

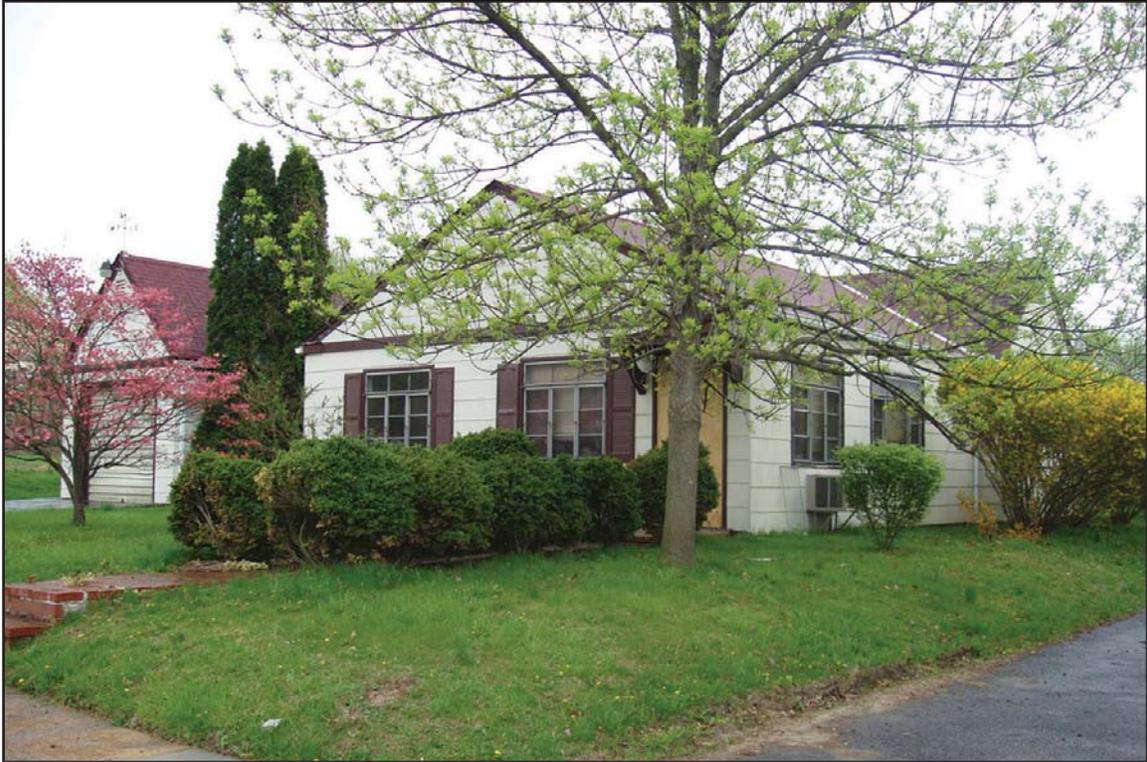
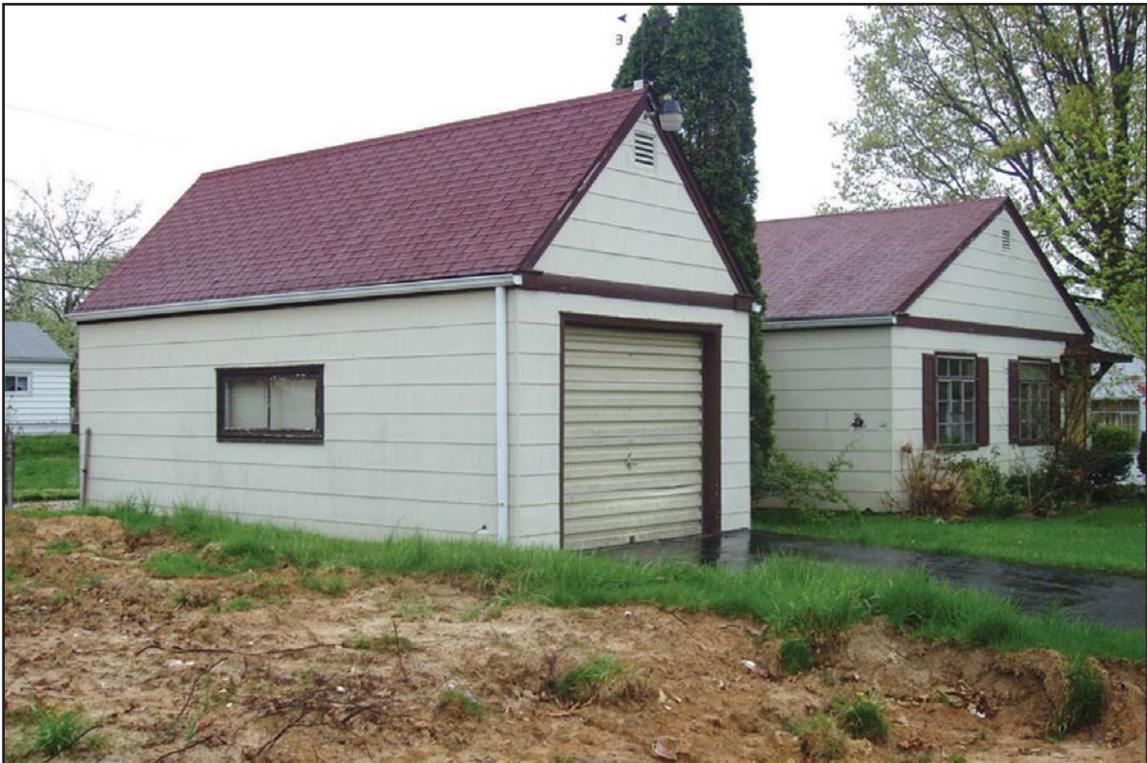
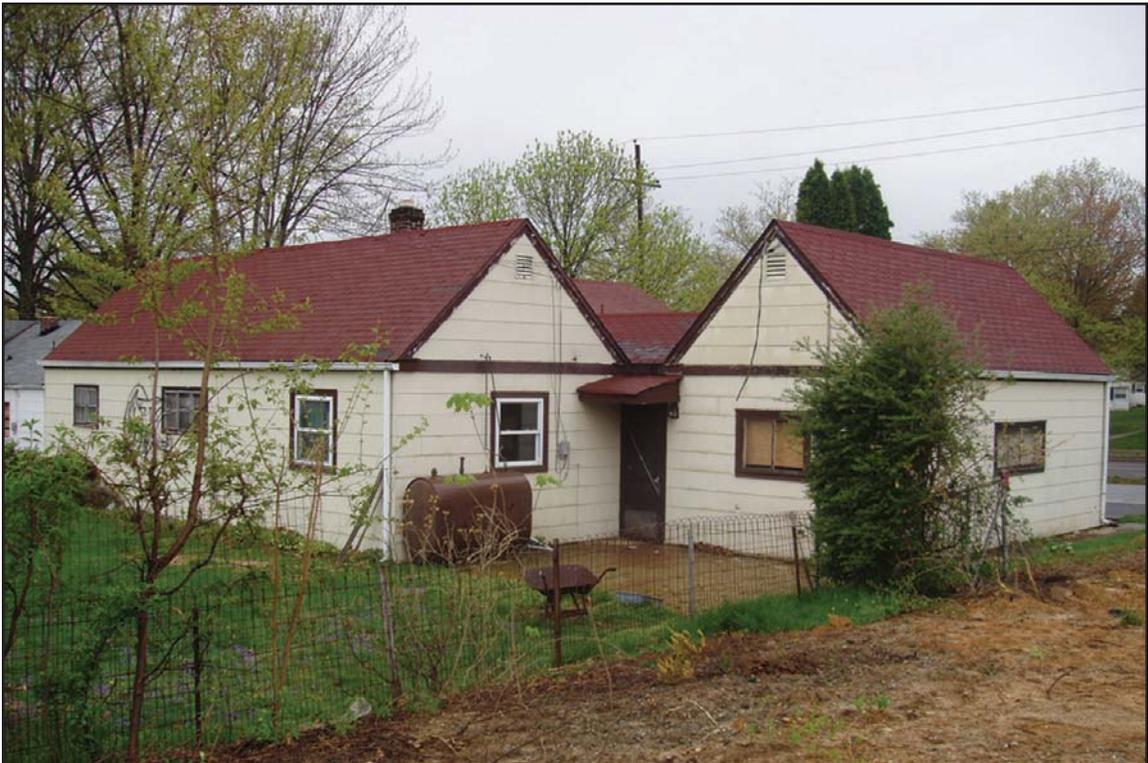
This property is located within the Willow Run I subdivision, which has been recommended not eligible for the NR. Individually, this resource does not meet NR eligibility Criteria A, B, C, or D. Historical research has produced no information indicating the resource to be significant for its association with significant events or persons, or for its ability to yield information important in prehistory or history (Criteria A, B, and D). In addition, the resource does not appear significant for its method of construction or architecture (Criterion C). This building is considered Minimal Traditional in style, which is not discussed in the *Suburbanization* context, or in the NR Bulletin *Historic Residential Suburbs*. 1208 Centre Road is not a significant example of its type or style. Extensive changes to the garage, including the movement of the garage to its current position flush with the front of the dwelling, the construction of additional living space to connect the garage to the dwelling, and replacement of some windows, have compromised the integrity of this building.

Plate 39. 1208 Centre Road, view east.

Plate 40. 1208 Centre Road, view south.

Plate 41. 1208 Centre Road, view west.

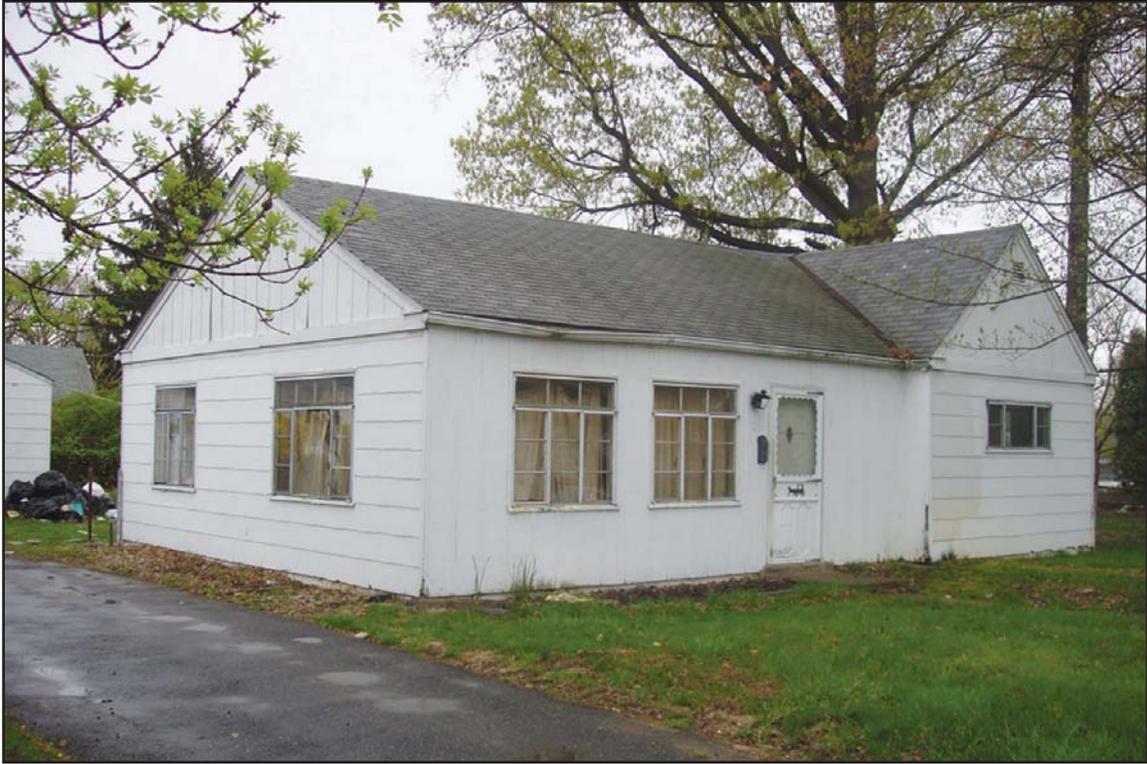
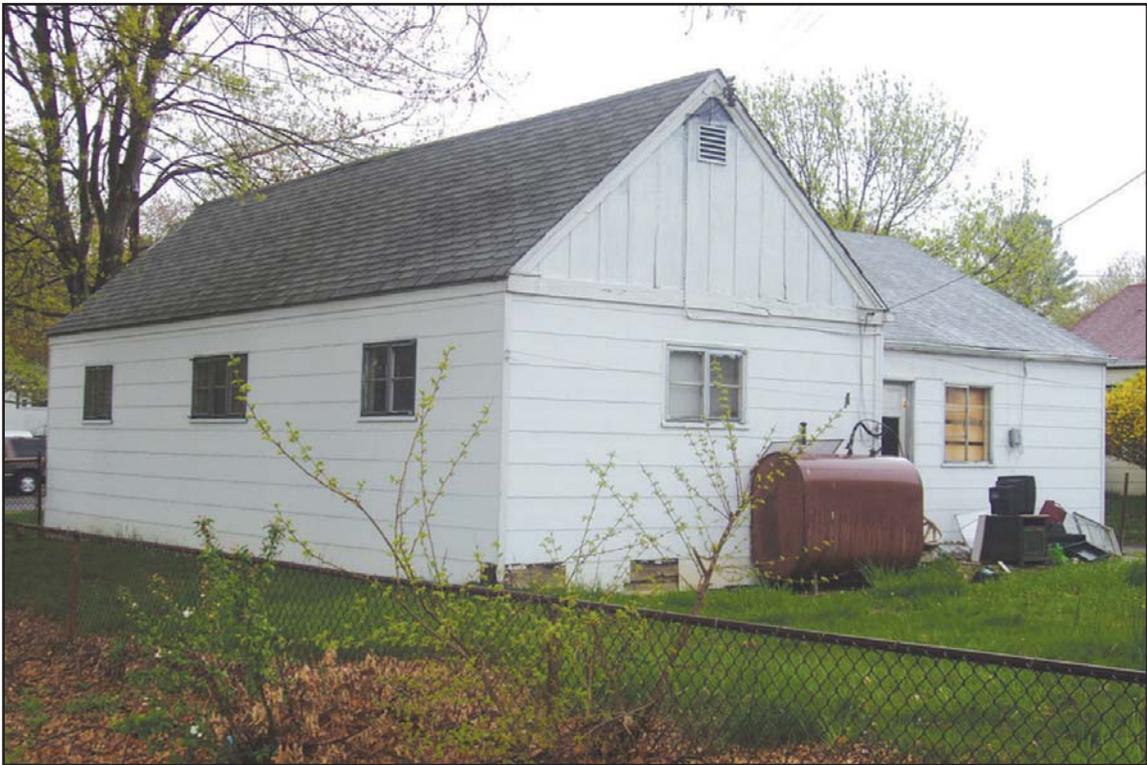
Plate 42. 1210 Centre Road, view south.

Plate 43. 1210 Centre Road, view north.

This property is located within the Willow Run I subdivision, which has been recommended not eligible for the NR. Individually, this resource does not meet NR eligibility Criteria A, B, C, or D. Historical research has produced no information indicating the resource to be significant for its association with significant events or persons, or for its ability to yield information important in prehistory or history (Criteria A, B, and D). In addition, the resource does not appear significant for its method of construction or architecture (Criterion C). This building is considered Minimal Traditional in style, which is not discussed in the context for *Suburbanization in the Vicinity of Wilmington, Delaware*, or in the NR Bulletin *Historic Residential Suburbs*. 1210 Centre Road is not a significant example of its type or style. In general, the integrity of this building is good, although it has been compromised somewhat by a replacement door and a few replaced windows. There are a number of similar buildings in this subdivision. Because the property lacks individual historical and architectural significance, 1210 Centre Road is recommended not eligible for the NR.

In 2005, subsequent to this evaluation, this structure was demolished as part of the SR 141 improvement project.

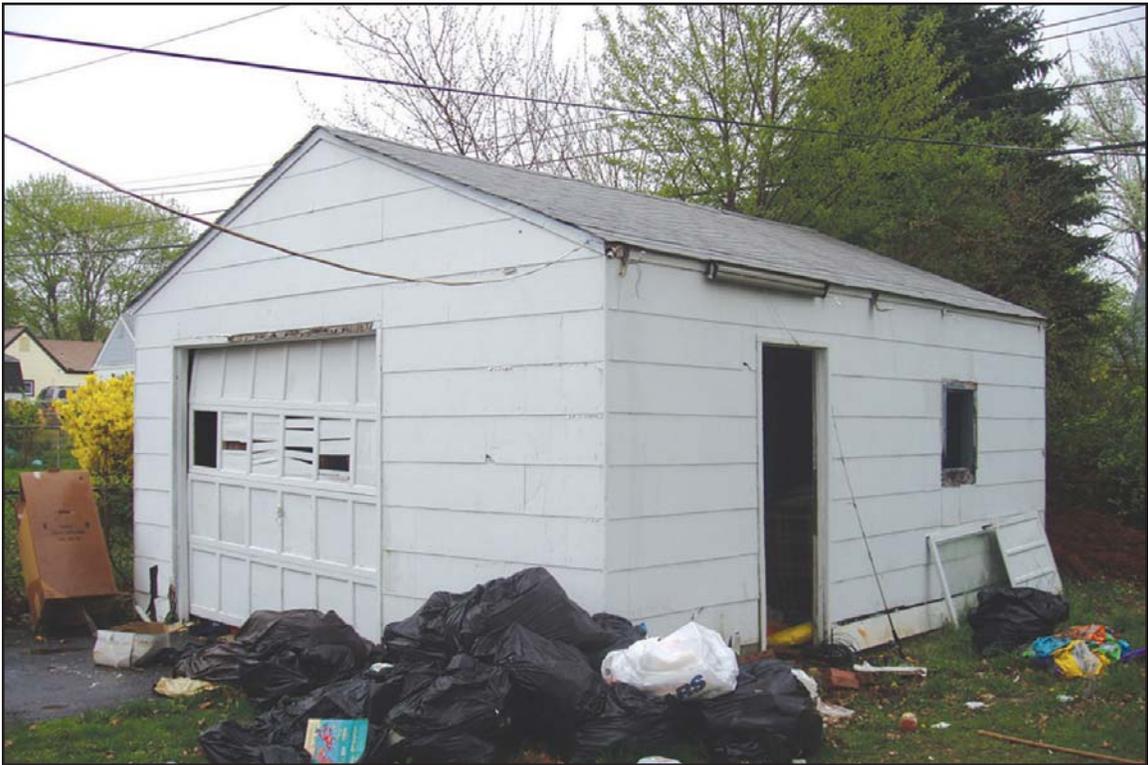
Plate 44. 1210 Centre Road, garage, view east.

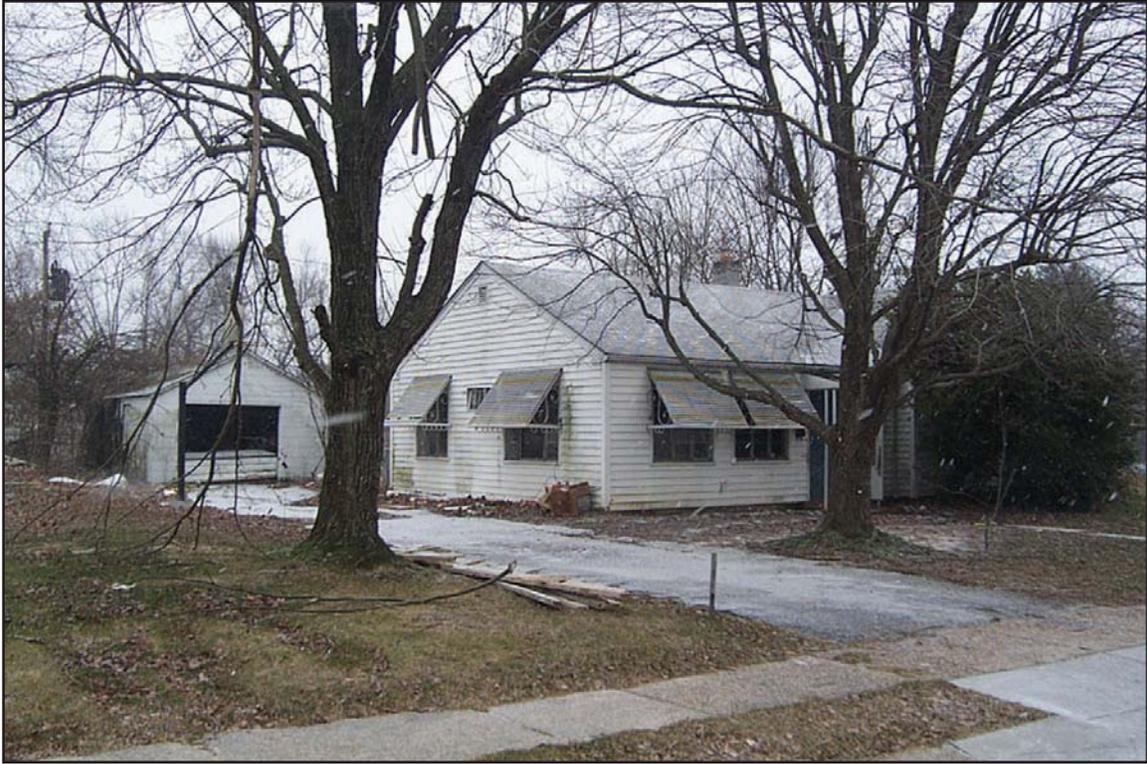
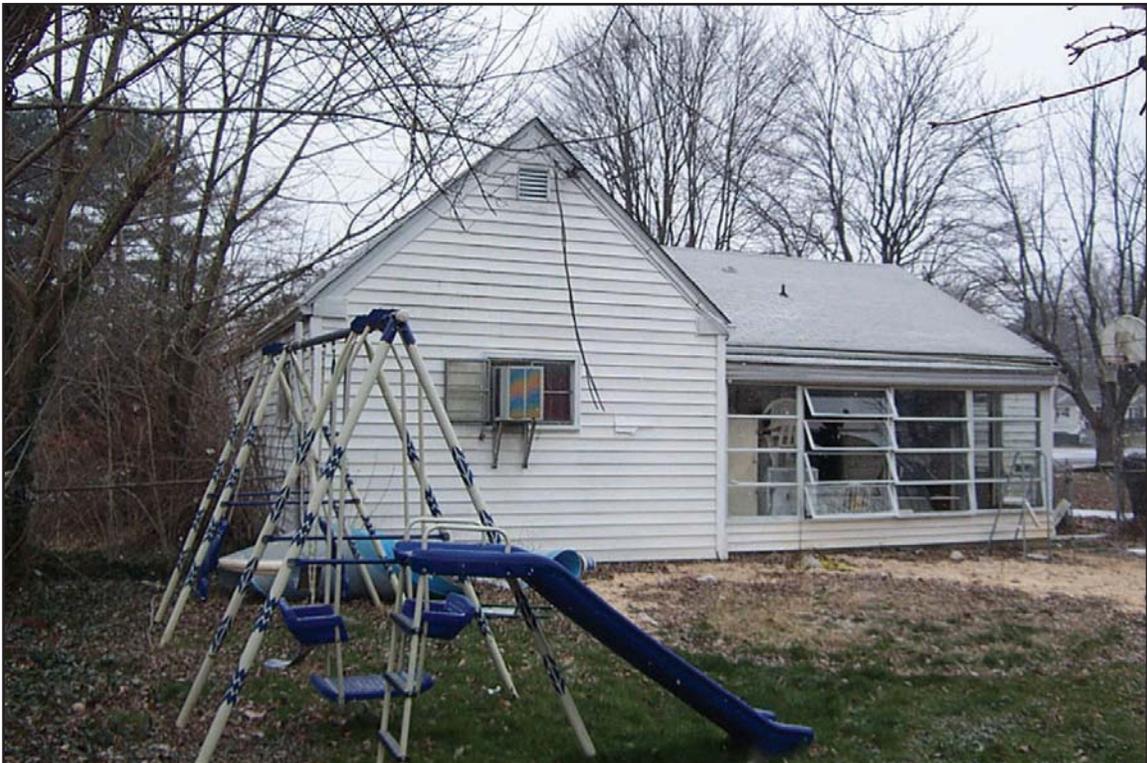
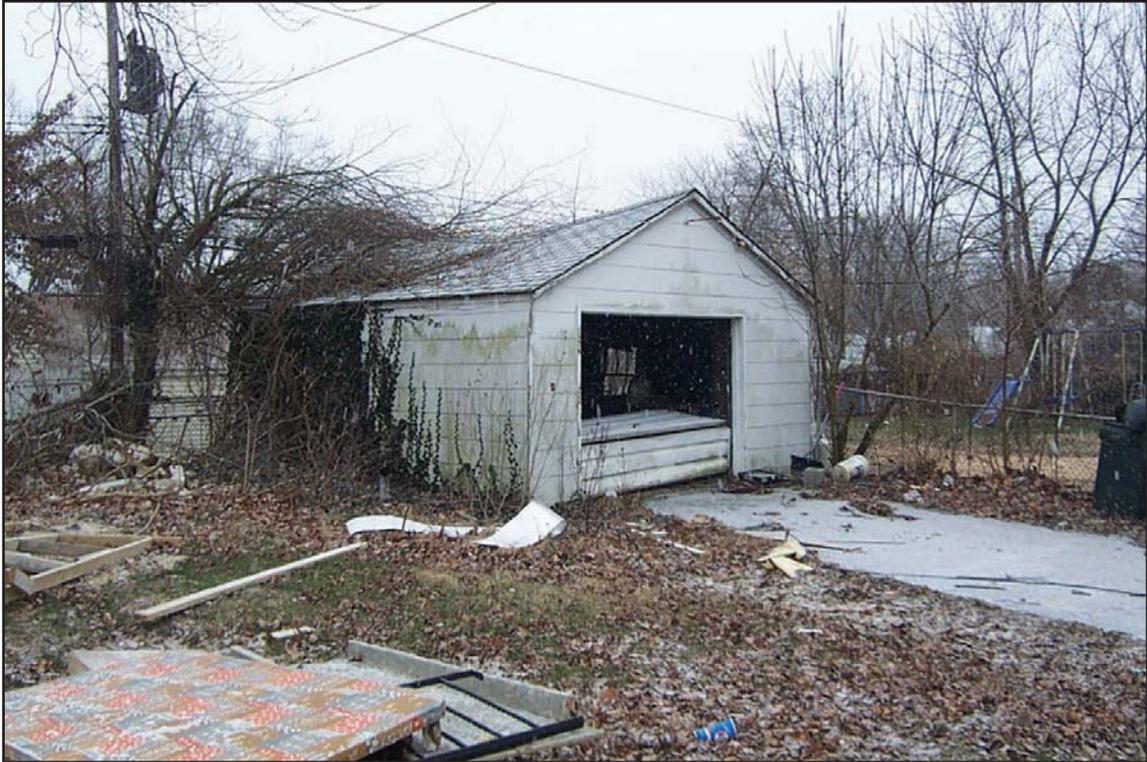
1220 Centre Road (N-14240) (Plates 45-47)

Plate 45. 1220 Centre Road, view south.

Plate 46. 1220 Centre Road, view north.

Plate 47. 1220 Centre Road, view south.

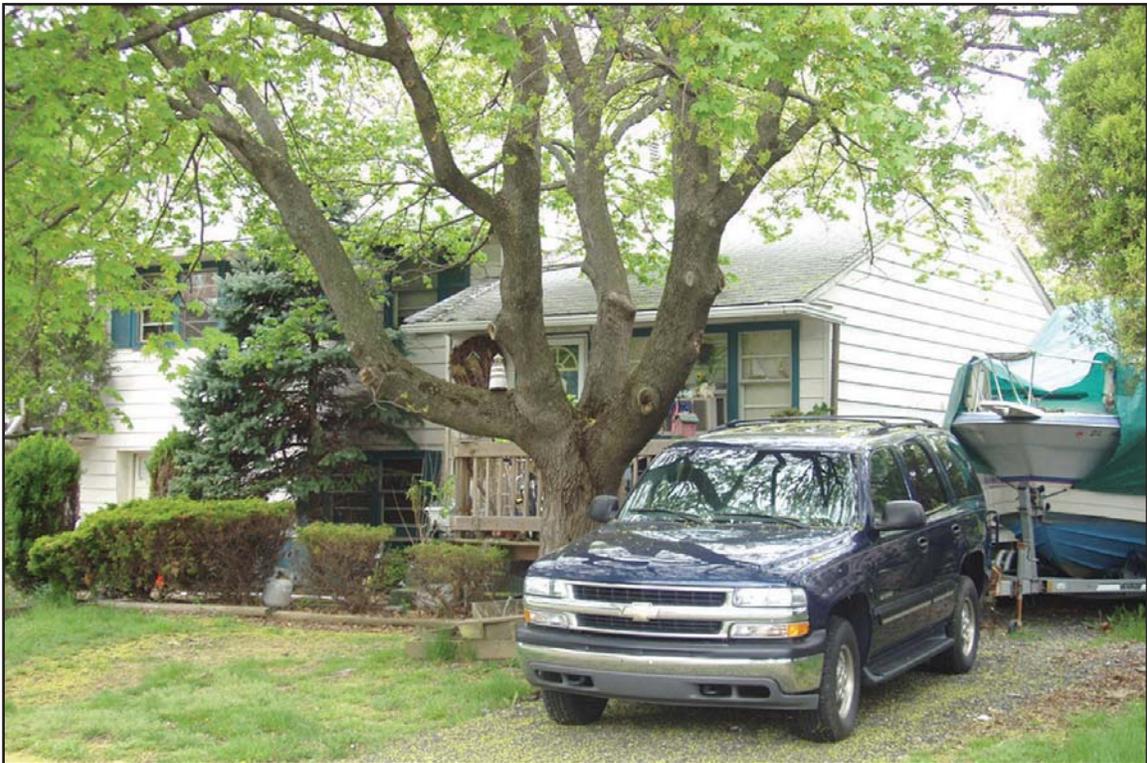
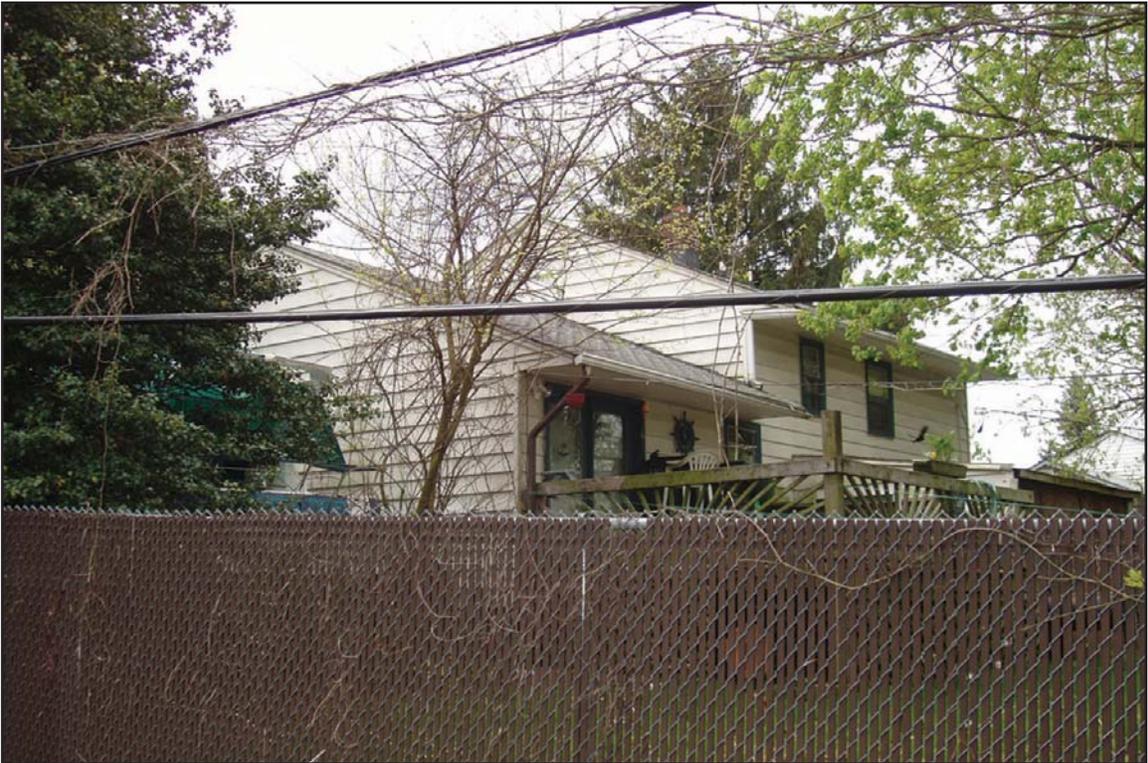
Plate 48. 1301 Centre Road, view west.

Plate 49. 1301 Centre Road, view south.

- **Historical Information**
This circa 1955 building was constructed by S&S Builders as part of the Woodland Heights development, directly adjacent to the Woodland Apartments. The split-level building style was just beginning to gain popularity as a variation on the ranch house, which was also popular in suburban developments. Split-level dwellings were popular in subdivisions from the 1950s through the 1970s.⁵⁶ Wooden decks have been added to the building.

- **Evaluation**
This resource does not meet NR eligibility Criteria A, B, C, or D. Historical research has produced no information indicating this resource to be significant for its association with significant events or persons, or for its ability to yield information important in prehistory or history (Criteria A, B, and D). In addition, the resource does not appear significant for its method of construction or architecture (Criterion C) because it lacks significance as an individual building type. Split-level dwellings were popular from the 1950s through 1970s, and can be found in subdivisions throughout the country. In addition, S&S Builders have not been found to have been more significant than the many other developer/builders during this period.

The historic context for *Suburbanization in the Vicinity of Wilmington, Delaware* ends at approximately 1950. Having been built in 1955, the building type represented in the Woodland Heights subdivision – the split-level – was outside of the scope of this contextual background. The style is, however, briefly noted in the NR Bulletin *Historic Residential Suburbs: Guidelines for Evaluation and Documentation for the National Register of Historic Places*.⁵⁷ The split-level design is mentioned as a sub-style under “The Suburban Ranch House” in the Postwar Suburban House and Yard, 1945-1960 context. In addition to retaining integrity, the dwellings in suburban developments, per the Wilmington context, must be associated with significant trends in suburbanization (transportation, finance, etc.). Resources in this subdivision do not appear to meet this test. With the exception of the addition of decks to the front and rear elevations, and the replacement of the main entry door, the integrity of this building is good. However, given the lack of historical and individual architectural significance, this property is recommended not eligible for the NR.
