**IV. HISTORIC ARCHITECTURAL SURVEY
and EVALUATION**

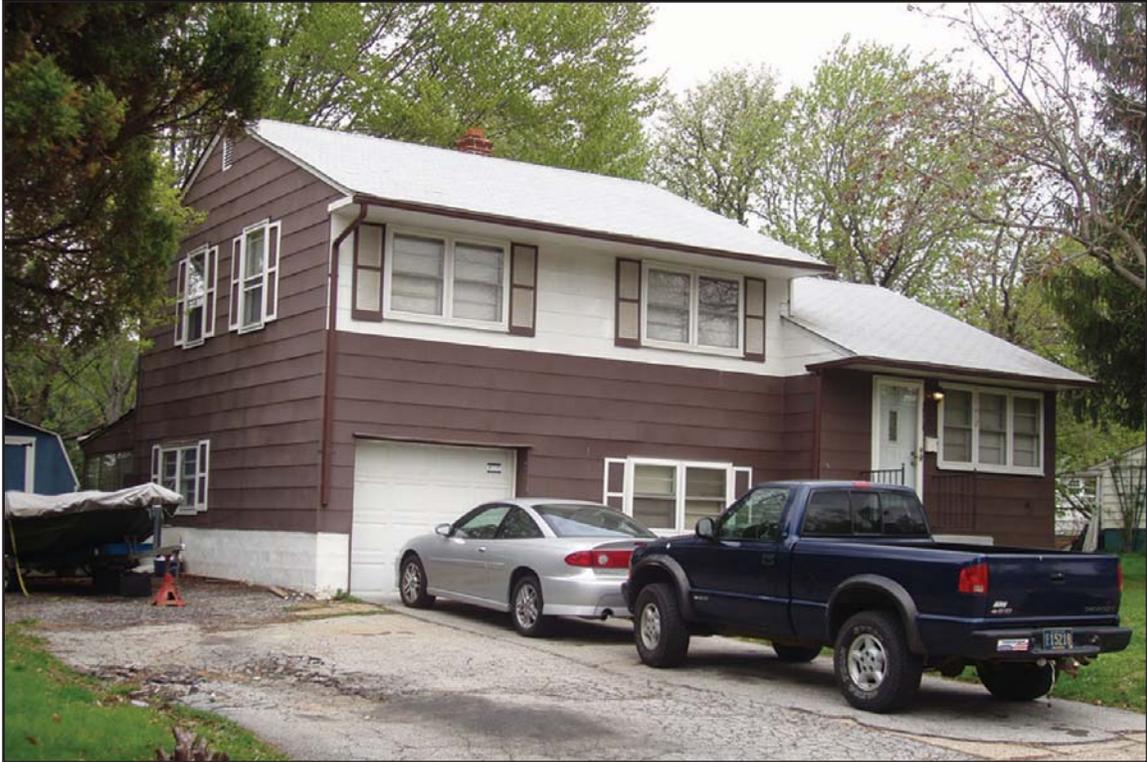
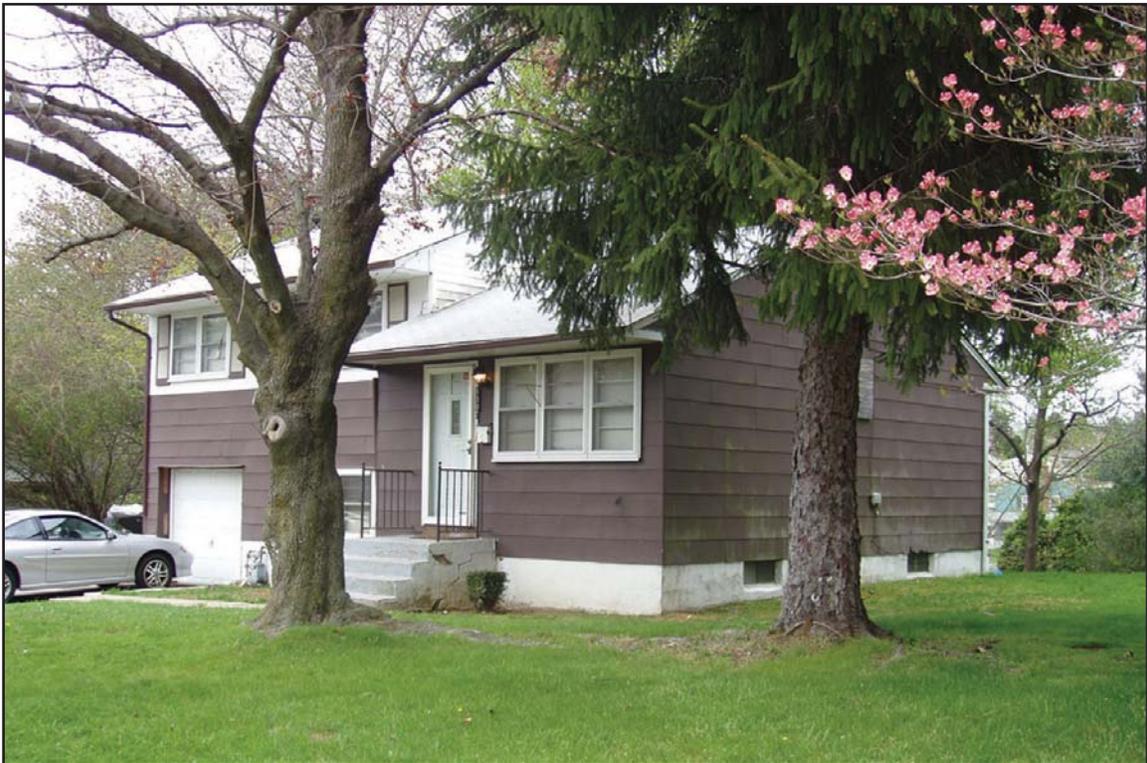
Plate 50. 1303 Centre Road, view north.

Plate 51. 1303 Centre Road, view west.

The integrity of this building is generally good with the exception of the replacement of the windows and addition of a full glass storm door. However, given the lack of historical and individual architectural significance, 1303 Centre Road is recommended not eligible for the NR.

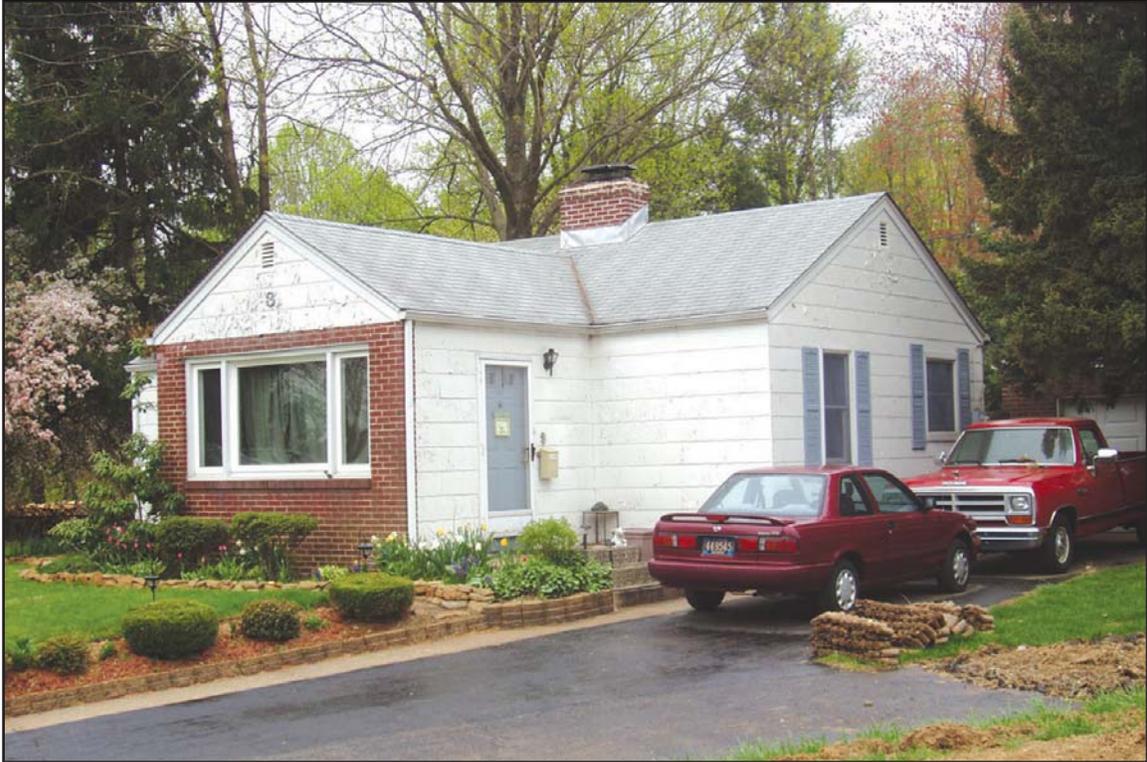
Plate 52. 3 Eton Court, view south.

persons, or for its ability to yield information important in prehistory or history (Criteria A, B, and D). In addition, the resource does not appear significant for its method of construction or architecture (Criterion C). The property is considered part of the Willow Run I subdevelopment, which is recommended not eligible for the NR. Individually, the property does not contain a significant example of a building type noted in the *Suburbanization in the Vicinity of Wilmington, Delaware* context or the NR Bulletin *Historic Residential Suburbs*. Despite the replacement of the windows and front door, the building retains good integrity. However, given the lack of historical and individual architectural significance, 3 Eton Court is recommended not eligible for the NR.

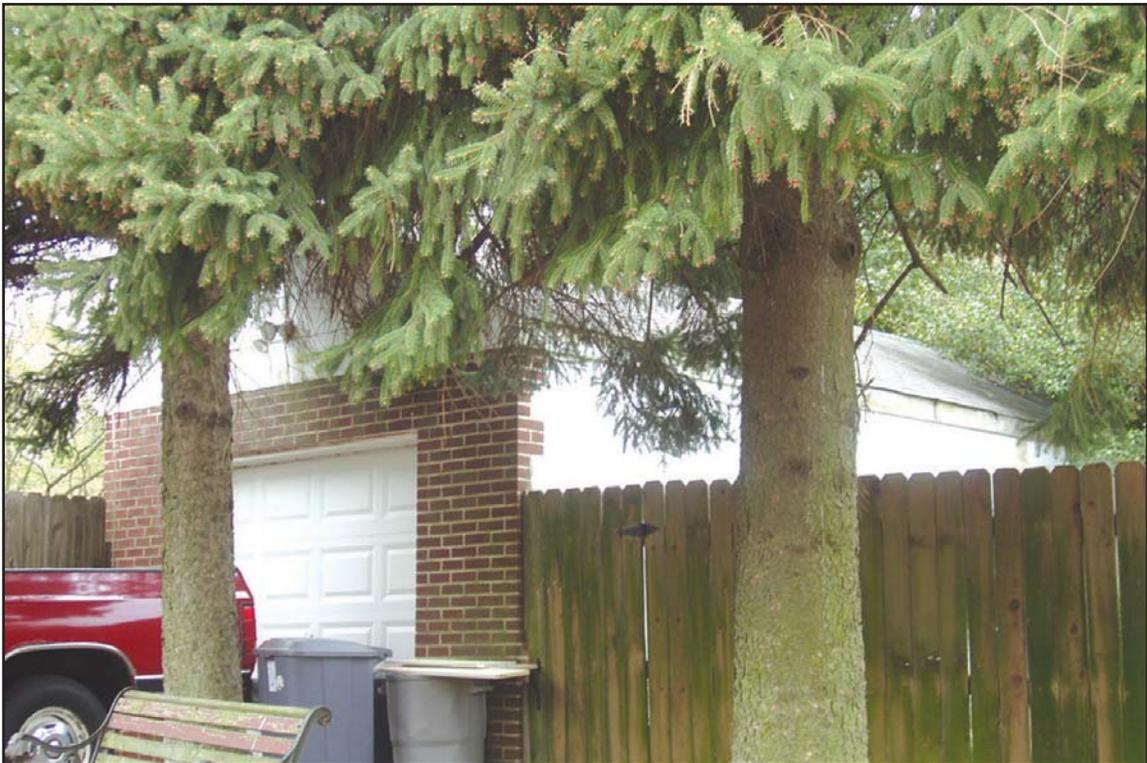
Plate 53. 3 Eton Court, garage, view south.

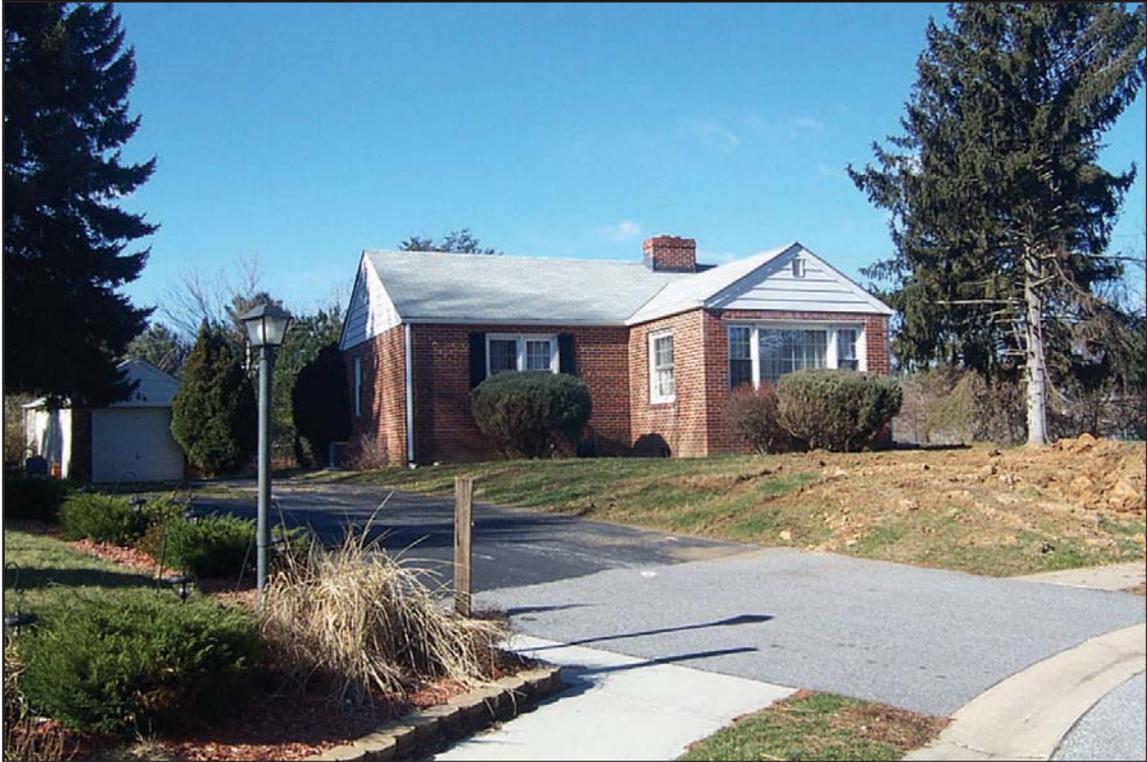
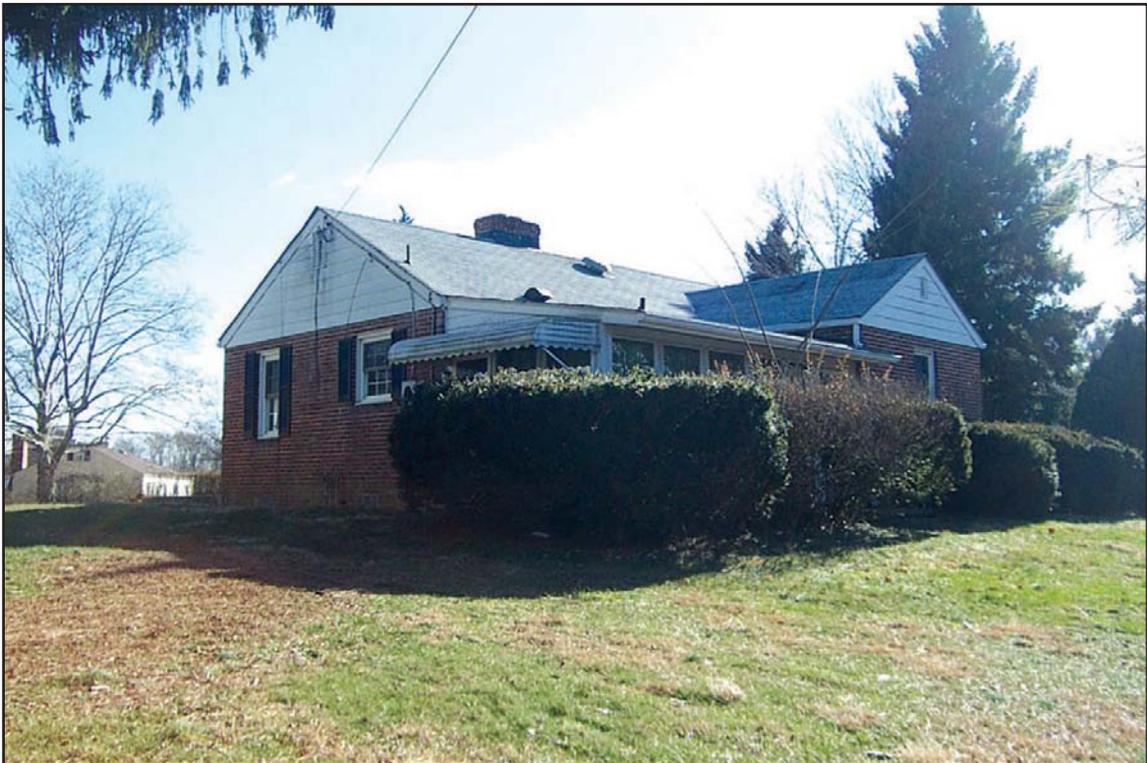
This .37-acre property is located on a cul-de-sac at the edge of the Willow Run I subdivision outside of Wilmington, Delaware. The dwelling is a one-story, three-bay building with a cross gable roof and cross-shaped plan. The roof is clad in asphalt shingles, and a brick chimney is located at the ridge. The building is clad in brick. The main door, consisting of a replacement pane and panel door and storm door, is located on the western elevation. A large vinyl multi-light picture window with flanking 6/6 vinyl double-hung sash windows faces the street. Paired and single vinyl 1/1 double-hung sash windows are located in other areas of the building. Some windows have inoperable louver shutters. An enclosed porch has been added to the southwestern quadrant of the building. A door is located on the western elevation. A one-story detached garage is located to the southeast of the dwelling. The garage has an asphalt shingle-clad front gable roof and brick and stucco clad the elevations. The garage door is an overhead folding panel garage door.

Plate 54. 5 Eton Court, with garage, view west.

Plate 55. 5 Eton Court, view southeast.

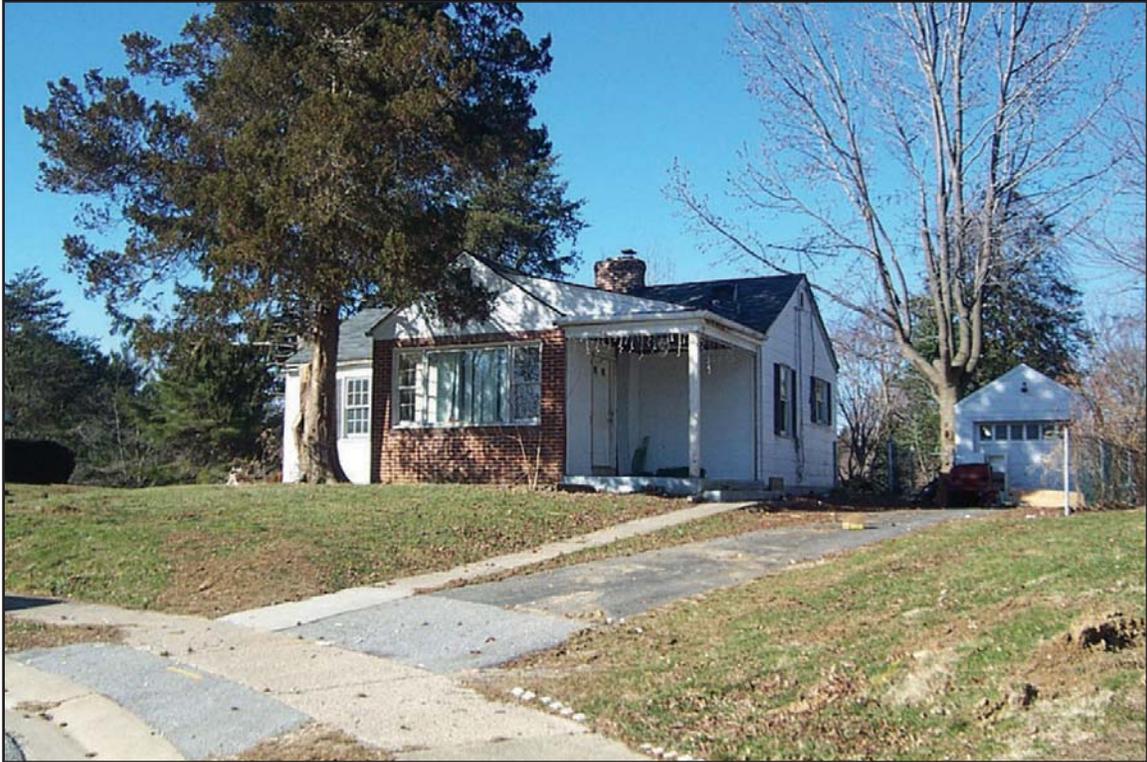
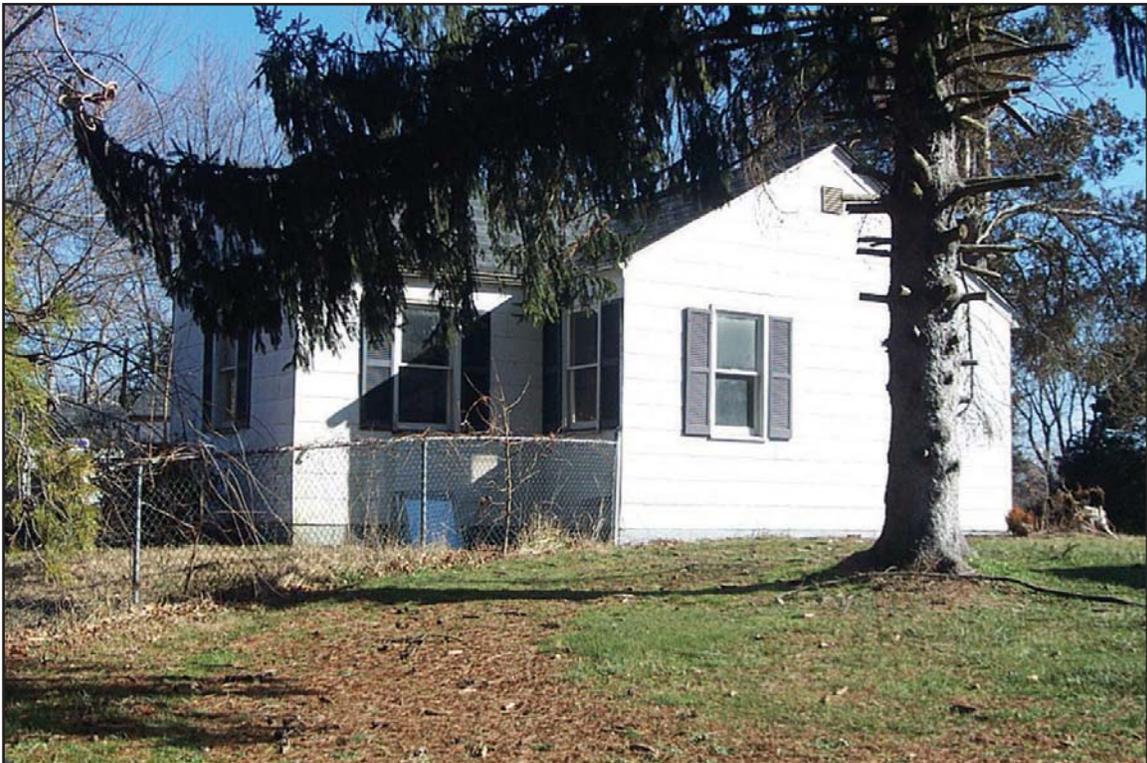
7 Eton Court (N-14245) (Plates 56-57)

Plate 56. 7 Eton Court with garage, view northwest.

Plate 57. 7 Eton Court, view northeast.

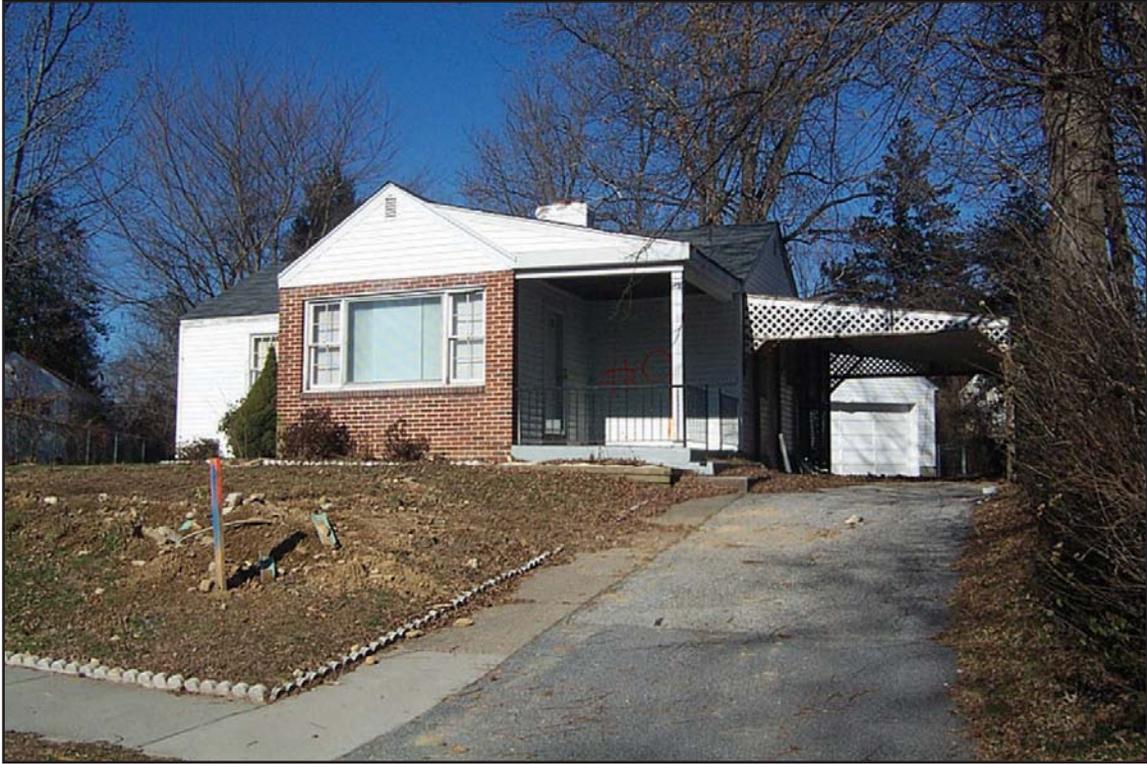
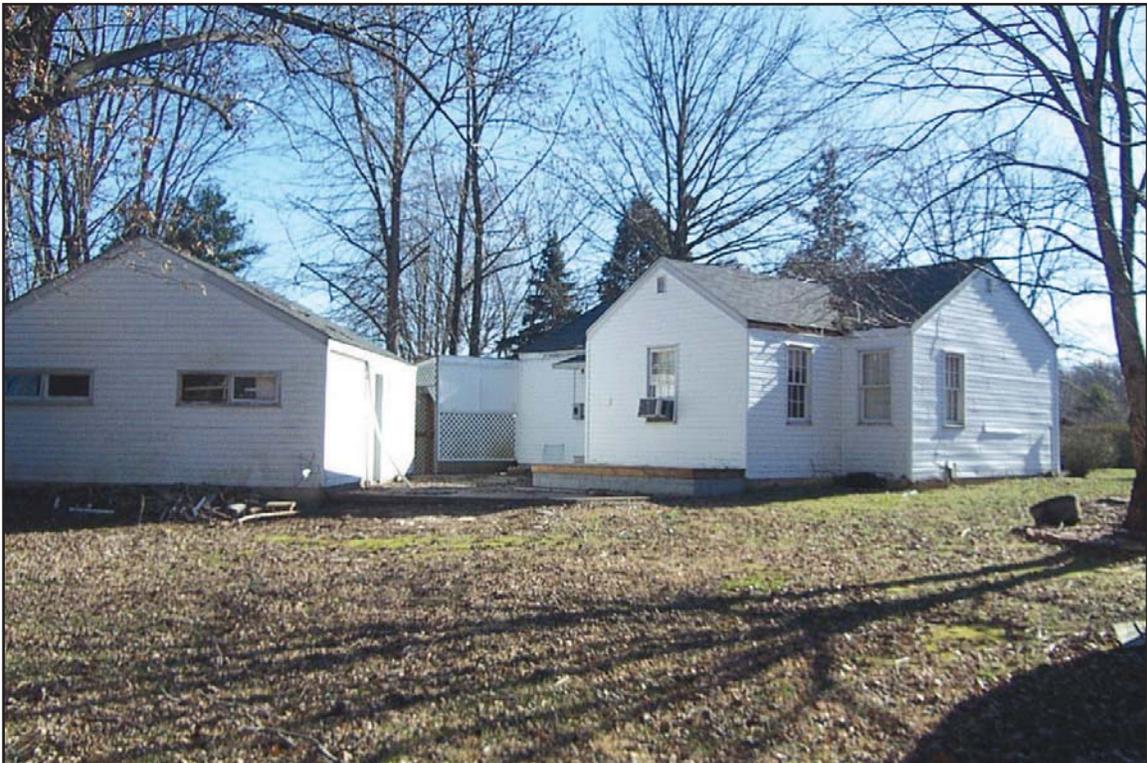
Plate 58. 9 Eton Court, view northwest.

Plate 59. 9 Eton Court, view southeast.

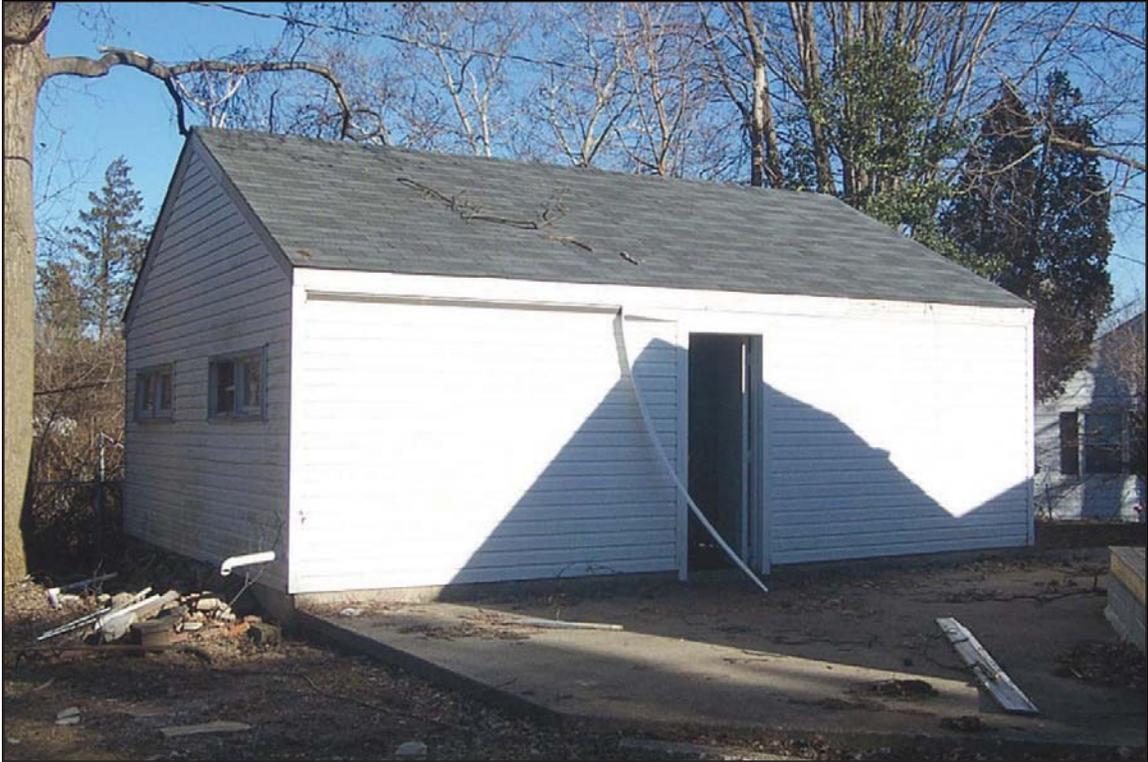
Plate 60. 9 Eton Court, garage, view northeast.
