CRS No. N05225

Name: B.F. Hanson House

Address: 1102-1104 Middletown Warwick Road Tax Parcel: 1302600020

CULTURAL RESOURCE SURVEY
SURVEY UPDATE FORM

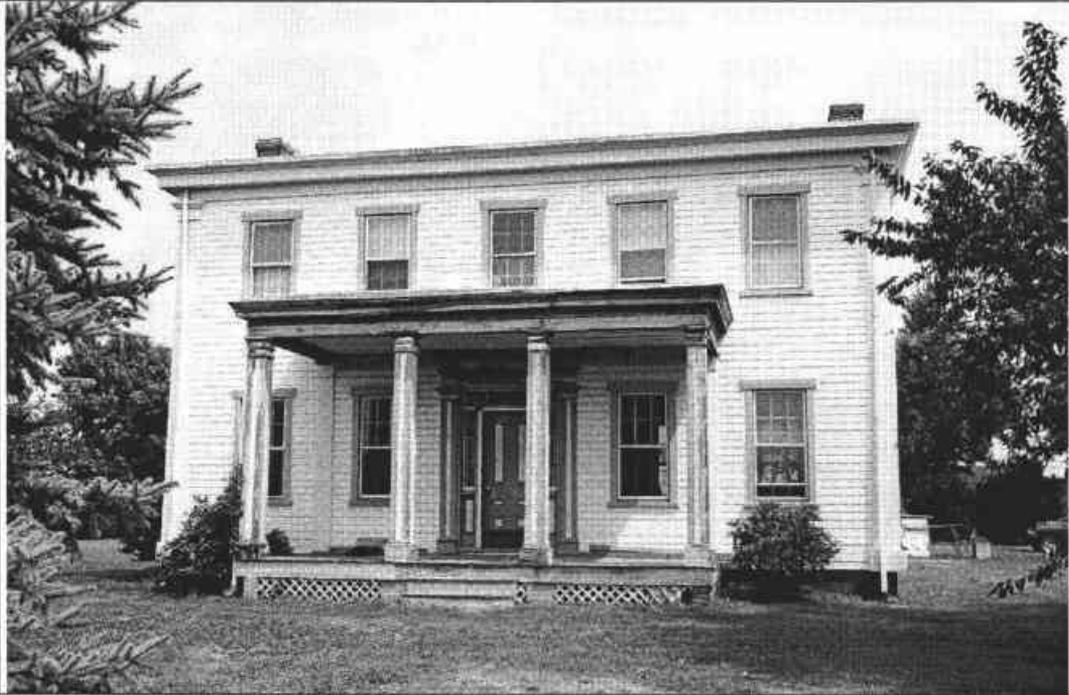
N05225. Photograph 1: Dwelling, façade, view to east. Note Greek Revival porch, corner boards, and door surround.

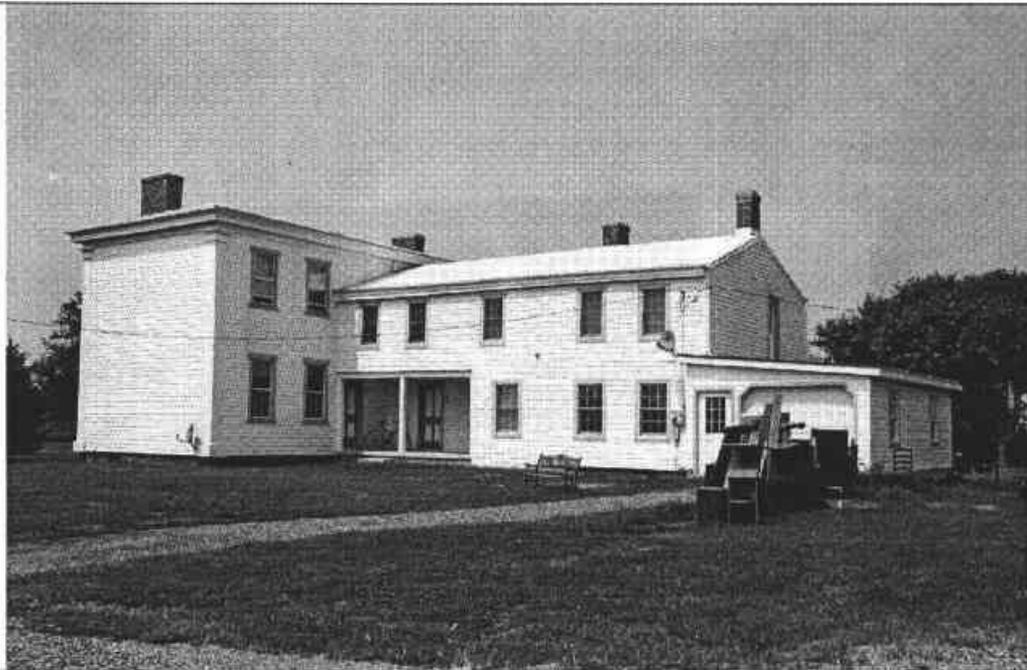
N05225. Photograph 2: Dwelling, south and east elevations, view to northwest. Note post-1980 addition to right of photograph.

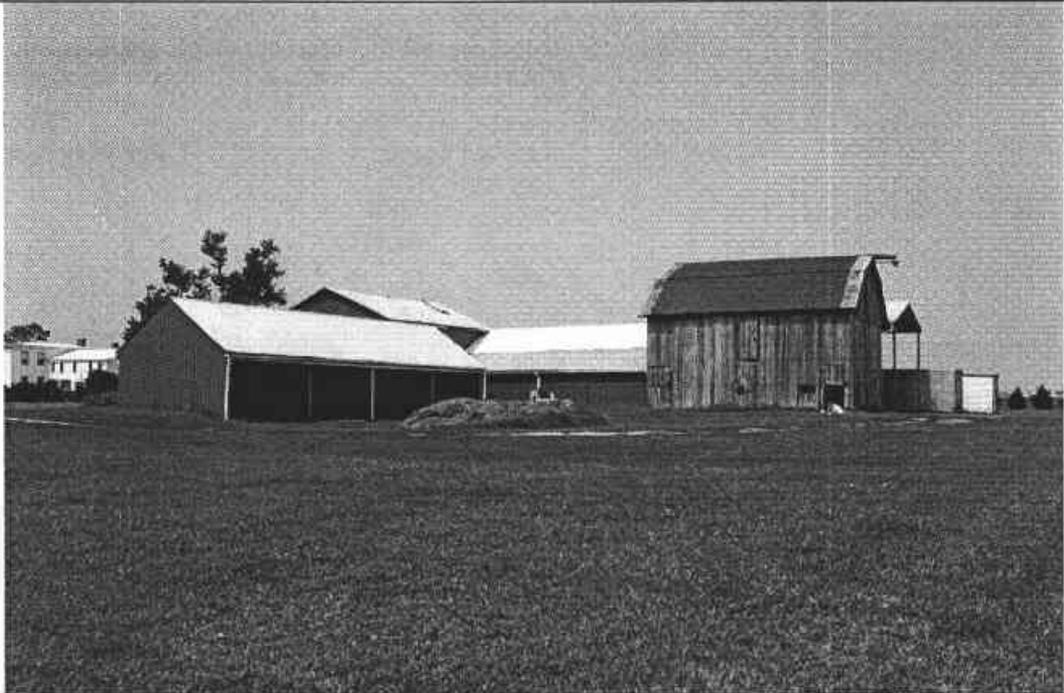
N05225. Photograph 3: Overview of horse barn complex, view to east. Note corncrib/granary to the right and former cart shed to the left.

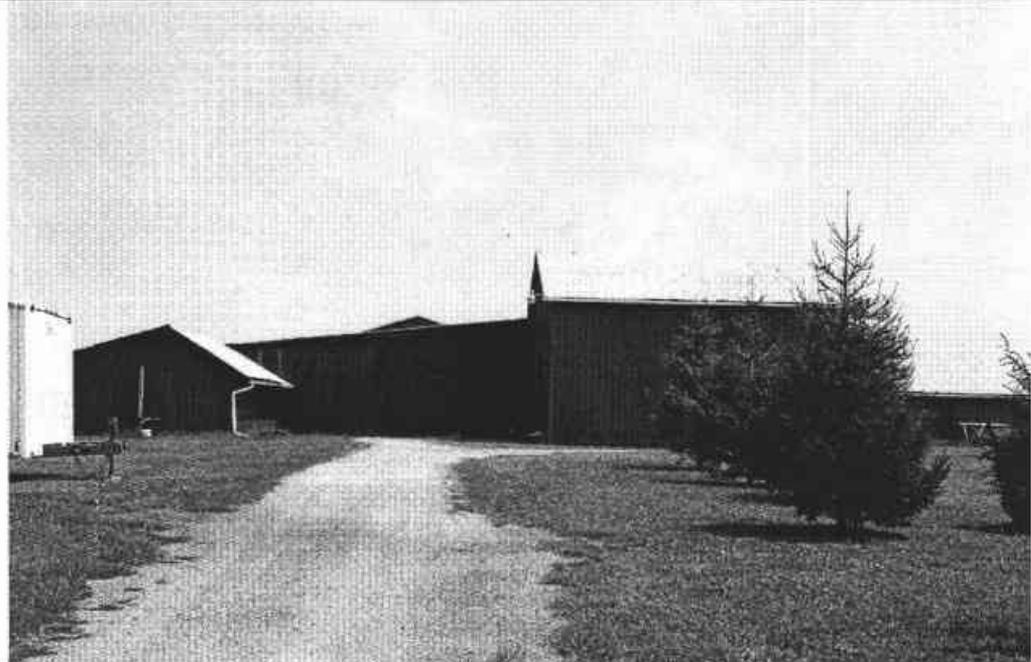
N05225. Photograph 4: Overview of horse barn complex, view to northwest. Note horse barn and open pole shed addition to right.

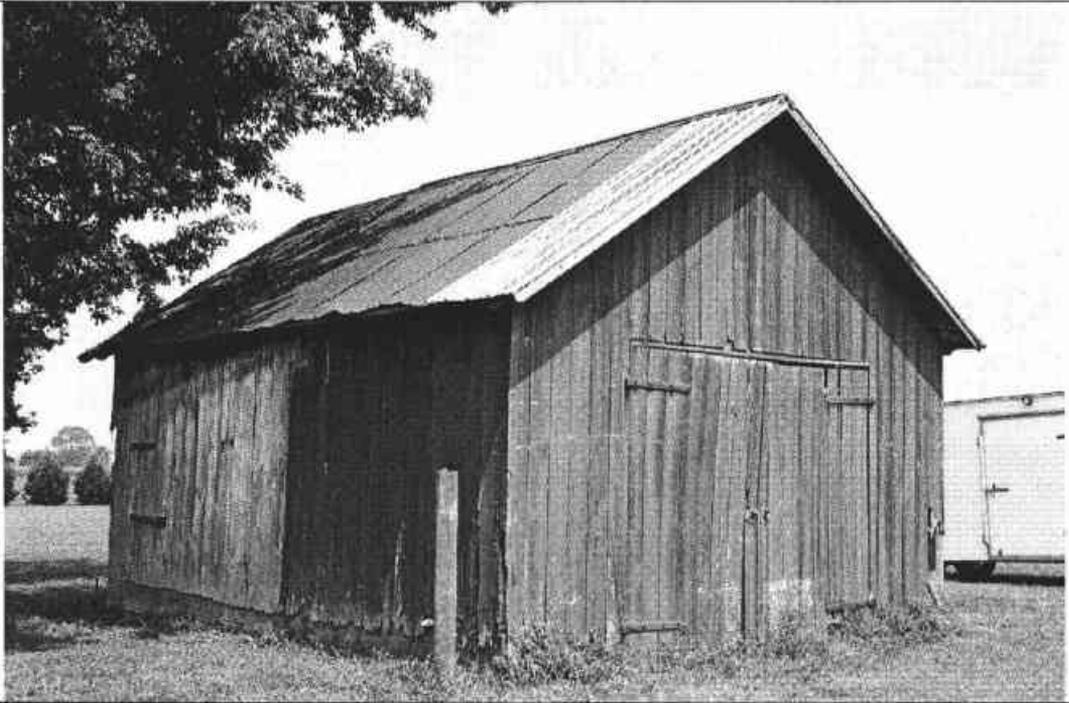
N05225. Photograph 5: Shed, west and south elevations, view to northeast. Note ghost of shed roof addition to the left (west elevation).

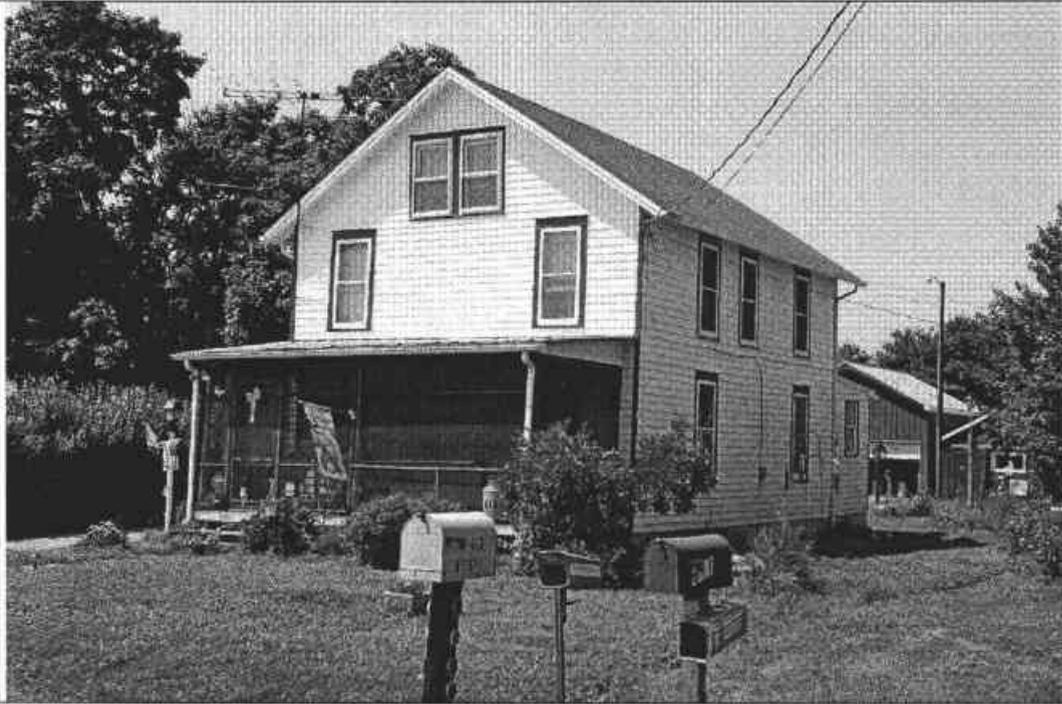
N05235. Photograph 1: Kate Kaiser House, overview of house, view to northwest. Note simple vernacular style and screened in porch.

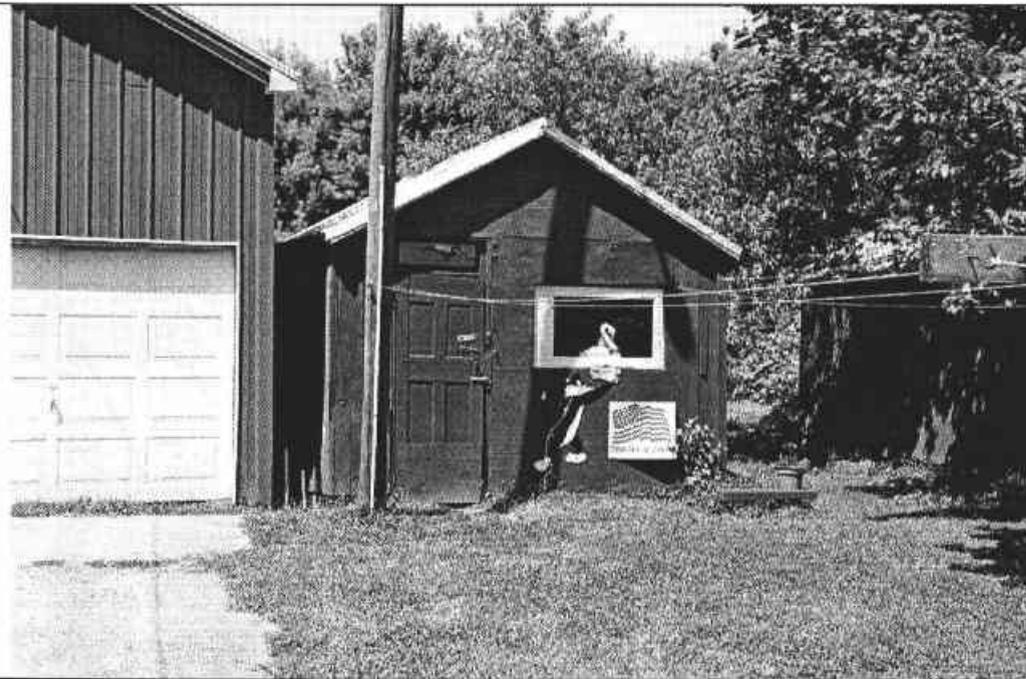
N05235, Photograph 2: Kate Kaiser House, *circa*-1920 garage, south elevation, view to north. Note filled in opening, pedestrian door and modern window.

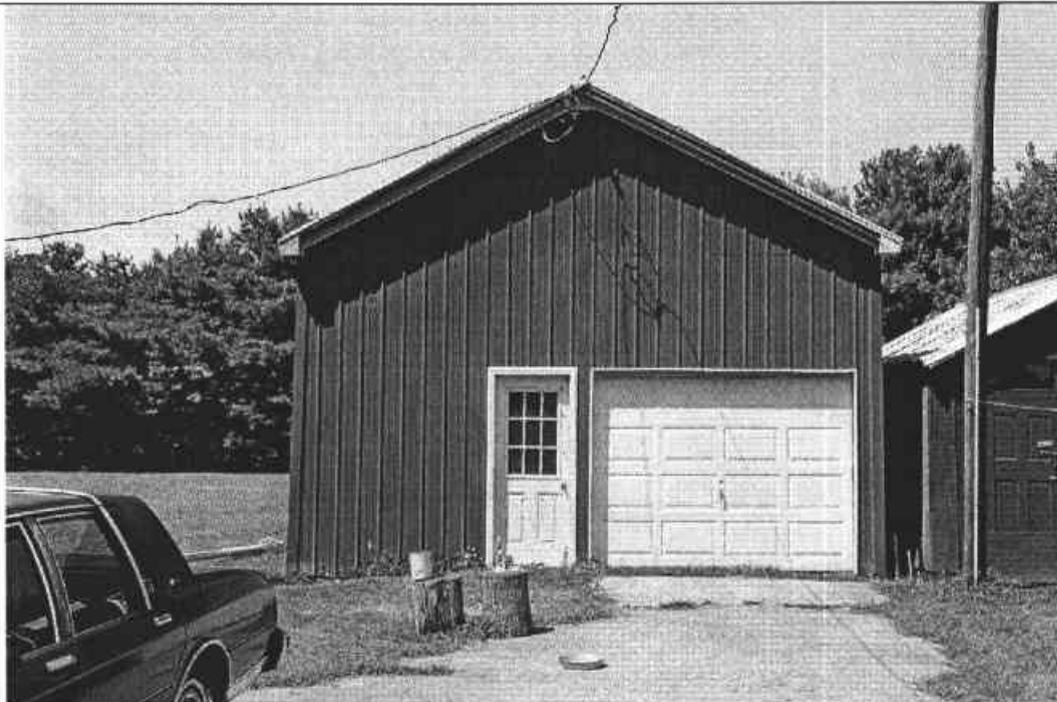
N05235. Photograph 3: Kate Kaiser House, *circa*-1940 garage, south elevation, view to north. Note replacement cladding, modern overhead garage door, and modern pedestrian door.

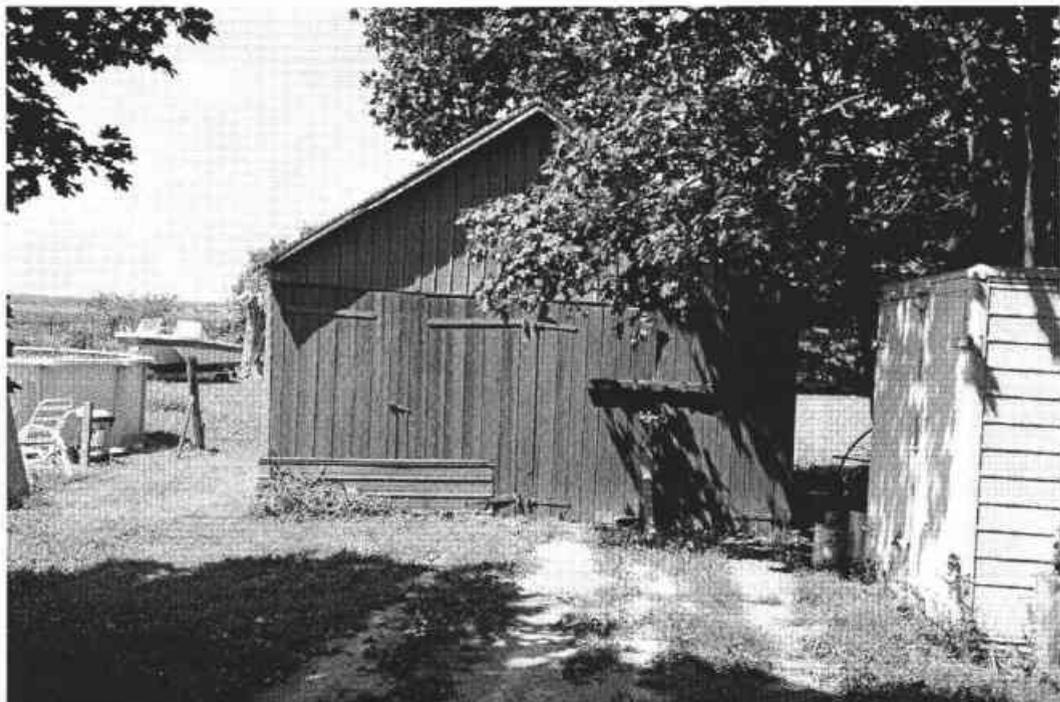
N05235. Photograph 4: Kate Kaiser House, barn, south elevation, view to north. Note the truck bed that has been converted into a darkroom on the right side of the photograph.

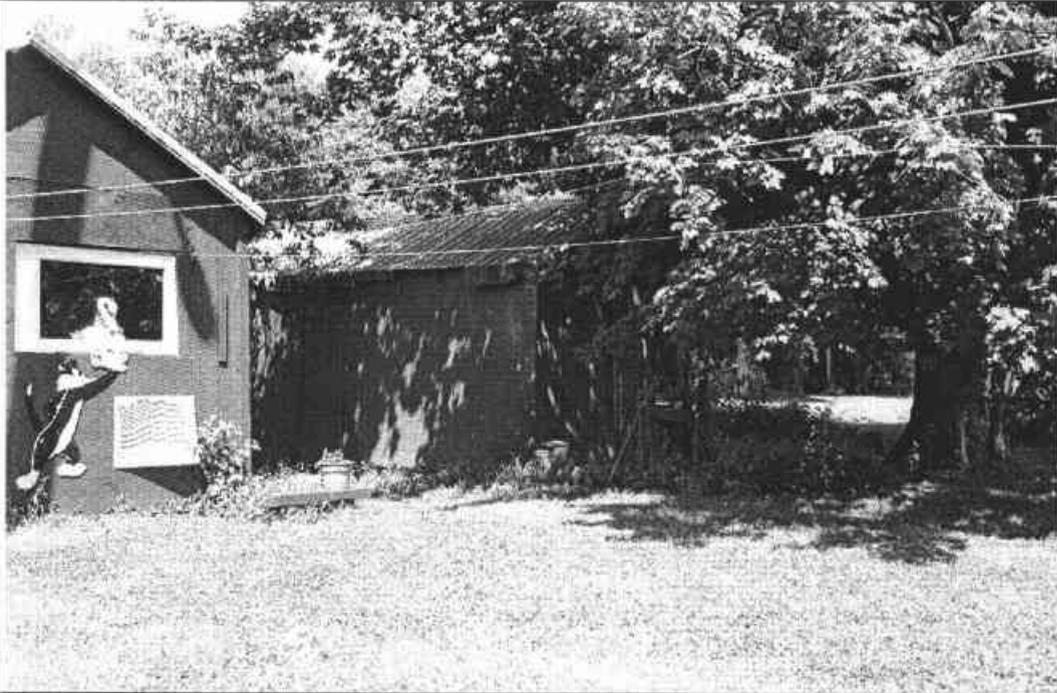
N05235. Photograph 5: Kate Kaiser House, shed, south elevation, view to northeast. This shed is located east of the two garages.

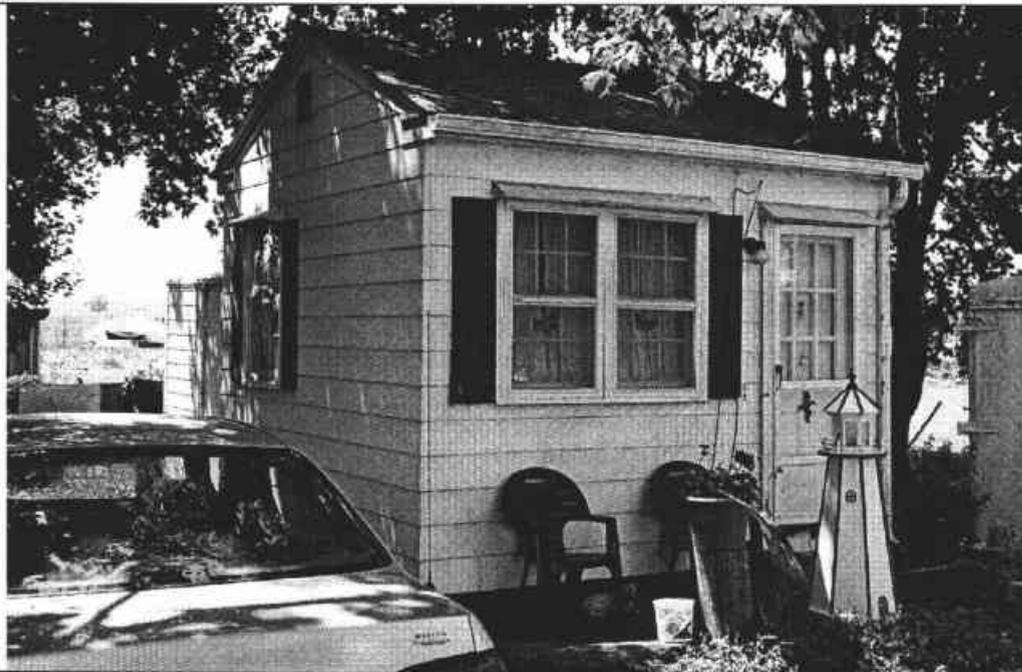
N05235, Photograph 6: Kate Kaiser House, office, east elevation, view to west. This building was moved to the property from an automobile dealer at Ginn's Corner.

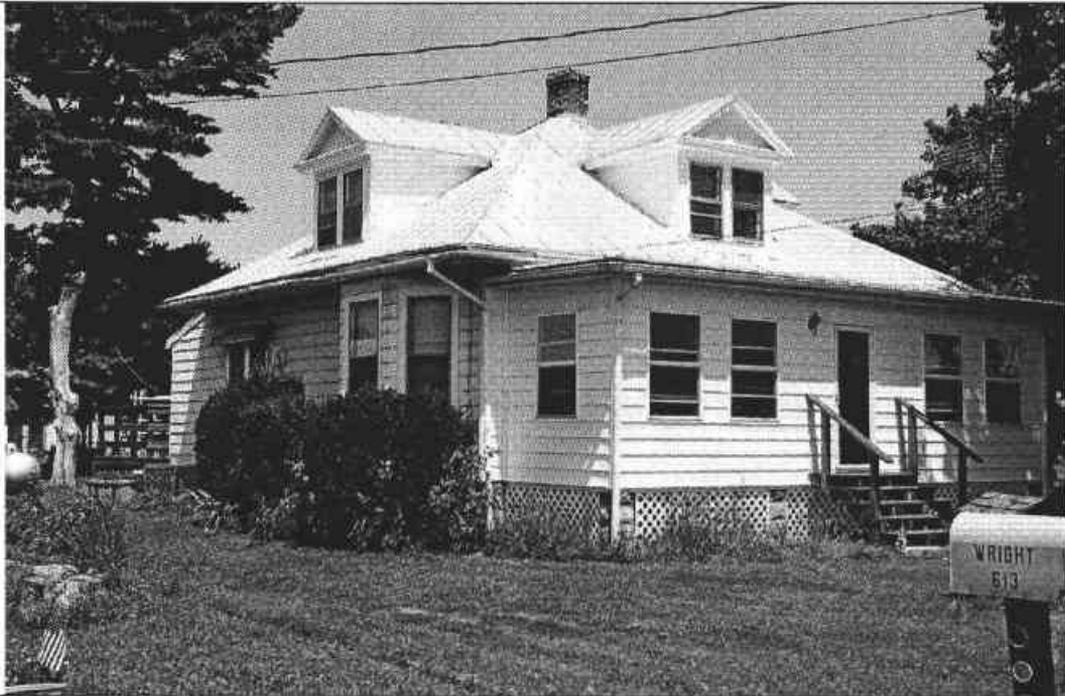
N05236. Photograph 1: Ida Holton House, south and west elevations, view to northeast. Note *circa*-2003 enclosed porch on the south elevation and replacement aluminum

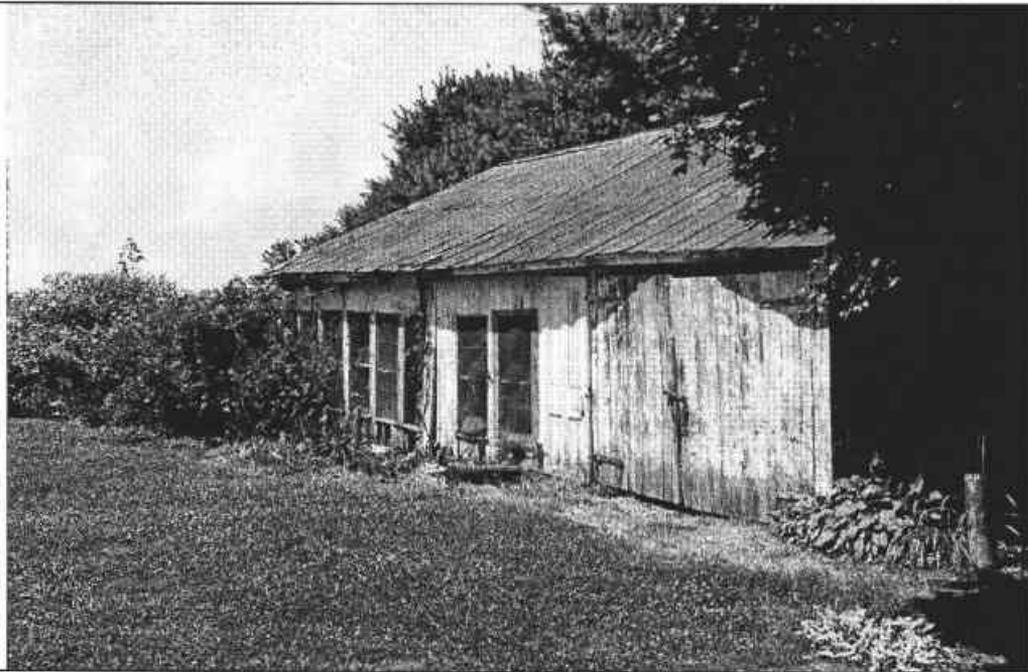
N05236. Photograph 2: Ida Holton House, shed #1, south elevation, view to northwest. Note batten doors, screened window bays, and general deteriorated condition of shed.

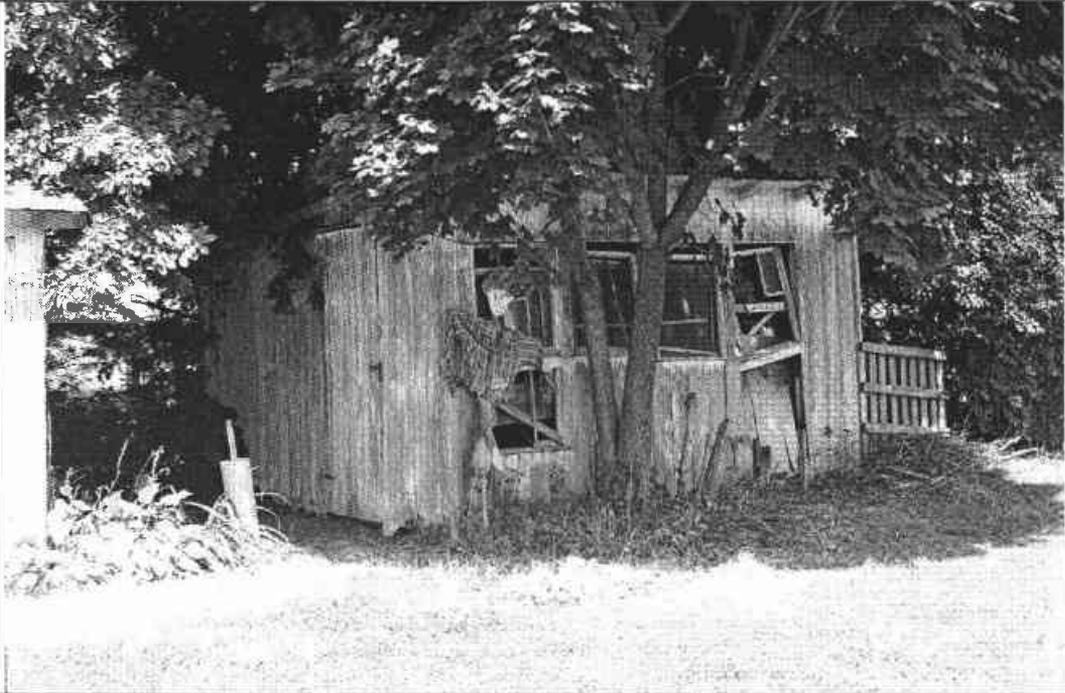
N05236. Photograph 3: Ida Holton House, shed #2, south elevation, view to north. Note deteriorated condition of shed.

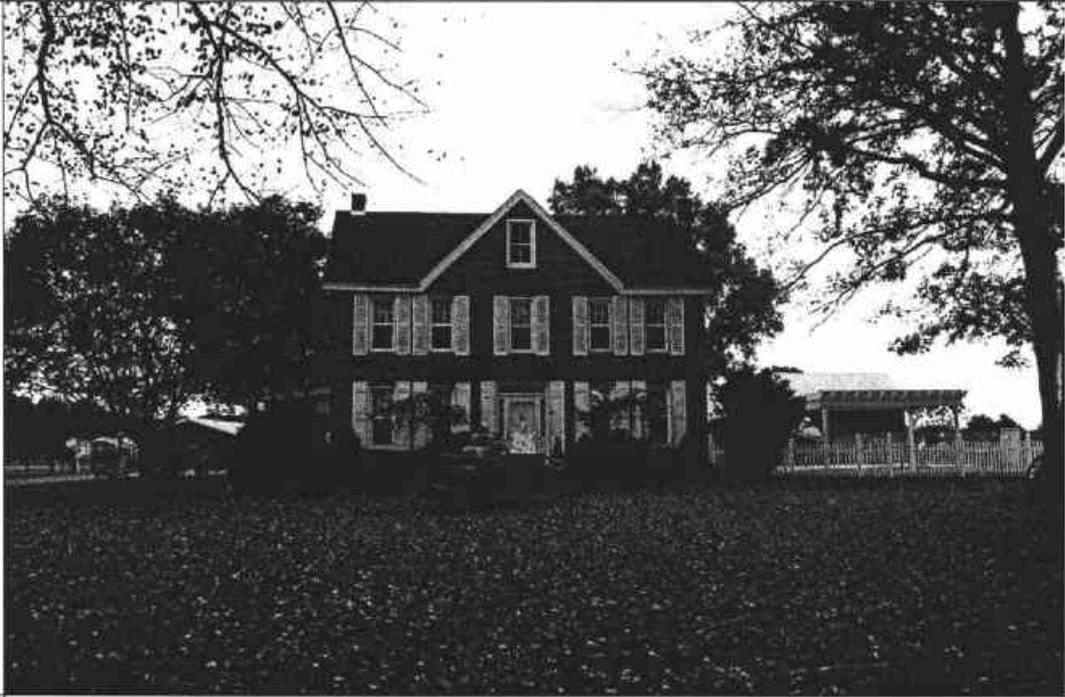
N05238. Photograph 1: Lynch Farm, dwelling, north elevation, view to south.

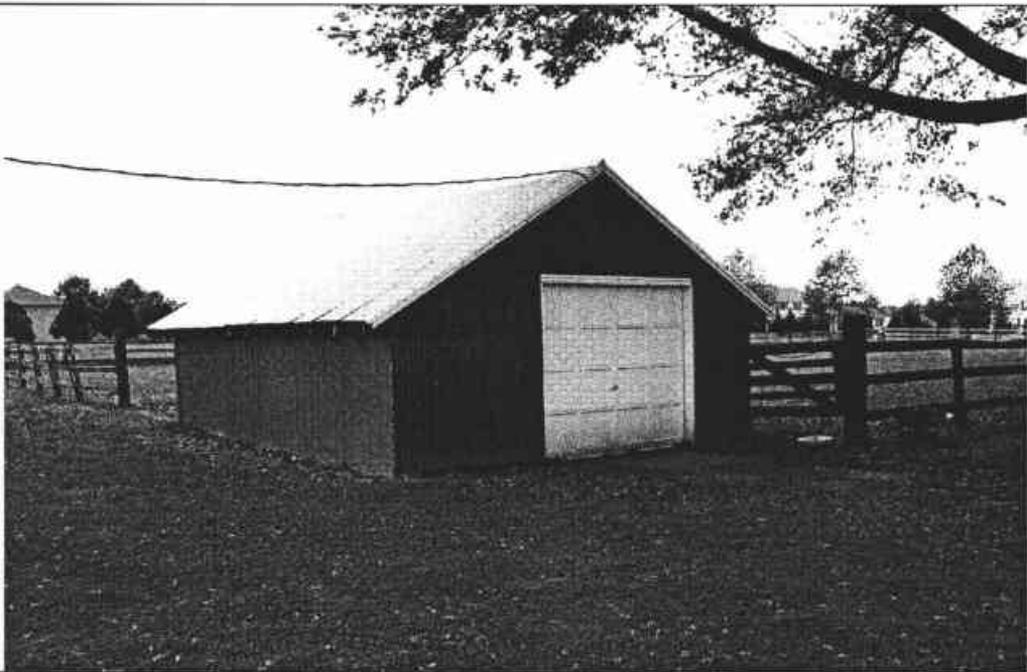
N05238. Photograph 2: Lynch Farm, shed, south and east elevations, view to northwest.

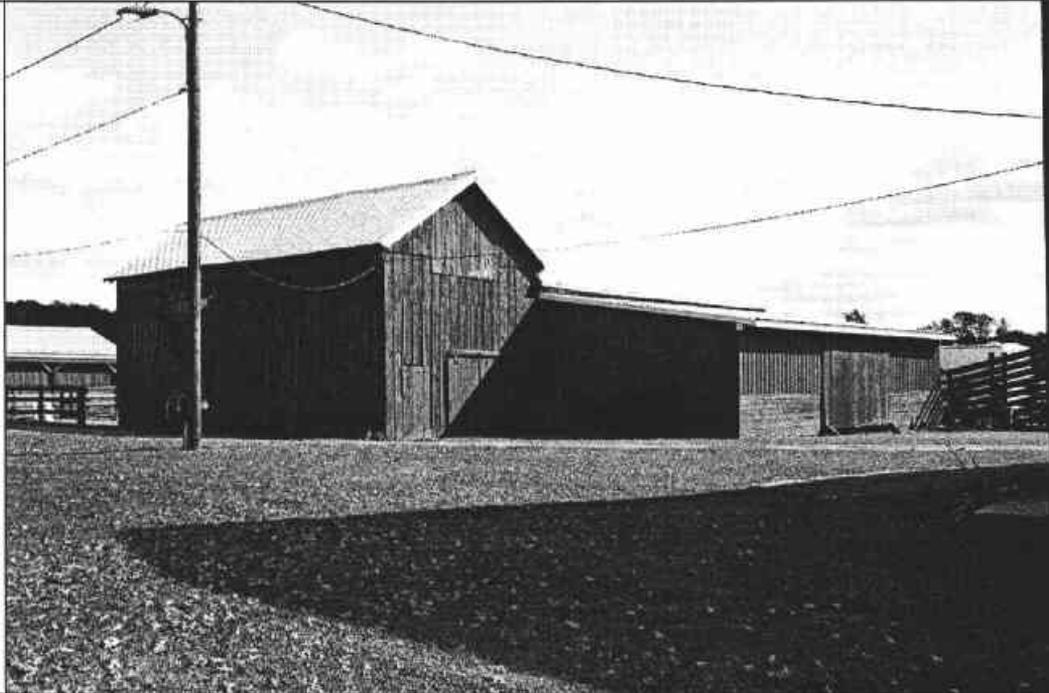
N05238. Photograph 3: Lynch Farm, barn, north and east elevations, view to southwest. The barn is representative of other outbuildings on the Lynch Farm in style and cladding.

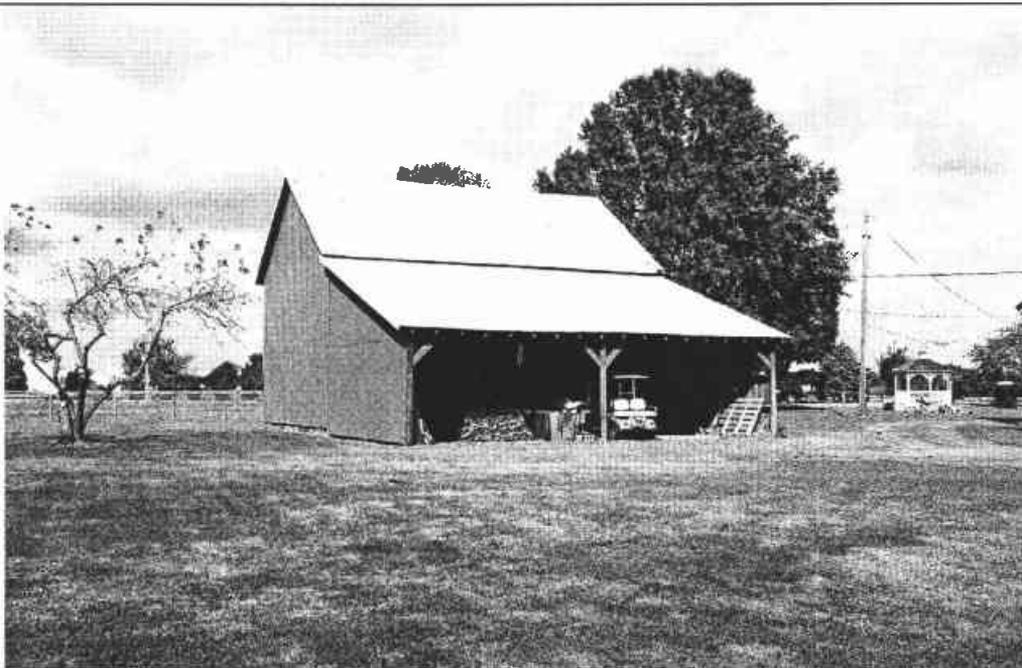
N05238. Photograph 4: Lynch Farm, corncrib/granary, west and south elevations, view to north. Note the two open bays on the south elevation.

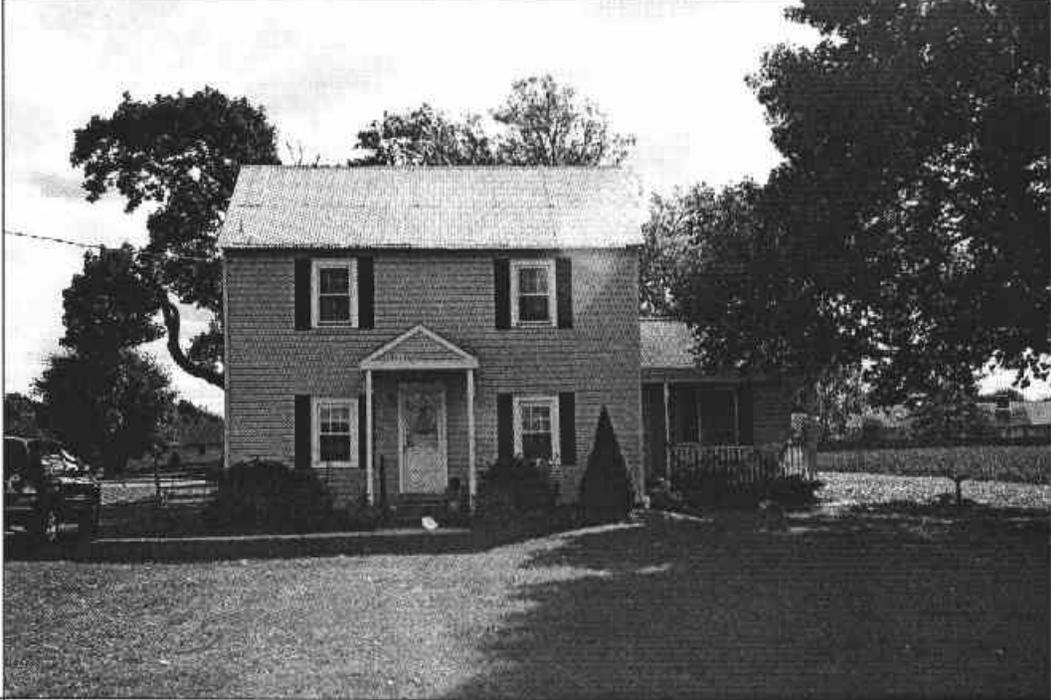
N05238. Photograph 5: Lynch Farm, tenant house, north elevation, view to south. Note later porch and addition as well as replacement windows and siding.

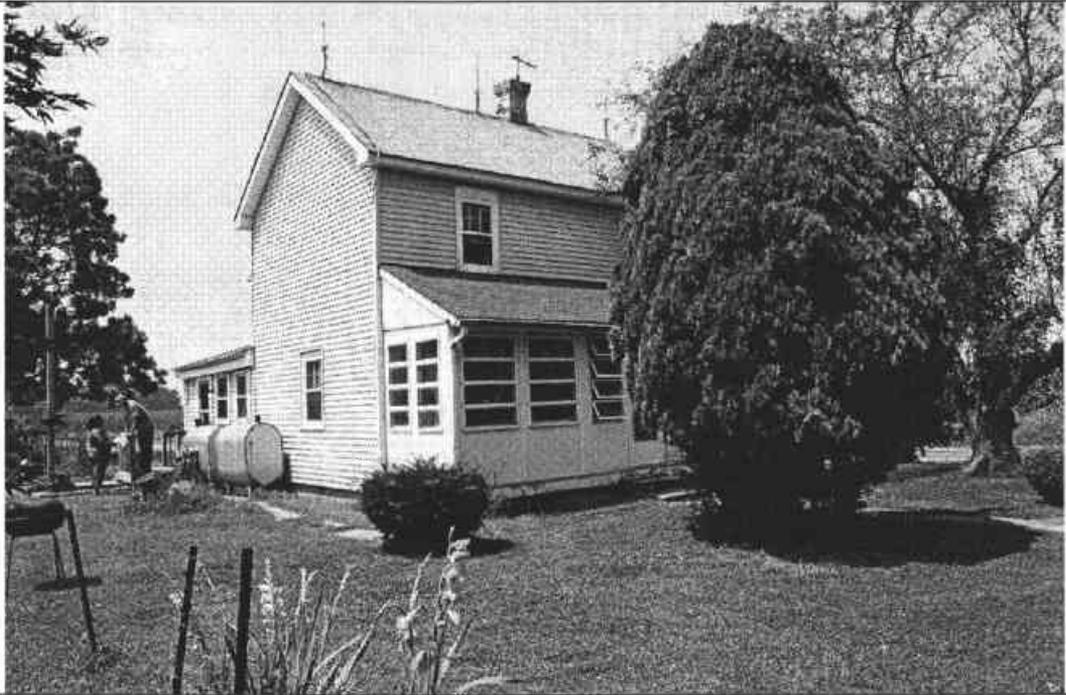
N05240. Photograph 1. G.F. Brady House, overview of house looking northwest, showing east and south elevations. Note enclosed porch on façade.

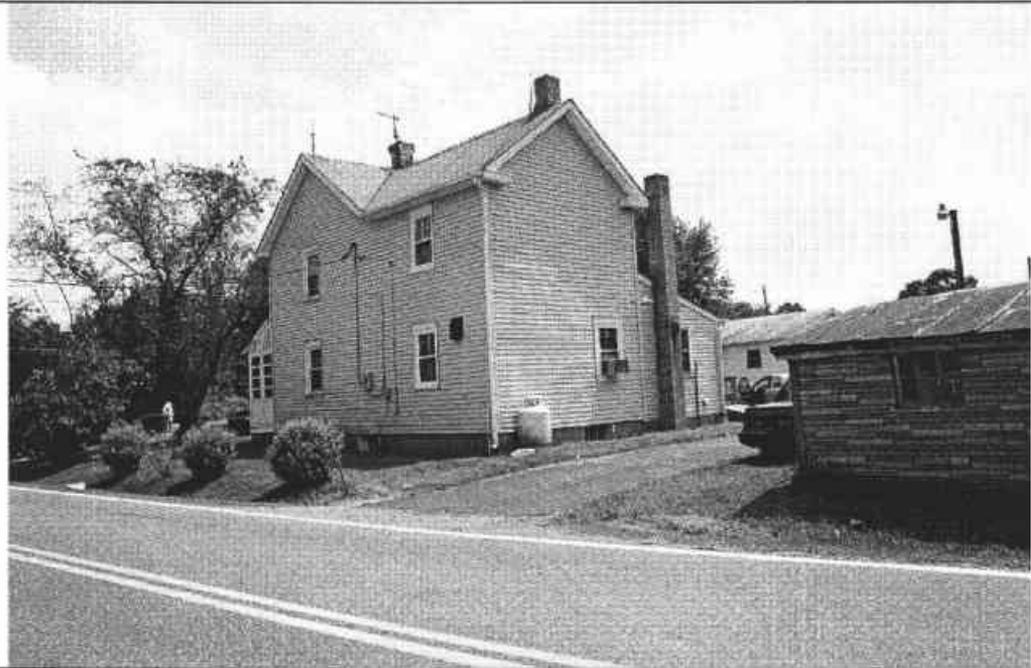
N05240, Photograph 2. G.F. Brady House, overview of house looking southeast, showing west and north elevations, showing rear ell with replaced exterior chimney and shed in foreground.
