CRS No. N14332

Name: Henry and Sophie Eihinger House

CULTURAL RESOURCE SURVEY
PROPERTY IDENTIFICATION FORM

U.S. 301 Project Development

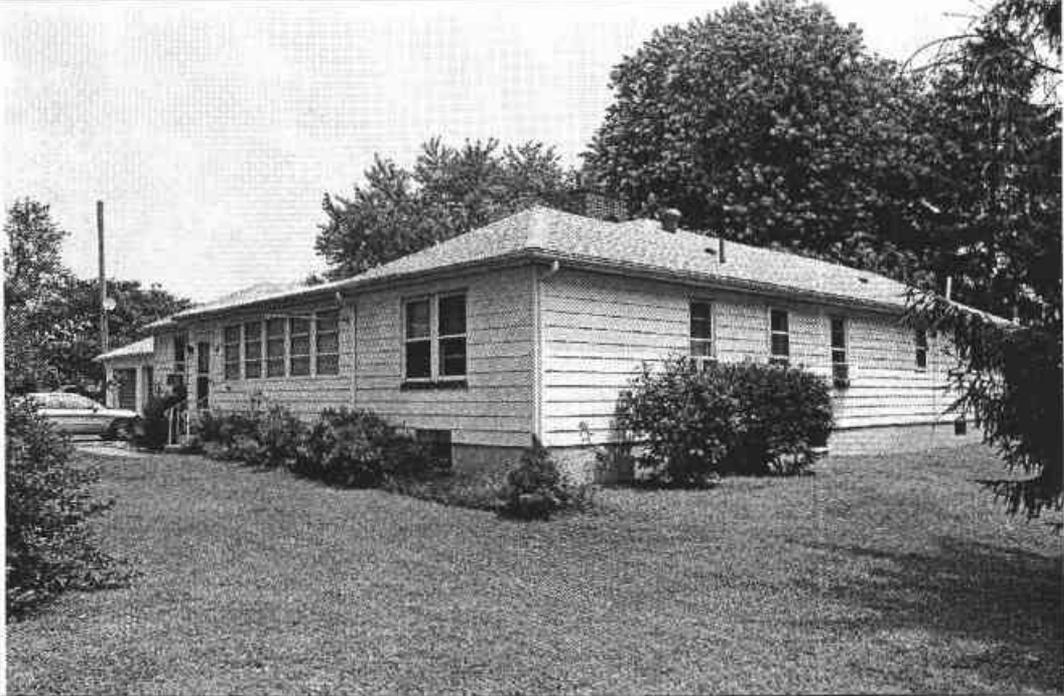
N14332. Photograph 1: Dwelling, south and west elevations, view to northeast. Note the multiple additions located on the east elevation.

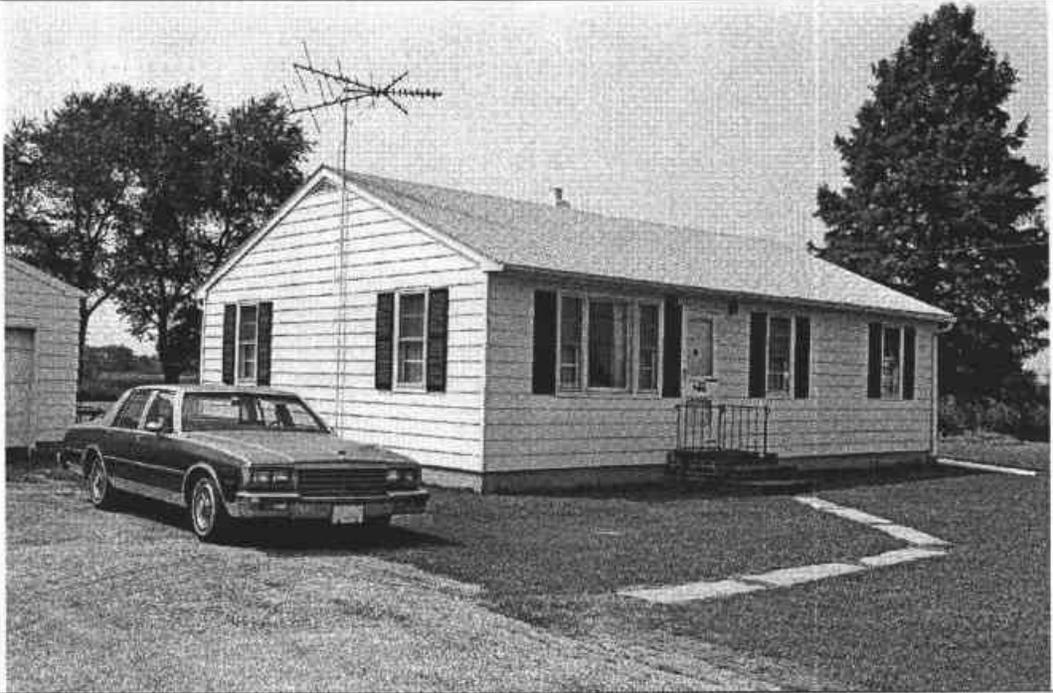
N14333. Photograph 1: Dwelling, south and east elevations, view facing northwest. This Minimal Traditional dwelling is a common example of mid-twentieth-century architecture in the area.

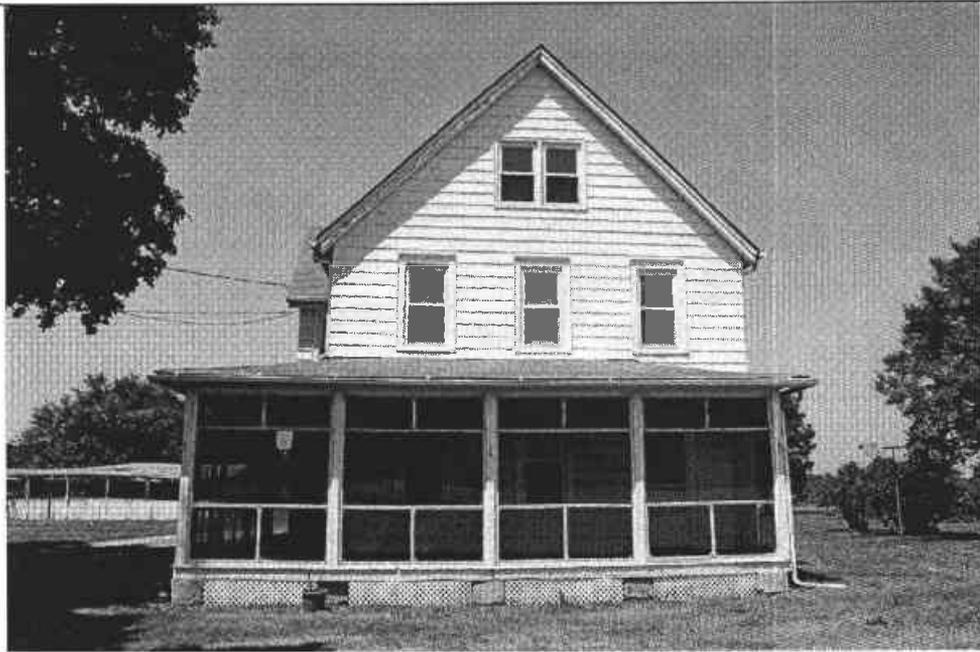
N14334. Photograph 2: Dwelling (ca. 1900), east elevation, view to west. Note original porch. Former poultry house (now demolished) is located to rear left of photograph.

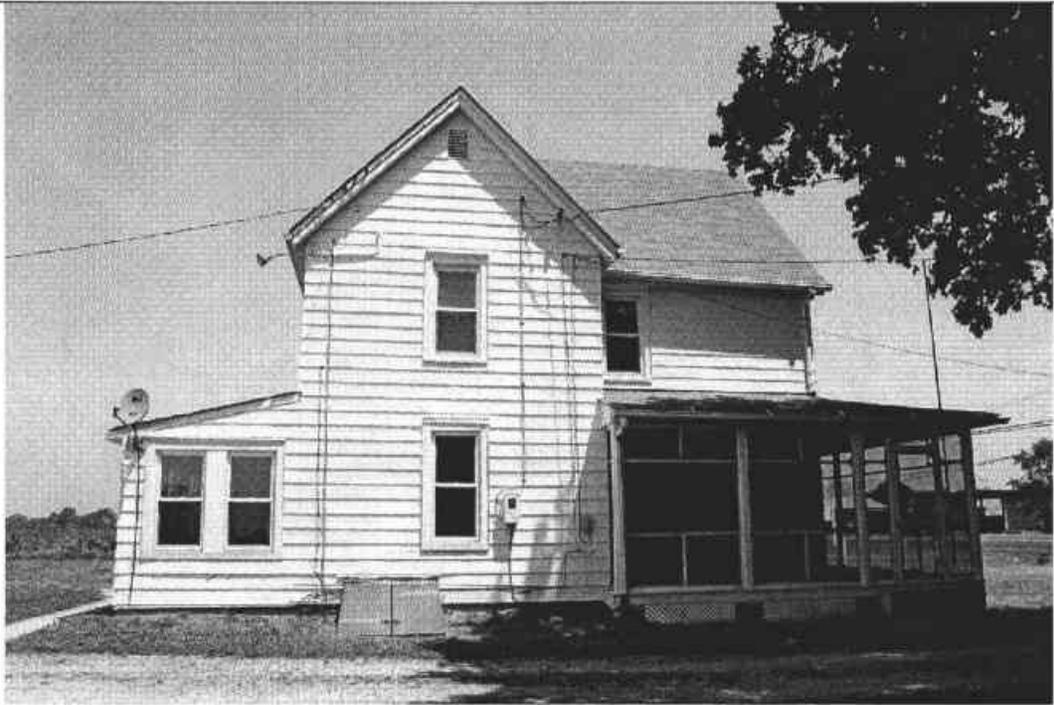
N14334. Photograph 3: Dwelling, south elevation, view to north. Note replacement siding and windows.

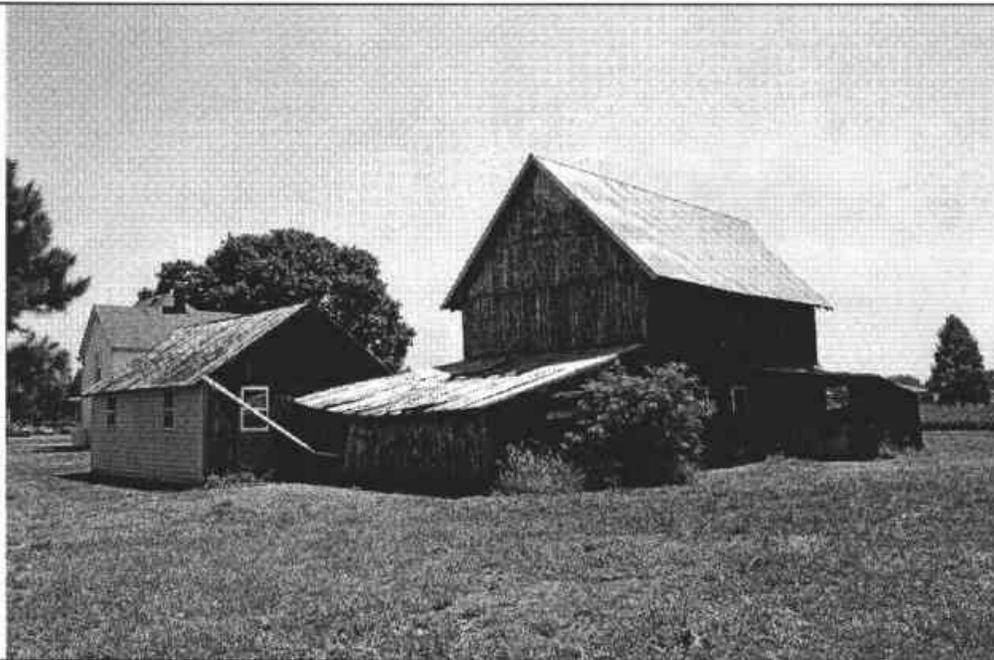
N14334. Photograph 4: North and west elevations of barn complex (ca. 1900), view to southeast. The carriage house (left) and horse barn (right) were formerly separate structures that were joined by the central addition.

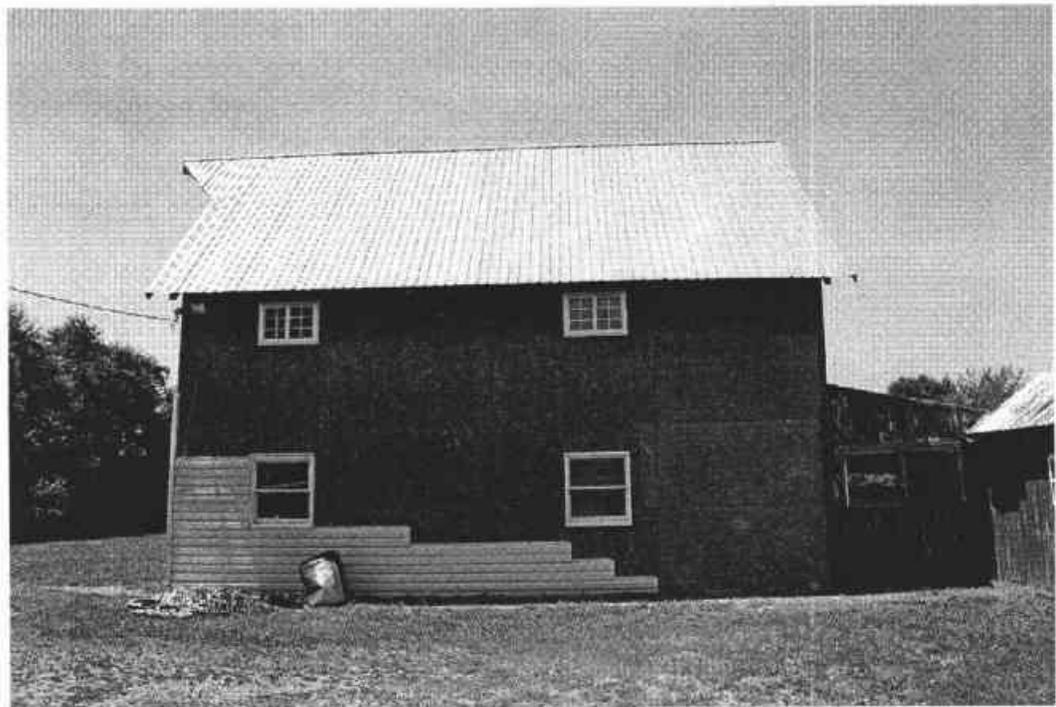
N14334. Photograph 5: Barn, east elevation, view to west. Note vinyl siding and replacement windows.

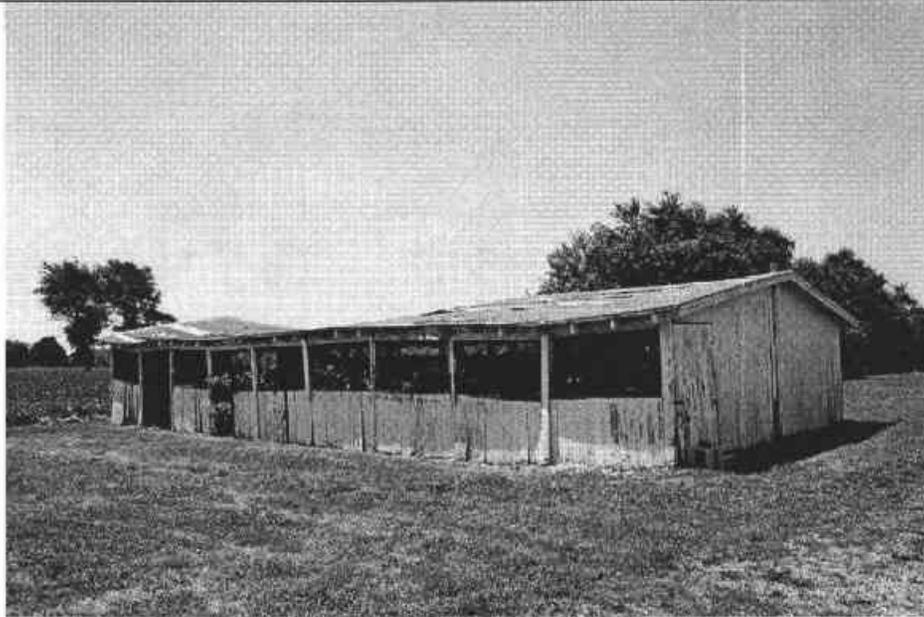
N14334. Photograph 6: Appearance of poultry house in July 2005, prior to demolition, view to southwest.

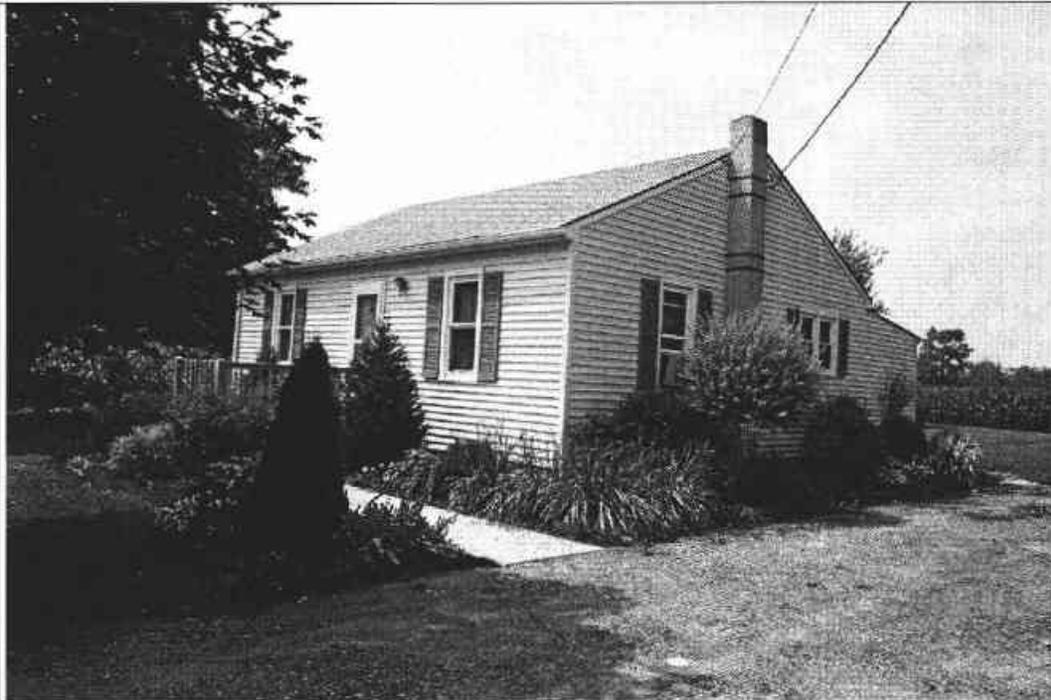
N14335. Photograph 1: B. Irvin and Elizabeth Armstrong House, south and east elevations, view to northwest. Note vinyl siding, replacement windows and replacement door.

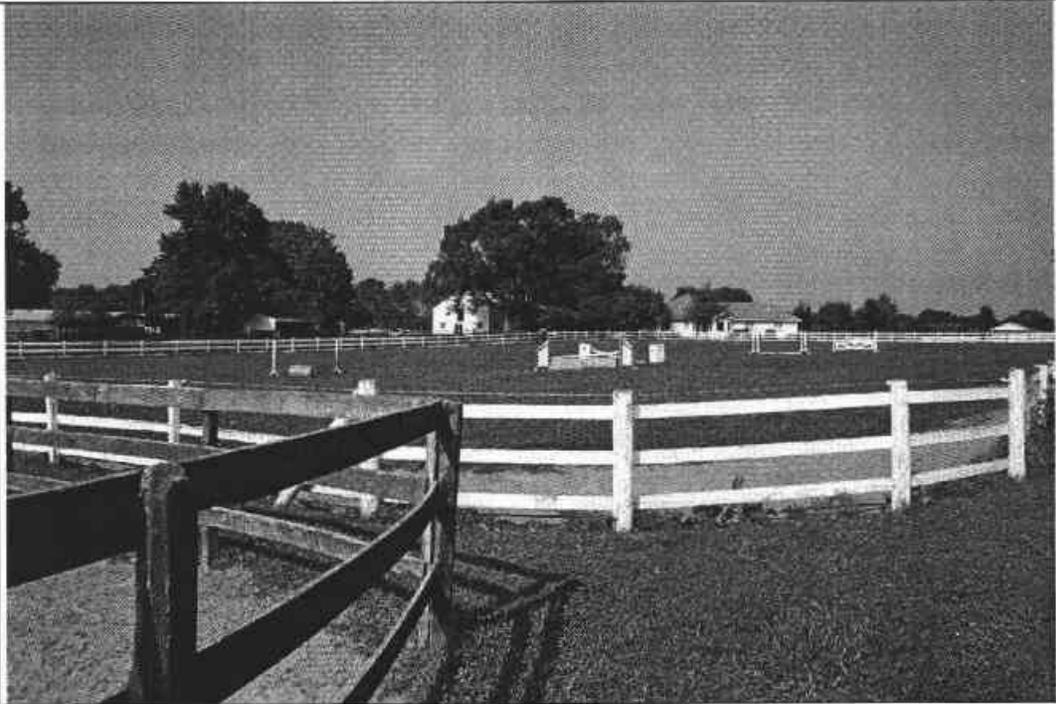
N14336. Photograph 1: Overview of farm from gravel drive, showing modern equipment/machine shed (ca. 1970), stable (ca. 1960), and modern dwelling (1993), view to southwest.

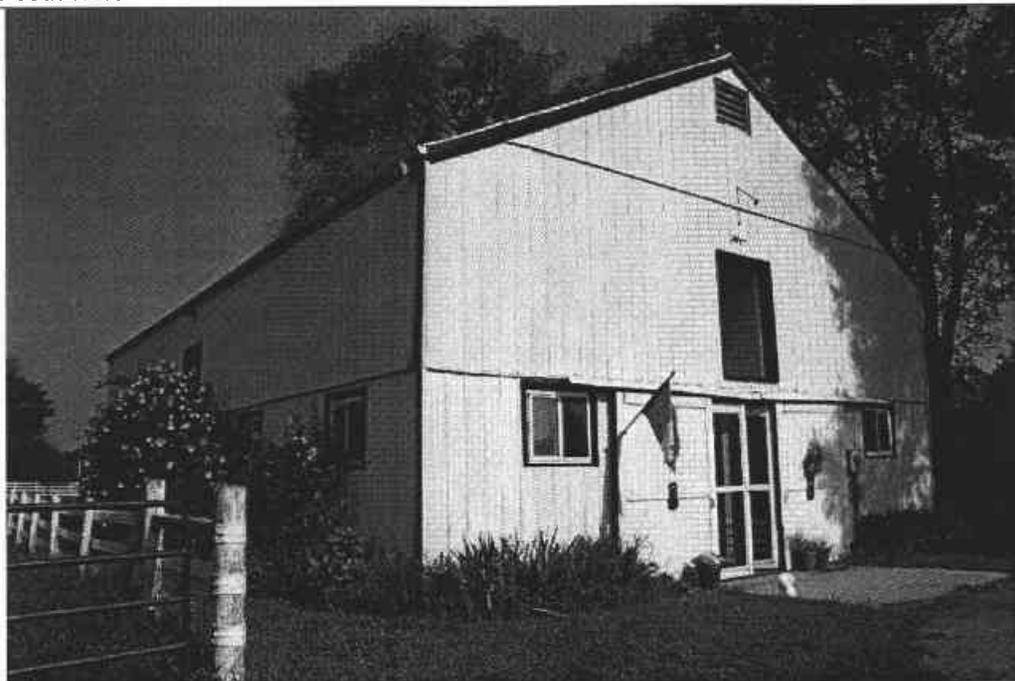
N14336. Photograph 2: Stable, south and east elevations, view to northwest.

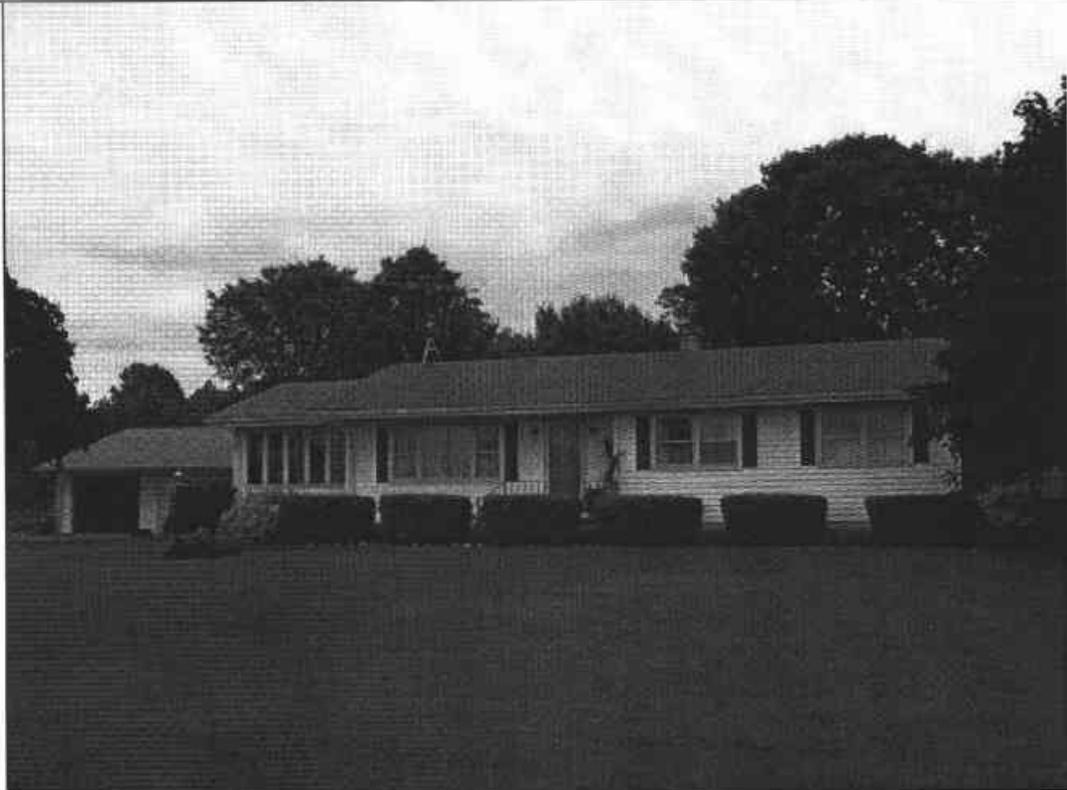
N14337. Photograph 1: Ralph and Phyllis Bailey House, dwelling, north elevation, view to south. Note the detached two-car garage on the left side of the photograph. The Ranch house is a common property type in Delaware.

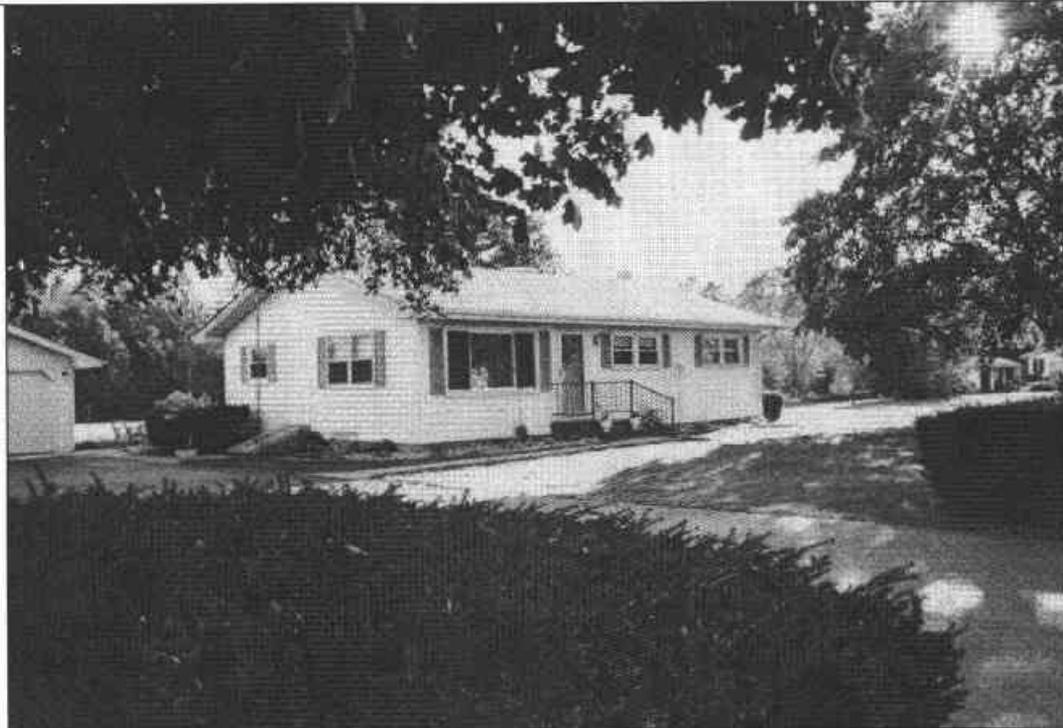
N14338. Photograph 1: Lester and Thelma Biddle House, dwelling, north and east elevations, view to southwest. The Ranch house is a common property type in Delaware.

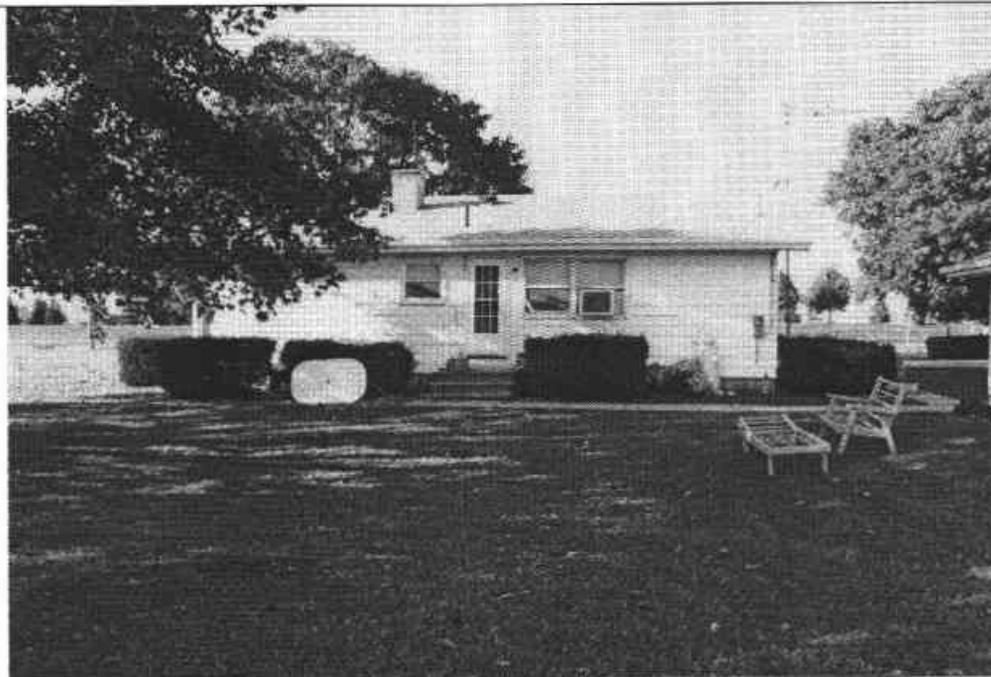
N14338. Photograph 2: Lester and Thelma Biddle House, dwelling, south elevation, view to north. Note the concrete steps leading to the rear entry and the manicured lawn.

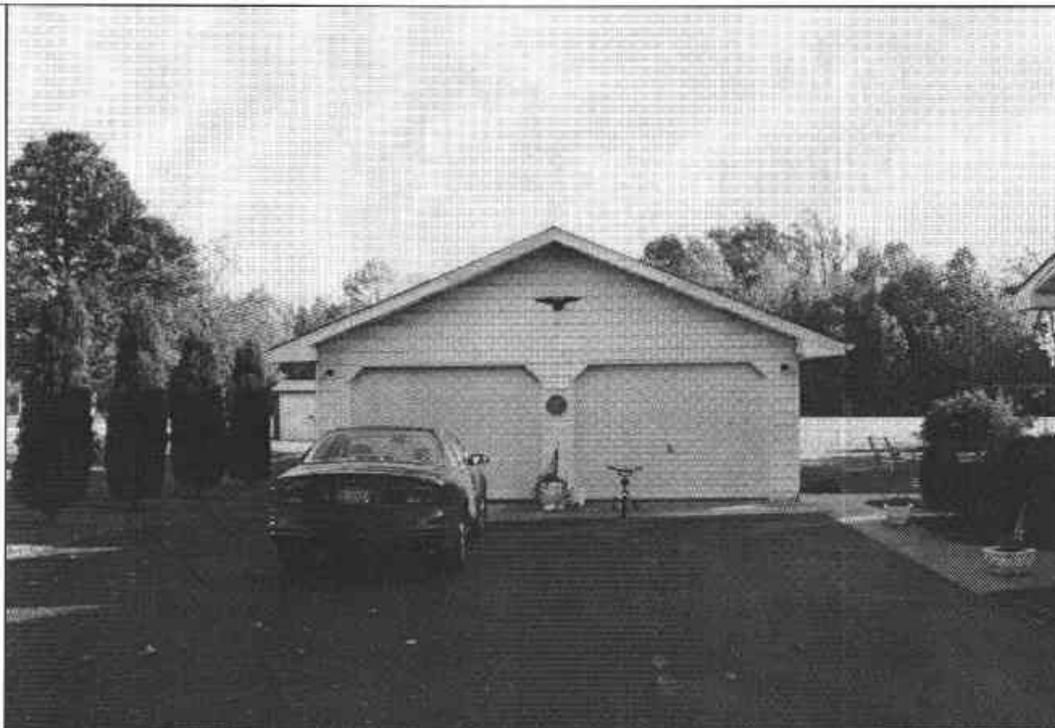
N14338. Photograph 3: Lester and Thelma Biddle House, garage, north elevation, view to south. This modern detached garage lies southeast of the *circa*-1960 Ranch house and is accessed by an asphalt drive.

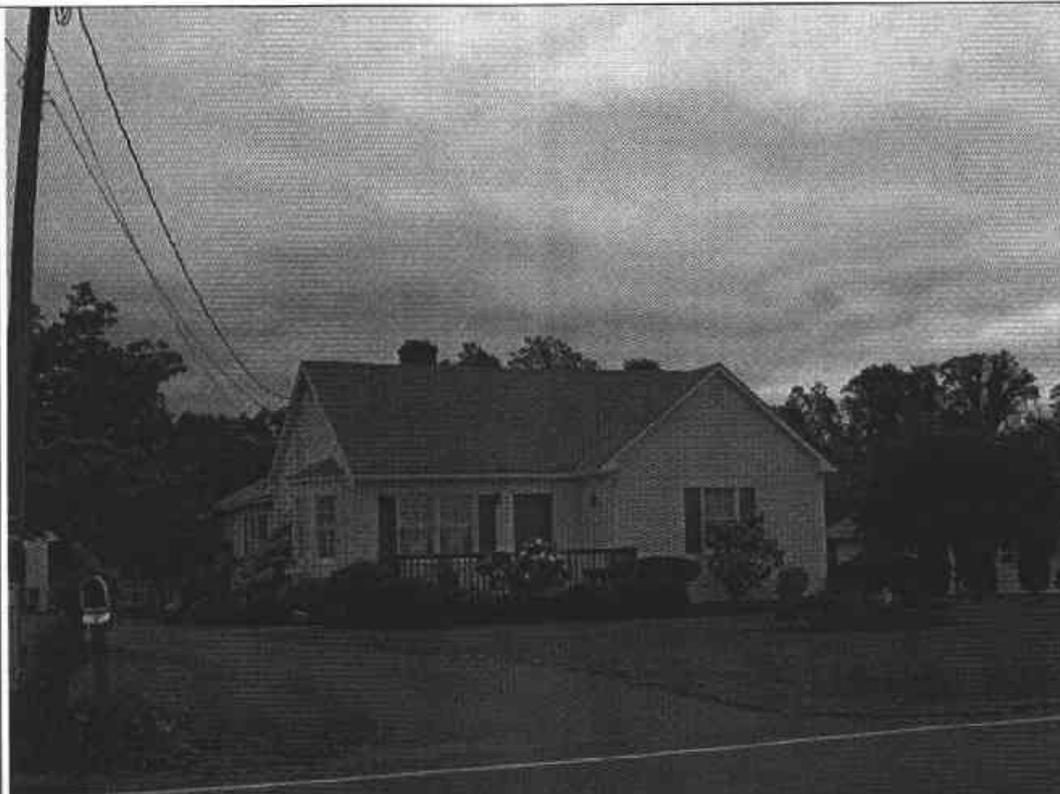
N14339. Photograph 1: Ira and Mary Emerson house, north and east elevations, view to southwest. Note vinyl siding and replacement windows.

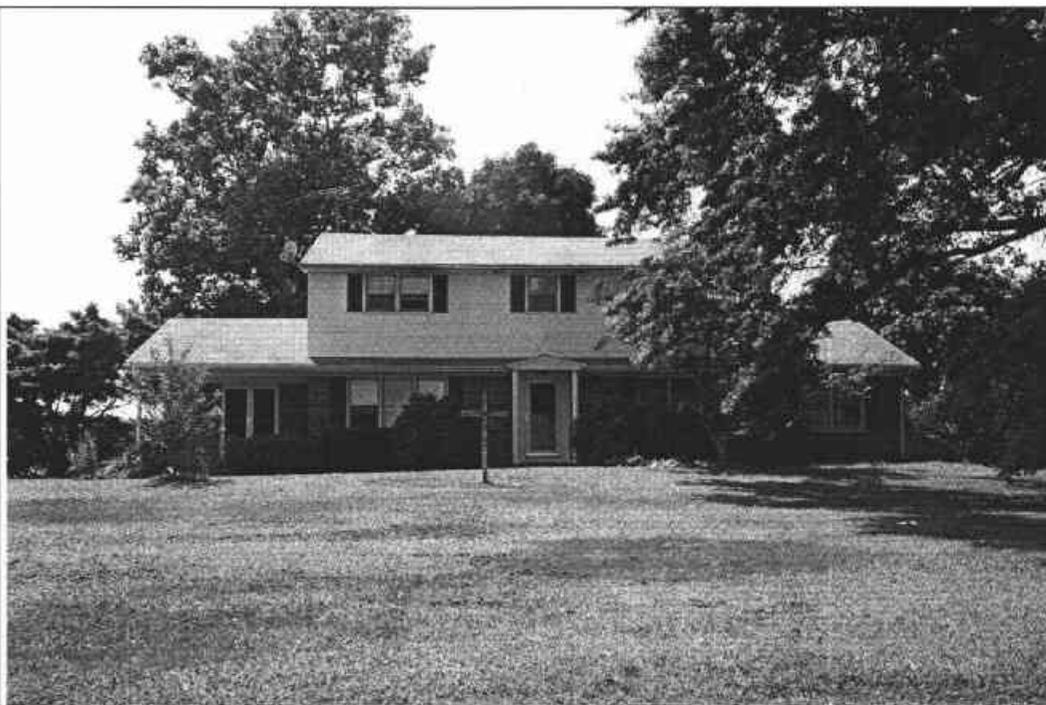
N14340. Photograph 1: Dwelling (1959), east elevation, view looking west.

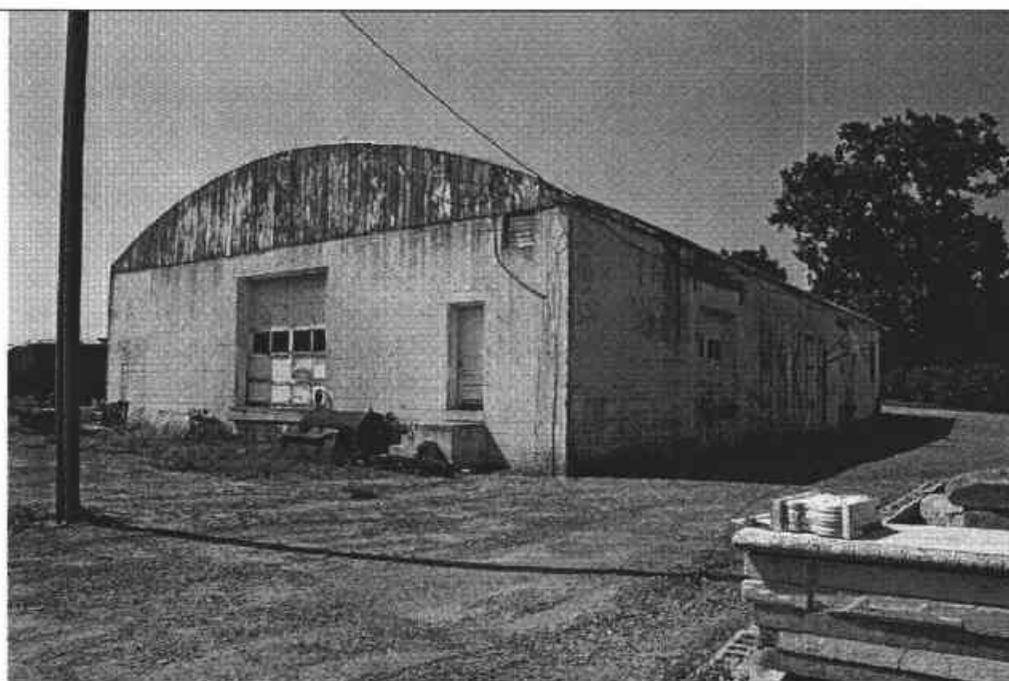
N14340. Photograph 2: Potato grading facility (1960; now demolished), south and east elevations, view looking northwest. Note painted signage at east elevation.

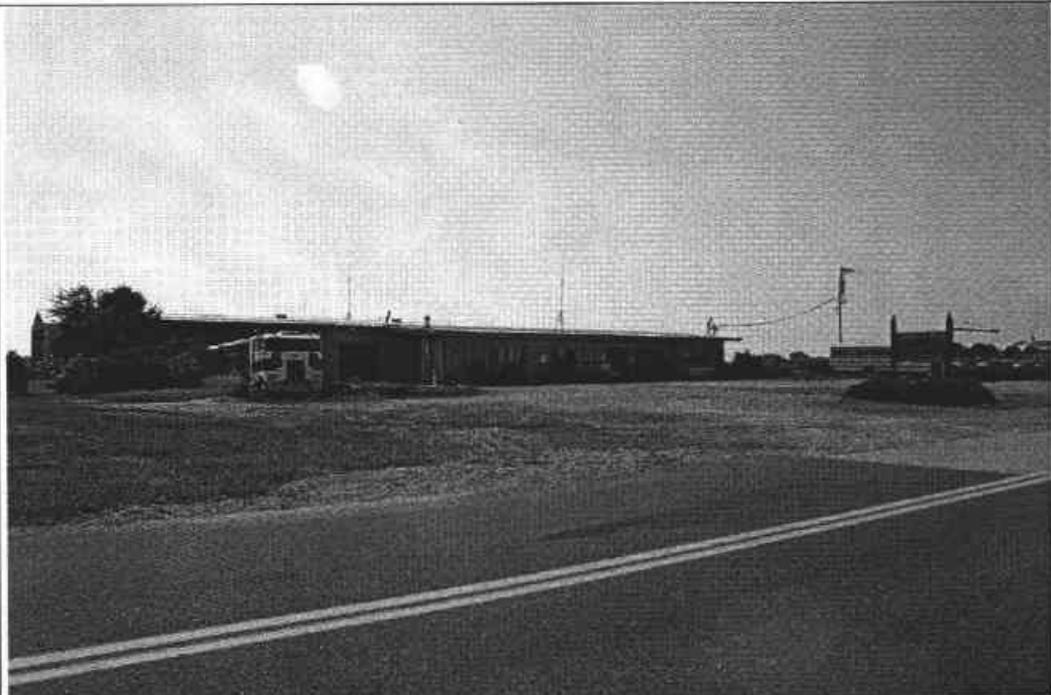
N14340. Photograph 3: Modern egg grading facility/farm store at southern end of property, view to northwest.

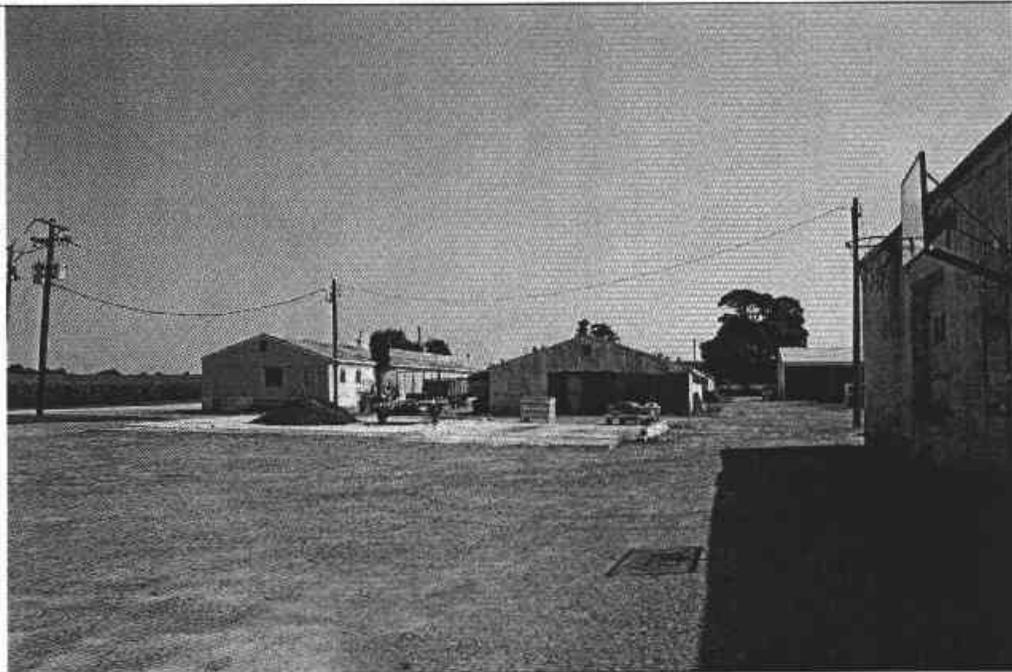
N14340. Photograph 4: Poultry houses from the 1970s to the left and potato grading facility to the right, view looking south.

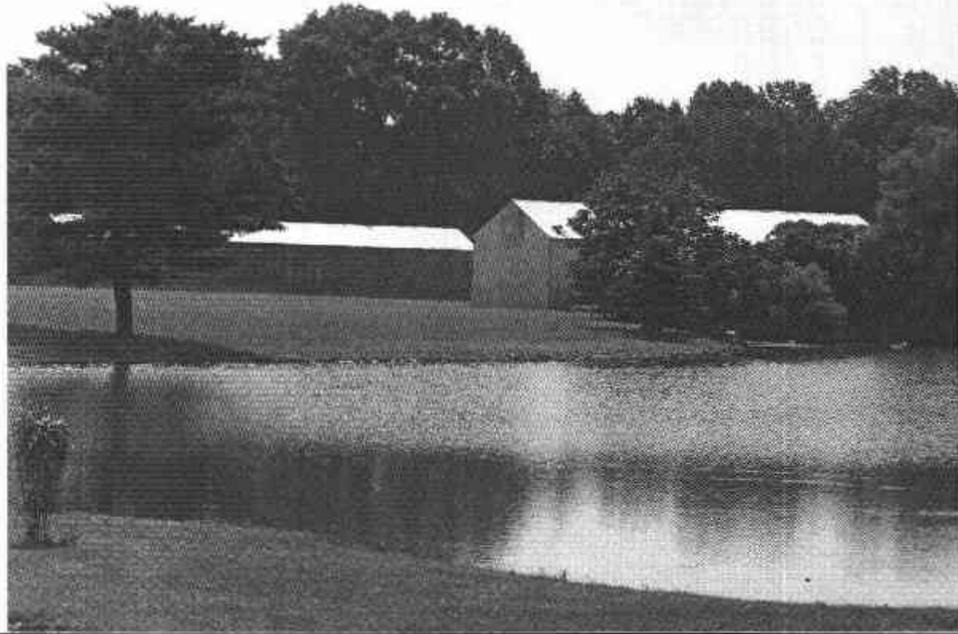
N14340. Photograph 5: Frame pole barns on the Steele Farm. The mid-twentieth-century barn on the left was previously located on the Baker Farms property and was moved after 1962 (July 2006).
