CRS No. N14376

Name: Wilson J. and Evelyn Mae Haman House

CULTURAL RESOURCE SURVEY
PROPERTY IDENTIFICATION FORM

U.S. 301 Project Development

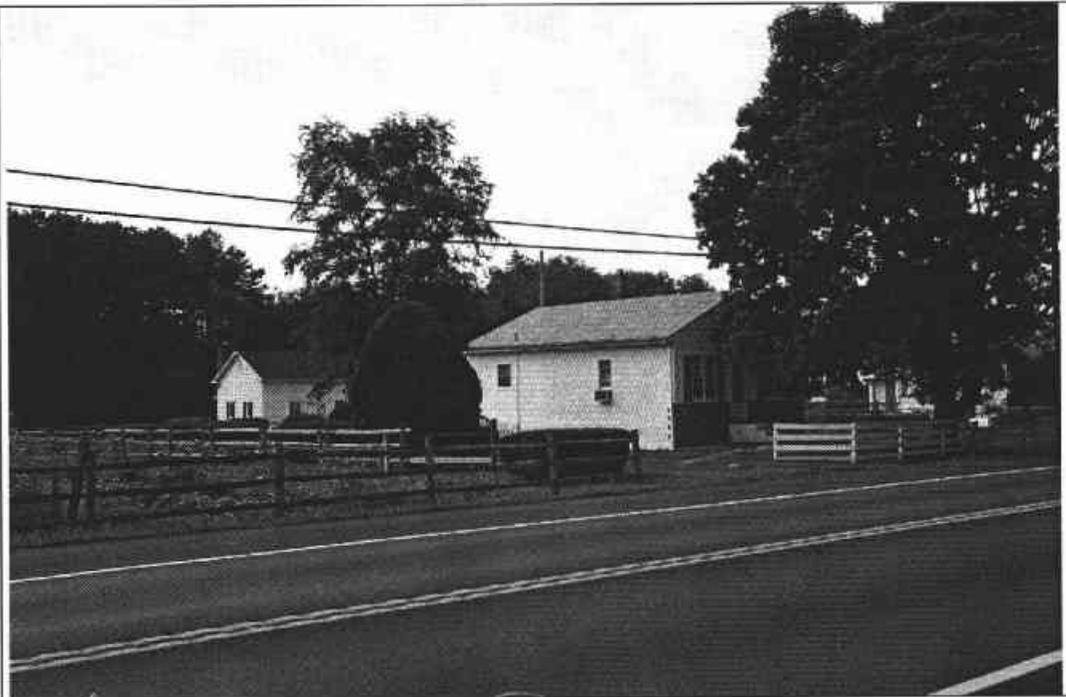
N14376. Photograph 1: Property overview, south and east elevations, view looking northwest. This dwelling is a representative example of a mid-twentieth-century Minimal Traditional property..

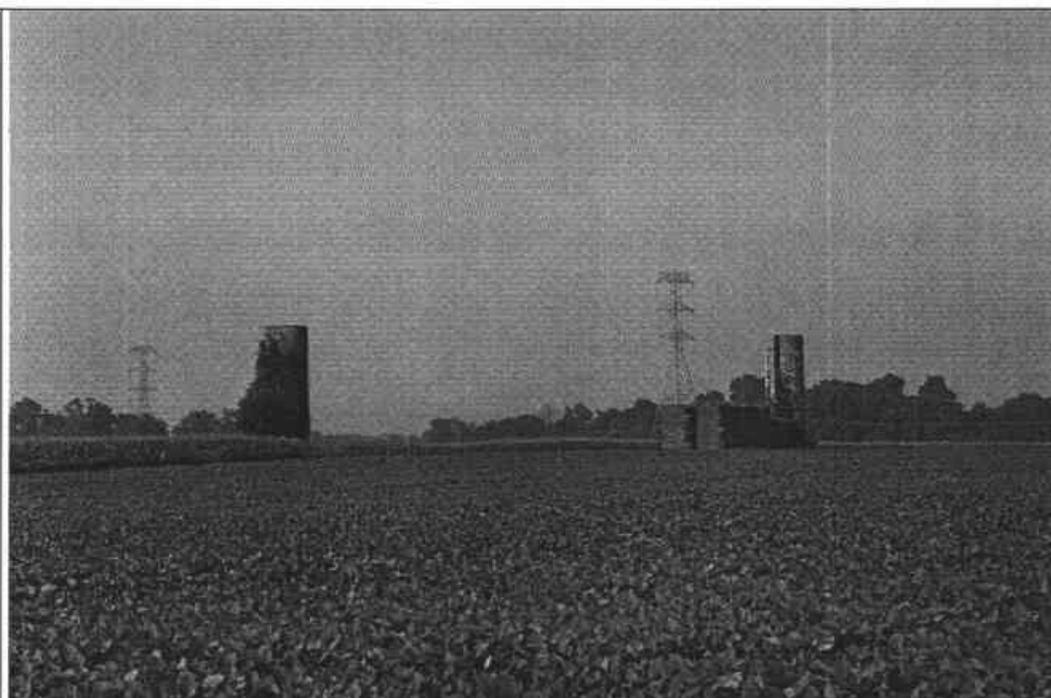
N14377. Photograph 1: Silos, northwest elevation, view to the southeast.

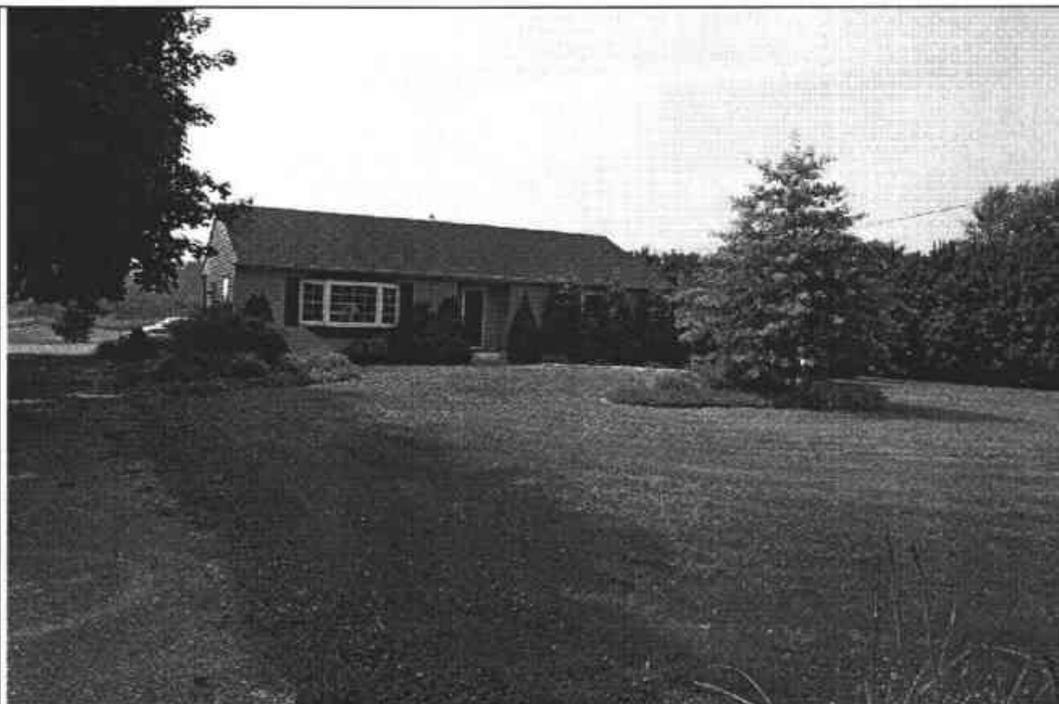
N14378. Photograph 1: Murphy House, view of façade, looking west. A two-bay garage has been added to the house onto the rear (west) elevation.

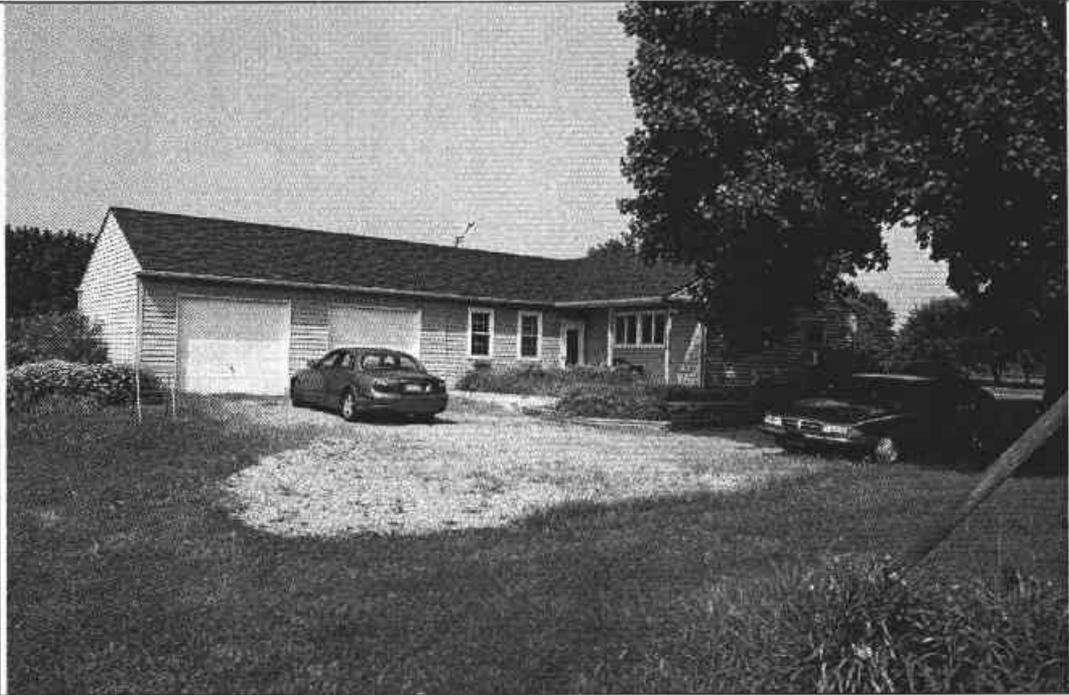
N14378. Photograph 2: View of garage addition, view looking north.

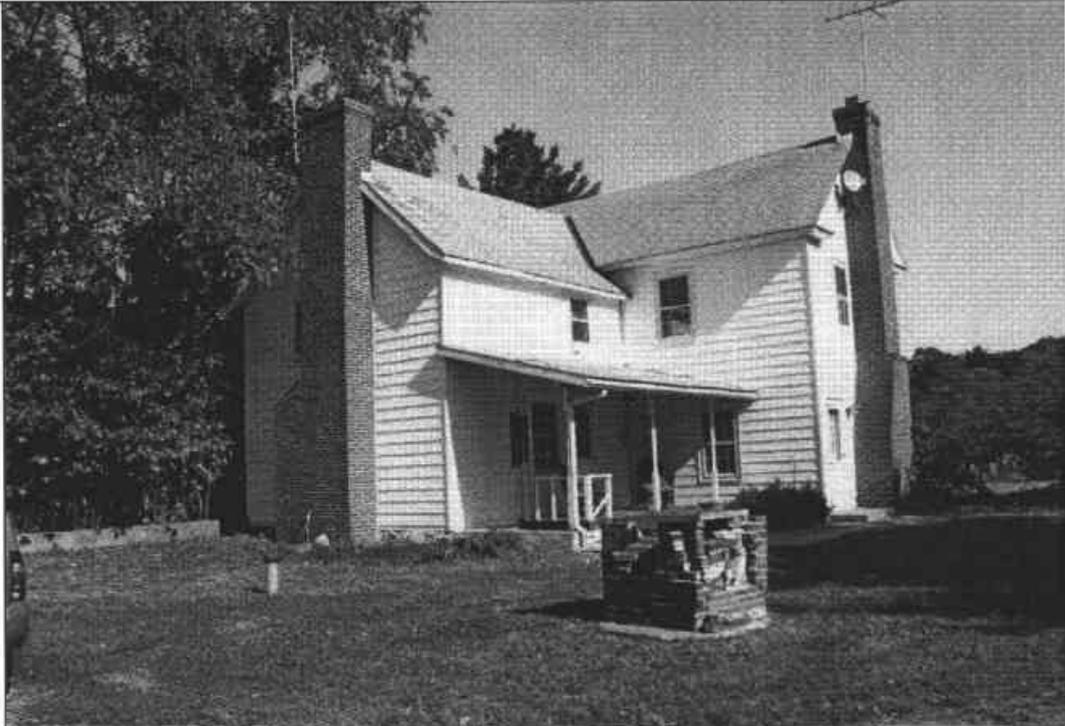
N14379. Photograph 1: Dwelling, west and south elevations, view to northeast.

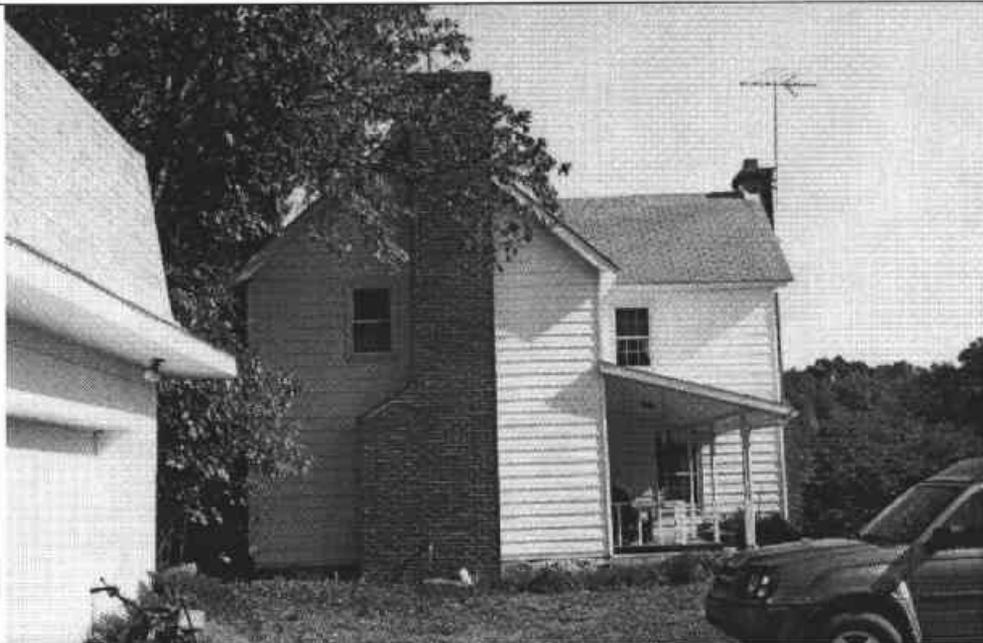
N14379. Photograph 2: Dwelling, west elevation, view to east. Note the exterior brick chimney on the west elevation of the rear ell, which was erected by the current owner ca. 1965.

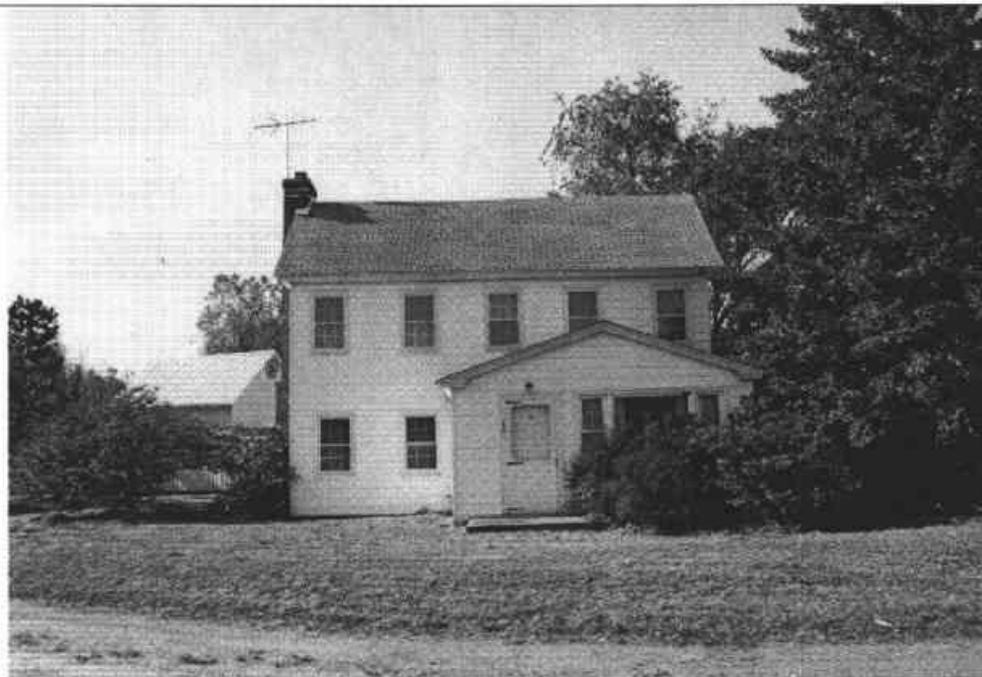
N14379. Photograph 3: Dwelling, east elevation, view to west. Note the one-story gable front addition with Chicago window that extends from the eastern elevation.

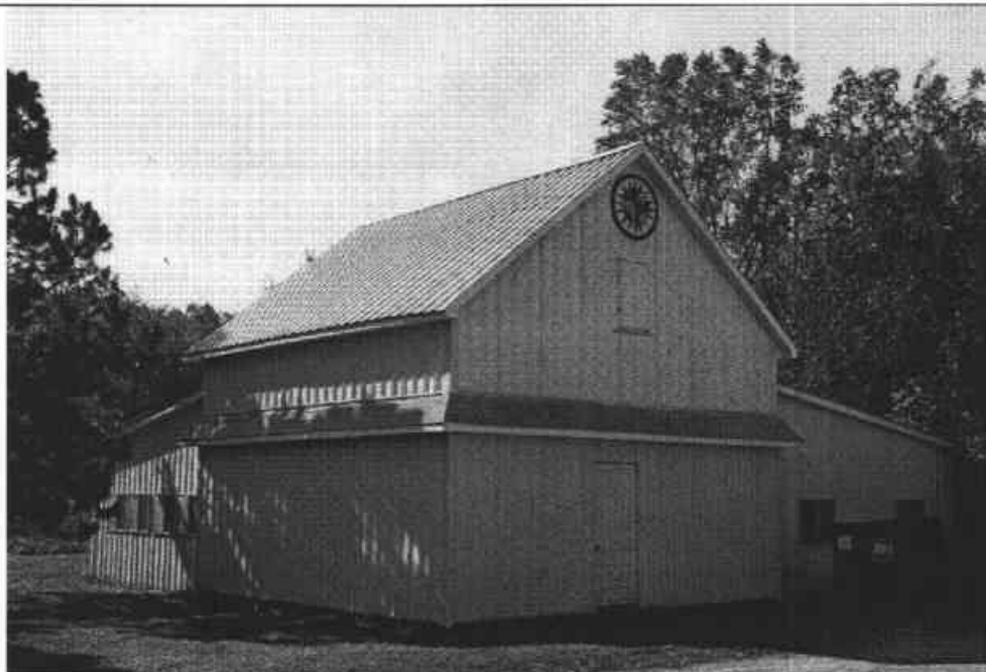
N14379. Photograph 4: Granary, east and north elevations, view to southwest. Note vertical metal siding and the additions extending from the south and west elevations.

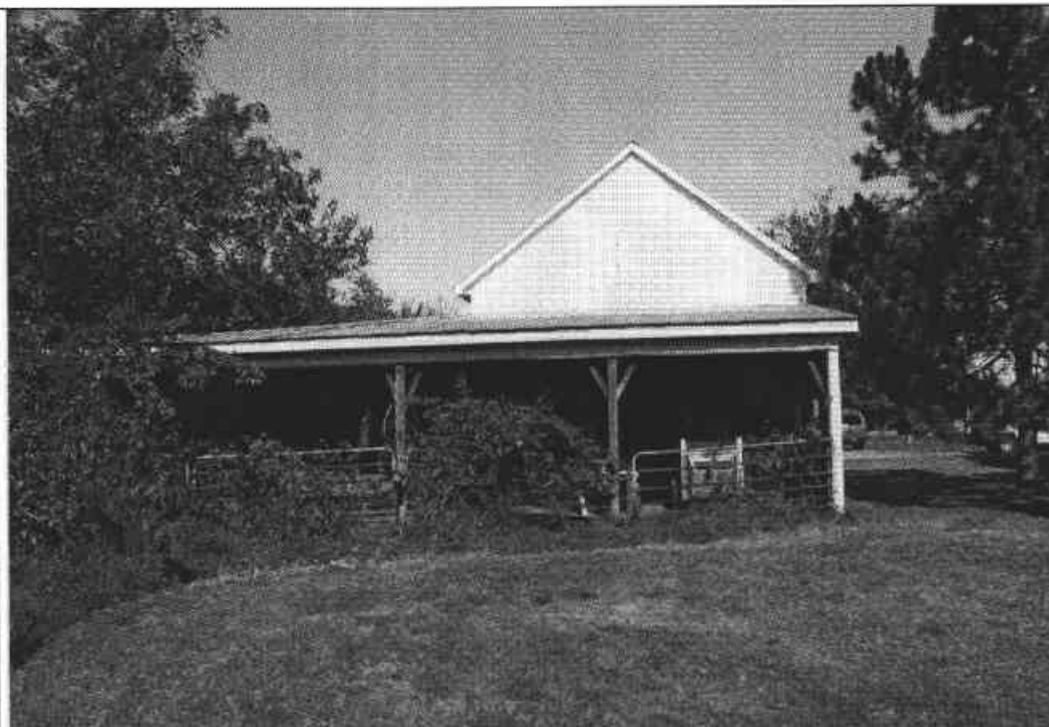
N14379. Photograph 5: Granary, south elevation, view to north. Note the lean-to addition with open bays.

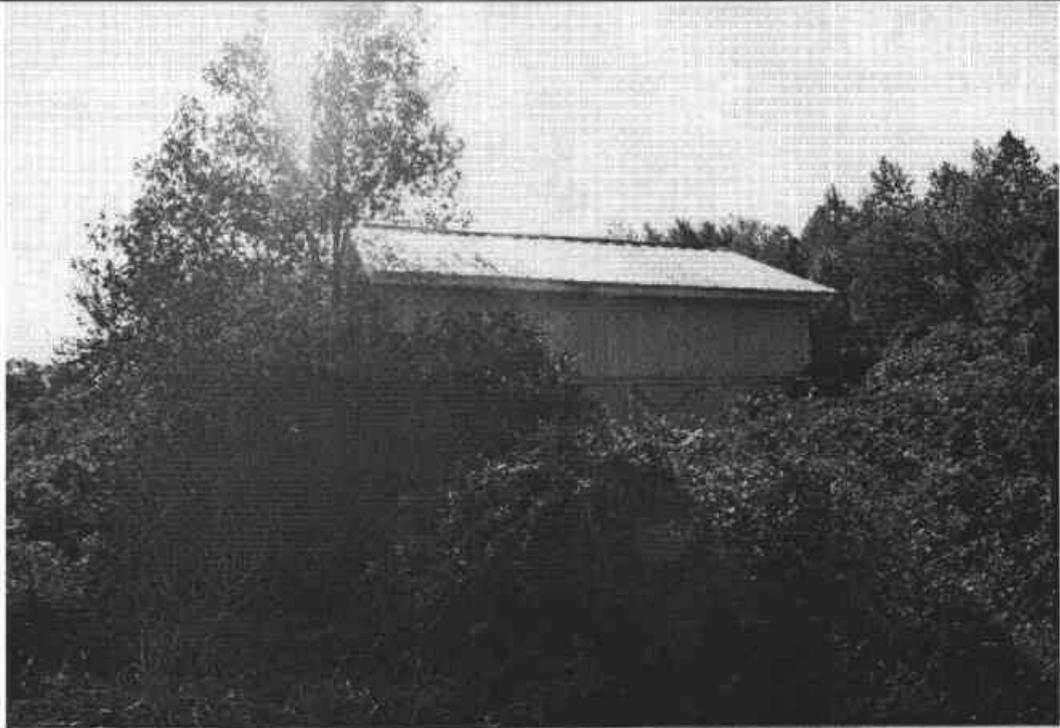
N14379. Photograph 7: Outbuilding for goats, north elevation, view to south. Note the mature trees and overgrown vegetation surrounding the outbuilding.

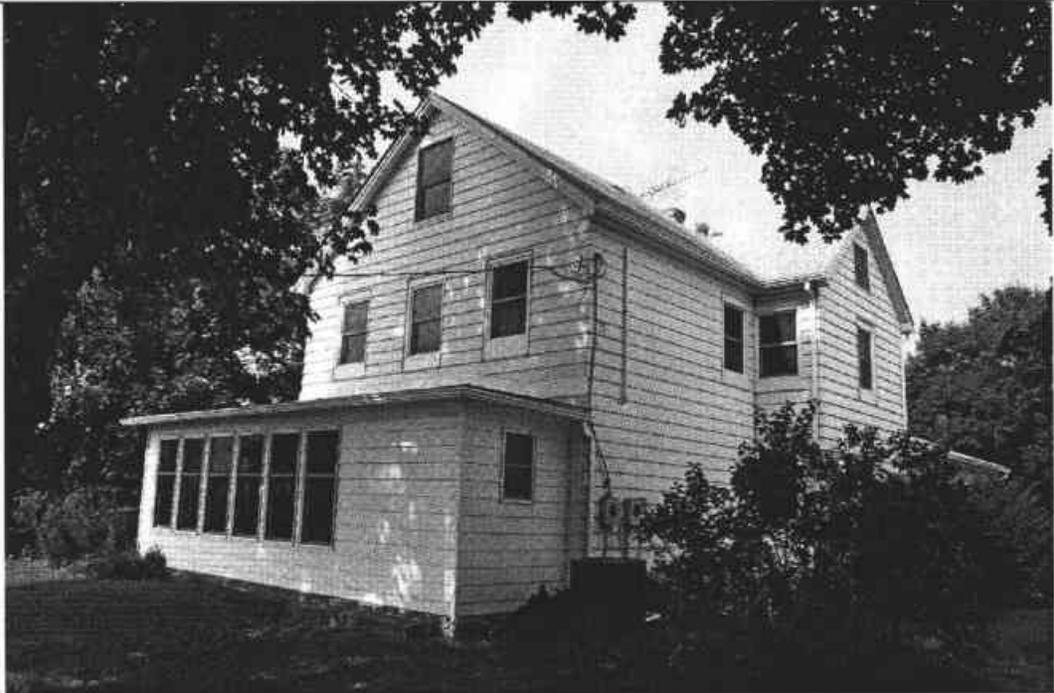
N14380. Photograph 1: Dwelling, east and north elevations, view to southwest. Note the replacement windows with faux lights, original fenestration openings, enclosed porch, and replacement cladding (aluminum).

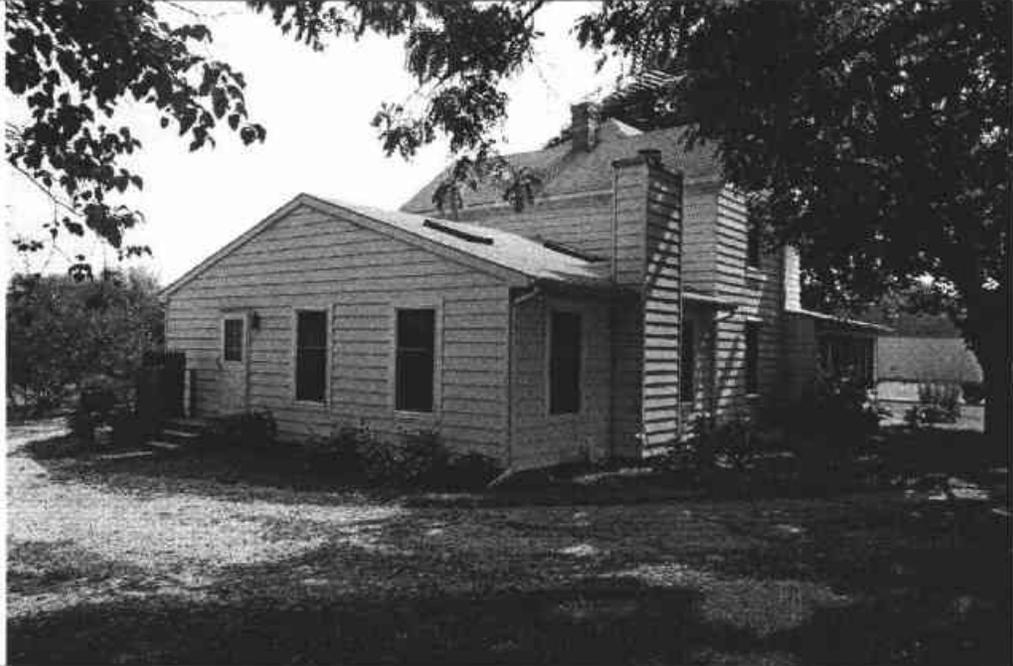
N14380. Photograph 2: Dwelling, west and south elevations, view to northeast. Note the *circa*-1990 addition extending from the core.

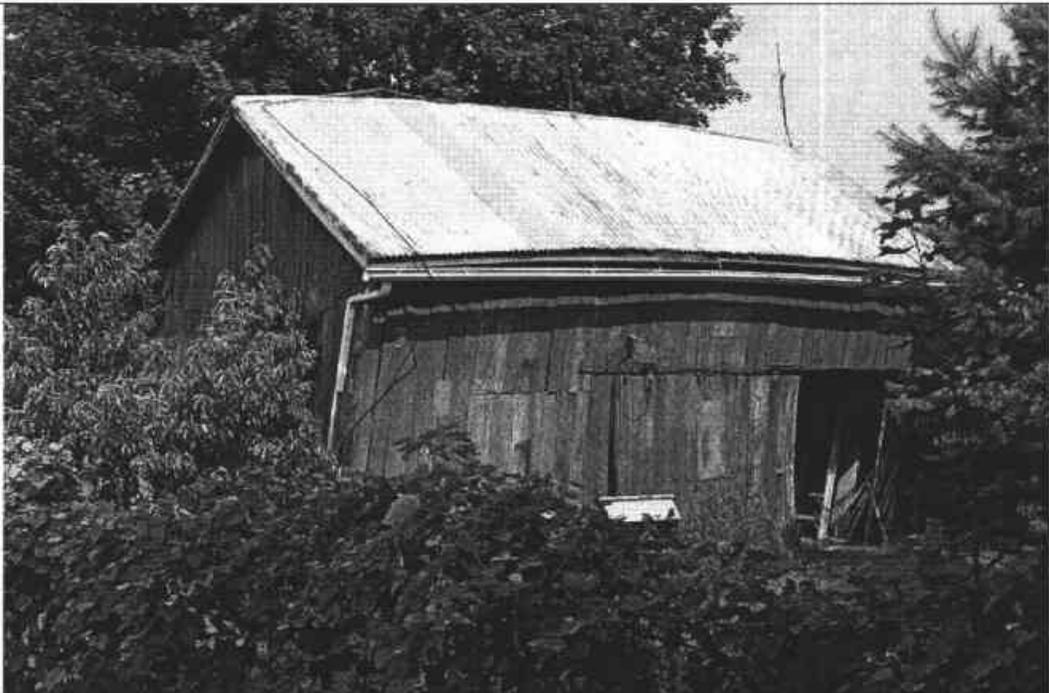
N14380. Photograph 3: Barn, east and south elevations, view to northwest. Note the sliding batten doors and the barn's poor condition. The north and west elevations were not accessible.

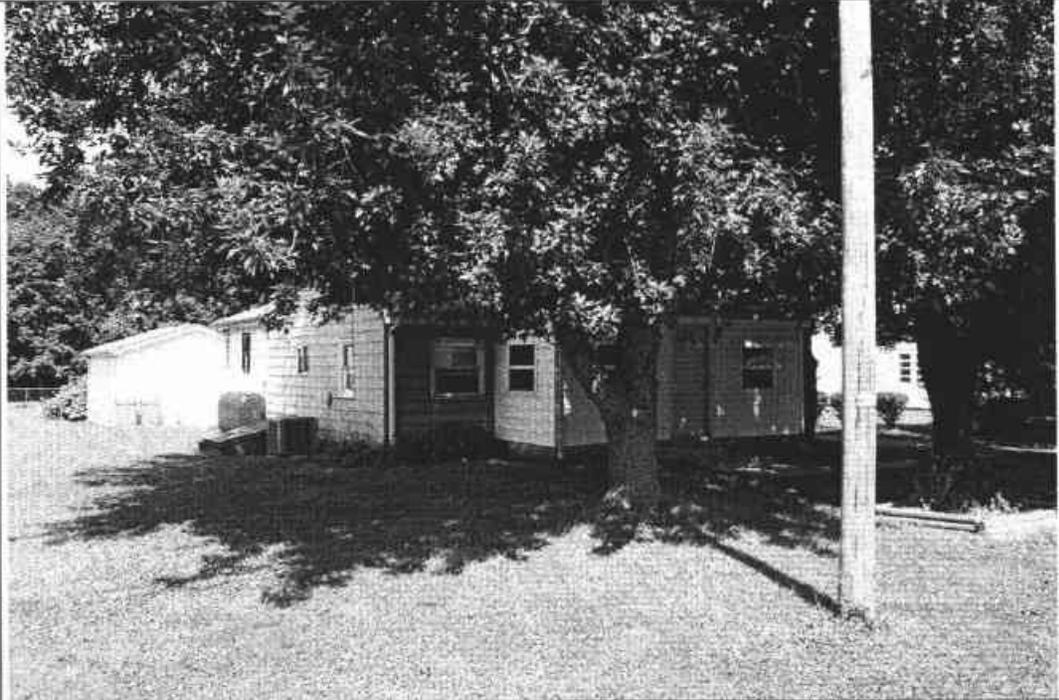
N14381. Photograph 1: Dwelling, south and east elevations, view to northwest. Note the multiple additions, modern cladding, and replacement windows and doors.

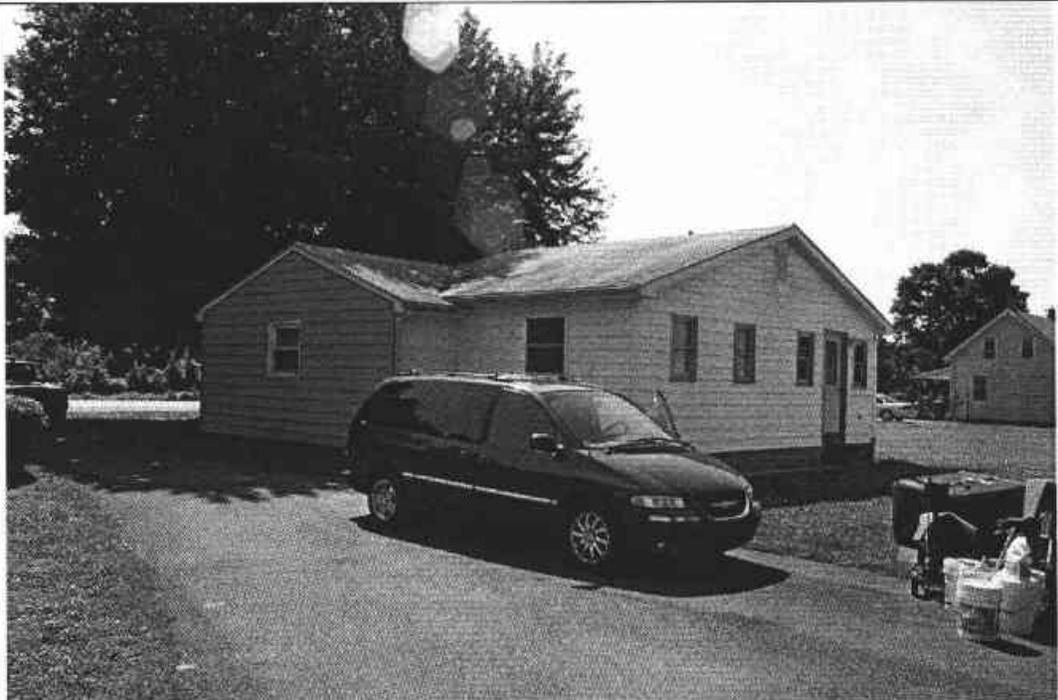
N14381. Photograph 2: Dwelling, north and west elevations, view to southeast. Note the scale of the rear addition as compared to the historic core.

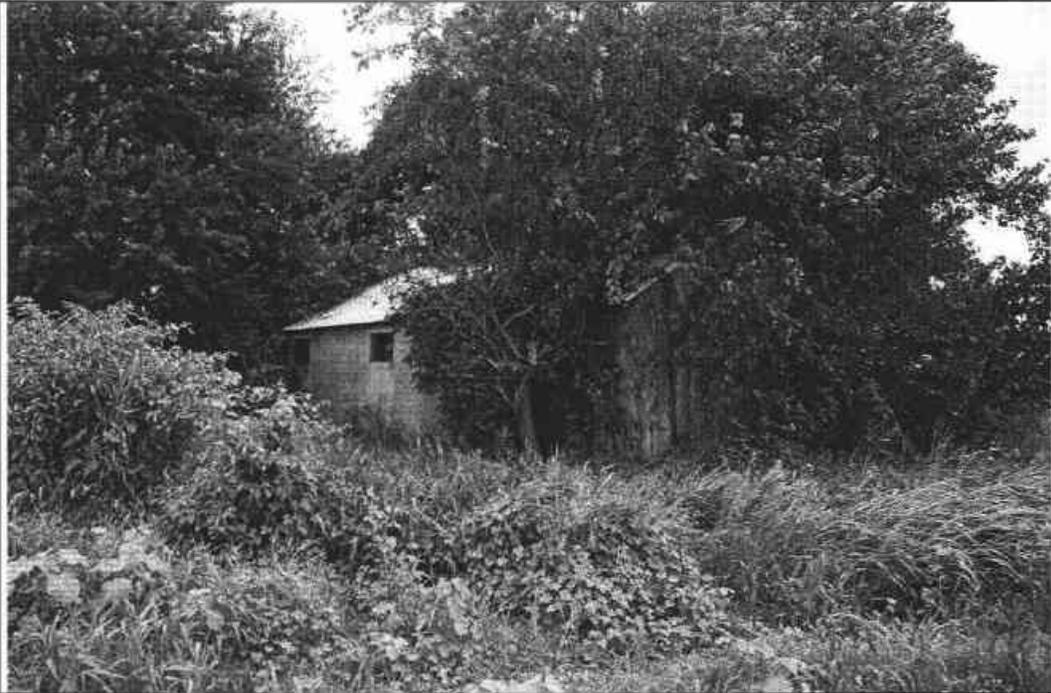
N14382. Photograph 1: Structure, north and west elevations, view looking southeast. This tenant house is located in the middle of a large agricultural field. The dwelling is abandoned and has fallen into disrepair.

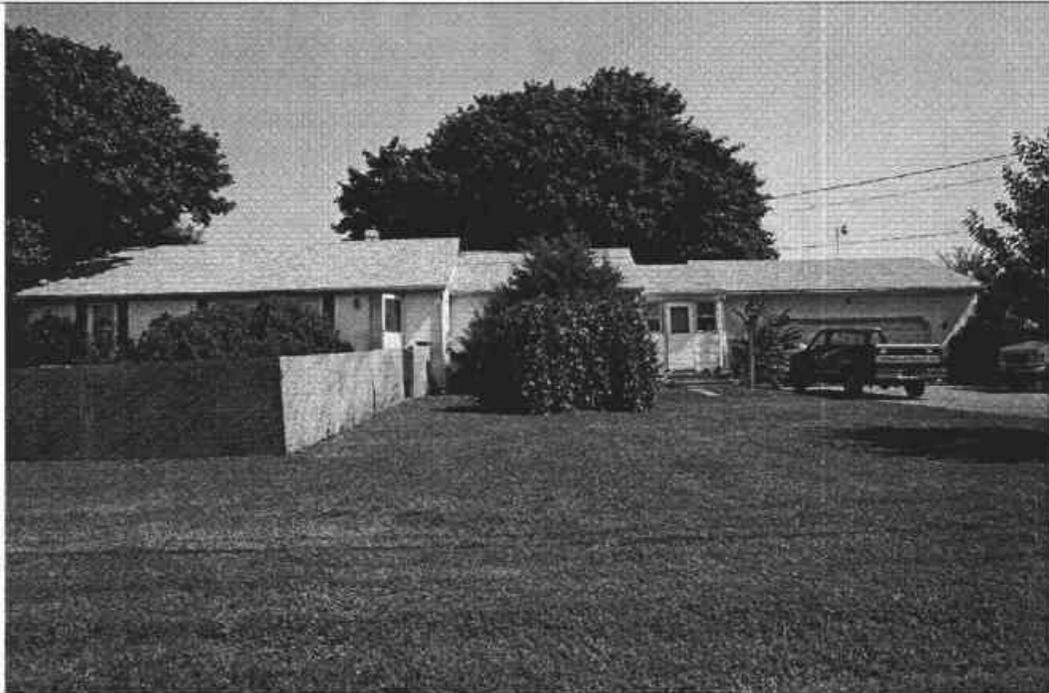
N14384. Photograph 1. Ealy House, view of south elevation (façade), looking north.
