I. PROJECT DESCRIPTION

Parsons conducted a Phase I archaeological investigation for the Right Turn Lane Project, located at the southbound US 13/State Route (SR) 299 junction in historic Odessa, New Castle County, Delaware (Figure 1). DelDOT planned to widen the west southbound lane on US 13 to provide a turn lane onto westbound SR 299, with potential impact to the corner property. The area investigated extended westward from US 13 and northward from SR 299 to the “Existing R/W” (Right of Way, or ROW) on the DelDOT 6/5/2000 plan sheets. At the time of the survey, construction plans included replacing the existing sidewalk and widening the road. While no standing structures presently appear within the project area, construction had the potential to impact historic features. Possible secondary impact included sign and utility relocation, and staging areas for construction within the ROW. Subsequent to the survey, archeological monitoring occurred for removal of the existing sidewalk.

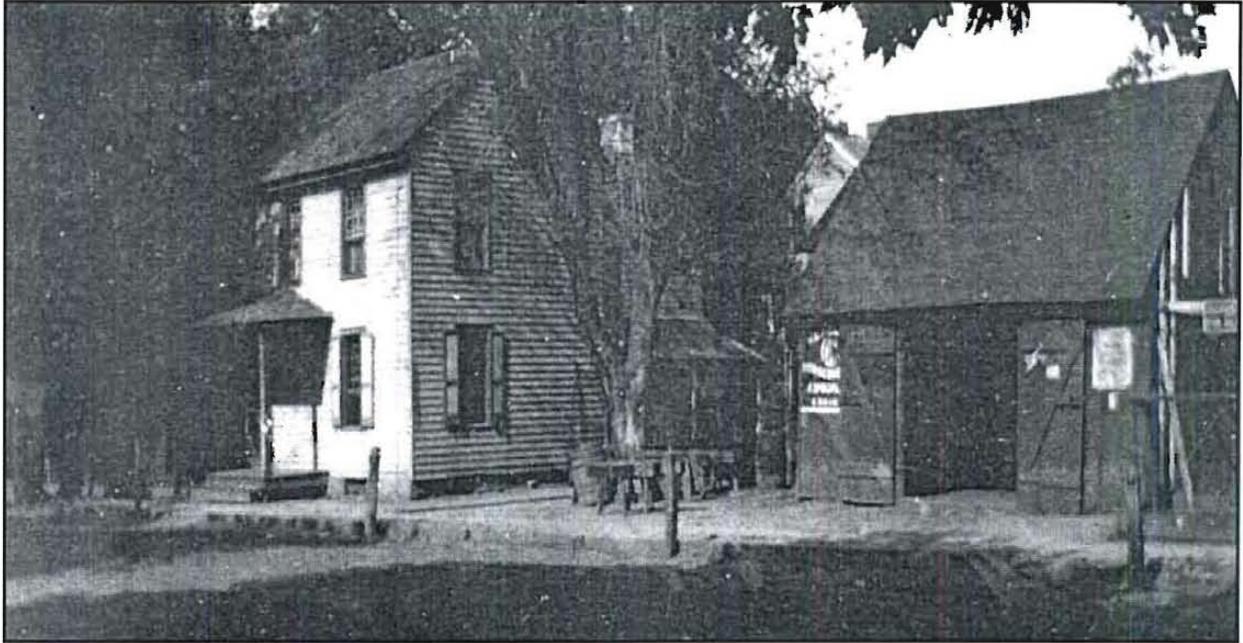
Figure 7: Kielkopf House, Ca. 1908 and Blacksmith Shop, View To The Southwest

The earliest known photographic image of the Kielkopf House complex was from a 1908 postcard, view to the southwest (Figure 7). John Kielkopf constructed both the house and blacksmith shop sometime in the late 1880s or early 1890s, with both structures fronting Sixth Street. The house had a partial cellar, with a small cellar window north of the porch. Horse hitching posts can be seen in the street, with wheel repair anvils around the tree between the house and shop. Note that the street was several feet lower than the elevation of the front porch floor.

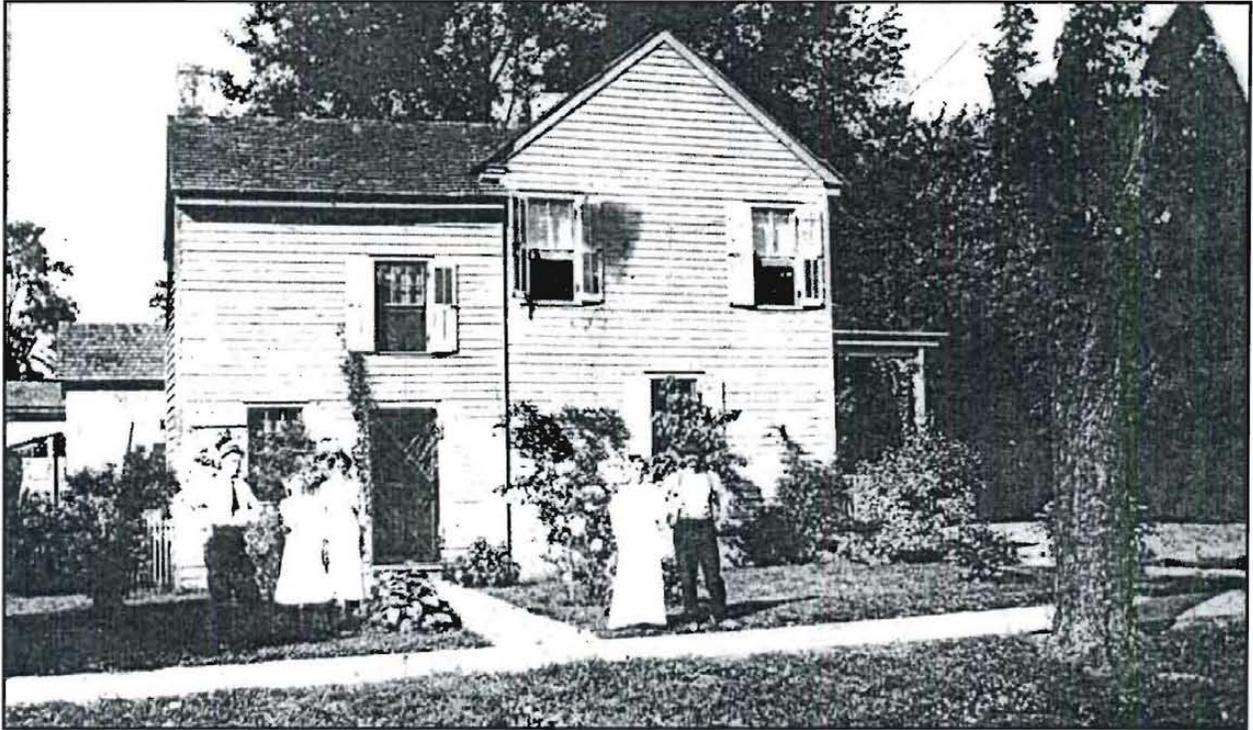
Figure 8: Privy (Far Rear), Shed, and House, Ca. 1910-1915

A photograph taken between 1910-1915 from the south reveals the privy and a shed north of the house, and a concrete sidewalk that were not on the 1908 photograph (Figure 8). A wider porch has been added to the front of the house along Sixth Street and the southern entrance did not yet have a porch. Both “chimneys” for the Kielkopf house were stove vents in the living room and kitchen (personal communication with Fred Kielkopf, September 7, 2000). Note that the tree between the sidewalk and Main Street had just been trimmed and the small branches were only two to three feet long. An electric railroad, or trolley, operated in Odessa from 1903 to 1907 along Main Street, and ran in front of the Kielkopf property (Caley n.d.:22-23; Figures 9 and 10). Powered by a motor on the car, the machine would go to the Odessa wharf, where the conductor had to go to the opposite end and drive it back to Middletown (Caley n.d.:22-23). The trolley company went bankrupt, and the rails were torn up in 1907 (Mandes 1950; Heite 1972:10).

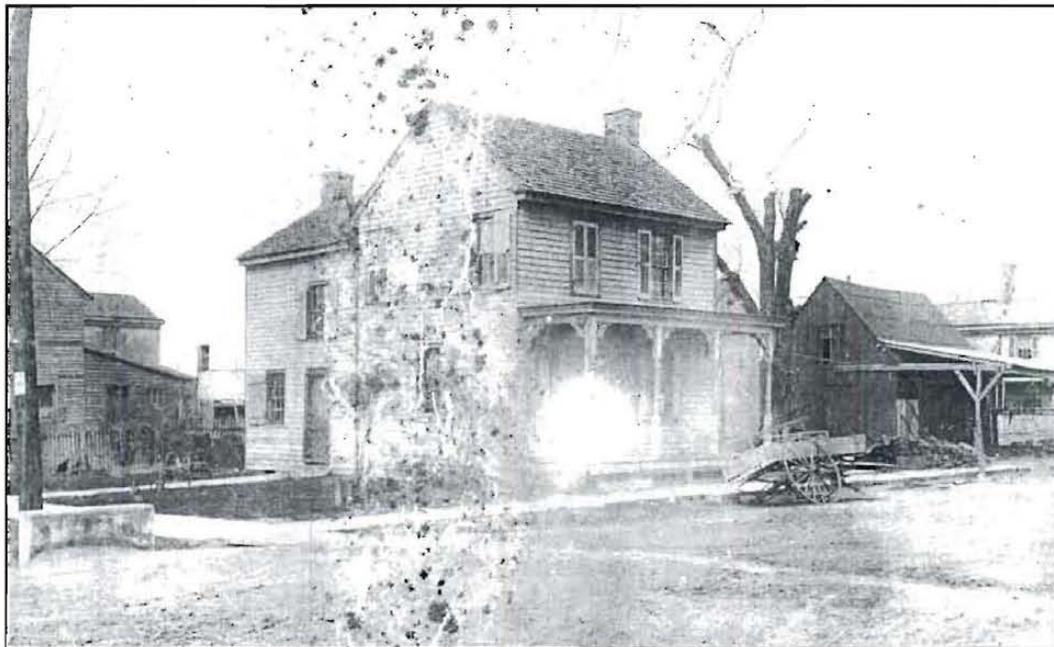
Figure 11: Kielkopf House, ca. 1910-1915, View Northwest

Another photograph shows the houses west and north of the Kielkopf House (Figure 11). The blacksmith shop is the darker structure to the right of the Kielkopf House. The small shed seen in Figure 8 north of the house is barely discernible. A wagon port roof extended from the blacksmith shop to the edge of the sidewalk fronting Sixth Street.

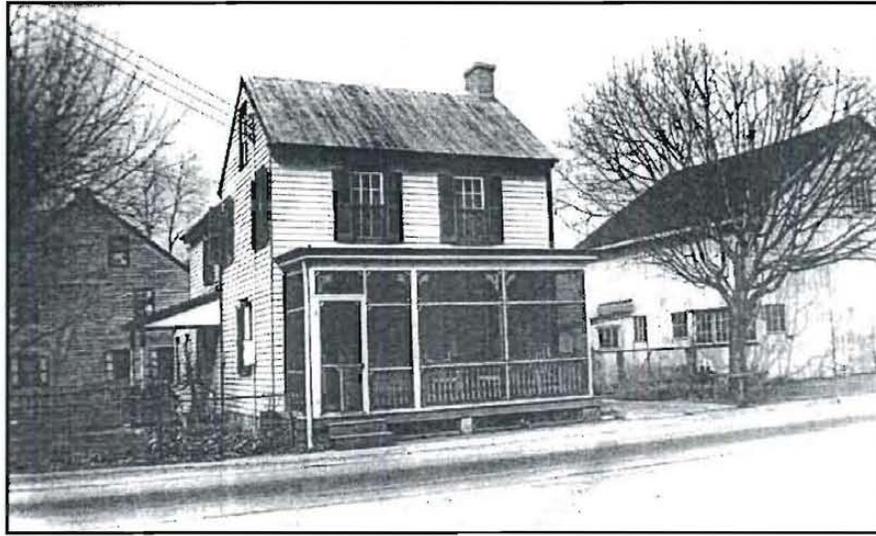
Figure 12: Kielkopf House with Enclosed Porch and Second Blacksmith Shop, ca. 1940, view northwest.

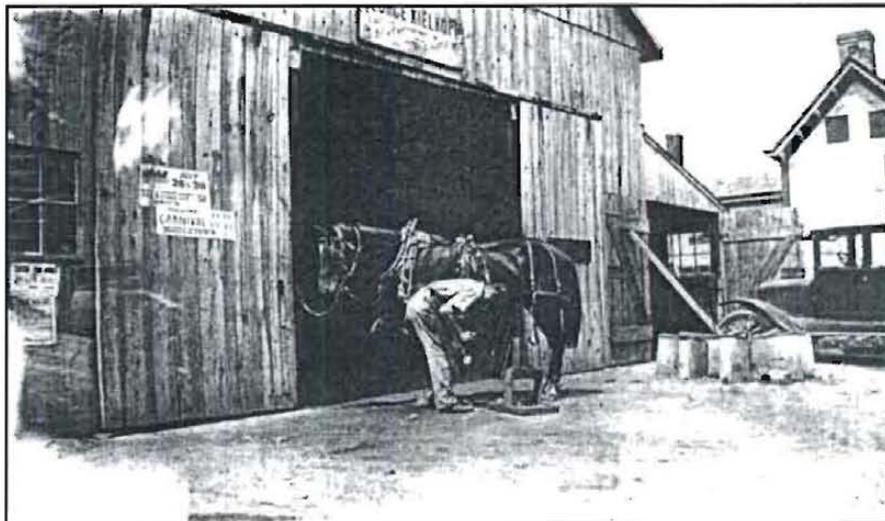
Figure 13: George Kielkopf Shoeing a Horse Ca. 1940, With Dugan/Carty House To The North

John George Kielkopf, son George, and grandson Fred, were blacksmiths. Fred Kielkopf operated a well drilling business in the shop for several years after World War II, and still owns the building containing Lorenzo's Pizza across Route 13 (formerly Sixth street) to the east. During Fred Kielkopf's tenure, the porch on the east side facing Route 13 was enclosed, and a small addition was constructed on the north side of the kitchen/dining room area (Figure 12; personal communication with Fred Kielkopf, September 7, 2000). A new blacksmith shop was constructed over the old shop between WWI and WWII, and the old shop was torn down from inside the new establishment (Figures 13 and 14).

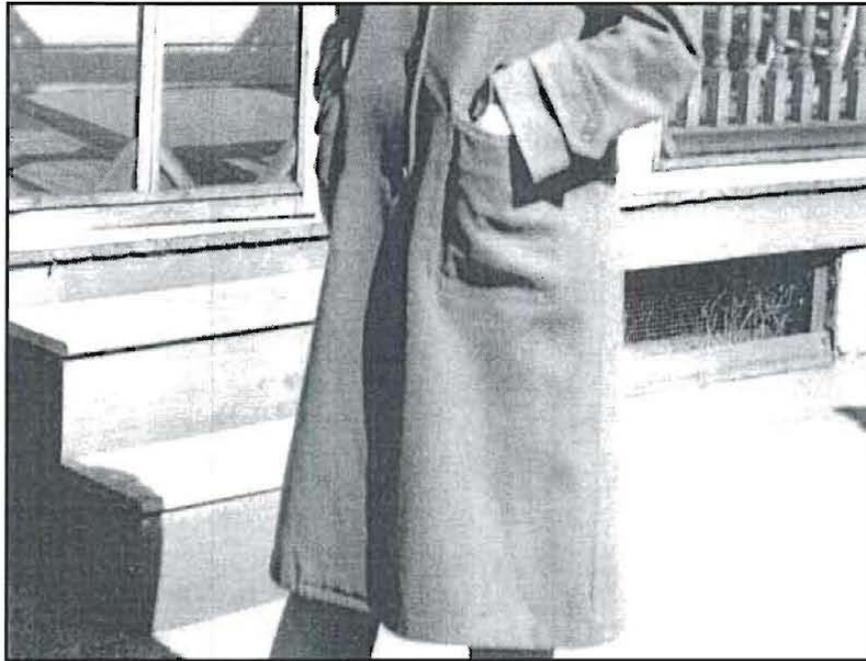
Figure 15: Screen Under Porch Visible Right of the Steps

The crawlspace below the enclosed porch fronting Route 13 was covered with wire mesh hardware cloth (Figure 15). The cement sidewalk visible in Figure 15 may or may not be the same sidewalk observed in Figure 8, but in any case was replaced with a new sidewalk and curb when the Route 13 southbound lanes were constructed after WWI. In 1946, the Delaware Department of Transportation raised Route 13 almost two feet in elevation in front of the Kielkopf residence (Figure 16). A high curb was built directly adjacent to the front board of the porch on the Kielkopf house, bringing the street almost level with the porch. Prior to 1946, the porch had two steps down to the sidewalk and then one step down from the curb to the street level. The wooden front steps were moved to the north side of the house to pour a high curb against the brick footers for the porch and directly against the fascia board of the porch.

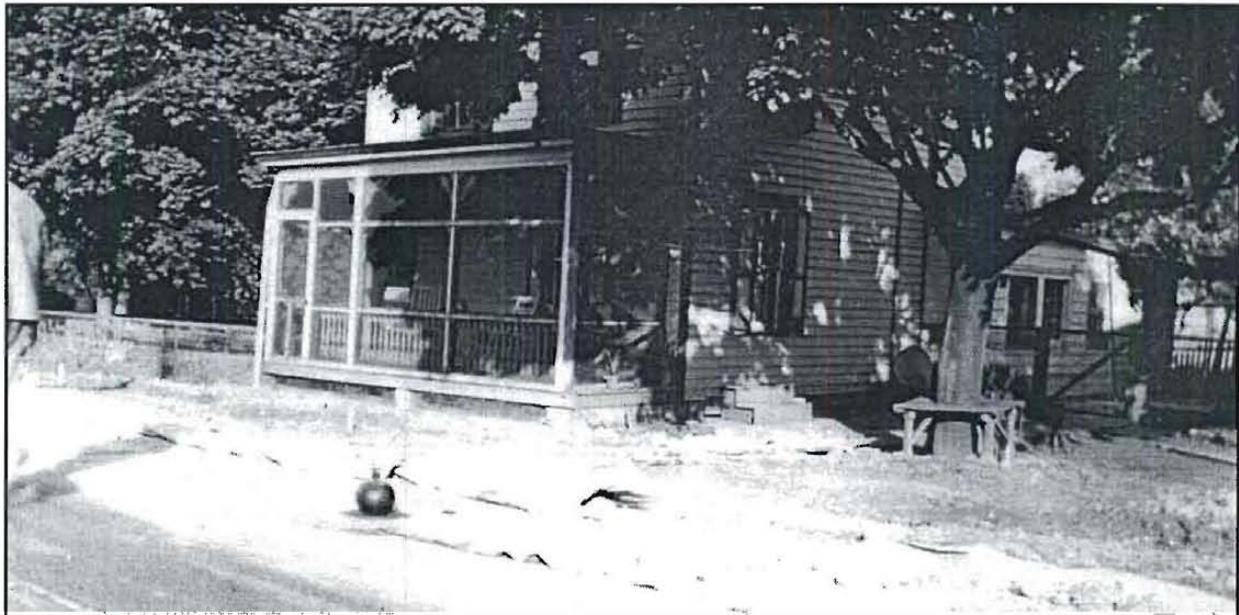
Figure 16: Elevation of Route 13 in 1946 to the Level of the Kielkopf Porch
(Note: the wooden steps have been moved off to the side of the house.)

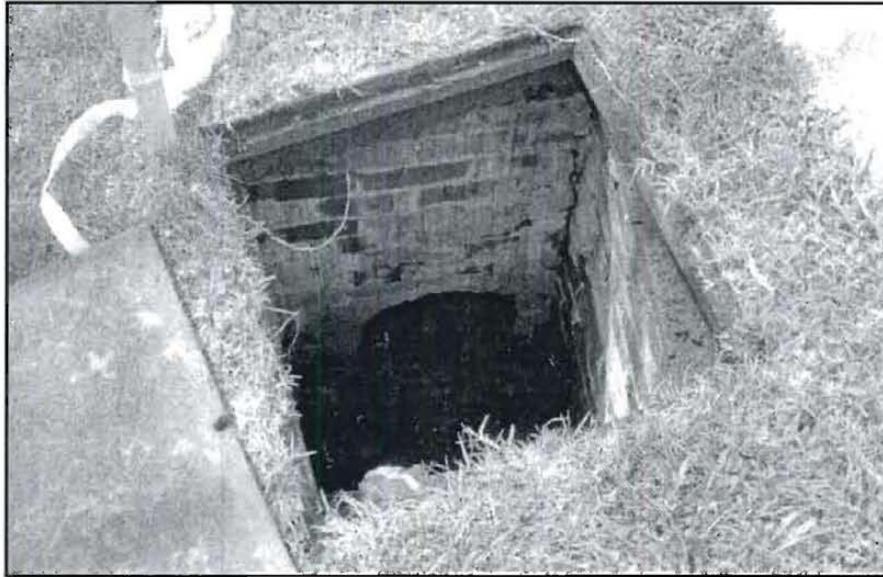
Figure 17: Brick-Lined Storm Drain Under Current Sidewalk, Built in 1946

A brick-lined storm drain was laid under the new sidewalk and currently extends along Routes 13 and 299 adjacent to the Kielkopf property (Figure 17). The drain may have been laid directly on the old sidewalk prior to the raising of the highway. Two additional drains were constructed near the blacksmith shop and the north property boundary.

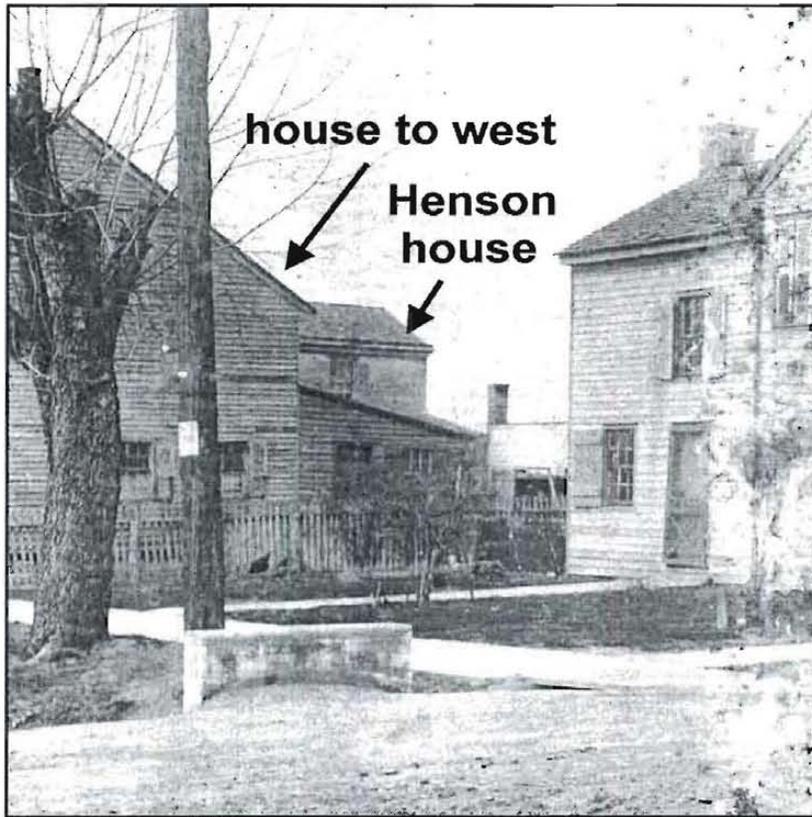
Figure 20: The House West of the Kielkopf House, ca. 1910-1915

The lot west of the Kielkopf property had a large two-story house and a small one-story shed-roofed kitchen addition on the rear. The gable was parallel to Main Street, with the house abutting the sidewalk. The house was present in many of the Kielkopf photographs, and was torn down to put in a one story ranch style house that was later bought by Tidewater Utilities (Figures 20 and 21).

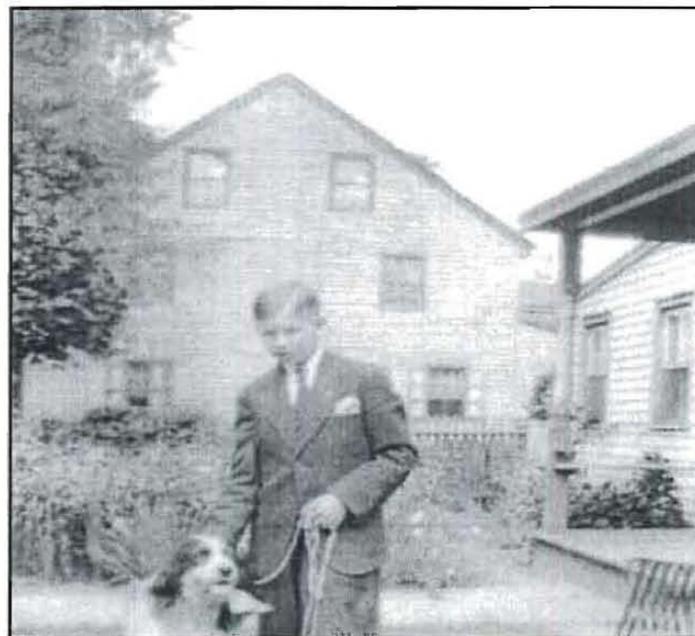
Figure 21: Ca. 1930s Photograph Showing the House West of the Kielkopf House, with a Young Fred Kielkopf

The Henson house adjacent to Corbit Alley (now Park Alley) was probably built in the early 1880s (see Figure 21). The Henson structure was a two-story I-house situated perpendicular to Main Street and set back a few feet from the sidewalk, but was apparently not the L-shaped structure illustrated on the 1868 Beers Atlas map (see Figure 4). The NRHP nomination form stated that the house was a 2-bay, late 19th century frame dwelling with later shed roof addition, extensively altered, and labeled as a non-contributing element to the historic district because of modifications (NRHP 1981:12; Figure 22). One- and two-story shed-roofed additions were added to the east side of the structure. Tidewater Utilities bought the lot in the 1980a and razed the house to construct a parking lot.
