CRS No. K-7623

Address: 239 Bowers Beach Road

Name: Dwelling, 239 Bowers Beach Road

CULTURAL RESOURCE SURVEY
PROPERTY IDENTIFICATION FORM

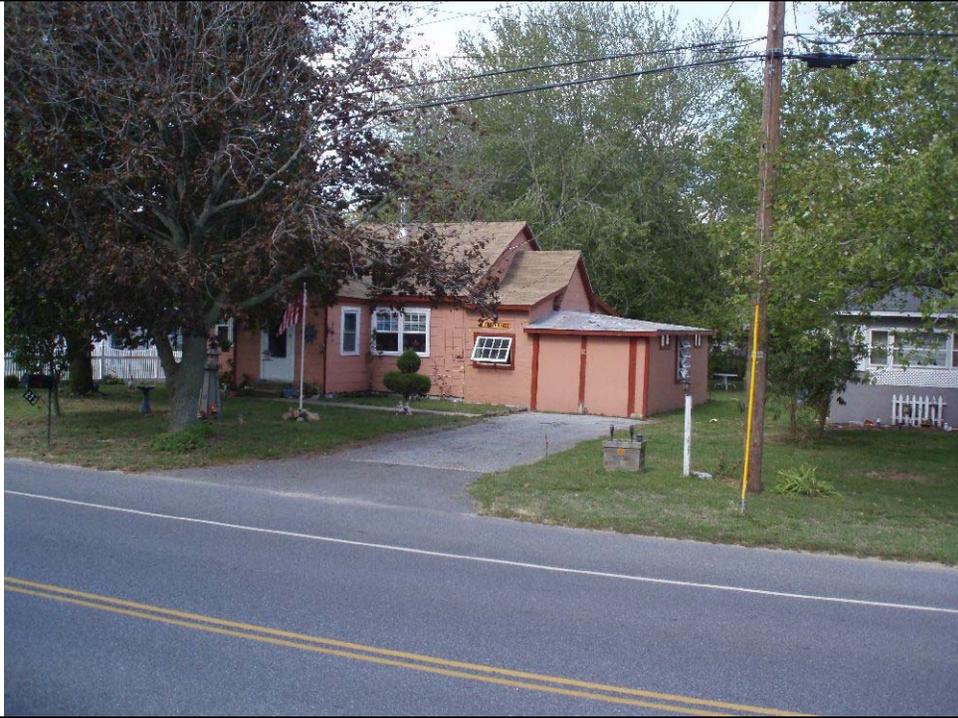
K-7623. Photograph 1: Overview of 239 Bowers Beach Road, looking northwest. Note the garage addition, which was constructed ca. 1960.

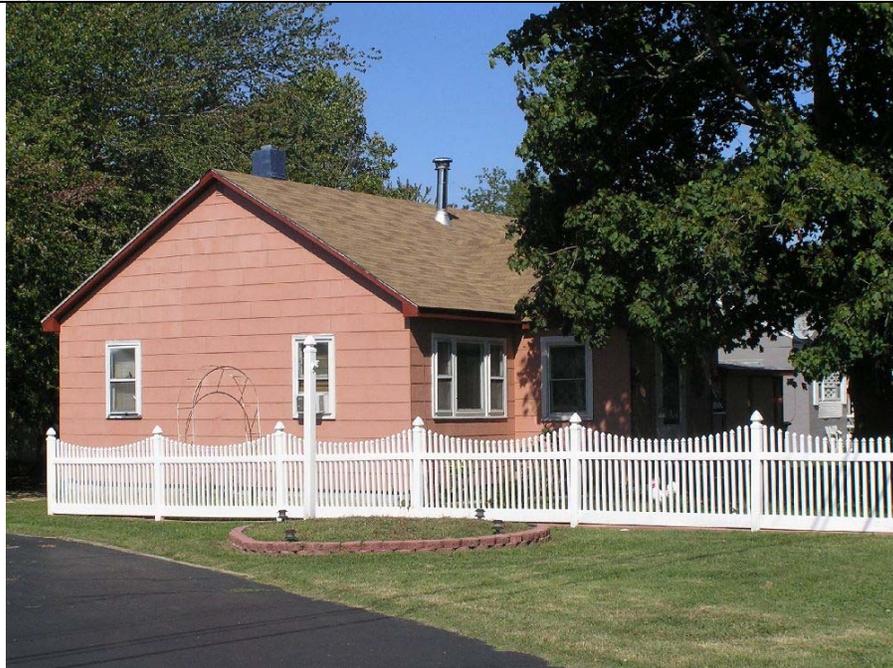
K-7623. Photograph 2: Dwelling, west and south elevations, view looking northeast. This side-gable dwelling is similar in form to the dwelling at 299 Bowers Beach Road and is clad in asbestos shingle siding.

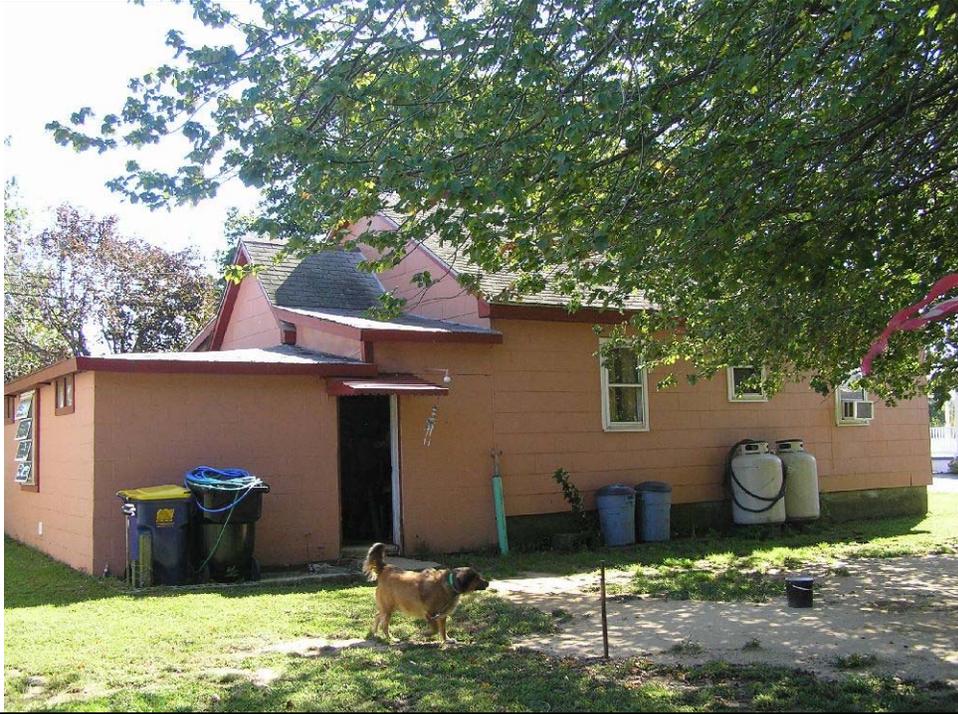
K-7623. Photograph 3: Dwelling, east and north elevations, looking south. Note the garage addition as well as the shed-roof addition to the hyphen.
