CRS No. K-7625

Name: Dwelling, 171 Bowers Beach Road

CULTURAL RESOURCE SURVEY
PROPERTY IDENTIFICATION FORM

1. HISTORIC NAME/FUNCTION: Dwelling, 171 Bowers Beach Road
2. ADDRESS/LOCATION: 171 Bowers Beach Road
3. TOWN/NEAREST TOWN: Little Heaven vicinity?
4. MAIN TYPE OF RESOURCE: building structure site object
landscape district
5. MAIN FUNCTION OF PROPERTY: Residential
6. PROJECT TITLE/ REASON FOR SURVEY (if applicable):
SR1, Little Heaven Grade Separated Intersection Improvements

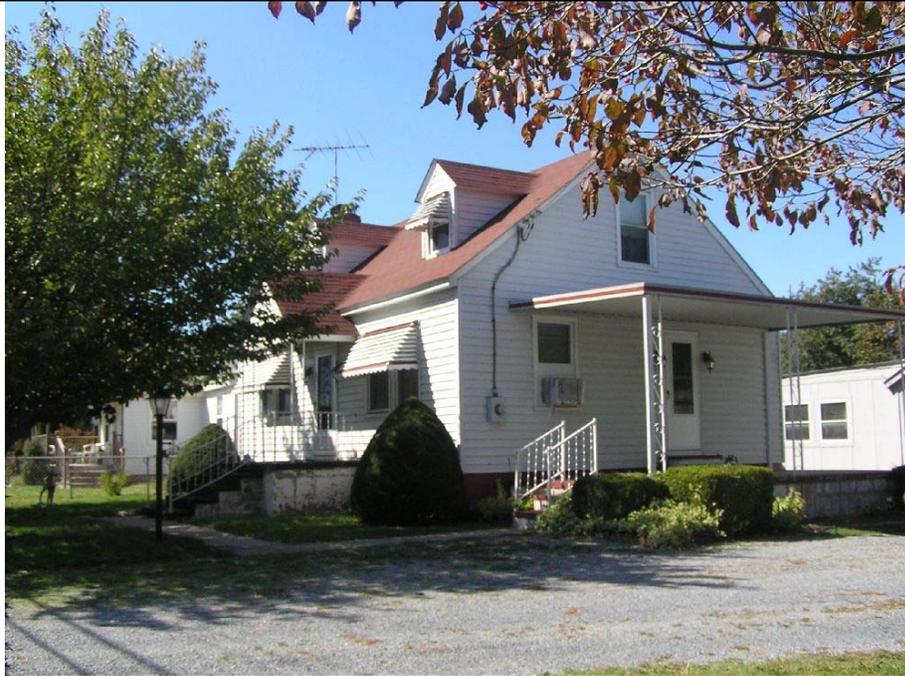
K-7625. Photograph 1: Dwelling, south and east elevations, view looking northwest. This dwelling was constructed by the current property owner's father in 1951.

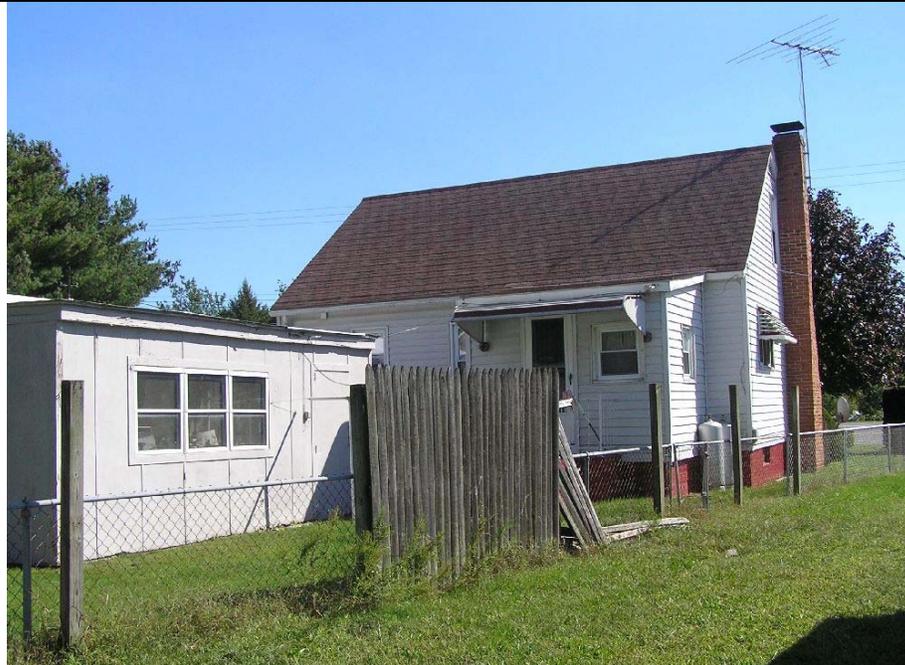
K-7625. Photograph 2: Workshop/garage, west elevation, and dwelling, north and west elevations, view looking southeast.

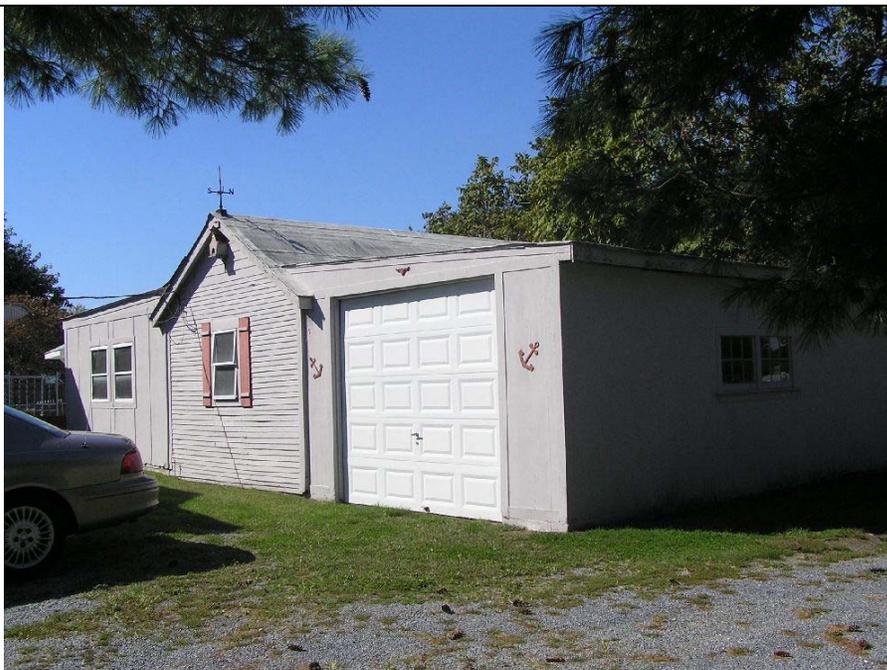
K-7625. Photograph 3: Workshop/garage, south and east elevations, looking northwest. The center front-gable section appears to be the oldest portion of the garage.

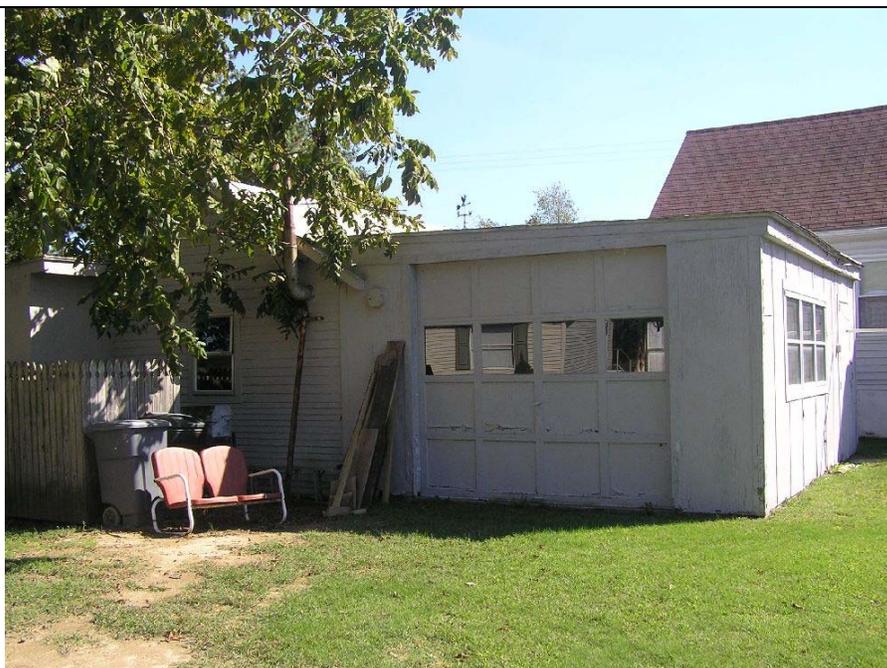
K-7625. Photograph 4: Workshop/garage, north and west elevations, view looking southeast.

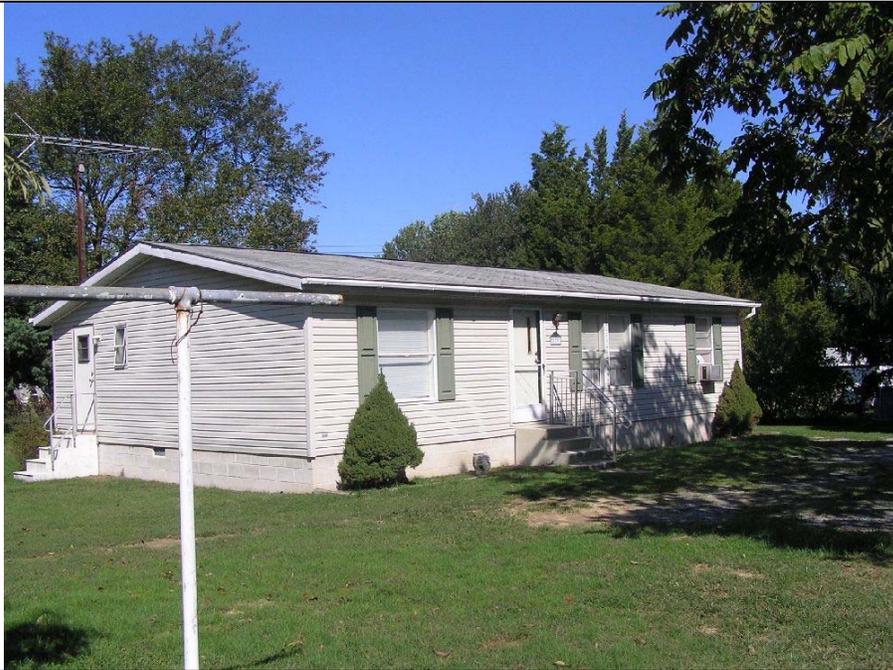
K-7625. Photograph 5: Modern dwelling, west and south elevations, looking northeast. This dwelling was placed on the property ca. 1990.

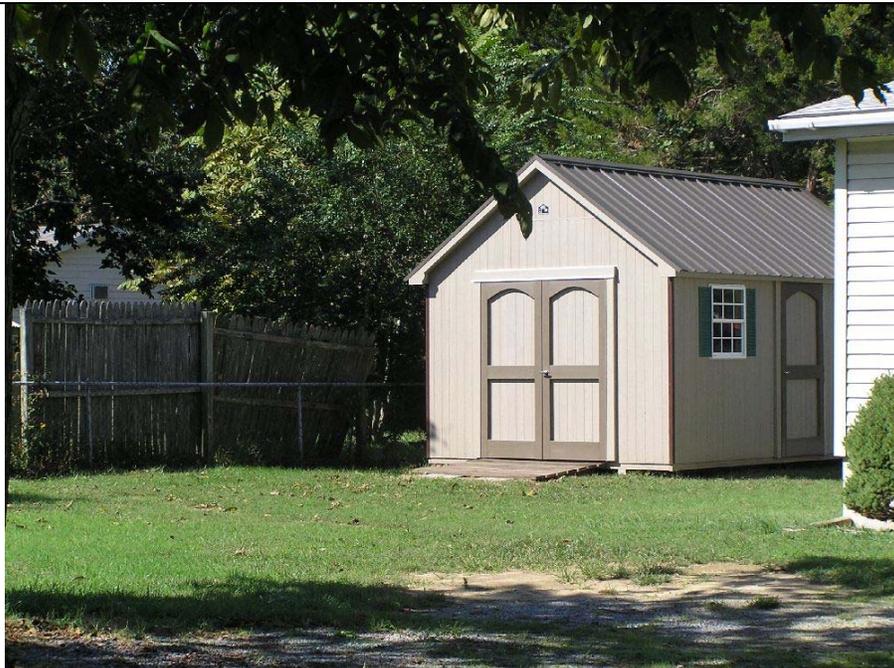
K-7625. Photograph 6: Modern shed, south and east elevations, looking northwest. This prefabricated shed is located to the west of the modern dwelling.
