## 5. HISTORY OF ROCKLAND

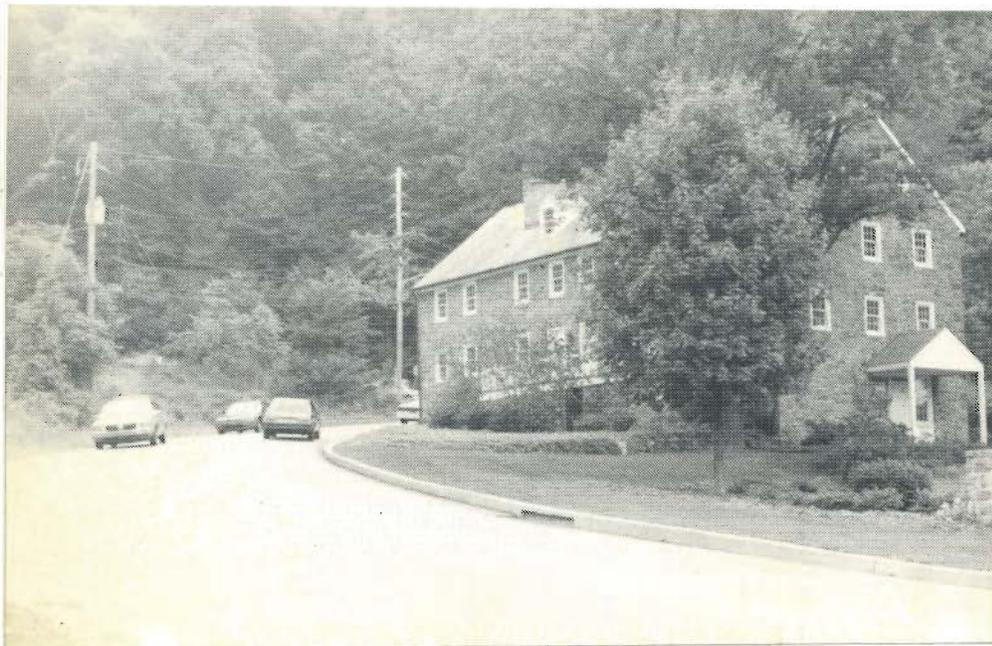
**Plate 2**  
Rockland  
project  
area

At right is a surviving mill worker house, similar to the one investigated, looking eastward from a point opposite the entrance to the former mill building. The road in foreground is the road over Rockland bridge, the extension of which would have passed in front of the houses.

Mr. Owens pointed out locations of the store, the two worker housing blocks, and other features of the former village. He said that the destroyed rows resembled the one surviving stone row (PLATE 2, BELOW) that aligns with their foundations (PLATE 3).
