Chapter 4

PHASE IA ARCHAEOLOGICAL SENSITIVITY ASSESSMENT

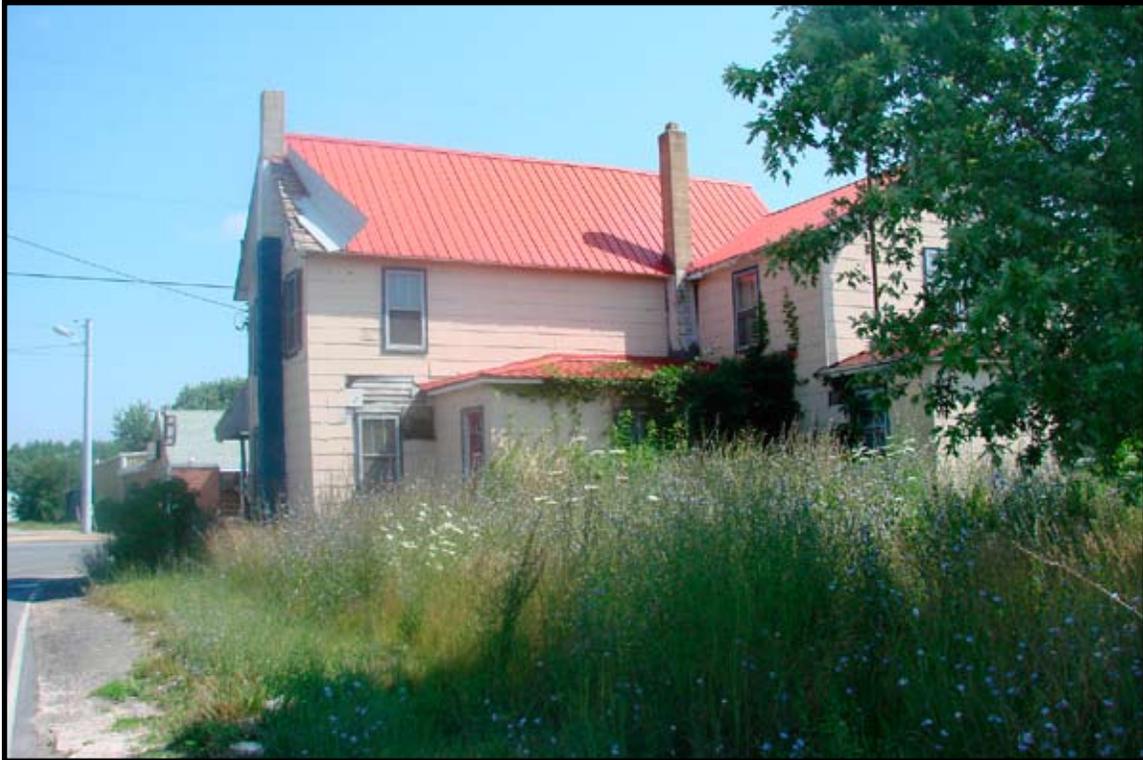
Plate 4.1. The setting of the Pearson House [CRS # K-6920] on the southeast side of the intersection of Pearson's Corner Road and Forrest Avenue. Note the existing disturbance along the east side of Pearson's Corner Road where a turning lane is proposed. View facing north. (Photographer: William Liebeknecht, July 2008) [HRI Neg. # 08021/D1:4005].

Direct impacts at this location comprise widening of the intersection to provide turning lanes and improved visibility. While these have the potential to affect archaeological resources associated with properties at the historic “corner”, inspection showed considerable pre-existing disturbance along the narrow strips to be

directly impacted and there was concluded to be no potential for adverse effects here. Although the intersection is located on well-drained soils, the absence of nearby water sources and a lack of distinguishing topography suggest a low probability for prehistoric resources.

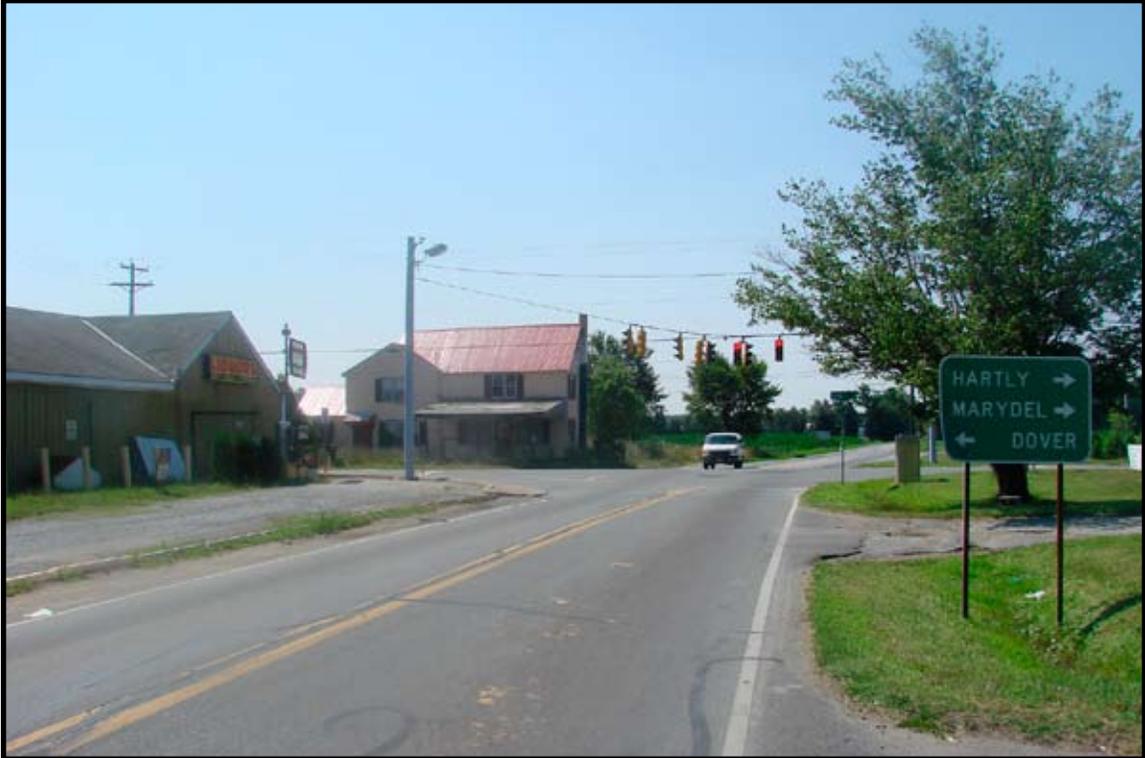
Plate 4.2. View facing south along Pearson’s Corner Road towards the intersection with Forrest Avenue. Pearson House [CRS # K-6920] in center of view. (Photographer: William Liebeknecht, July 2008) [HRI Neg. # 08021/D1:4039].

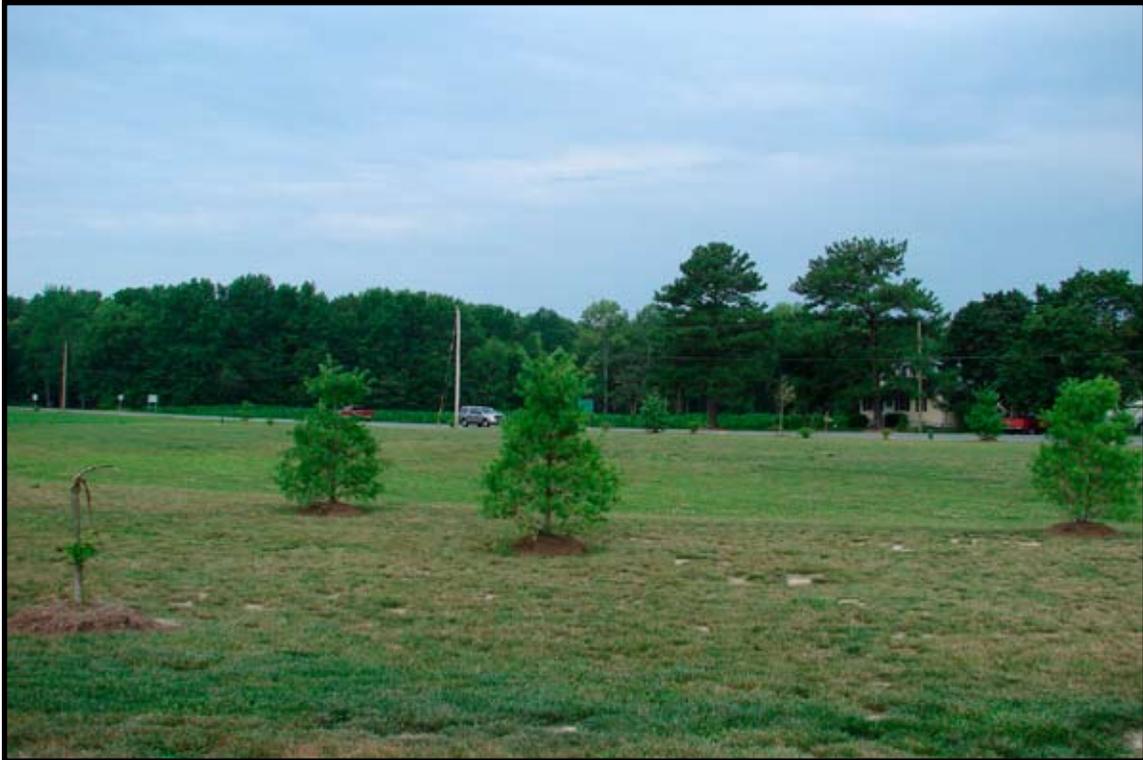
Plate 4.3. View facing west from the Royal Farms property towards Halltown Road. Red truck at left center is at approximate location of proposed circle. (Photographer: William Liebeknecht, July 2008) [HRI Neg. # 08021/D1:4166].

The new roundabout or new signal options call for a new road running east towards the Royal Farms facilities. This alignment runs across an almost level grass field lying on poorly drained soils. No features were noted and the sensitivity for both historic and prehistoric resources is considered to be low.

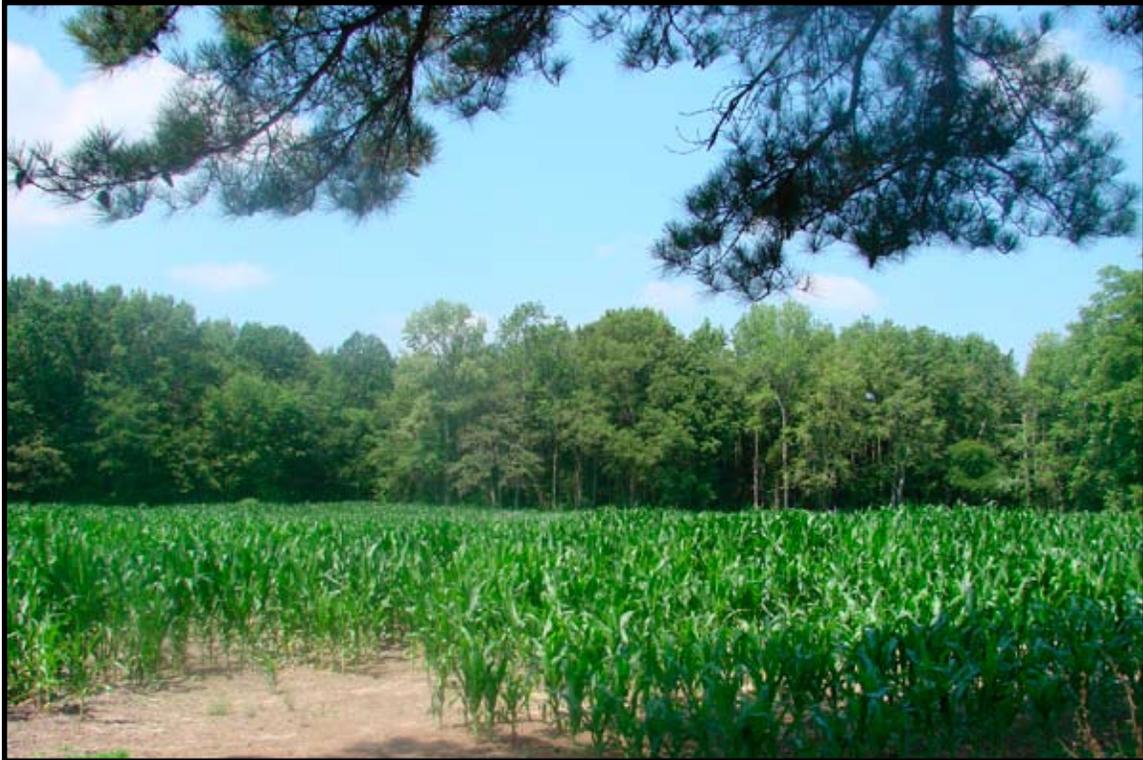
Plate 4.4. View facing northwest across open field portion of Delaware Route 44 realignment option. Soils here are poorly drained Fallsington Sandy Loams and Woodstown Loams (Photographer: William Liebeknecht, July 2008) [HRI Neg. # 08021/D1:4146].

The route of the proposed new alignment runs across cultivated fields in the south and woodland to the north, some distance west of the pre-1922 alignment of Hartly Road prior to the changes made under Contract CK-9 of that year. As noted above, the location of the apparently short-lived Crouch structure (shown only on the 1859 map) evidently lies to the east of the proposed new alignment. No indications of the site of a structure were identified on the portion of the alignment adjacent to this property. No other features or artifacts were identified on the proposed alignment, which runs on poorly drained soils between Hartly Road and Halltown Road.

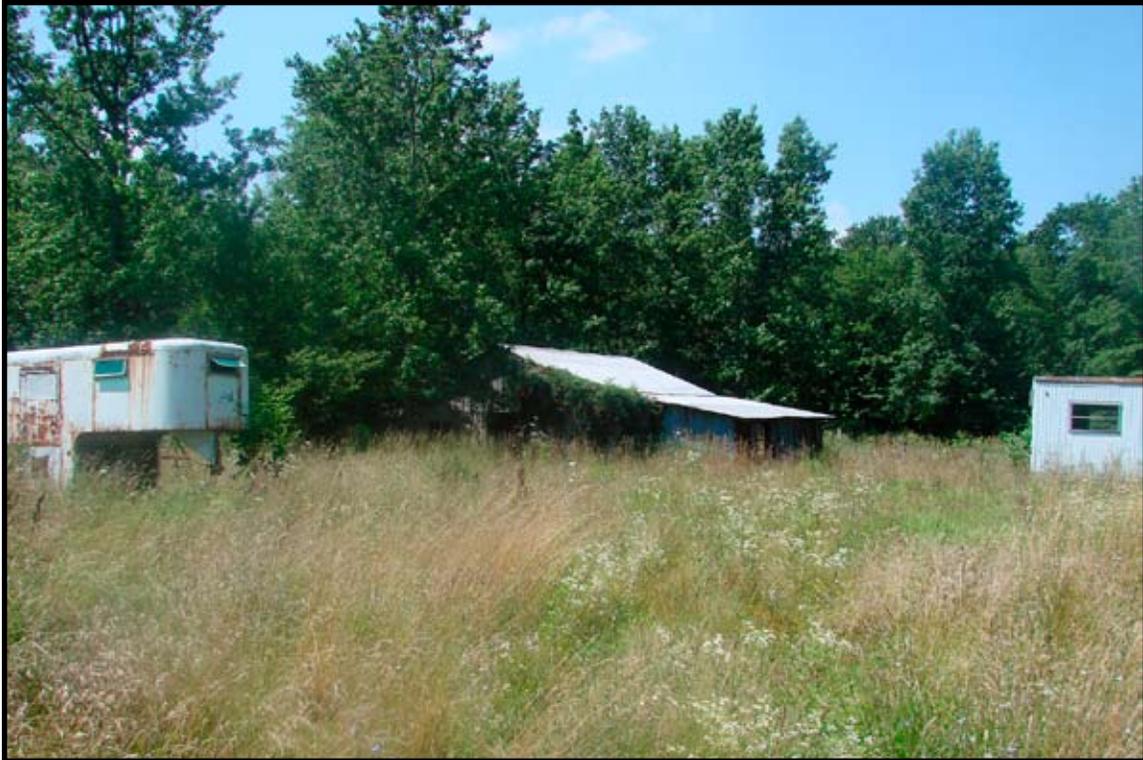
Plate 4.5. View facing south-southwest from Hartly Road across meadow towards woodland edge. Soils are poorly drained Fallsington Loams. (Photographer: William Liebeknecht, July 2008) [HRI Neg. # 08021/D1:4120].
