**S.R. 26 ALTERNATIVE ROUTE
STORM WATER MANAGEMENT AREAS 1-7, BALTIMORE HUNDRED
SUSSEX COUNTY, DELAWARE**

**PHASE I ARCHAEOLOGY
ARCHAEOLOGICAL SURVEY REPORT FORM**

**THE STATE OF DELAWARE
DEPARTMENT OF TRANSPORTATION**

MAY 2009

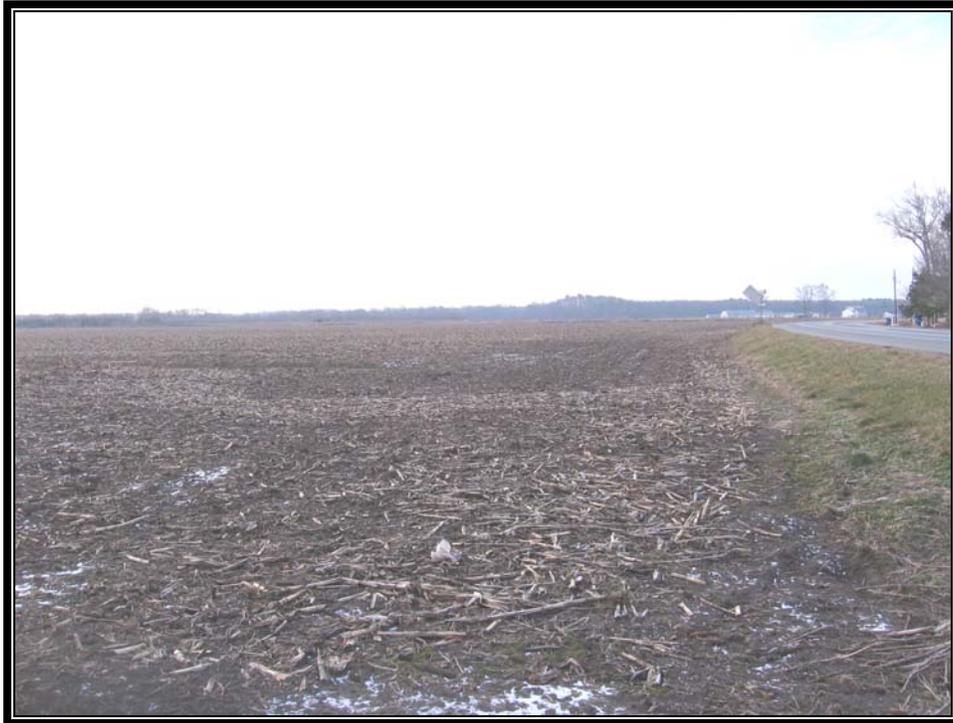
Photograph 1. Test Area 1 taken at the intersection of Burbage and Roxanne roads, facing south.

- 15. Fieldwork (describe survey; add maps as needed):** Seven test areas (Test Areas 1-7) which correspond to seven proposed storm water management areas comprise the APE. Test Area 1 is 0.38 ha or 0.95 ac in size and is located east of Roxanna Road, approximately 115.0 m (377.3 ft) south/southwest of the intersection of Roxanna and Burbage roads (See Figure 2, Sheet 1). Test Area 1 is located entirely within an actively plowed agricultural field across a gently undulating landform. Ten STPs were excavated in Test Area 1 and were labeled 1-1 through 1-10. The soil profiles for the Test Area 1 STPs were comprised of a black (10YR 2/1) Ap horizon silt loam with an average thickness of 42.0 cm (16.5 in) overlying a light brownish gray (10YR 6/2) Bw horizon clay loam. No artifacts or other cultural materials were recovered from the excavated Test Area 1 STPs and no cultural features were identified.

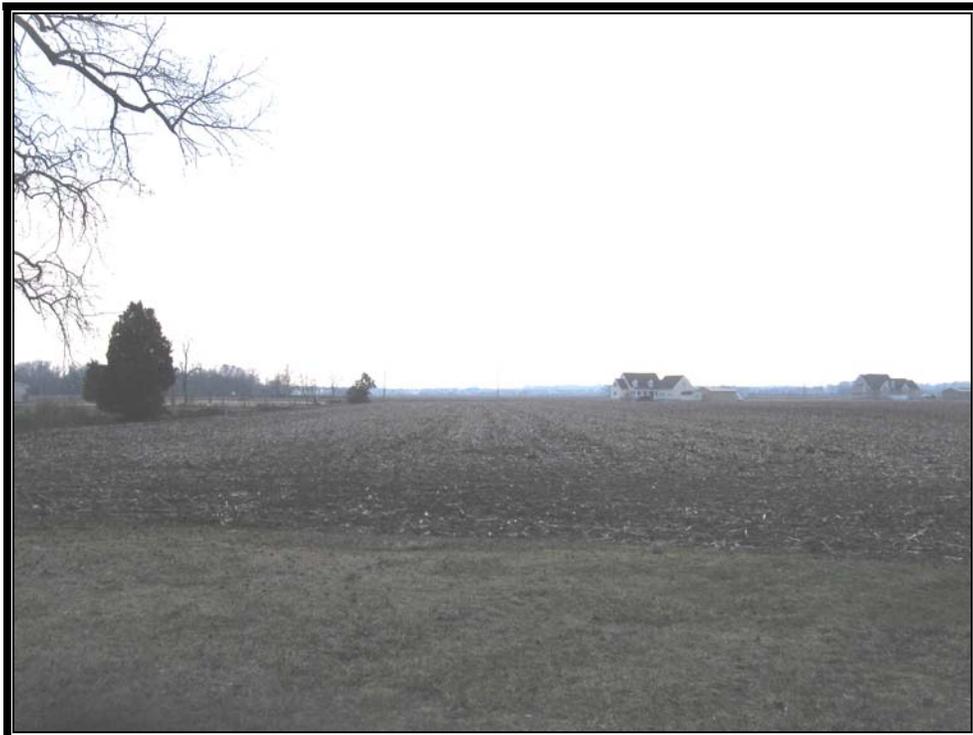
Photograph 2. Test Area 2, general overview, facing east.

Test Area 2 is 0.68 ha or 1.69 ac in size and is located in the southeast quadrant of the intersection of Roxanna and Burbage roads (see Figure 2, Sheet 1). Portions of Test Area 2 are located in an actively plowed agricultural field and a graded area of landscaped lawn associated with a nearby residence. Twenty-nine STPs were excavated in Test Area 2 and were labeled 2-1 through 2-29. The soil profiles for the Test Area 2 STPs were comprised of a black (10YR 2/1) Ap horizon silt loam overlying a light brownish gray (10YR 6/2) Bw horizon clay loam. The average thickness of the Ap horizon was greater in the excavated STPs that were located in the agricultural field than those located in the landscaped lawn. Two pieces of broken brown beer bottle glass and a rusted nail (modern/machine cut) fragment were noted in the uppermost level of STP 2-12. These materials are recent and most likely represent litter that has been incorporated into the plow zone. No other artifacts or cultural materials were recovered from the excavated Test Area 2 STPs and no cultural features were identified.

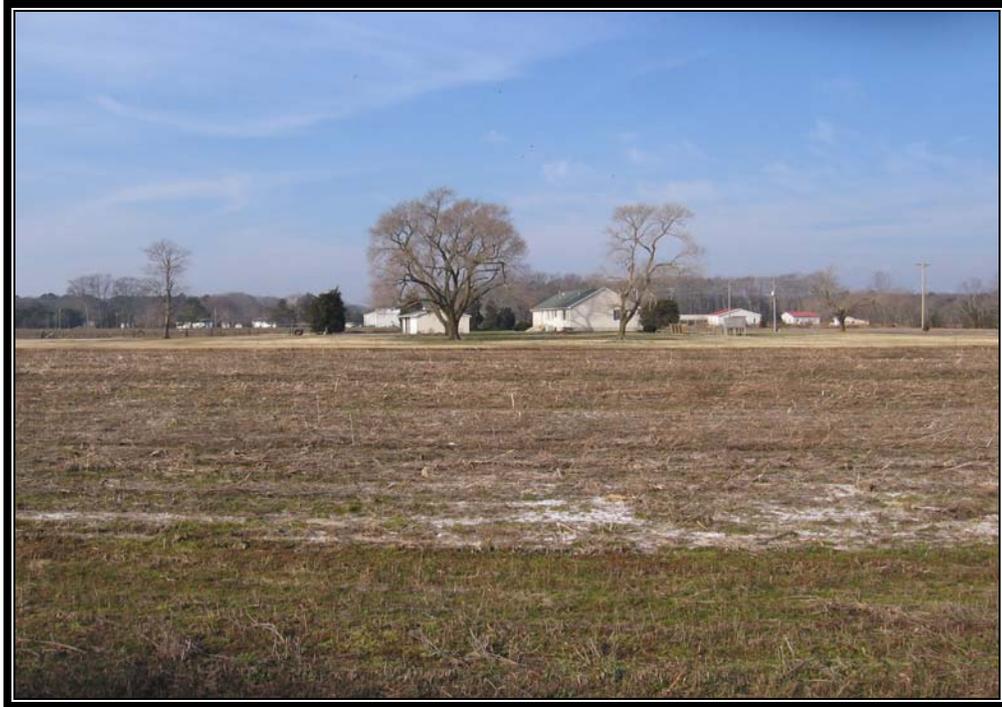
Photograph 3. Test Area 3, taken from Substation Road, facing west.

Test Area 3 is 0.34 ha or 0.86 ac in size and is located south of Burbage Road, east of Test Area 2, and south of Test Area 4 (see Figure 2, Sheet 1). Test Area 3 is located entirely within an actively plowed agricultural field and is adjacent to a drainage ditch which separates the agricultural field from a residential property. Twelve STPs were excavated in Test Area 3 and were labeled 3-1 through 3-12. The soil profiles for the Test Area 3 STPs were comprised of a black (10YR 2/1) Ap horizon silt loam with an average thickness of 50.0 cm (19.7 in) overlying a light brownish gray (10YR 6/2) Bw horizon clay loam. No artifacts or other cultural materials were recovered from the excavated Test Area 3 STPs and no cultural features were identified.

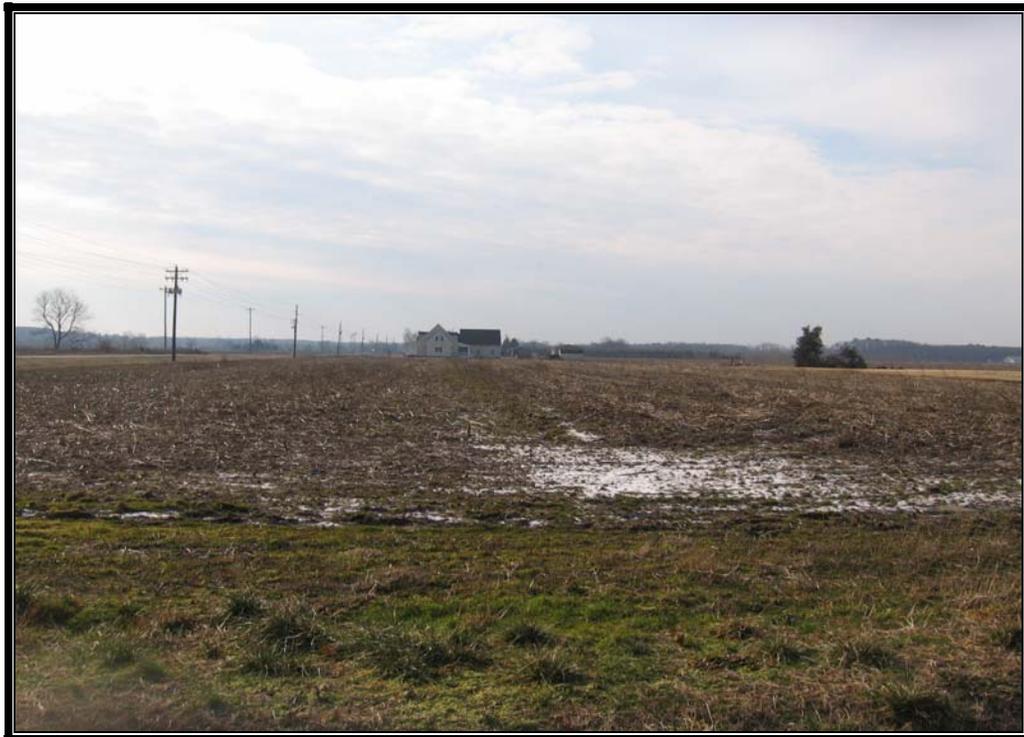
Photograph 4. Test Area 4, taken from Burbage Road, facing south.

Test Area 4 is 0.43 ha or 1.07 ac in size and is located north of Test Area 3 in the southwest quadrant of the intersection of Burbage and Substation roads (see Figure 2, Sheet 1). Test Area 4 is located entirely within an actively plowed agricultural field and is adjacent to a drainage ditch that separates the agricultural field from a residential property. Thirteen STPs were excavated in Test Area 4 and were labeled 4-1 through 4-13. The soil profiles for the Test Area 3 STPs were comprised of a black (10YR 2/1) Ap horizon silt loam with an average thickness of 39.0 cm (13.0 in) overlying a light brownish gray (10YR 6/2) Bw horizon clay loam. Partial gleying of the Bw horizon was present in the STPs

located in swales. The STPs located in the swales also exhibited thicker Ap horizons denoting leveling of the surface through erosive forces. One piece of broken brown beer bottle glass and a piece of unidentified metal were noted in the uppermost level of STP 4-4. These materials are recent and most likely represent litter that has been incorporated into the plowzone. No other artifacts or cultural materials were recovered from the excavated Test Area 3 STPs and no cultural features were identified.

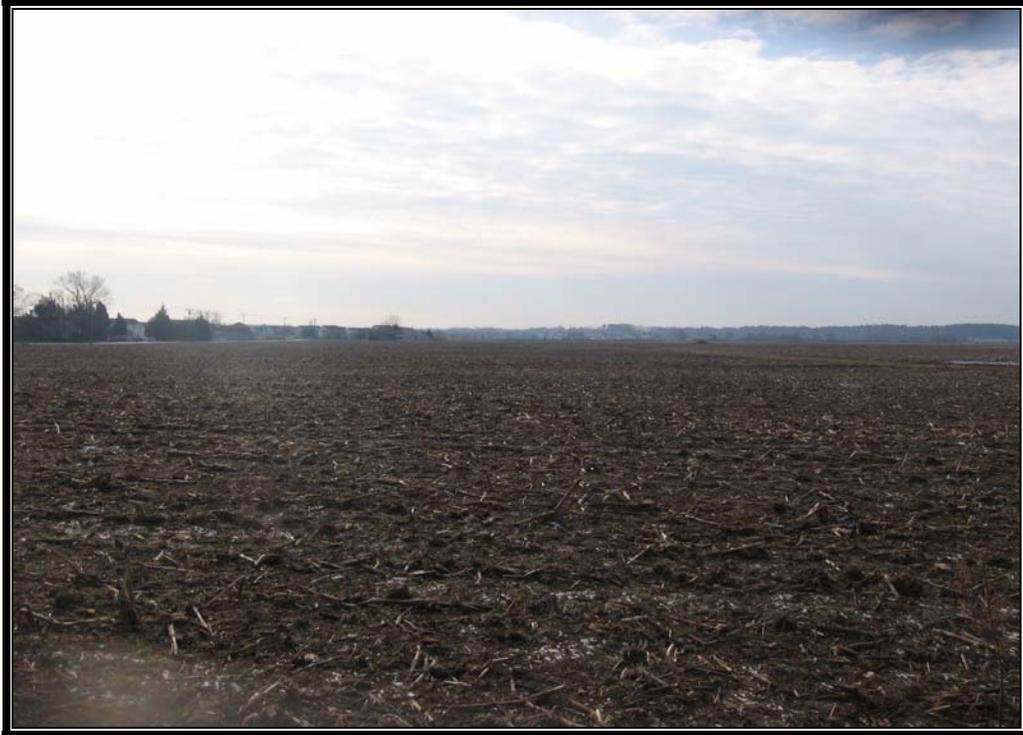
Photograph 5. Test Area 5, taken from Burbage Road, facing south.

Test Area 5 is in 0.81 ha or 2.0 ac size and is located in the southwest quadrant of the intersection of Burbage Road and Windmill Drive in a plowed agricultural field with drainage ditches. Test Area 5 cuts across an abandoned residential property (see Figure 2, Sheet 2). None of the structures present on the property are located within the test area. There are a brick home, gravel driveway, and dilapidated outbuildings on the property, including S-11513, the former Ocean View Post Office (moved). Forty-three STPs were excavated in Test Area 5 and were labeled 5-1 through 5-43. The soil profiles for the Test Area 5 STPs were comprised of either a black (10YR 2/1) Ap horizon silt loam with an average thickness of 33.0 cm (13.0 in) or a dark yellowish brown (10YR 4/4) Ap horizon sand silt loam overlying a light brownish gray (10YR 6/2) Bw horizon clay loam. Partial gleying of the Bw horizon was present in the STPs located in swales. The STPs located in the swales also exhibited thicker Ap horizons denoting leveling of the surface through erosive forces. A single piece of brown beer bottle glass was noted in the uppermost level in STP 5-10. This glass is recent litter which has been incorporated into the plowzone. No other artifacts or cultural materials were recovered from the excavated Test Area 5 STPs and no cultural features were identified.

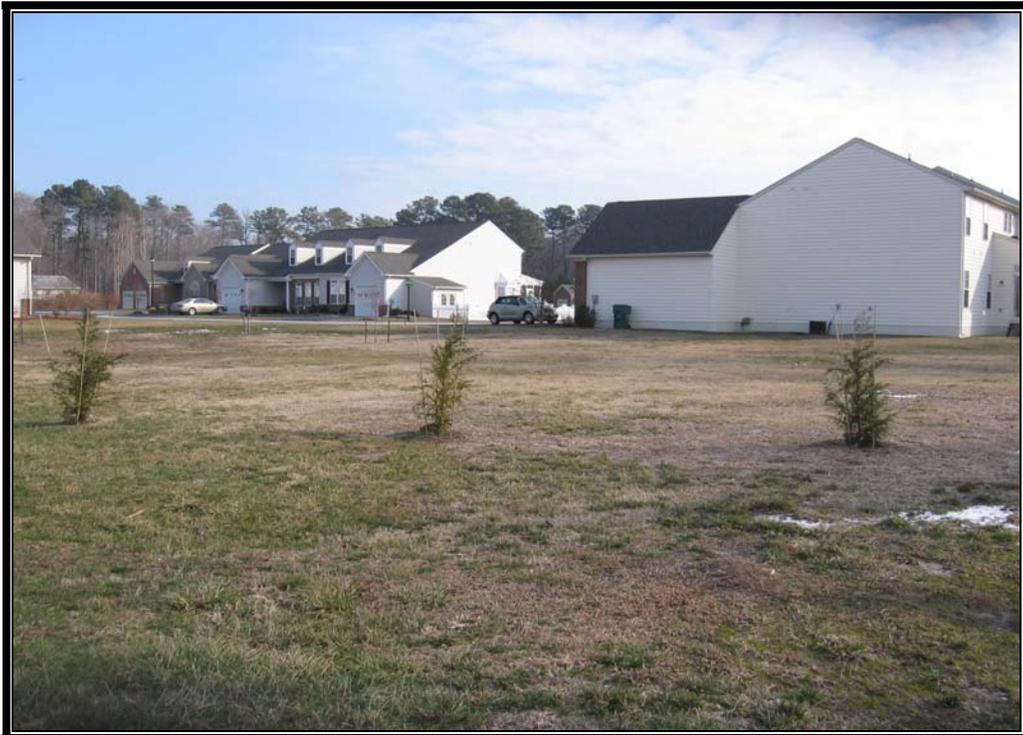
Photograph 6. Test Area 6, showing disturbances, facing northeast.

Test Area 6 is 0.21 ha or 0.52 ac in size and is located approximately 180.0 m (590.6 ft) south of the intersection of Burbage Road and Windmill Drive, on the east side of Windmill Drive in a residential area called Avon Park (see Figure 2, Sheet 2). Based on a visual inspection of the test area, it was determined that the residential development and its associated infrastructure activities had totally disturbed the test area. Two STPs were excavated in the test area (labeled 6-1 and 6-2). These excavations confirmed that the surface disturbance continued to depths which precluded the presence of *in situ* archaeological remains. The profiles for the two STPs consisted of fill overlying compacted gravels. Disturbances exhibited in the test area include graded fill, landscaped grass, areas of mounded earth with capped pipes protruding from the ground, as well as a utility box indicating buried utilities within the test area. No artifacts or other cultural materials were recovered from Test Area 6 and no cultural features were identified.

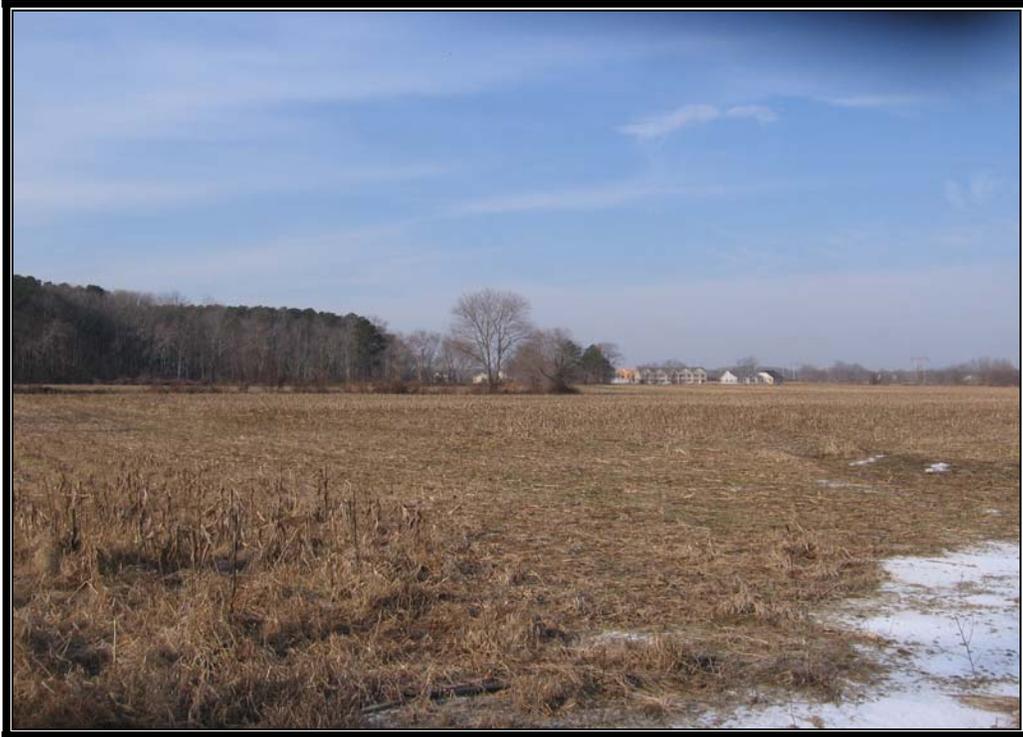
Photograph 7. Test Area 7, taken from Beaver Dam Road, facing northwest.

Test Area 7 is 1.21 ha or 3.0 ac in size and is located in the northwest quadrant of the intersection of Central Avenue and Beaver Dam Road adjacent to the north side of Beaver Dam Road (see Figure 2, Sheet 3). Test Area 7 is located entirely within an agricultural field across a gently undulating landform. Forty-eight STPs were excavated in Test Area 7 and were labeled 7-1 through 7-48. The soil profiles for the Test Area 7 STPs were comprised of a black (10YR 2/1) Ap horizon silt loam with an average thickness of 39.0 cm (15.4 in) overlying a light brownish gray (10YR 6/2) Bw horizon clay loam. No artifacts or other cultural materials were recovered from the excavated Test Area 7 STPs and no cultural features were identified.
