Cultural Resource Survey  
Property Identification Form

1. Name of Property: George and Stephanie Matheos Property (Tax Parcel 1-34-12-352.00)

This resource was evaluated in association with the federally funded Route 26 Road Improvement Project initiated under Contract 99-112-01 in Fall 1998. This residence is situated on the south side of Route 26, between Sawmill Road and Windmill Road. This I-House was constructed c. 1860.

Cultural Resource Survey  
Main Building Form

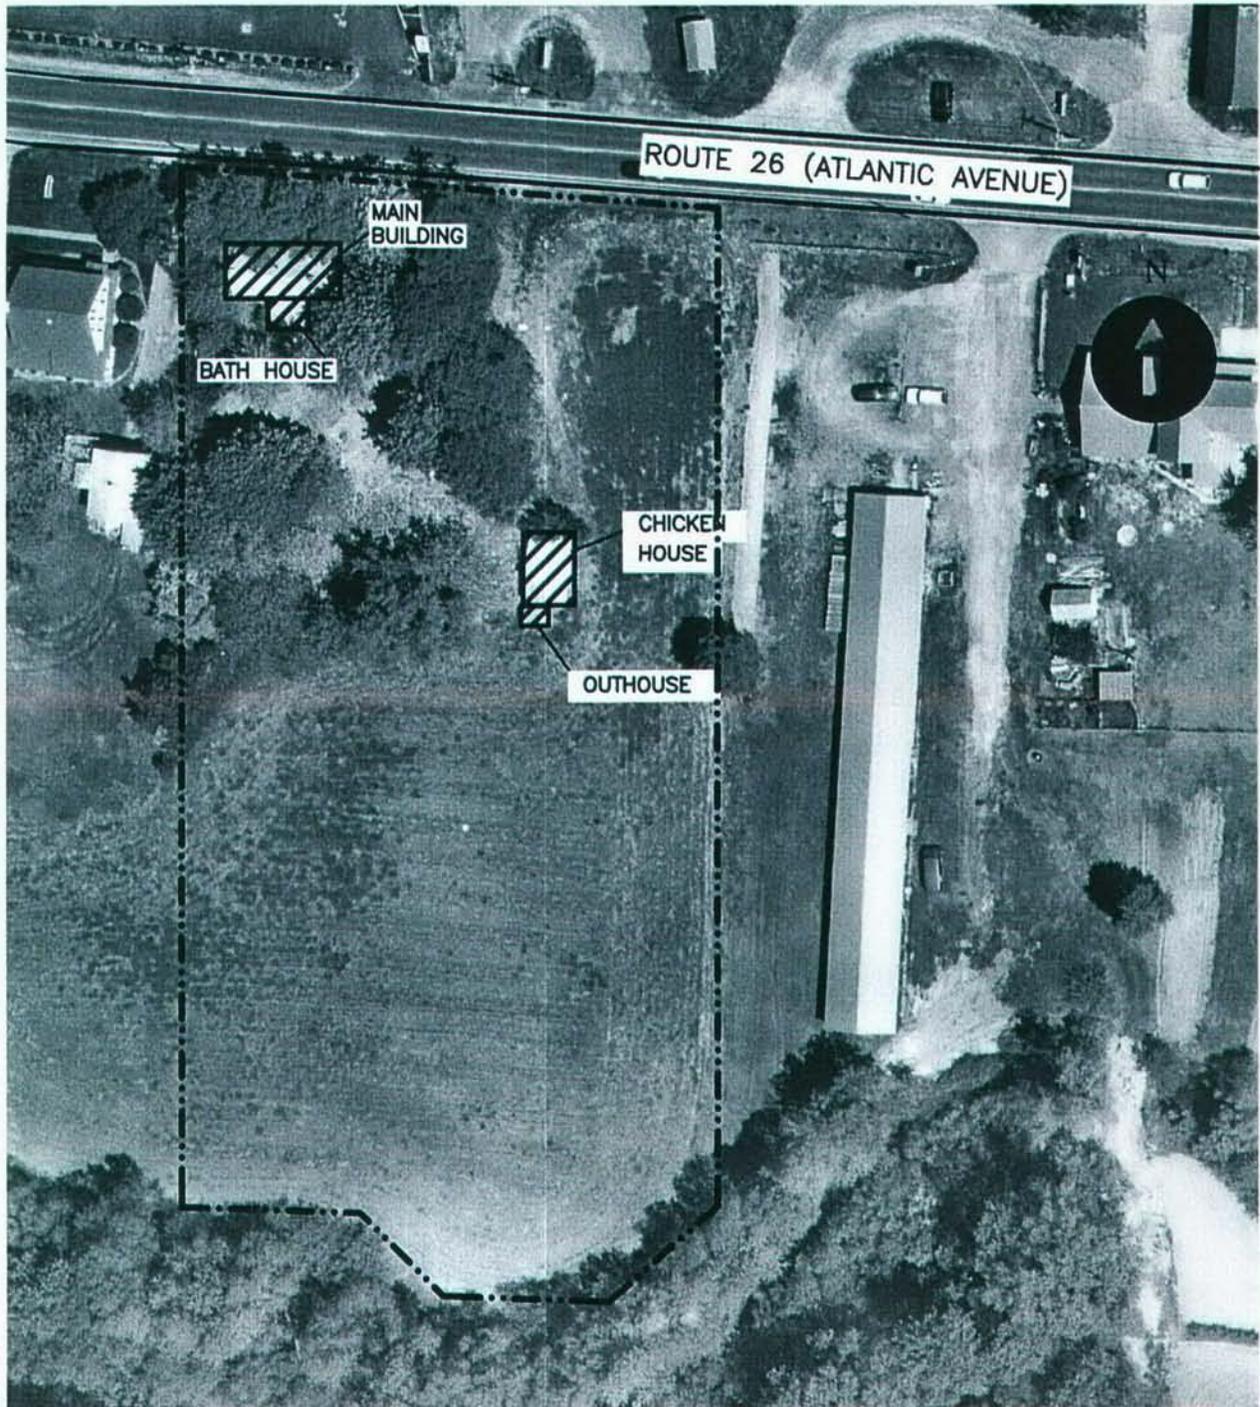
Sketch Plan:

To the southeast of the main building are three related outbuildings that appear to date to c. 1920. The first is a one-story wood bathhouse with a front-gable roof; the main façade has a single-leaf pedestrian entrance with a flush wood door. The second outbuilding is a wood chicken coop with a shed roof; it has a wood lean-to on its main façade. The third outbuilding is a one-story, wood outhouse with a front-gable roof; the main façade has a single-leaf entrance with a wood door.

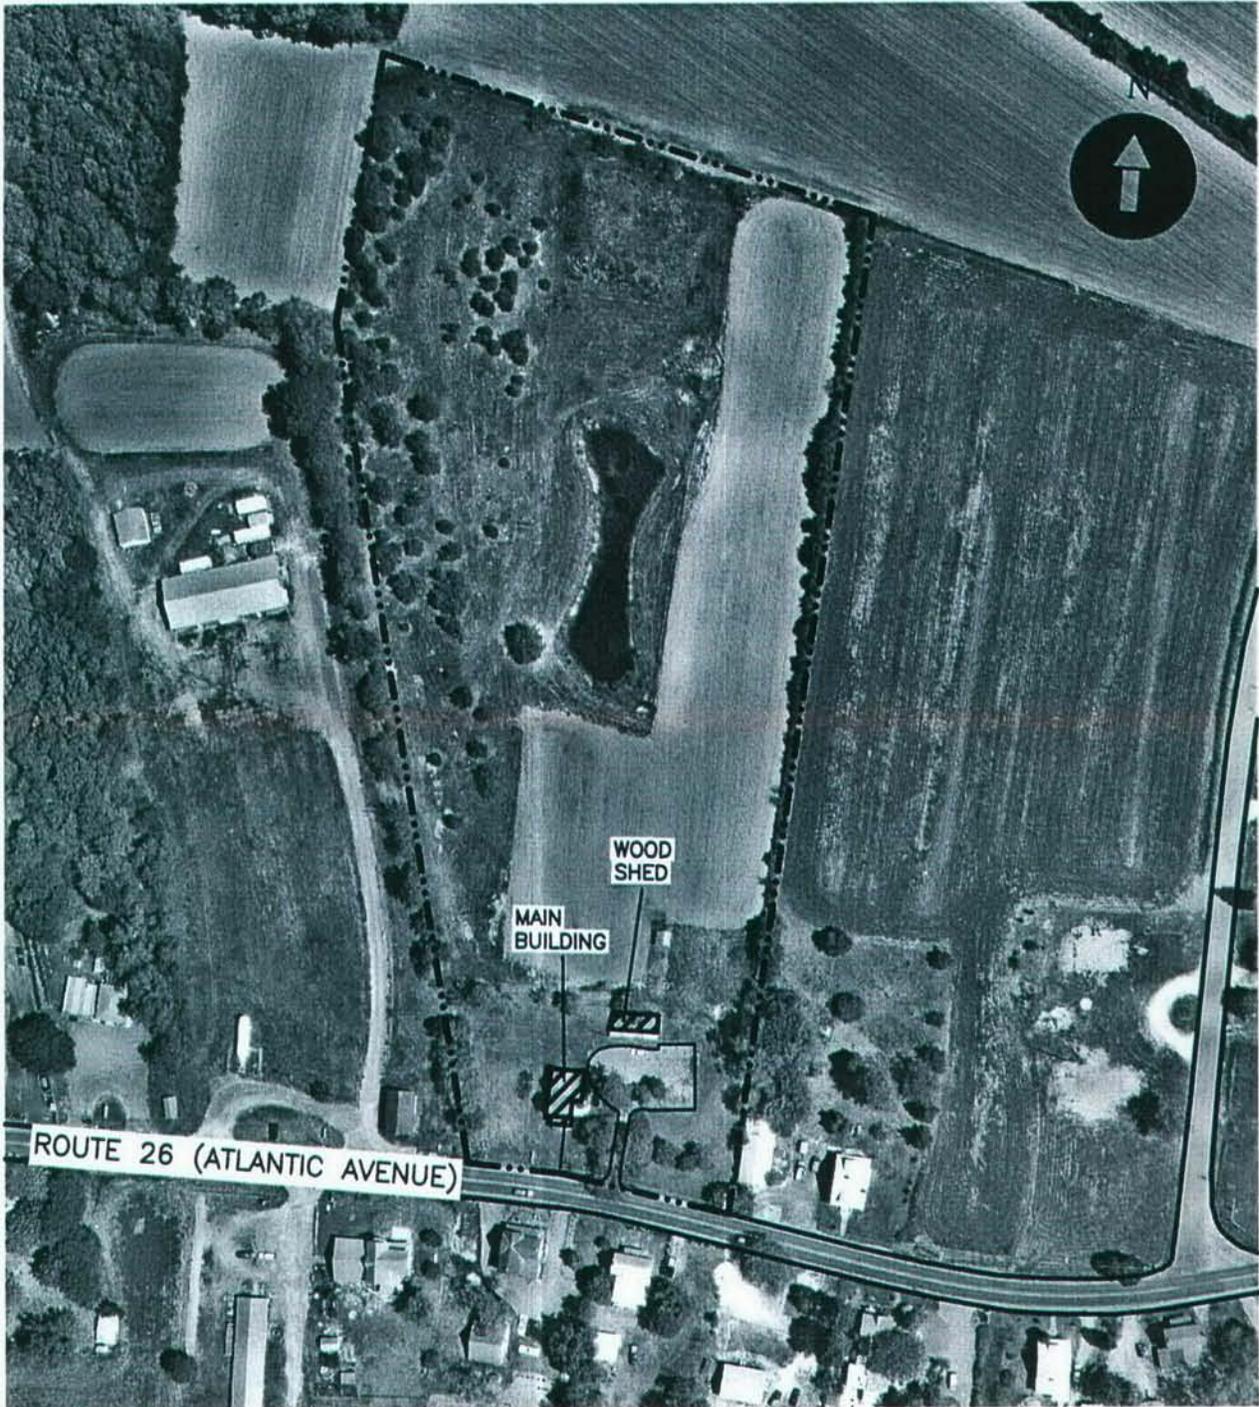
Sketch Plan:

To the northeast of the house there is a one-story, two-bay, woodshed with a corrugated metal side-gable roof. On the main (south) façade there are two bays of double-leaf vehicular entrances with sliding doors.

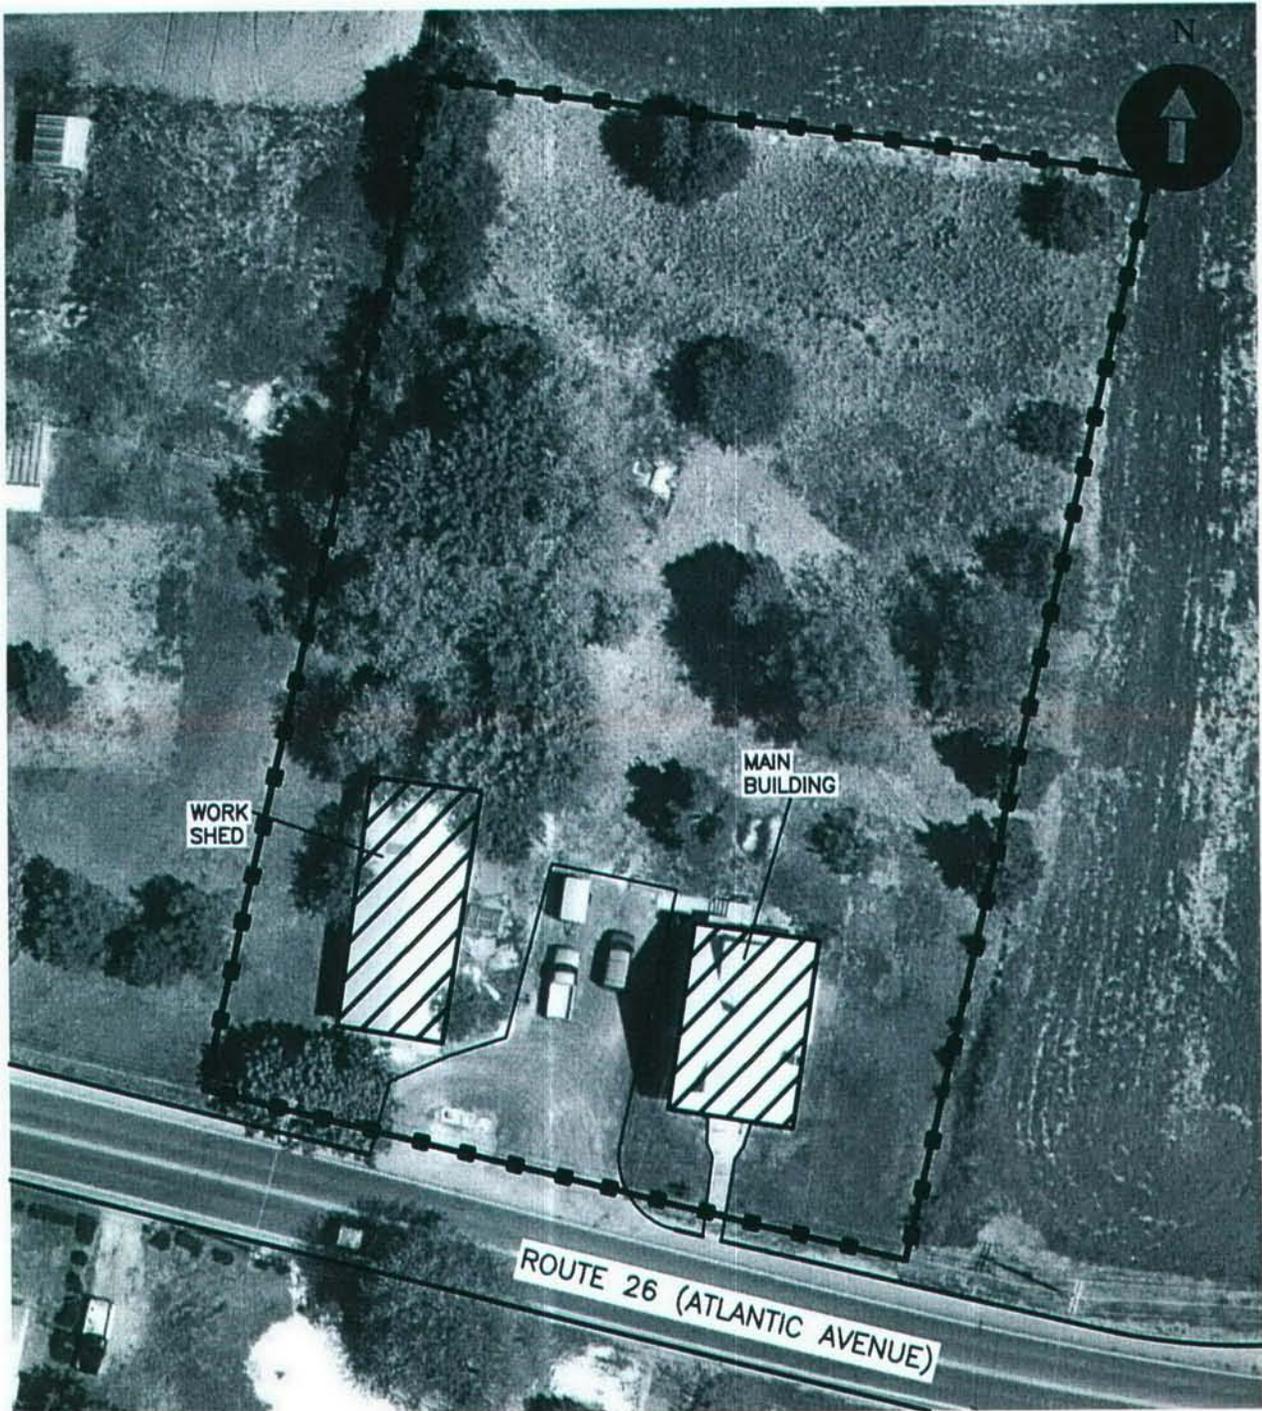
Sketch Plan:

To the west of the house is a one-story, three-bay, metal-clad work shed with a corrugated metal front-gable roof. The main (south) façade has a central vehicular entrance; to its east is a single-leaf pedestrian entrance and to the west is a wood 8/8 double-hung sash. The east façade has wood 2/2

windows and a one-bay vehicular entrance with a roll down door. The west façade has 8-light casement windows and a concrete block exterior chimney. Contributing.
