CULTURAL RESOURCE SURVEY
SURVEY UPDATE FORM

CRS # N01492

1. HISTORIC NAME/FUNCTION: E Start (Starl) House

CULTURAL RESOURCE SURVEY
LOCUS IDENTIFICATION FORM

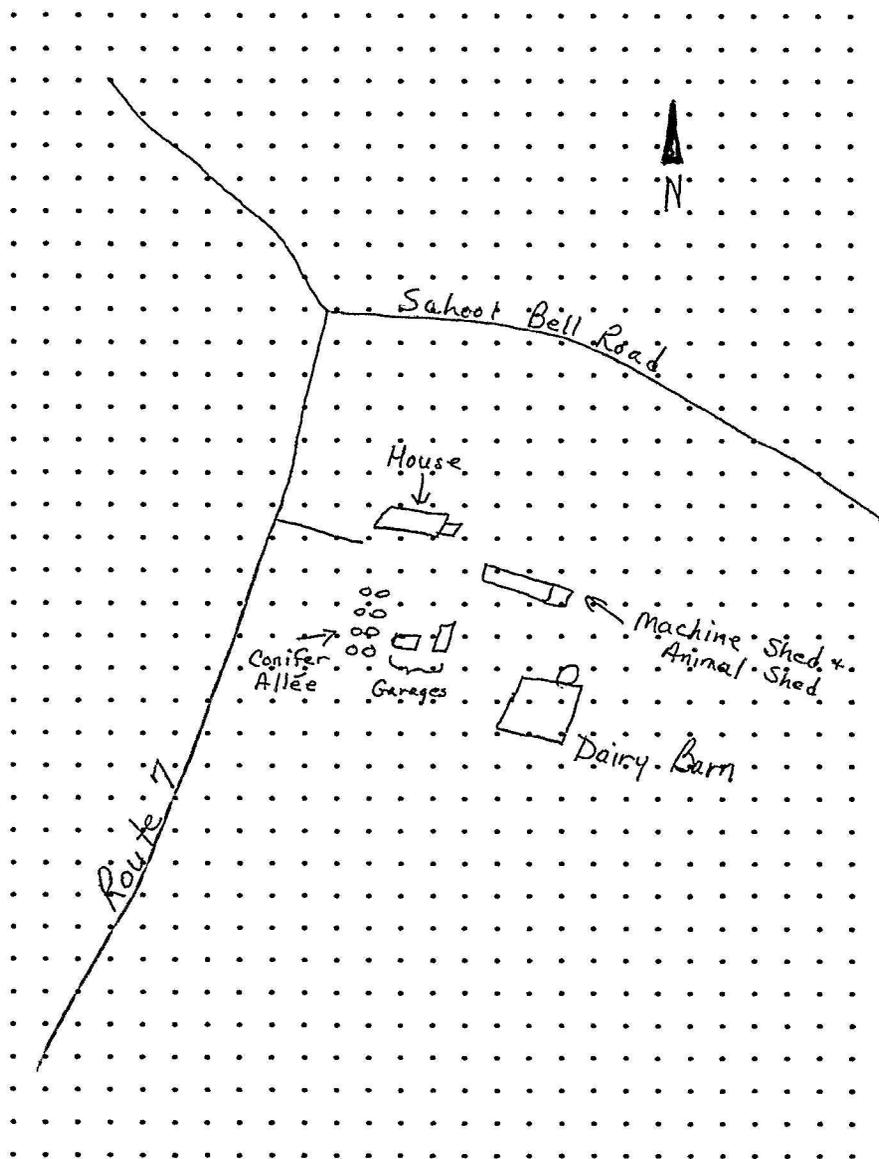
8. SKETCH MAP

Please indicate position of locus in relation to geographical landmarks such as streams and roads.

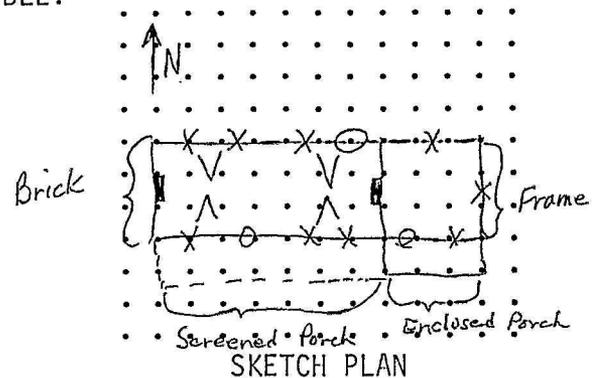
- a) Overall shape 2-unit linear massing
stories 2 1/2
bays 3 over 4
wings 2 story unit east end
- b) Structural system masonry loadbearing;
timber frame
- c) Foundation
materials fieldstone
basement below grade

- d) Exterior walls
materials stuccoed masonry (brick?); painted brick; aluminum siding
color(s) white
- e) Roof
shape; materials side gable, very steep on main block; composition shingling
cornice covered by drip gutters replaces slate
dormers two wall dormers, very steep gables, north and south elevations
chimney location(s) interior gable ends of main block stuccoed

- f) Windows
spacing 3 over 4, south; 4 over 4, north; symmetrical
type 1/1 modern replacement sash
trim wood lintels & sills; ogee arches in dormer windows and attic
shutters none

- g) Door
spacing second bay from west in south elevation
type plate glass above panels
trim fluted pilasters, dentil cornice; soffit and reveals have reeded strips

- h) Porches
location(s) across south elevation
materials wood on concrete slab
supports wood Tuscan Doric columns
trim
- i) Interior details (if accessible)

3. CONDITION: good XX deteriorated _____

remarks: outbuildings lack maintenance

d) list major alterations and dates (if known) frame unit covered with aluminum siding, picture window cut in north side, half-enclosed porch unit added south side; veranda added south side of main block

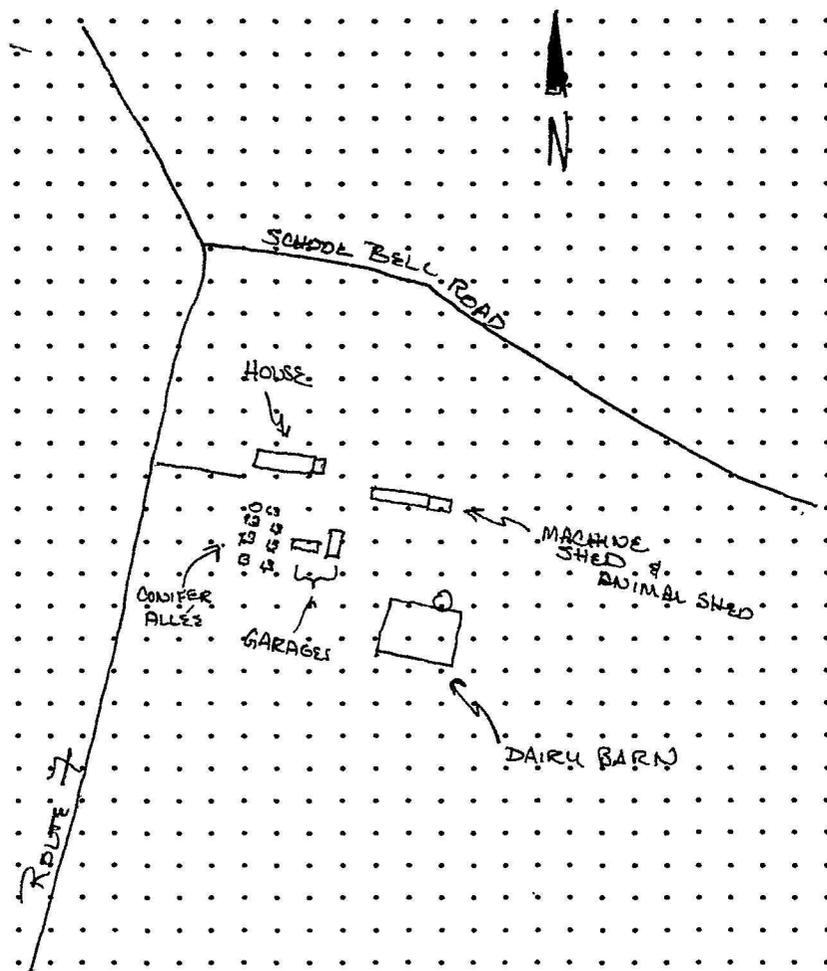
8. SKETCH MAP

Please indicate position of locus in relation to geographical landmarks such as streams and roads.

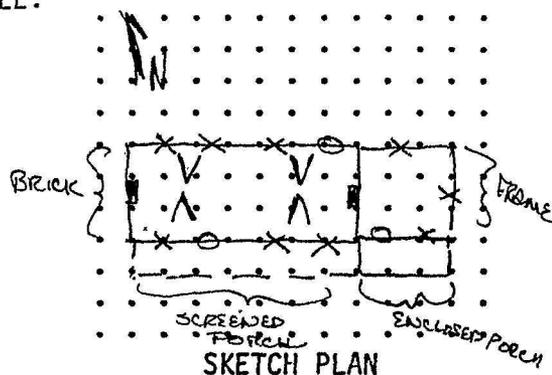
- a) Overall shape 2-unit linear massing
stories 2½
bays 3 over 4
wings 2 story unit east end
- b) Structural system masonry loadbearing;
timber frame
- c) Foundation materials fieldstone
basement below grade

- d) Exterior walls materials stuccoed masonry (brick?); painted brick; aluminum siding
color(s) white
- e) Roof shape; materials side gable, very steep on main block; composition shingling
cornice covered by drip gutters replaces slate
dormers two wall dormers, very steep gables, north and south elevations
chimney location(s) interior gable ends of main block; stuccoed

- f) Windows spacing 3 over 4, south; 4 over 4, north; symmetrical
type 1/1 modern replacement sash
trim wood lintels & sills; ogée arches in dormer-windows and attic
shutters none

- g) Door spacing second bay from west in south elevation
type plate glass above panels
trim fluted pilasters, dentil cornice; soffit and reveals have reeded strips

- h) Porches location(s) across south elevation
materials wood on concrete slab
supports wood Tuscan Doric columns
trim
- i) Interior details (if accessible)

3. CONDITION: good XX

remarks: outbuildings lack maintenance

d) list major alterations and dates (if known) frame unit covered with aluminum siding, picture window cut in north side, half-enclosed porch unit added south side; veranda added south side of main block
