CULTURAL RESOURCE SURVEY  
SURVEY UPDATE FORM

CRS # N01493

1. HISTORIC NAME/FUNCTION: Linden Hill

2. ADDRESS/LOCATION: 34 N Dupont Highway, Saint Georges, Delaware 19733

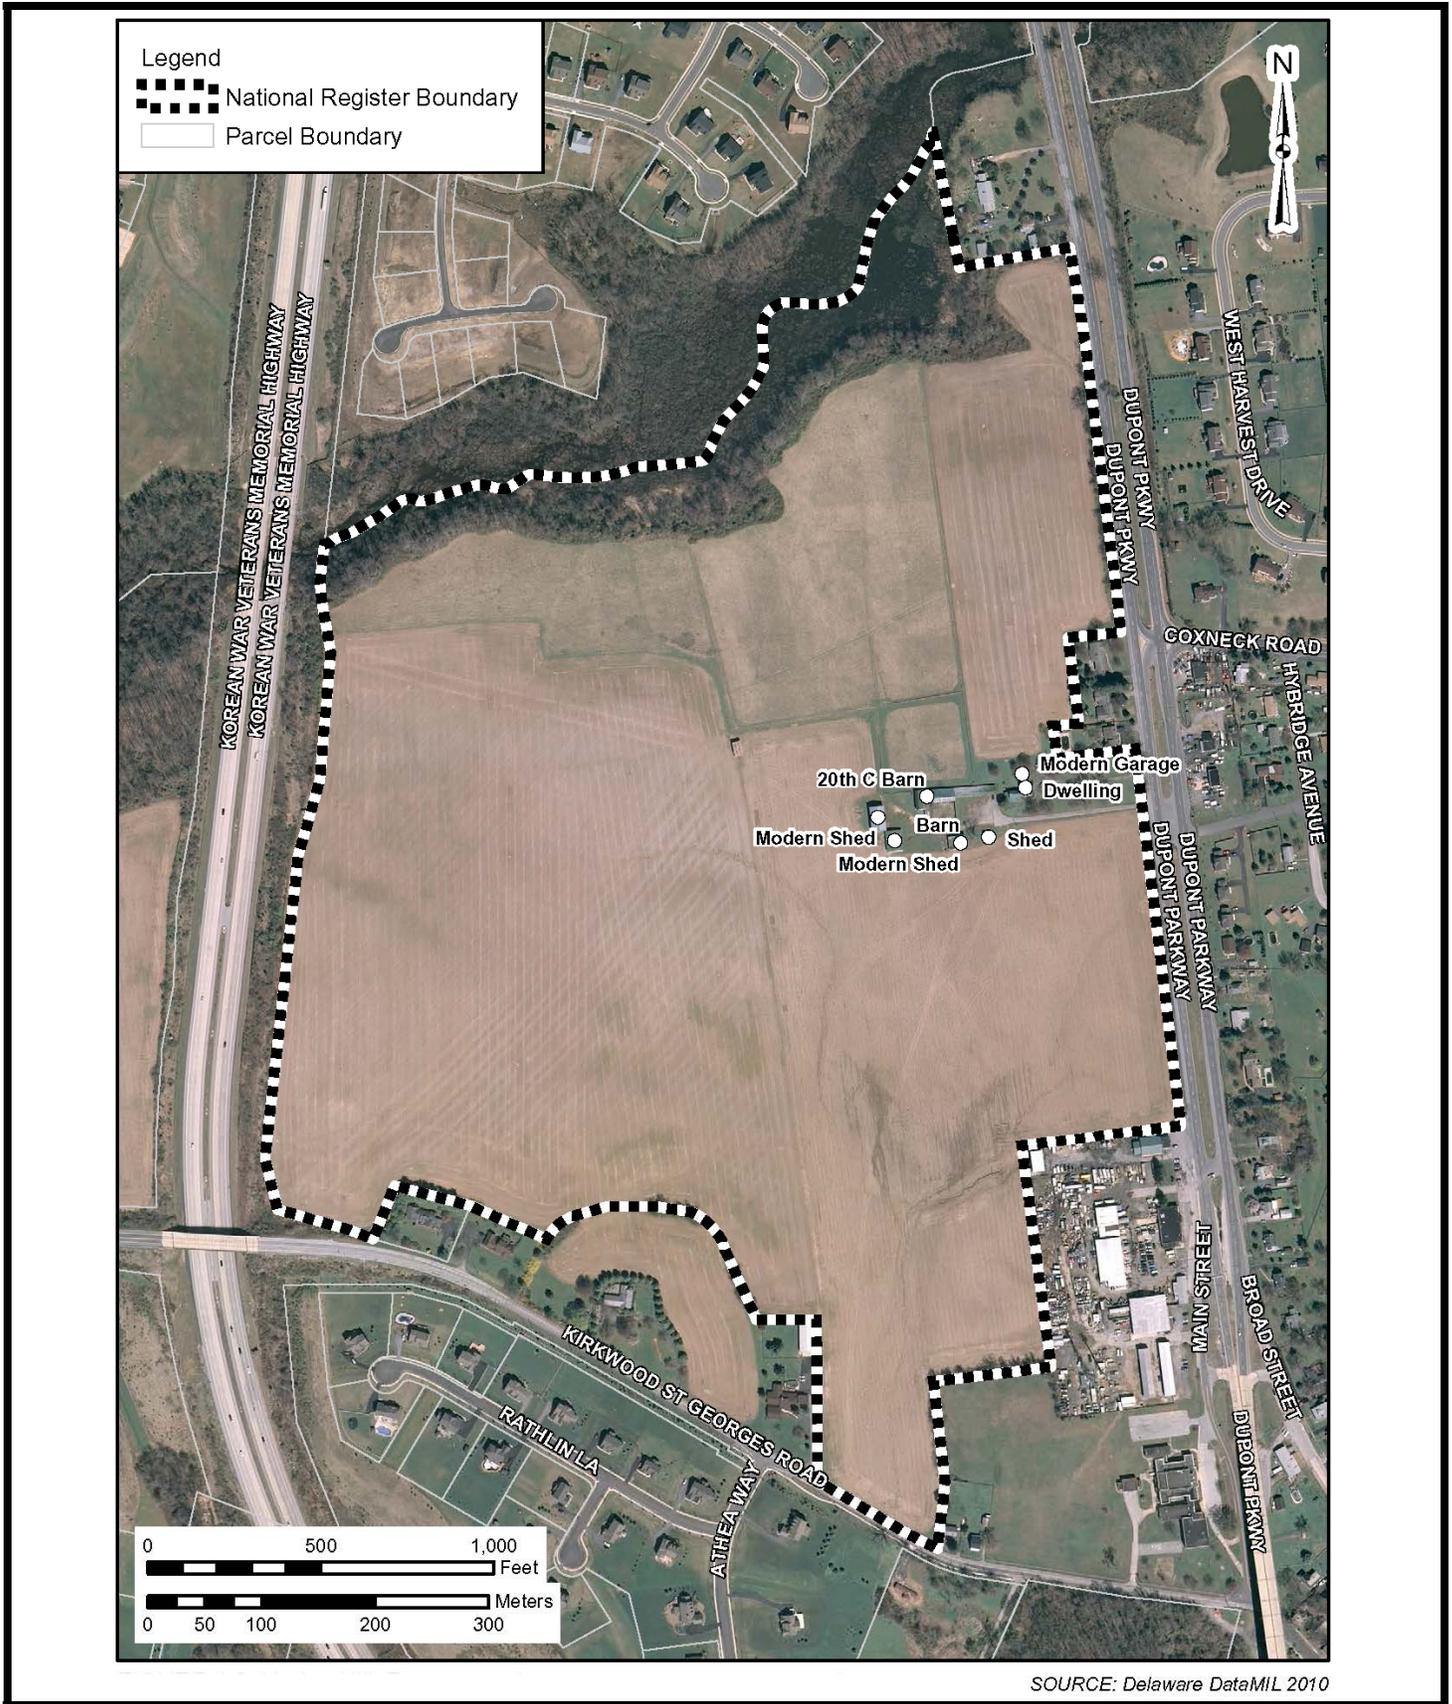
4. SITE PLAN:  
INDICATE NORTH ON PLAN

Farm buildings were not surveyed at the request of the owner. Based on aerial photography, one new outbuilding has been added east of the gambrel roof barn. The southwest outbuilding (described as a modern intrusion in the 1979 nomination) appears to have been removed and replaced with a new, larger structure since that time.

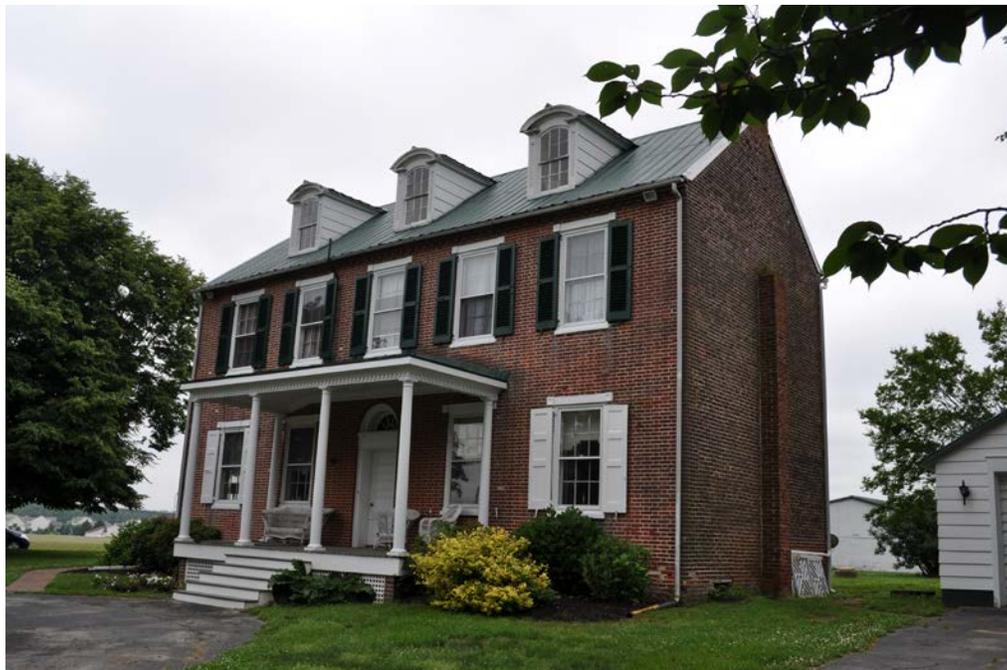
- a. Facade: Direction: East
  - 1) Bays 5
  - 2) Windows 12
  - fenestration regular
  - type 6/6 wood sash
  - trim lug sills and bull's eye cornered lintels
  - shutters operable paneled wood on 1<sup>st</sup> story, operable louvered wood on 2<sup>nd</sup> story

- 3) **Door(s)** 1  
     **location** center bay, 1<sup>st</sup> story  
     **type** single-leaf 5-panel wood  
     **trim** arched fanlight
- 4) **Porch(es)** 1-story 3-bay half-hipped porch w/ Tuscan columns and dental molding

Description   Façade (east elevation) and north elevation of main building (.001) looking southwest; Southeast corner of main building looking northwest

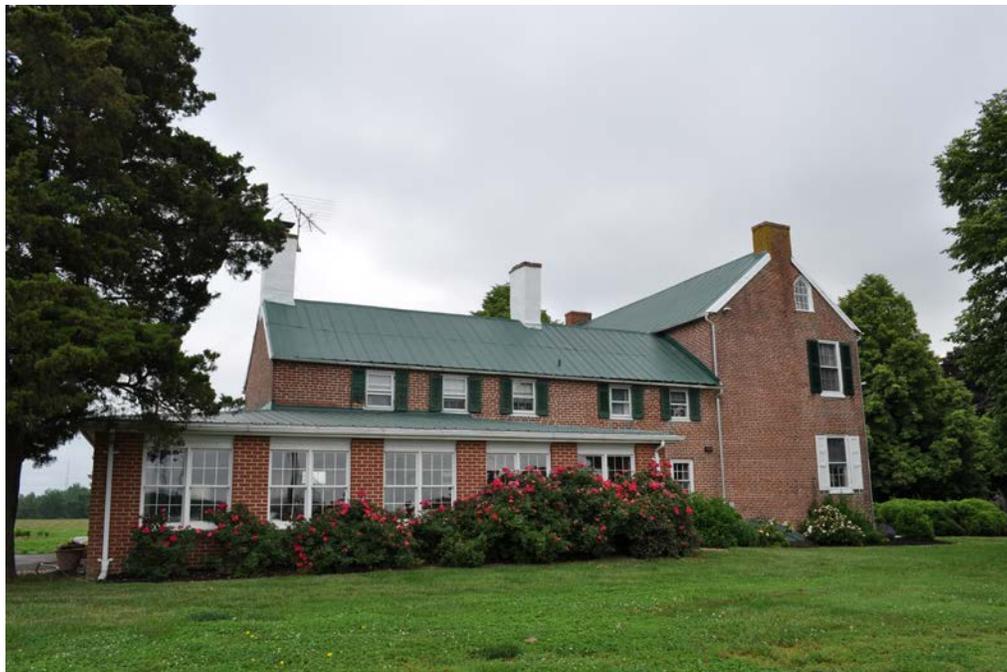
4. INTEGRITY: A large 5-bay addition was constructed on the south end of the rear ell after the previous survey in 1979.

- 1) **Bays** 8
- 2) **Windows** 15  
     **fenestration** regular on main block, 5 bay rear ell, 5 bay south addition  
     **type** 6/6 wood sash on main block, arch in 2.5 story; 6/6 on 1<sup>st</sup> story of rear ell and 9-light in second story of rear ell; 6/6 double-hung paired vinyl sash on addition  
     **trim** dentil molding trim on lintel of windows on the addition  
     **shutters** operable wood panel and louvered on main block and rear ell
- 3) **Door(s)** 0  
     **location** N/A  
     **type** N/A  
     **trim** N/A
- 4) **Porch(es)** N/A

Description   South elevation of main building(.001) (including addition) looking north; West elevation of main building looking east

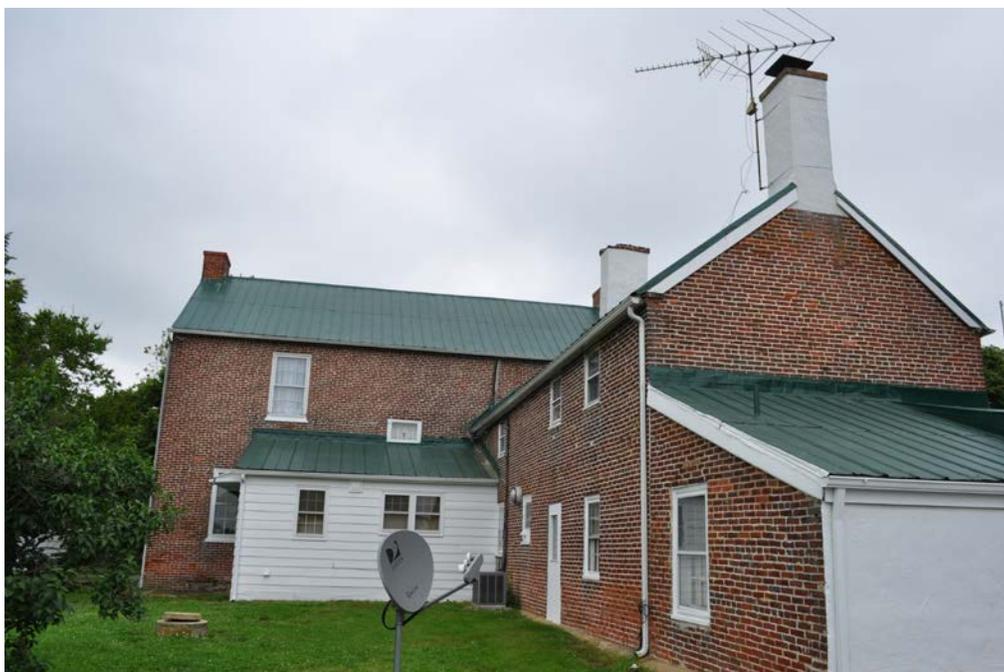
- 1) **Bays** 6 bays
- 2) **Windows** 7  
     **fenestration** irregular – 3 on main block, 2 on lean-to inset into ell; 2 on addition  
     **type** 6/6 and fixed wood sash on main block, 6/6 and 6/1 on lean-to, 6/6 double-hung vinyl sash on addition  
     **trim** dentil molding lintel on addition  
     **shutters** N/A
- 3) **Door(s)** 1  
     **location** center bay of addition  
     **type** single-leaf  
     **trim** dentil molding lintel
- 4) **Porch(es)** N/A
