CULTURAL RESOURCE SURVEY  
SURVEY UPDATE FORM

CRS # N05036

1. HISTORIC NAME/FUNCTION: Wilson Farm

2. ADDRESS/LOCATION: 1863 McCoy Road, Bear, Delaware 19701

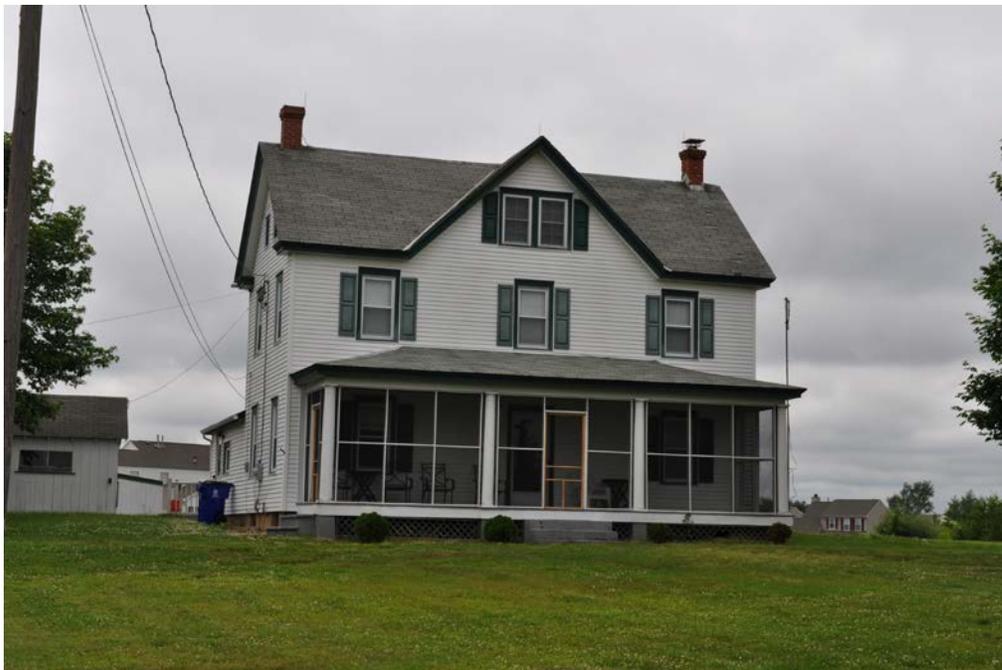
Description Façade (east elevation) of main building (.001) looking west; North elevation of main building (.001) looking southwest

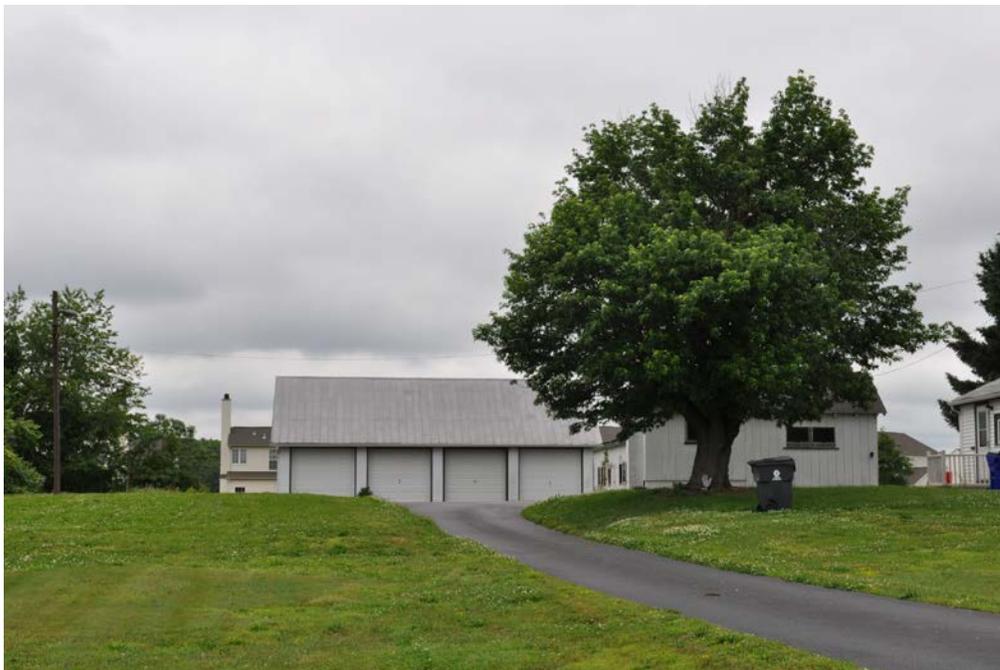
Description     Façades (east elevations) of garage (.002) and shed (.004) looking west; East elevation of shed (.003) looking southwest

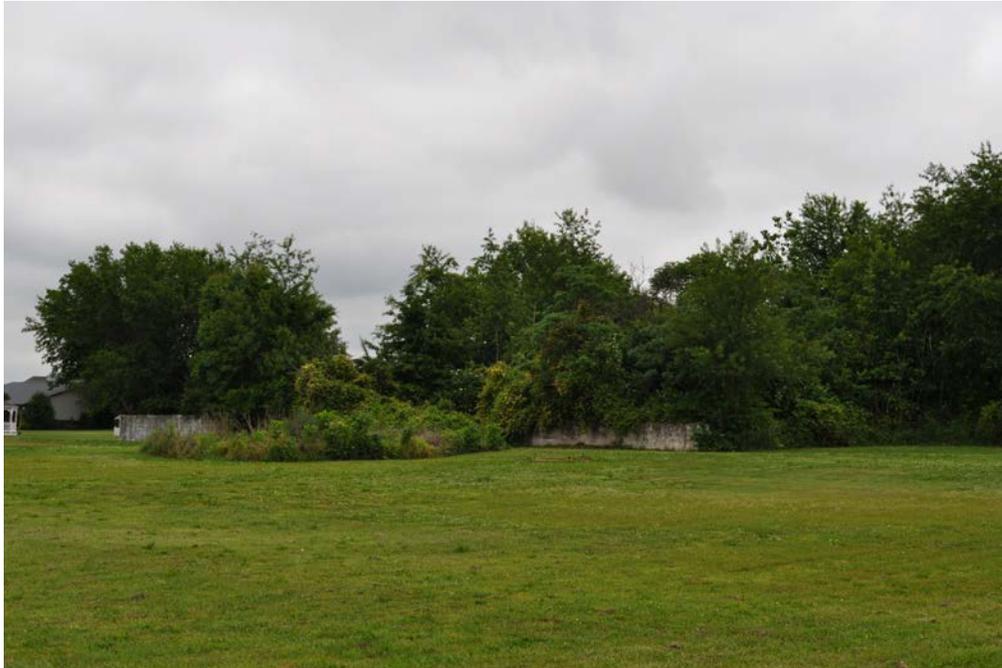
Description East end of barn foundation looking southwest

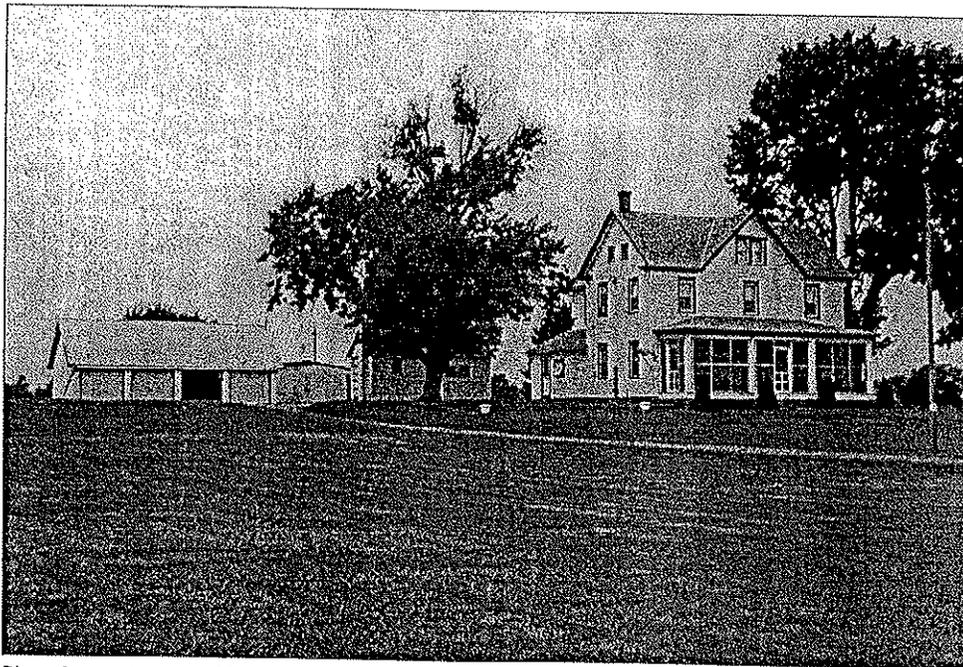
This complex is situated at the center of a farm complex on the west side of McCoy Road just to the south of the intersection of McCoy Road and Stewart's Road. The property is located at the extreme northwesterly limits of the project area and the Saint Georges Bridge was not observed to be visible from the property. The two and one half story frame, three bay, center hall house is covered by a cross gabled asphalt shingle roof. Narrow brick chimneys are located along the roof's ridge line inside of each gable end wall. A rear wing with multiple additions projects from the rear of the main block. All windows appear to be fitted with modern 1/1 double hung replacement sashes. The residence is fronted by a one story screened porch under a separate asphalt shingle roof. The porch roof is supported by four wooden columns. The farm complex includes three 20th century

outbuildings to the rear of house and a large dilapidated gambrel roofed frame barn to the south. Stylistically, the house appears to date to the mid-19th century and a residence labeled "T.W. Bellville" appears in this approximate location on the Beers map of 1868 (Figure 2.6). The Hopkins map of 1881 (Figure 2.9) shows the Bellville House to be the primary residence of a 118-acre farm.

Plate 3.11. View looking northwest showing Historic Resource #7 (T.W. Bellville Farm Complex 1863 McCoy Road) (Photographer: Susan Ferenbach, May 1998) [HRI Neg. # 98006/8:17].
