CULTURAL RESOURCE SURVEY  
PROPERTY IDENTIFICATION FORM

1. HISTORIC NAME/FUNCTION: Monterey Farms

6. PROJECT TITLE/ REASON FOR SURVEY (if applicable):  
SR 1 Road Widening

Organization: The Louis Berger Group Date: June 2012

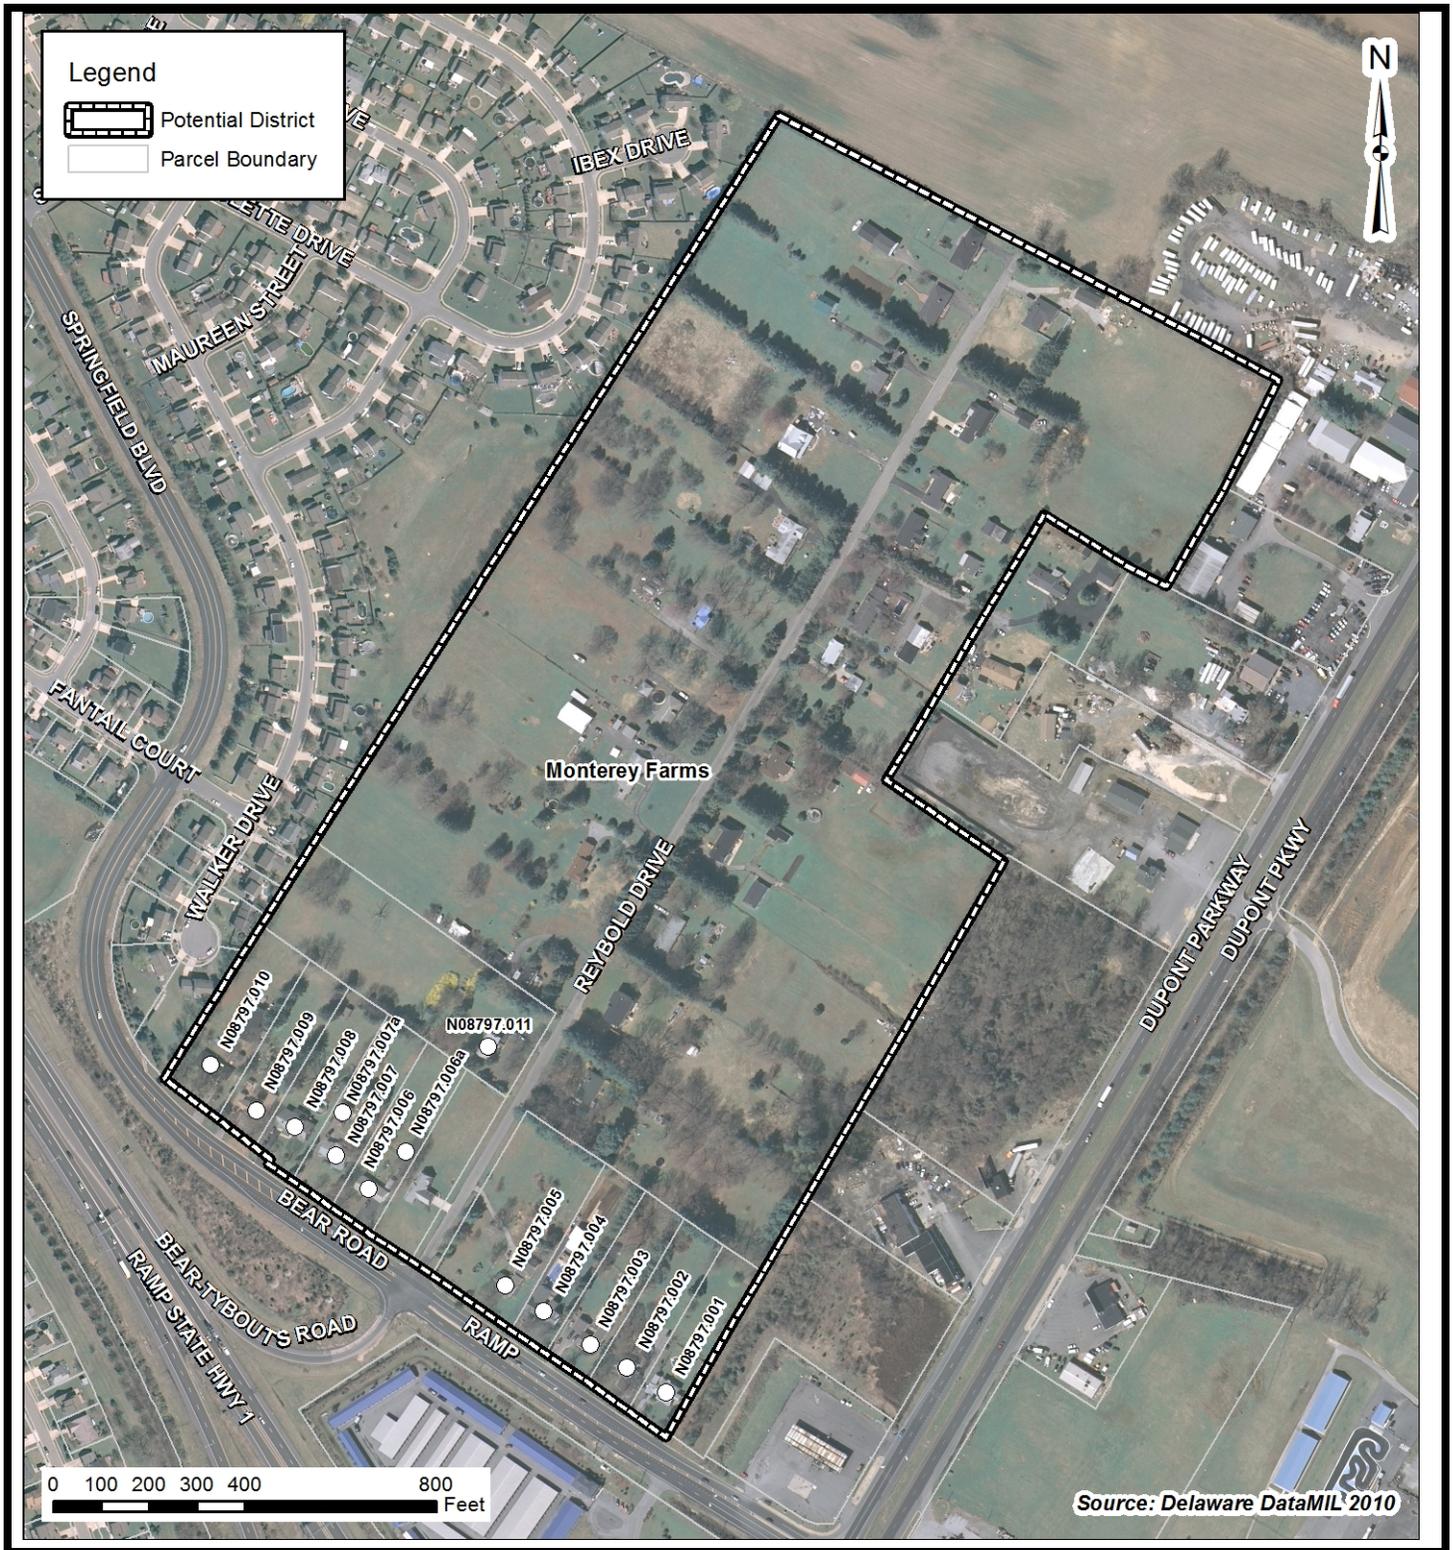
4. SITE PLAN:

Dwellings in the subdivision feature a variety of twentieth-century building forms, predominately Transitional Ranch and Ranch houses, but also Split Level, Colonial Revival, and Cape Cod forms. Many of the properties have secondary buildings including detached garages and sheds. A few dwellings along Bear Road have pools.

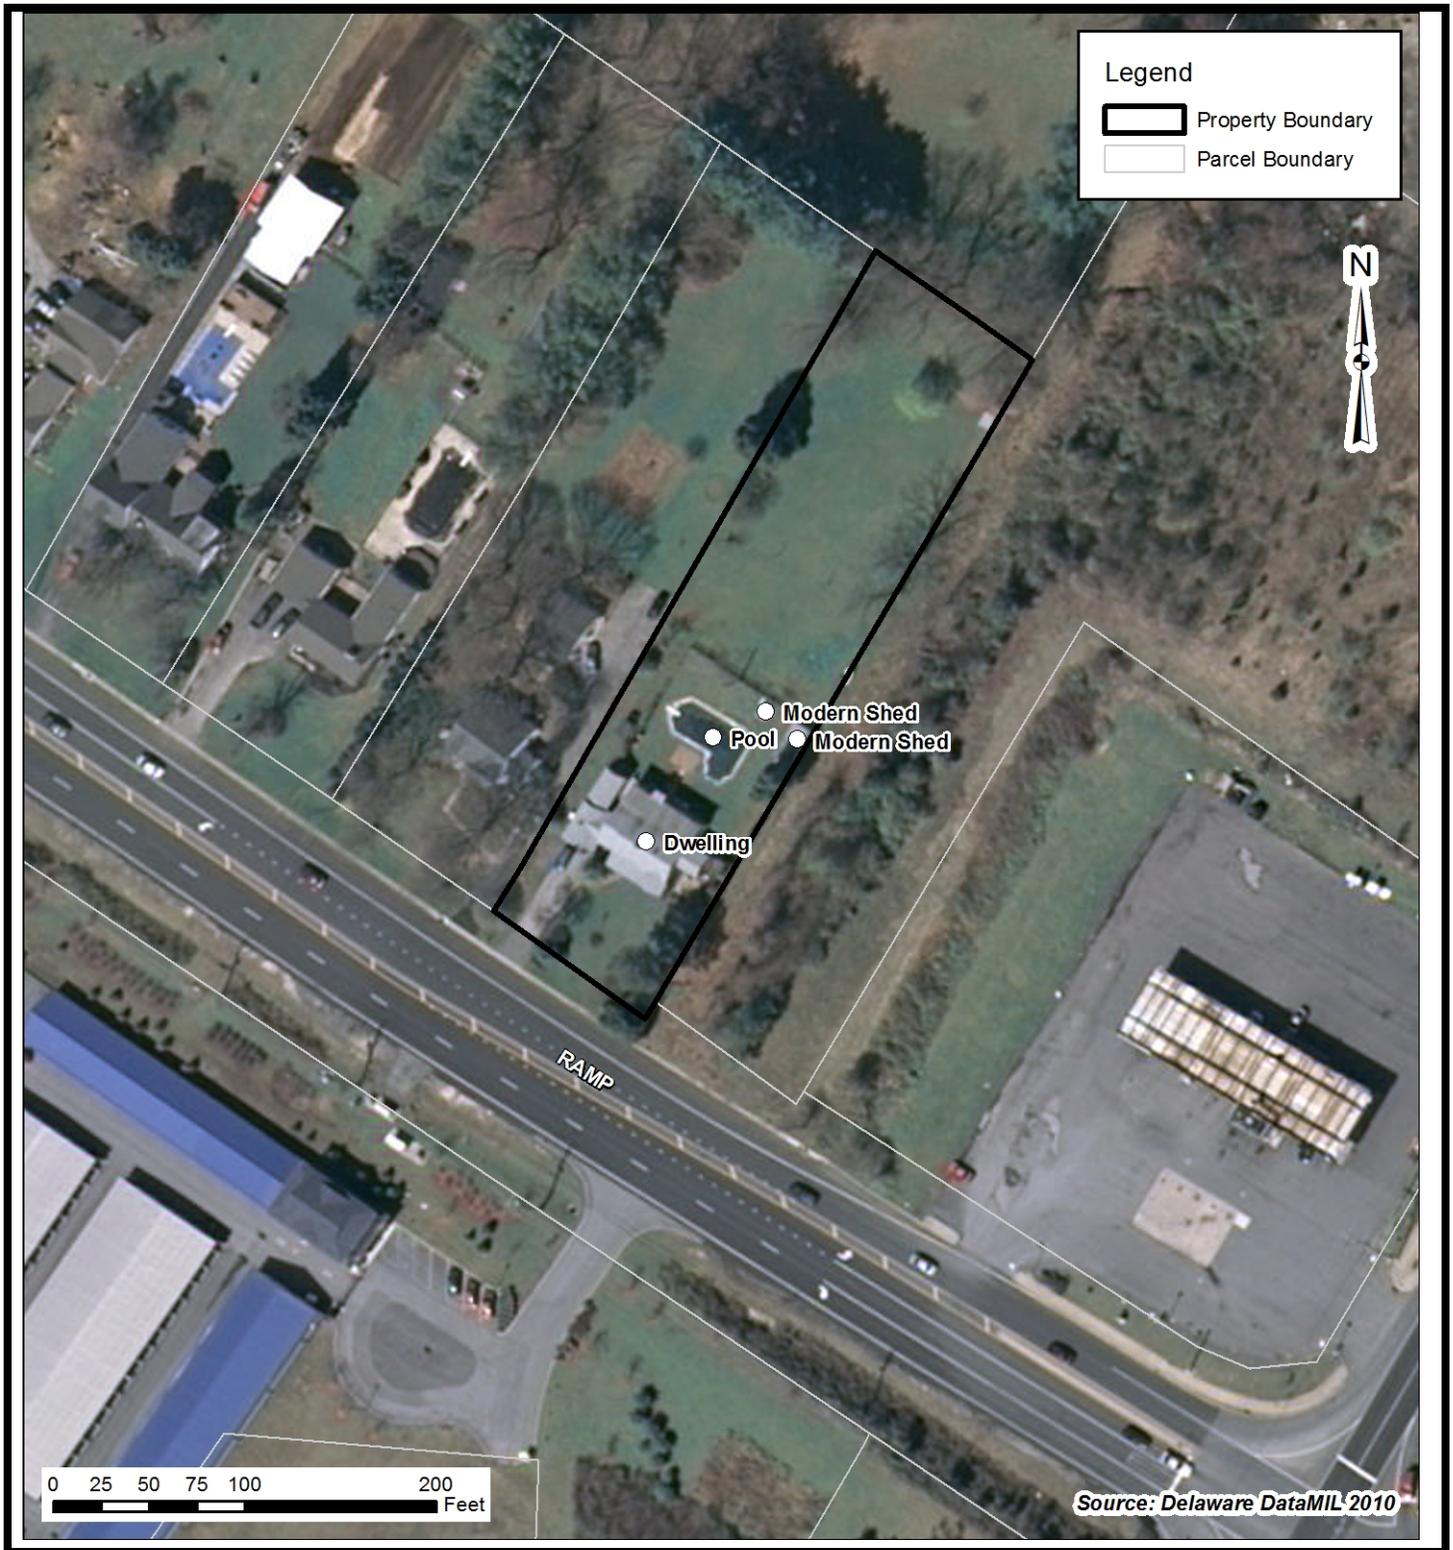
4. SITE PLAN:

An in-ground swimming pool and two small sheds stand northeast of the house and wood fencing encircles the pool and the rear yard. The sheds and the pool appear to have been erected after 1965.

10. **LANDSCAPING:** The house sits on a level .92-acre parcel and is fronted by a manicured lawn. Mature trees shade the front lawn and the house is fronted by landscaped beds. A paved driveway leads to the attached garage along the southwest side of the house. A wood fence encircles the rear yard and the in-ground swimming pool.

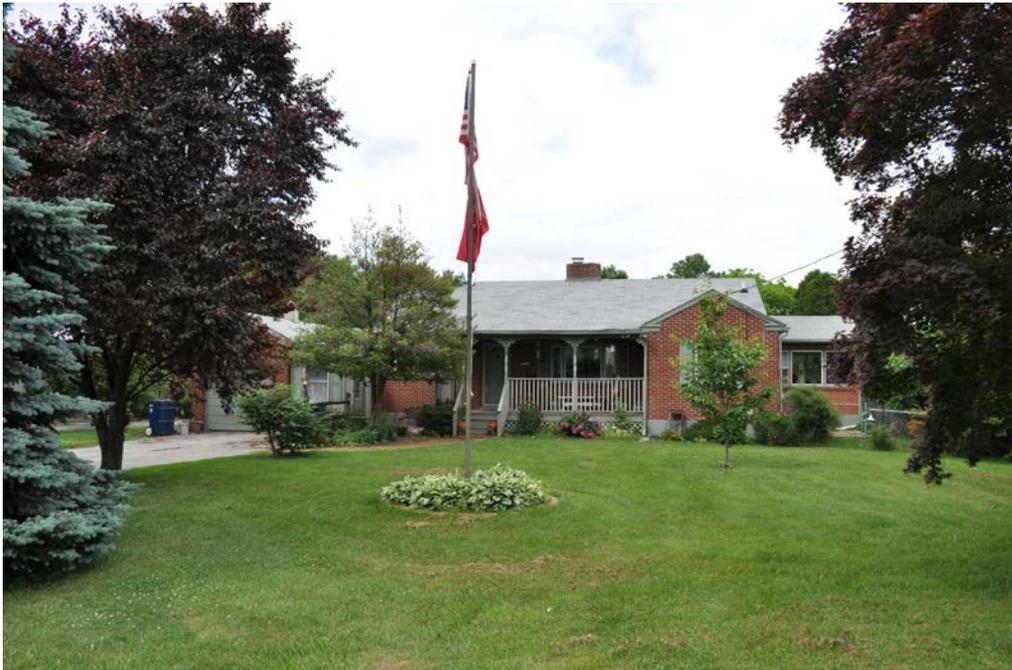
CRS # N08797.001 Date 5/22/2012 Photo Roll # N/A Surveyor S. Groesbeck  
P. Kuhn

Description Main (southwest) elevation looking north, Main elevation garage looking northeast

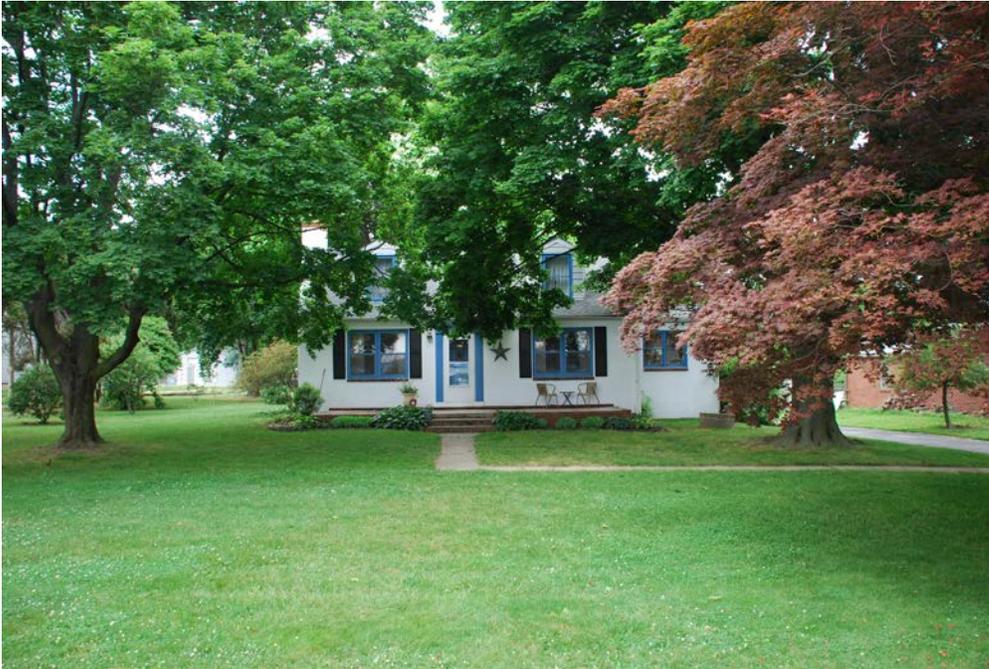
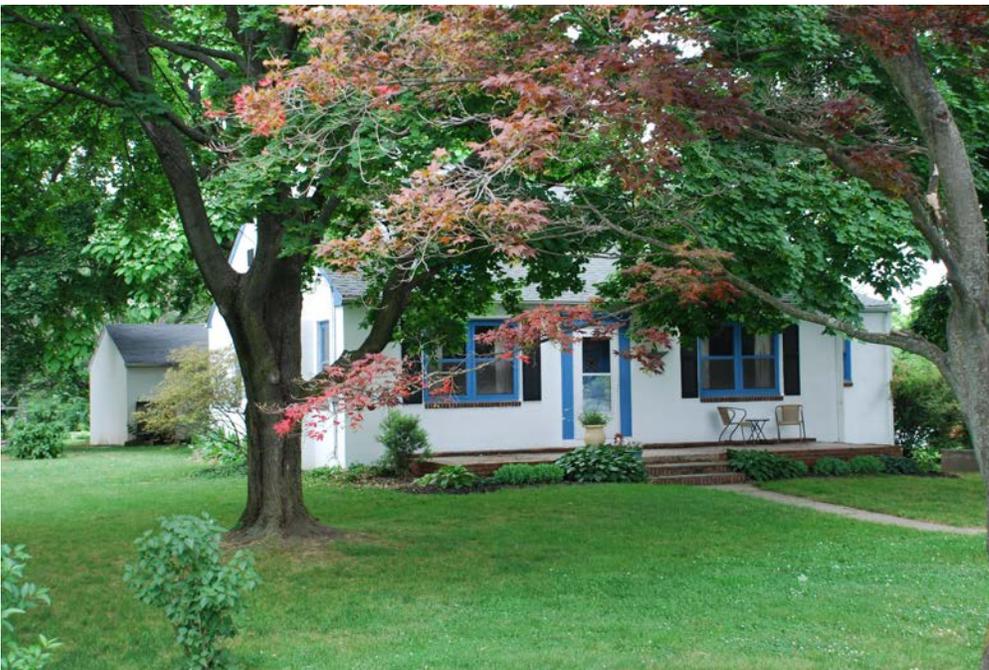
CRS # N08797.002 Date 5/22/2012 Photo Roll # N/A Surveyor S. Groesbeck  
P. Kuhn

Description Main (southwest) elevation looking northeast, Main elevation and northwest elevation looking east
