CULTURAL RESOURCE SURVEY  
PROPERTY IDENTIFICATION FORM

CRS # N08799  
SPO Map 08-09-34  
Hundred White Clay Creek  
Quad Newark East  
Other Parcel:0903030040

1. HISTORIC NAME/FUNCTION: Bolton House (Beers 1868)
2. ADDRESS/LOCATION: 20 N Old Baltimore Pike, , Newark, Delaware 19702
3. TOWN/NEAREST TOWN: Christiana vicinity?
4. MAIN TYPE OF RESOURCE:      building       structure       site       object   
   landscape       district
5. MAIN FUNCTION OF PROPERTY: Dwelling
6. PROJECT TITLE/ REASON FOR SURVEY (if applicable):  
SR 1 Widening

CULTURAL RESOURCE SURVEY  
MAIN BUILDING FORM

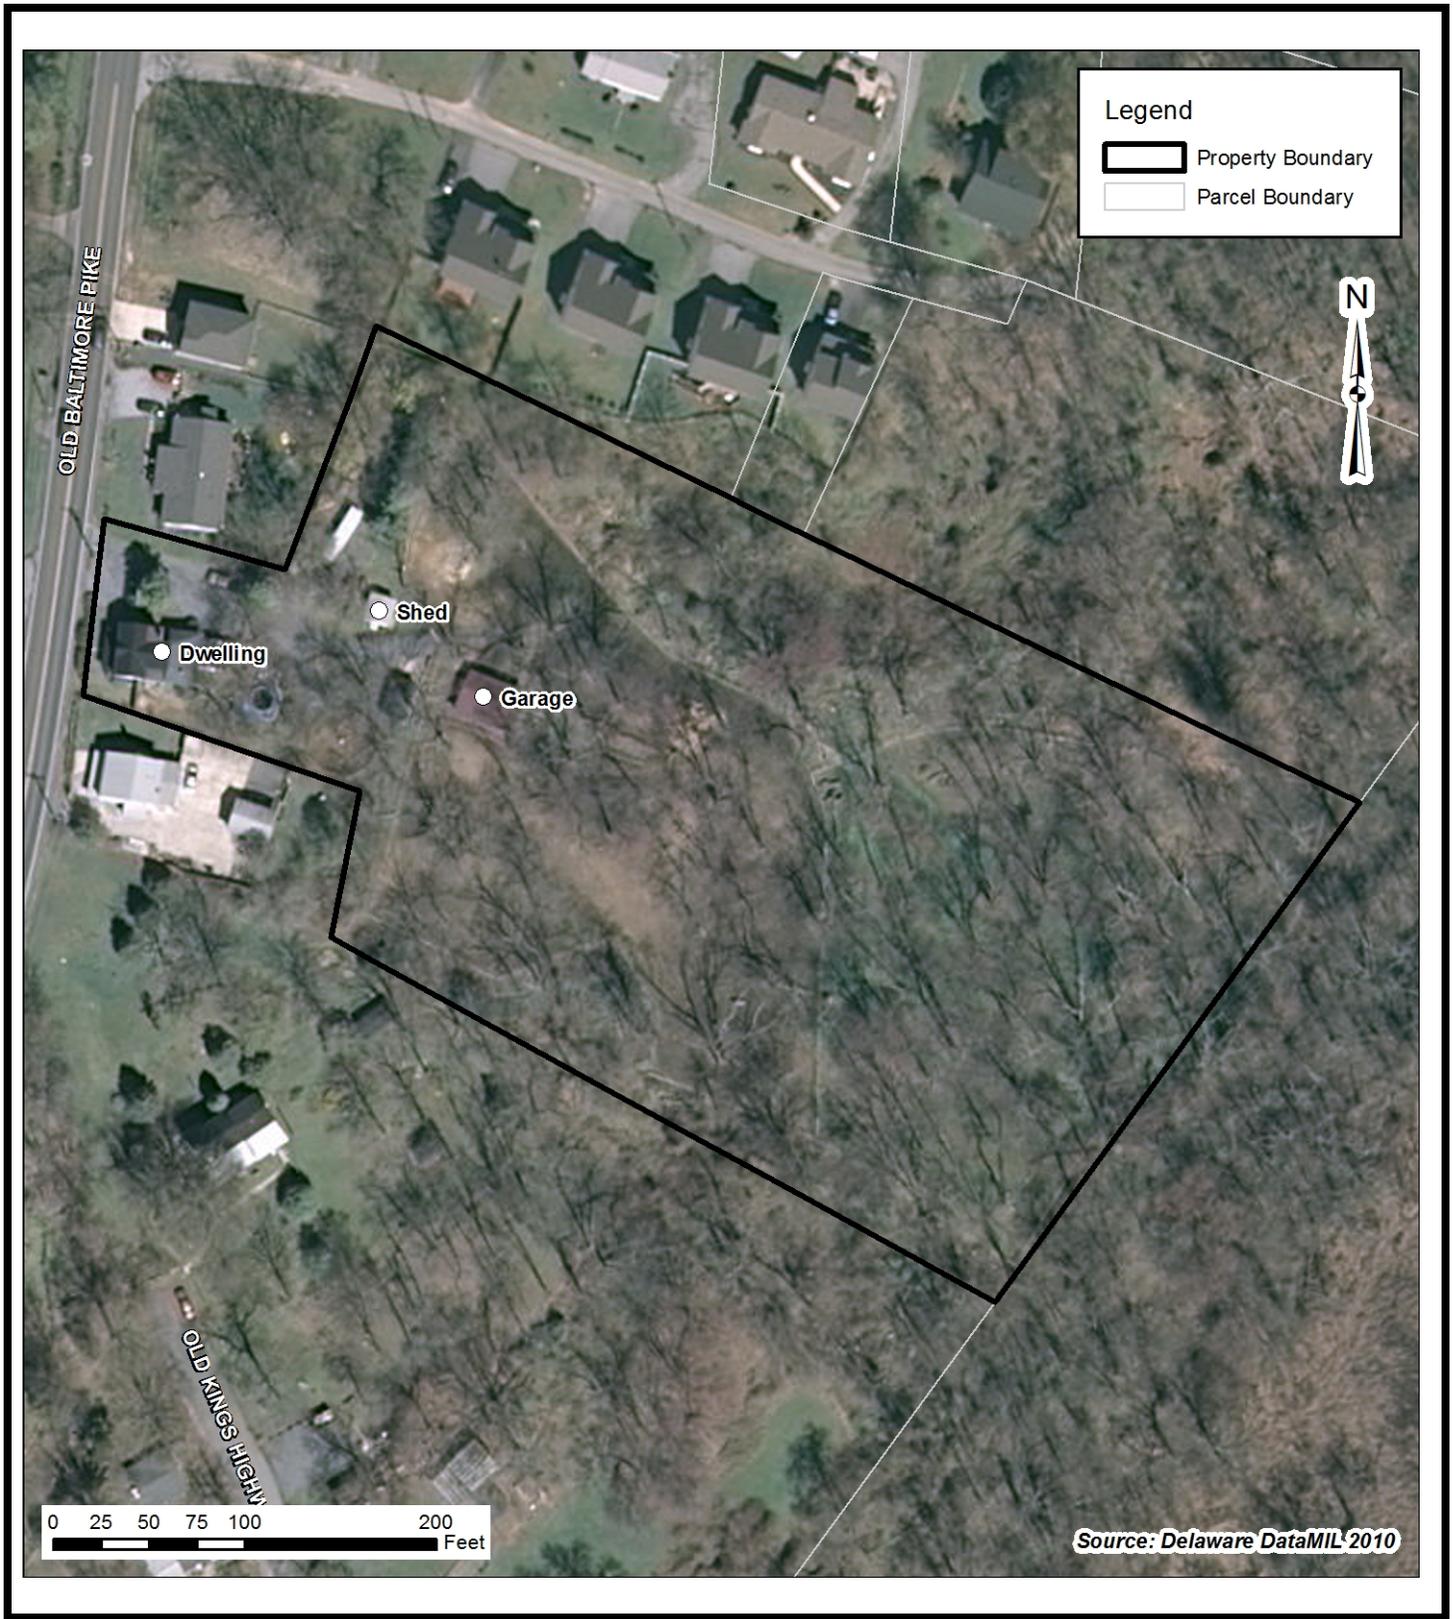
4. SITE PLAN:

10. LANDSCAPING: The majority of the property is forested, with the dwelling fronting the property along N Old Baltimore Pike. A gravel drive along the north side of the house leads a gravel parking area directly north of the house and continues east. Tall bushes grow along the road in front of the dwelling, partially obscuring views of the building.

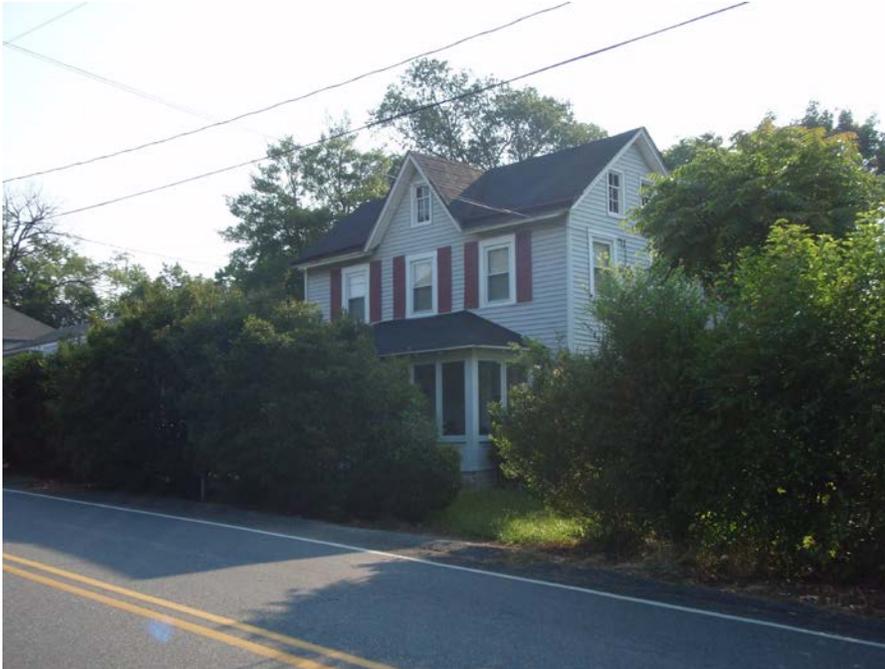
fenestration 2 bays on 1<sup>st</sup> story; 3 on 2<sup>nd</sup> story, 1 on 2.5 story center gable type 1-light fixed wood sash on 1<sup>st</sup> story porch; 1/1 double-hung vinyl sash replacements on 1<sup>st</sup> and 2<sup>nd</sup> stories, 2/4 wood sash on 2.5-story gable trim N/A shutters fixed vinyl shutters on 2<sup>nd</sup> story

4) Porch(es) partial width one story hipped roof porch w/ center door and 1-light wood sash ribbon windows w/ wood paneling below; roof has exposed rafter ends

fenestration 2 1/1 windows on 1<sup>st</sup> & 2<sup>nd</sup> and 2.5 story main block, 1 bay on 1<sup>st</sup> and 2<sup>nd</sup> story rear ell, 2 bays on addition

Description Façade (west elevation) and south elevation of main building looking northeast; Façade and north elevation of main building looking southeast

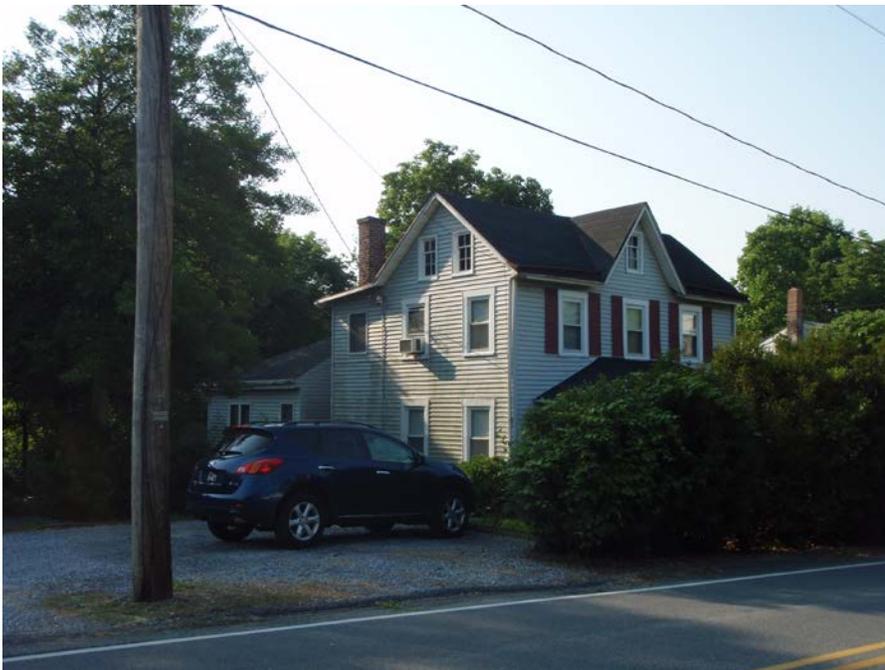
fenestration regular 2 bays on 1<sup>st</sup>, 2<sup>nd</sup>, and half story of main block; 1 bay on 2-story shed roof; 1 window bay on addition
