CULTURAL RESOURCE SURVEY
PROPERTY IDENTIFICATION FORM

CRS # N08804
SPO Map 08-09-34
Hundred White Clay Creek
Quad Newark East
Other Parcel 0903000074

1. HISTORIC NAME/FUNCTION: Dwelling, 82 N Old Baltimore Pike
2. ADDRESS/LOCATION: 82 N Old Baltimore Pike, Newark, Delaware 19702
3. TOWN/NEAREST TOWN: Christiana vicinity?
4. MAIN TYPE OF RESOURCE: building structure site object
 landscape district
5. MAIN FUNCTION OF PROPERTY: Single Dwelling
6. PROJECT TITLE/ REASON FOR SURVEY (if applicable): SR1 Lane Widening

CULTURAL RESOURCE SURVEY
MAIN BUILDING FORM

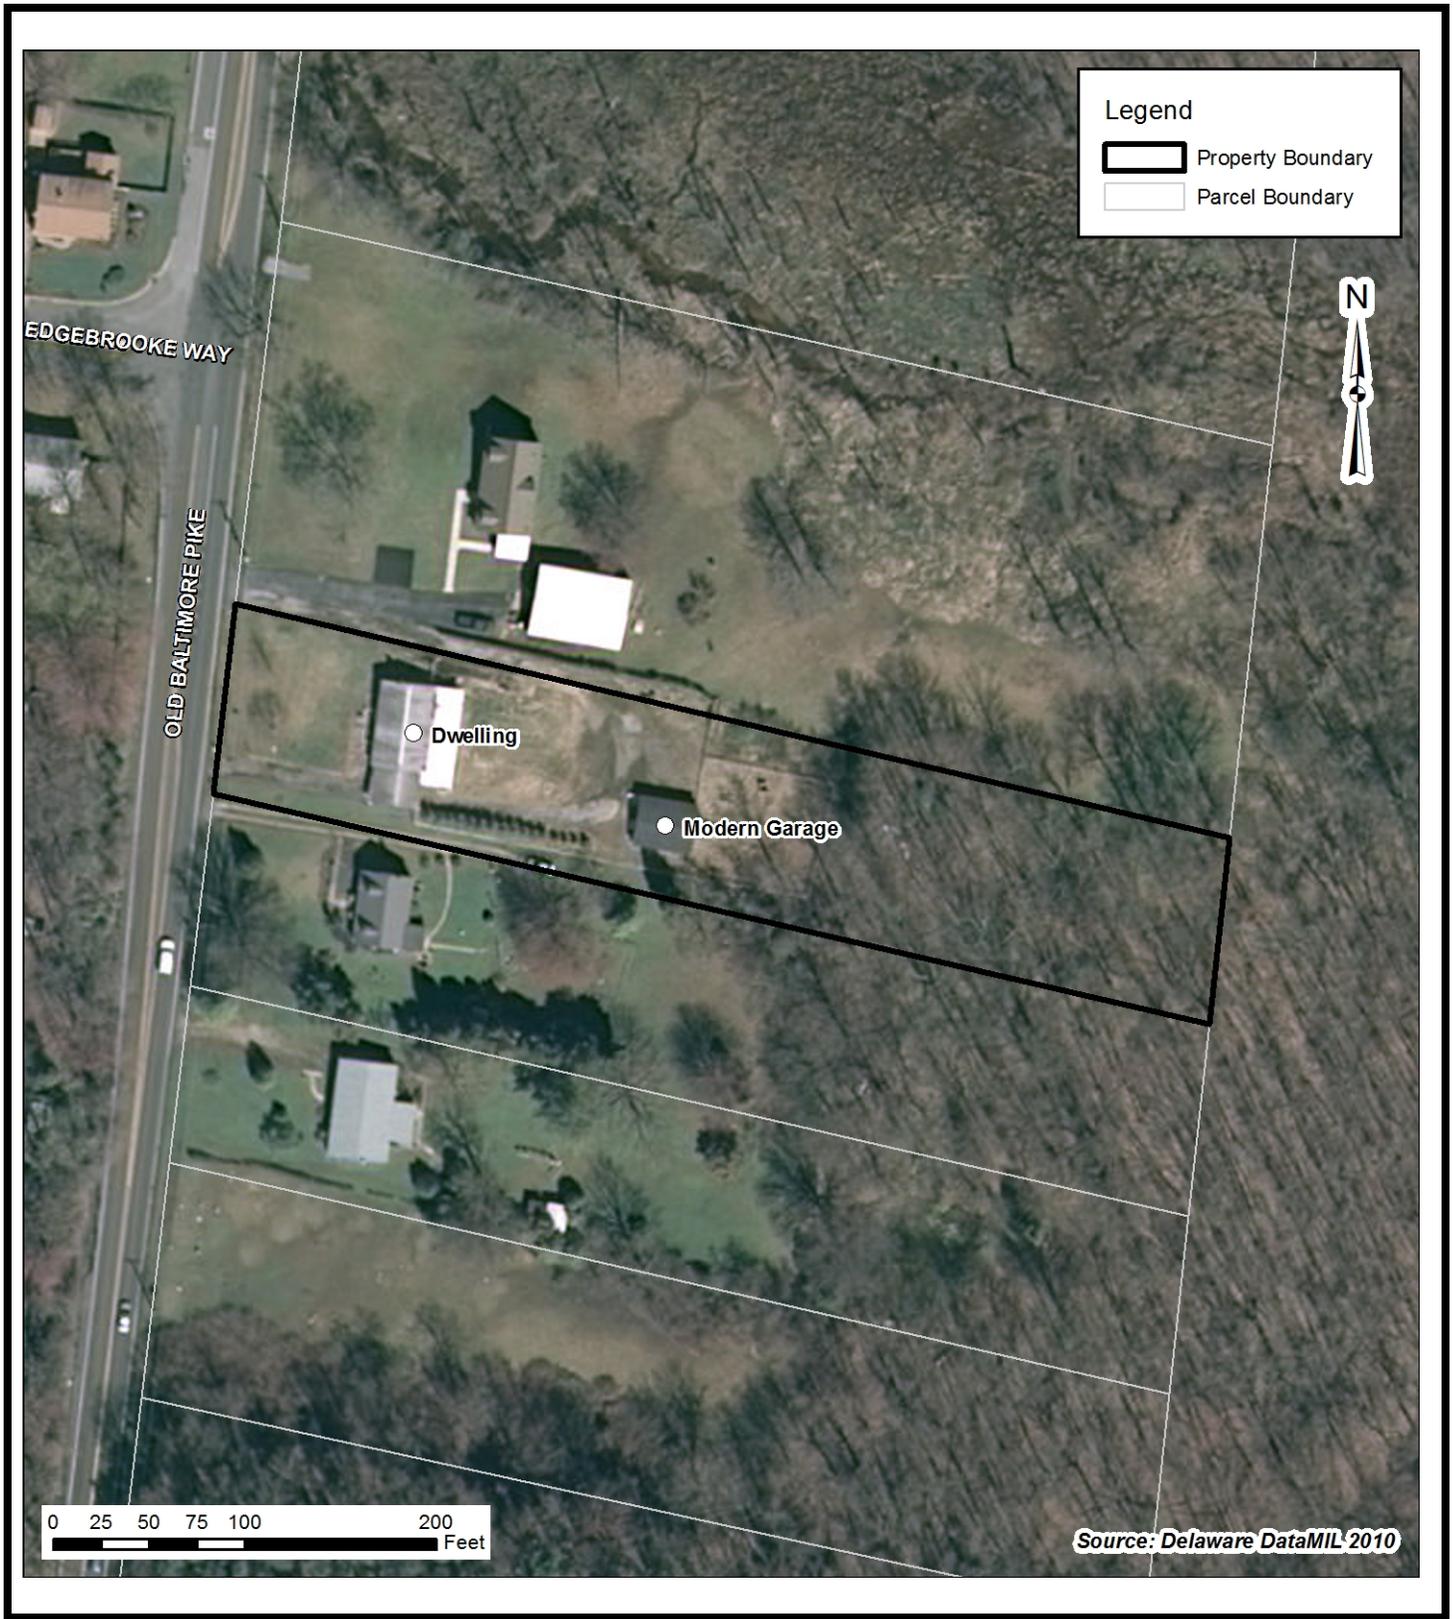
INDICATE NORTH ON PLAN

10. LANDSCAPING: The house is set back from the road on a grassy, level parcel. Scattered mature trees shade the front yard of the property. An unpaved driveway leads to the garage on the south side of the house and an additional unpaved driveway extends along the north side of the house, leading to the rear of the property.

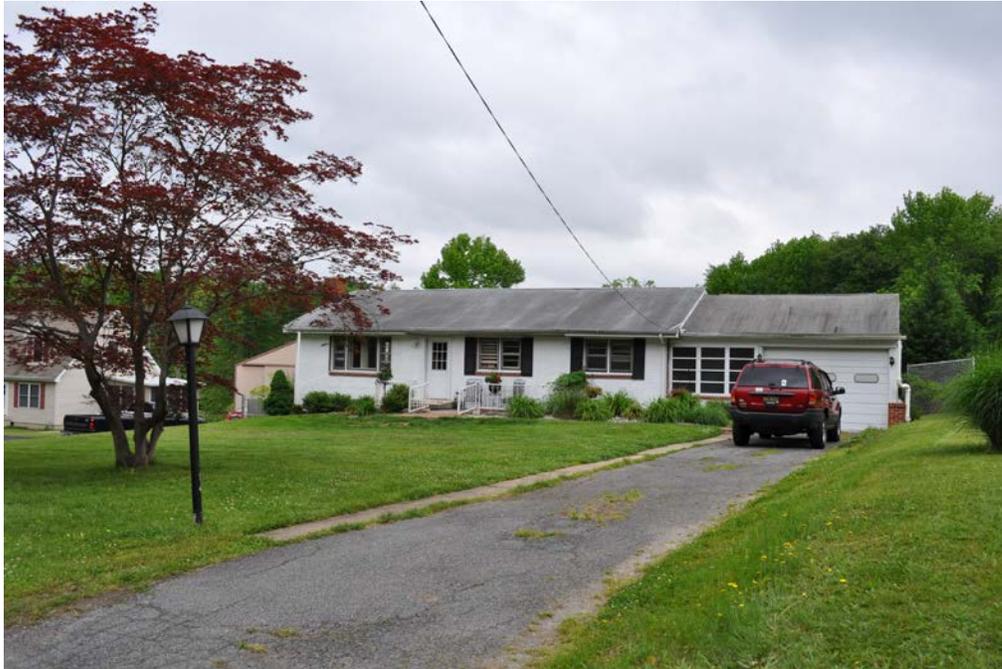
Description Main (west) elevation looking northeast; Main and north elevations looking southeast
