CULTURAL RESOURCE SURVEY
PROPERTY IDENTIFICATION FORM

CRS # N08807
SPO Map 08-09-33
Hundred Newcastle
Quad Newark East
Other Parcel 1002800012

- HISTORIC NAME/FUNCTION: Dwelling, 114 E Main Street
- ADDRESS/LOCATION: 114 E Main Street, Newark Delaware, 19702
- TOWN/NEAREST TOWN: Christiana vicinity?
- MAIN TYPE OF RESOURCE: building structure site object
landscape district
- MAIN FUNCTION OF PROPERTY: Single Dwelling
- PROJECT TITLE/ REASON FOR SURVEY (if applicable):
SR 1 Widening

CULTURAL RESOURCE SURVEY
MAIN BUILDING FORM

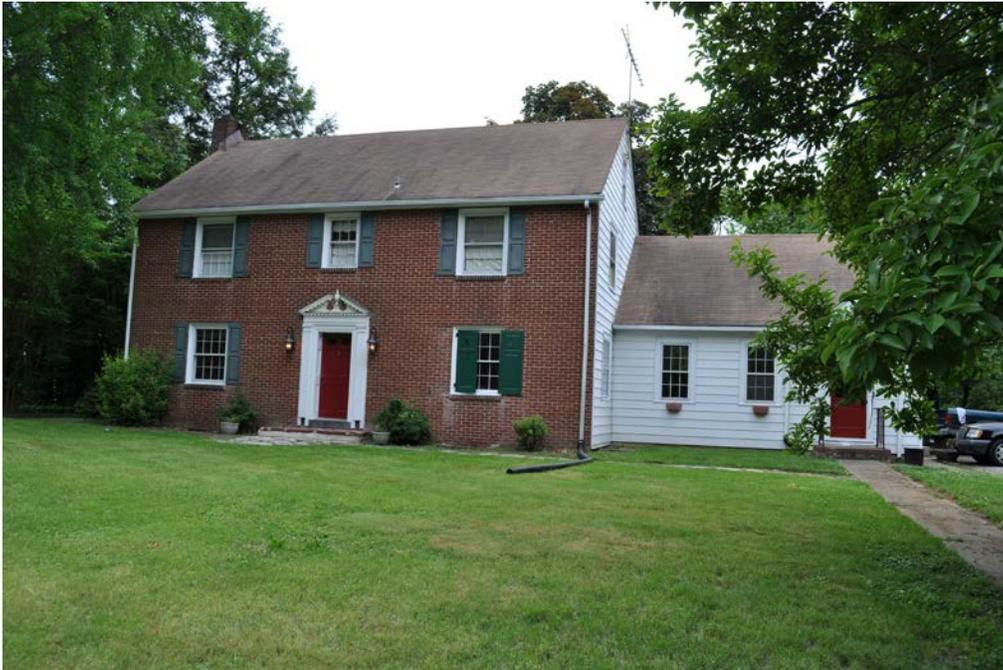
Description Façade (east elevation) of main building (.001) looking west; Southeast corner of main building looking northwest
