CULTURAL RESOURCE SURVEY
PROPERTY IDENTIFICATION FORM

- HISTORIC NAME/FUNCTION: Teague House
- ADDRESS/LOCATION: 166 Bear Christiana Road, Bear, Delaware 19701
- TOWN/NEAREST TOWN: Bear vicinity?
- MAIN TYPE OF RESOURCE: building structure site object
landscape district
- MAIN FUNCTION OF PROPERTY: Single-family dwelling
- PROJECT TITLE/ REASON FOR SURVEY (if applicable):
SR 1 Road Widening

CULTURAL RESOURCE SURVEY
MAIN BUILDING FORM

CRS # N08813.001

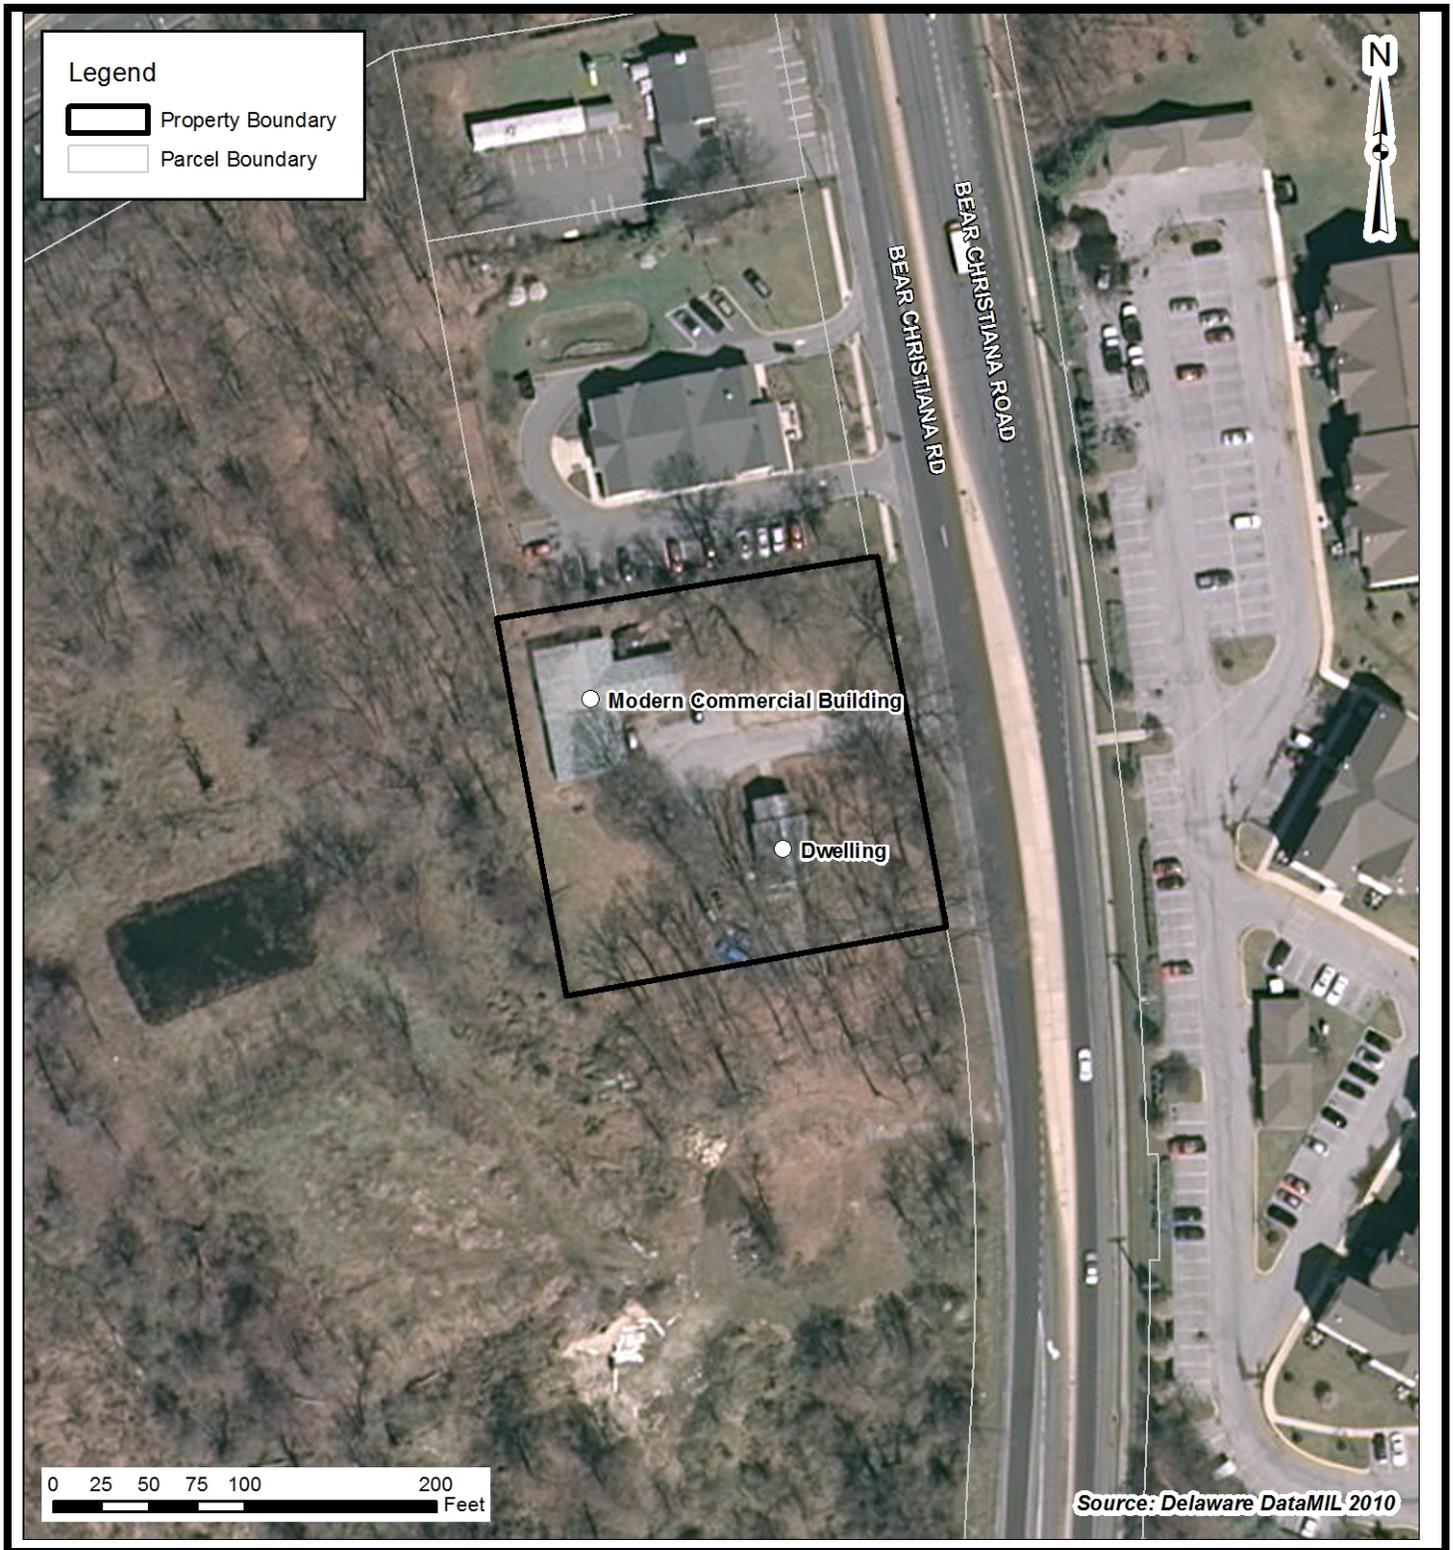
4. SITE PLAN:

10. **LANDSCAPING:** The parcel contains a little less than an acre of land is now has both residential and commercial uses. A paved drive leads west from Bear Christiana Road to the store and includes parking areas for the store and the dwelling. The remainder of the lot has a grassy lawn with mature trees and a few bushes.

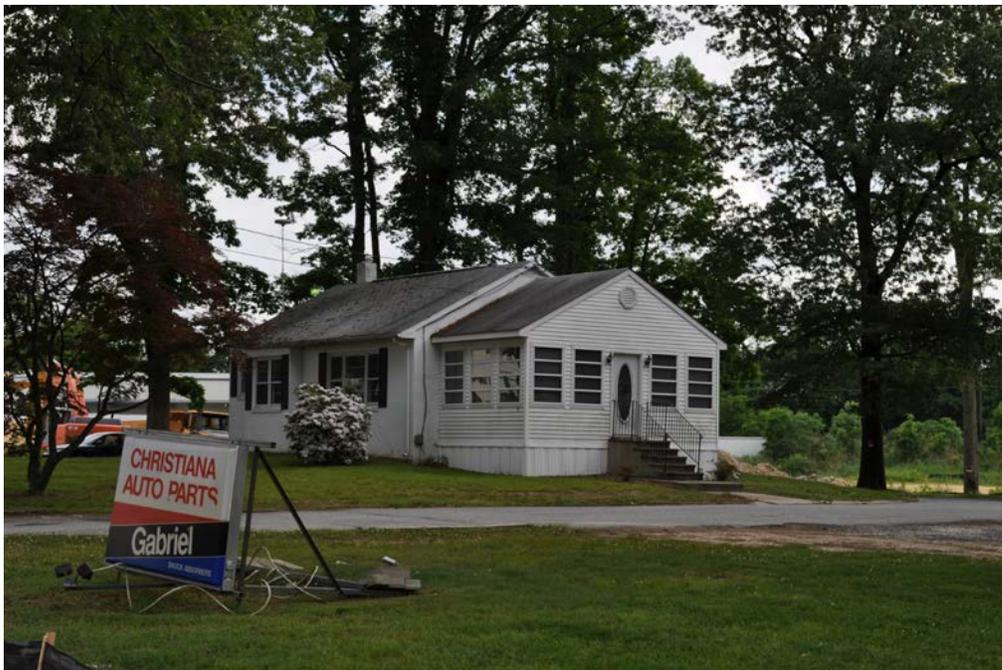
Description Northeast corner of main building (.001) looking southwest; Southeast corner of main dwelling (.001) looking northwest
