CULTURAL RESOURCE SURVEY
PROPERTY IDENTIFICATION FORM

1. HISTORIC NAME/FUNCTION: Forest & Parker Trailer Sales
2. ADDRESS/LOCATION: 851 Pulaski Highway, Bear, Delaware 19701
3. TOWN/NEAREST TOWN: Bear vicinity?
4. MAIN TYPE OF RESOURCE: building structure site object
 landscape district
5. MAIN FUNCTION OF PROPERTY: Commercial Building
6. PROJECT TITLE/ REASON FOR SURVEY (if applicable): SR1 Lane Widening

CULTURAL RESOURCE SURVEY
MAIN BUILDING FORM

CRS # N08817.001

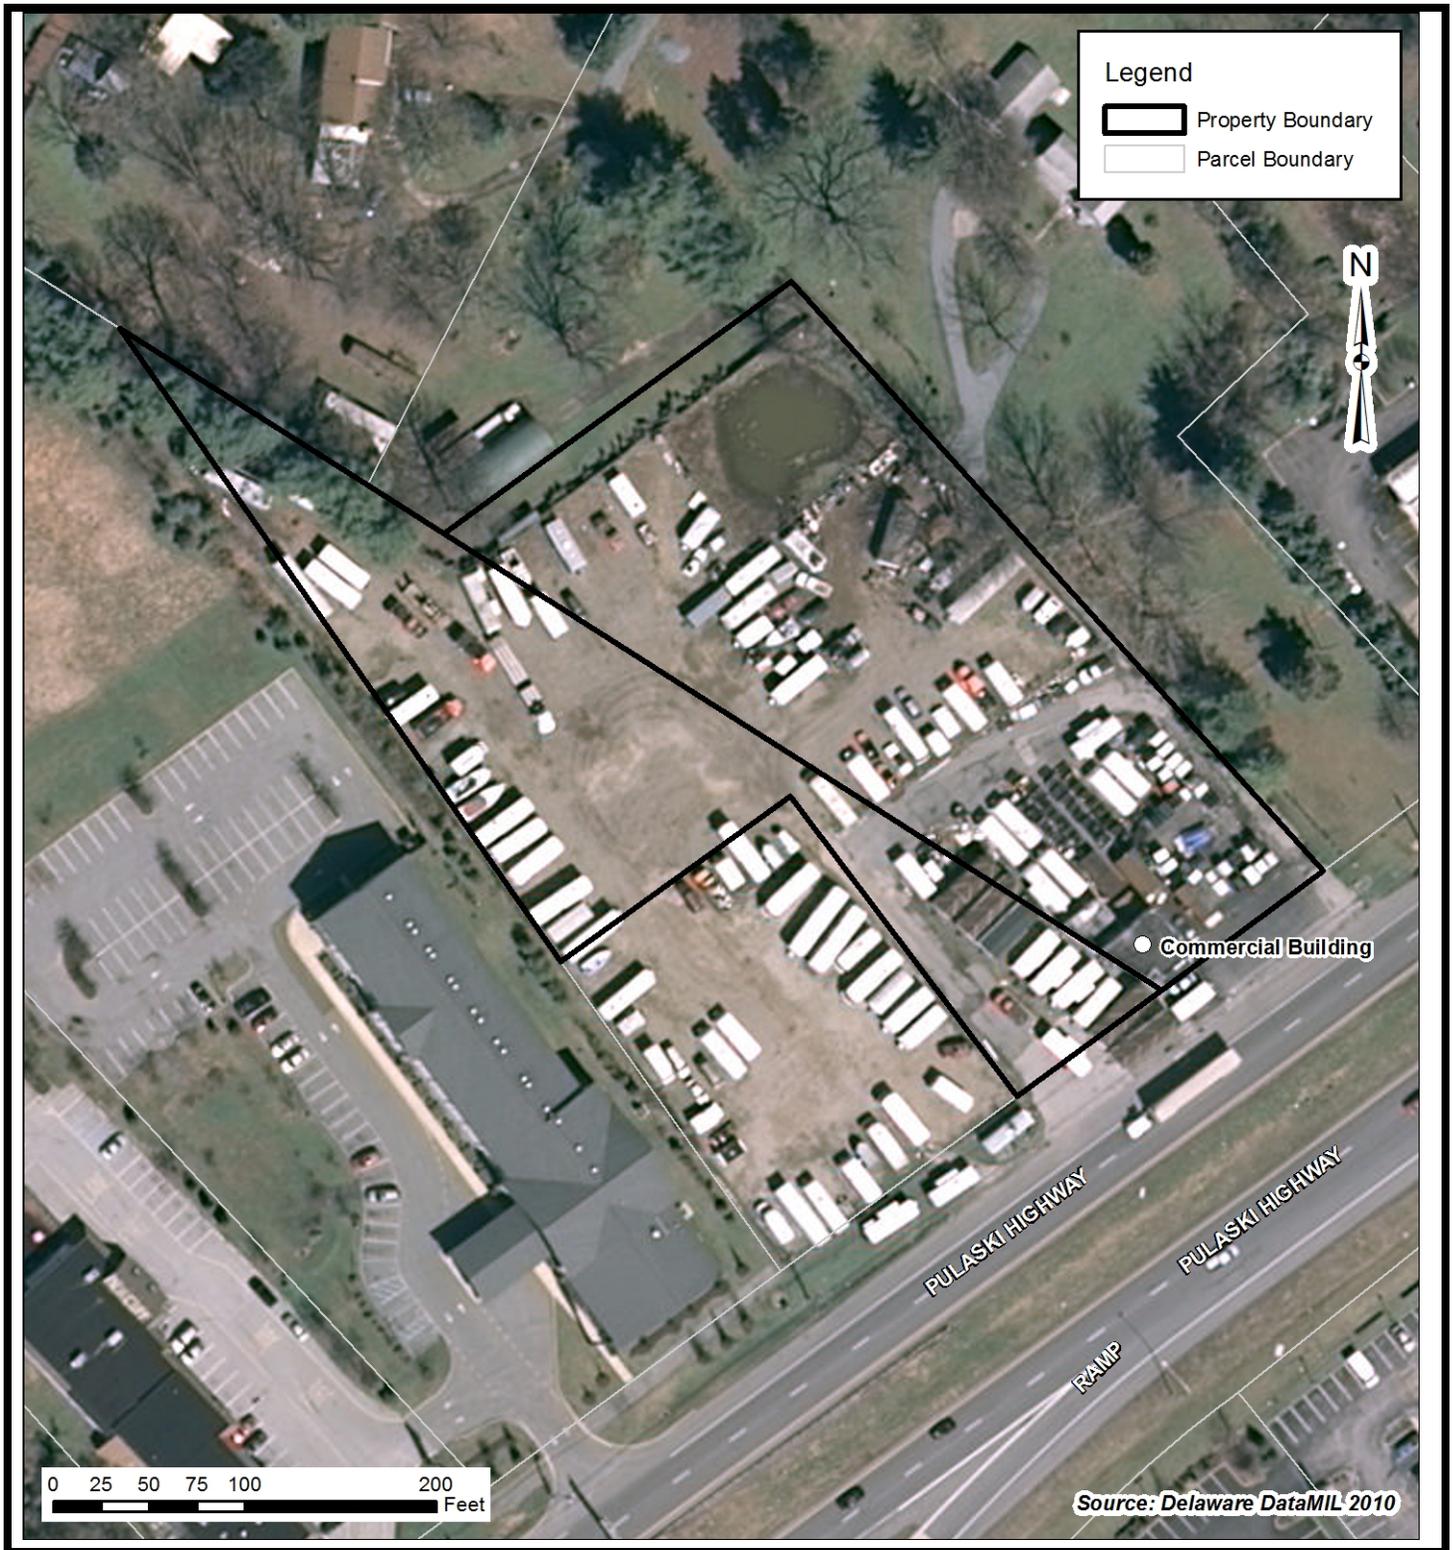
4. SITE PLAN:

10. **LANDSCAPING:** This commercial building is set back from the road and surrounded by a paved parking and storage area. West and north of the building is a gravel storage area that is enclosed by chain-link metal fencing.

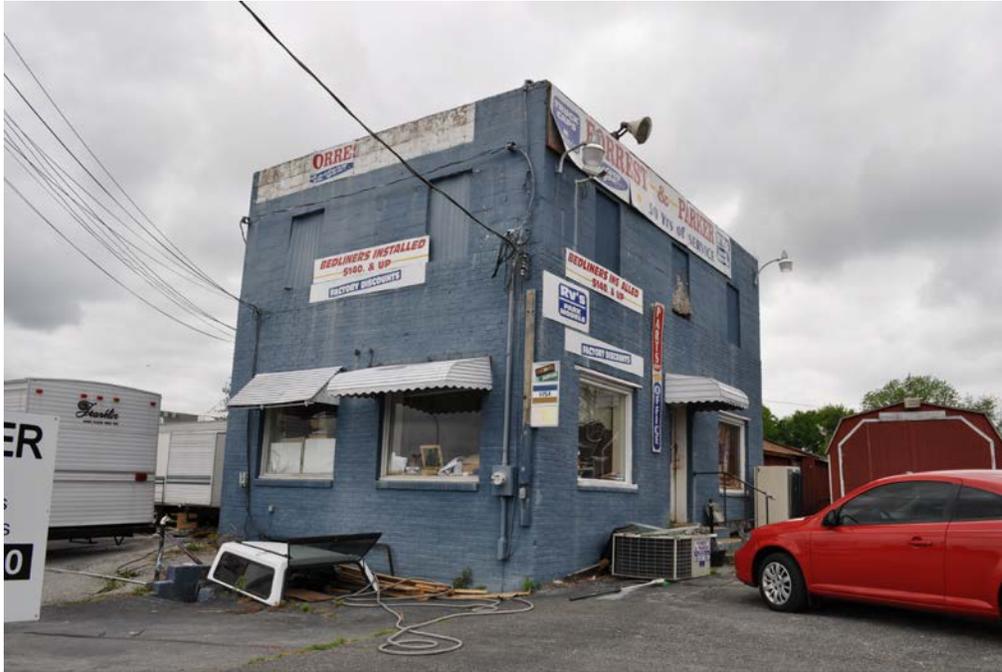
Description Main (northeast) and southeast elevations of main building (.001), looking north;
Southwest elevation looking northeast
