CULTURAL RESOURCE SURVEY  
PROPERTY IDENTIFICATION FORM

CRS # N08823  
SPO Map 08-09-32  
Hundred Newcastle  
Quad St Georges  
Other Parcel 1004440255

1. HISTORIC NAME/FUNCTION: Dwelling, 1082 Bear Road
2. ADDRESS/LOCATION: 1082 Bear Road, New Castle, Delaware 19720
3. TOWN/NEAREST TOWN: Bear vicinity?
4. MAIN TYPE OF RESOURCE:      building       structure       site       object   
   landscape       district
5. MAIN FUNCTION OF PROPERTY: Single Dwelling
6. PROJECT TITLE/ REASON FOR SURVEY (if applicable): SR1 Lane Widening

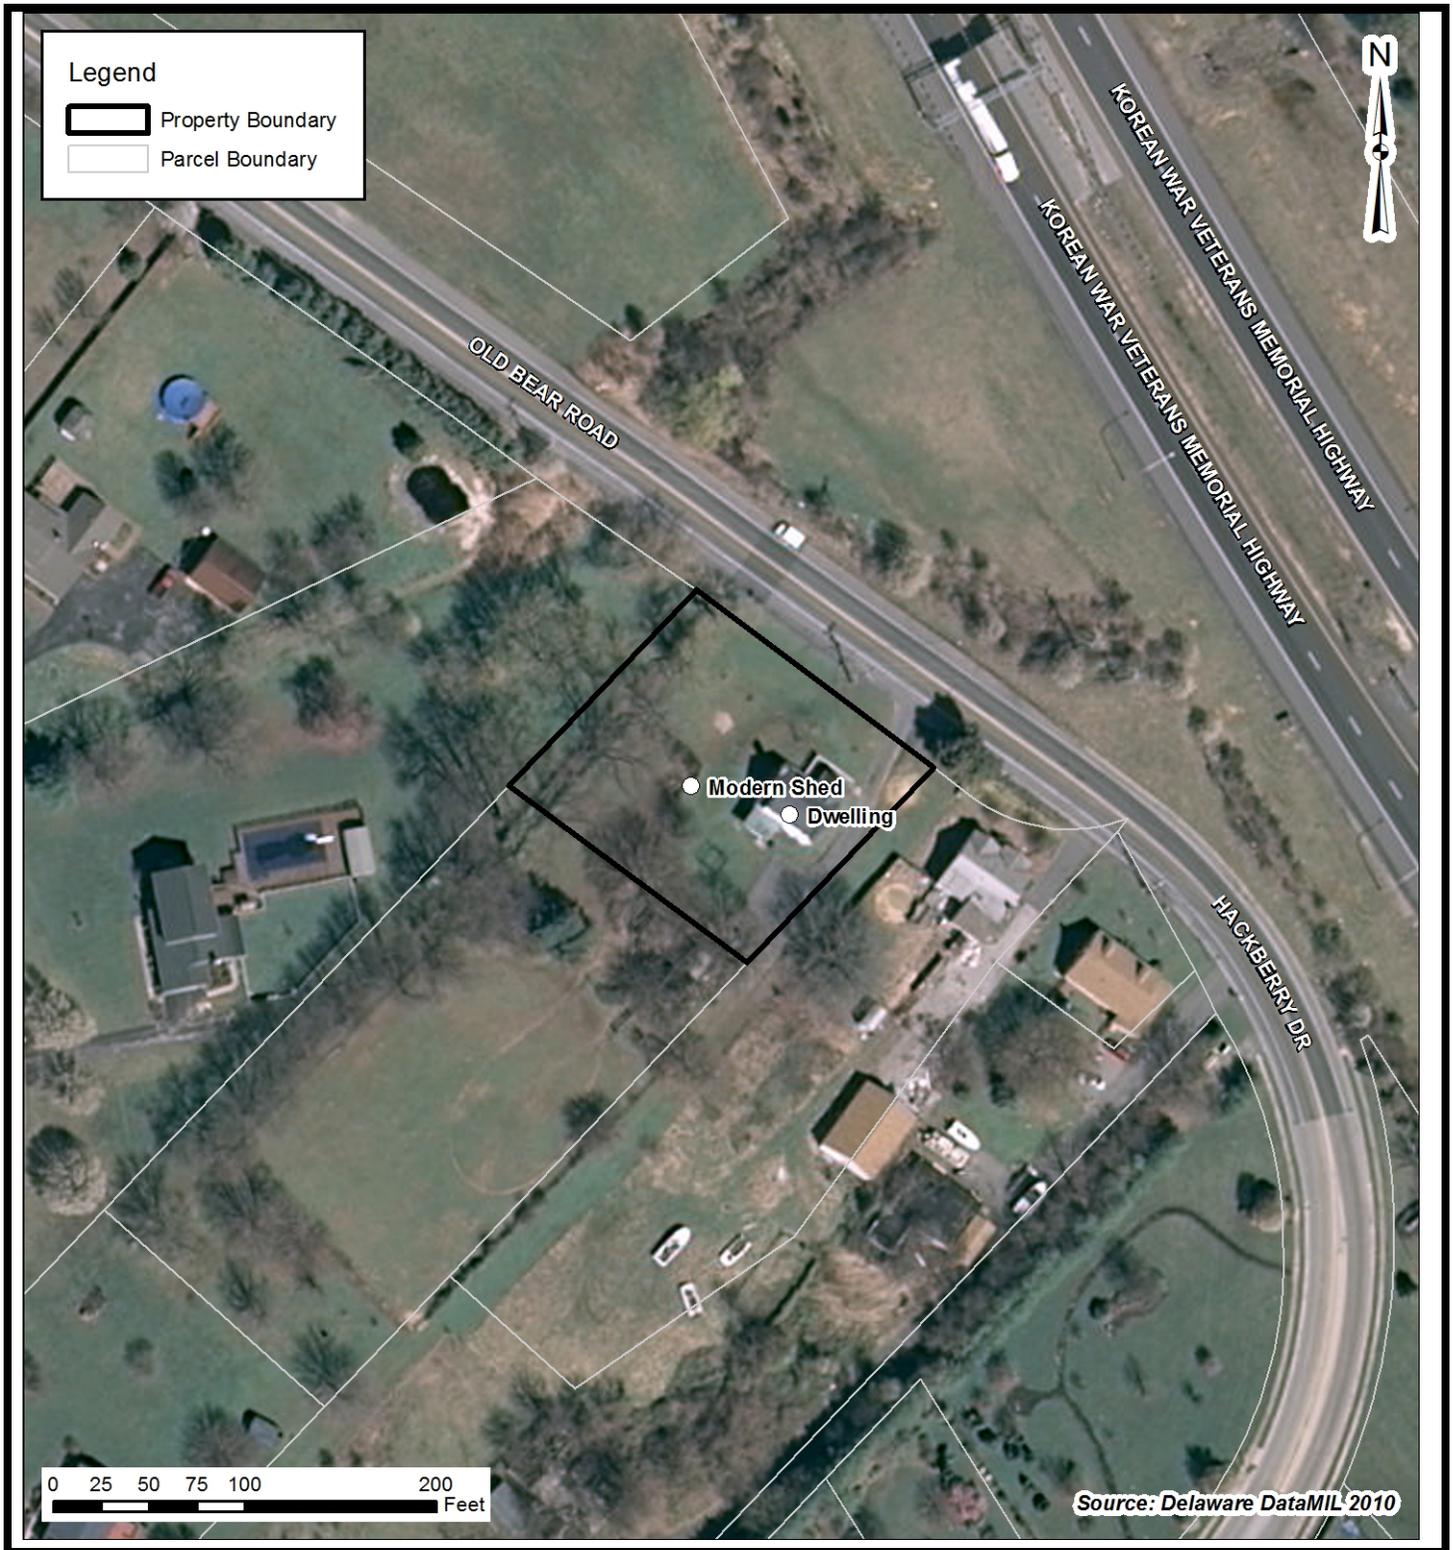
4. SITE PLAN:

A small prefabricated shed, built after 1965, stands southwest of the house.

10. **LANDSCAPING:** Facing northeast, the house is set back from the road on a level, grassy lot. Mature trees shade the rear of the lot and a paved driveway leads to the house along its east side. Directly north of the house is State Route 1, which is partially blocked from view by mature plantings.

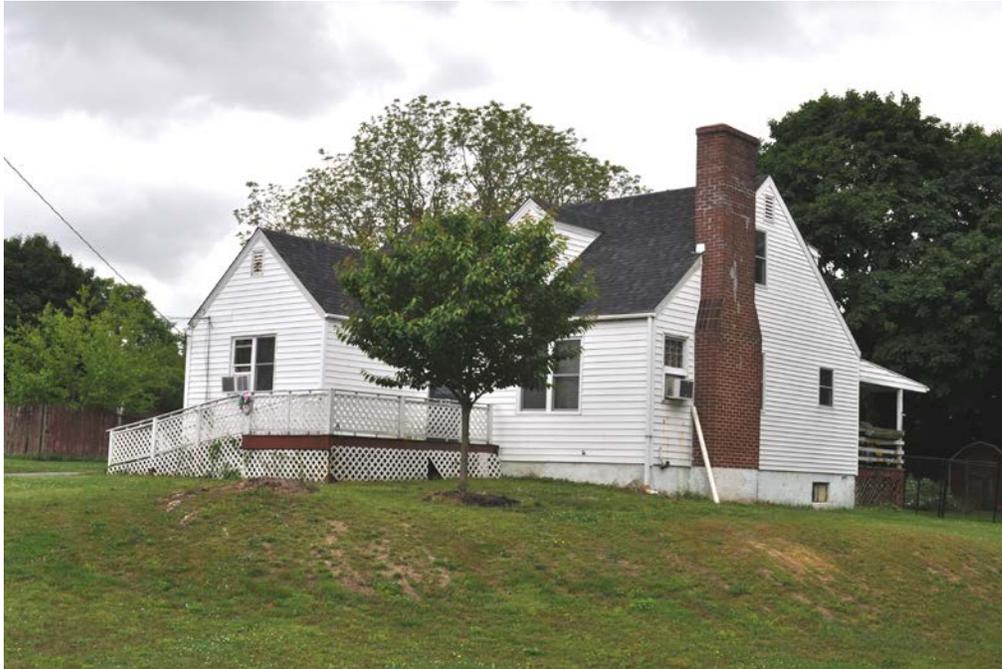
CRS # N08823      Date 5/22/2012      Photo Roll # N/A      Surveyor S. Groesbeck  
P. Kuhn

Description Main (northeast) and northwest elevation looking southeast
