CULTURAL RESOURCE SURVEY
SURVEY UPDATE FORM

CRS # N05042

1. HISTORIC NAME/FUNCTION: Bloomfield

2. ADDRESS/LOCATION: 4663 Kirkwood St. Georges Road, Saint Georges, 19733

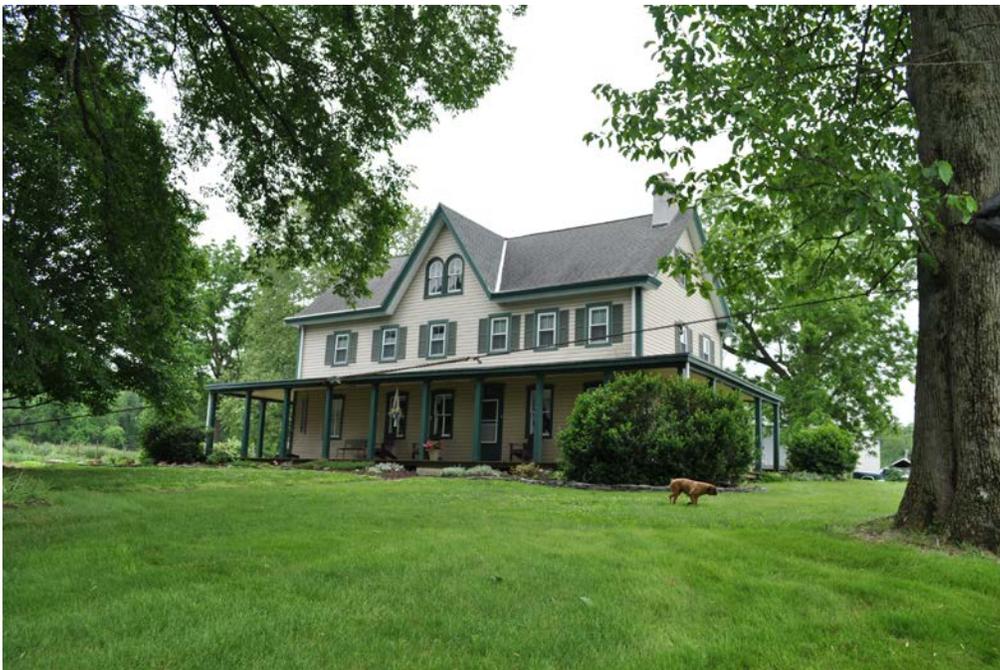
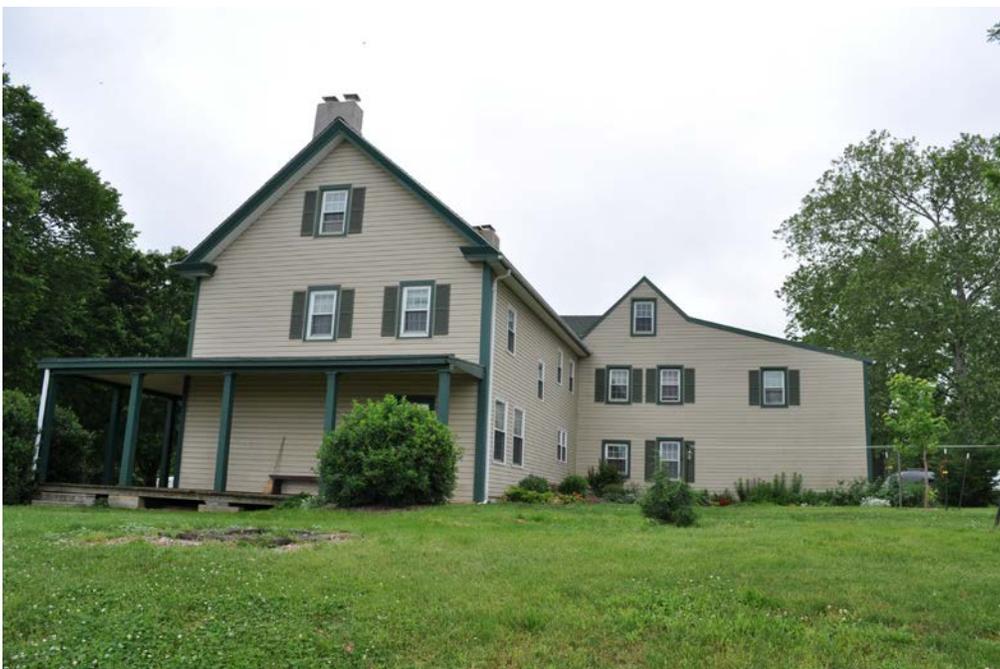
CRS # N05042 Date 5/22/2012 Photo Roll # n/a Surveyor S Groesbeck & P Kuhn

4. INTEGRITY: The dwelling's exterior siding has been replaced with vinyl and some windows replaced with vinyl sash windows. The porch on façade was a new wood floor. The door openings on first floor of west elevation of rear ell removed. The majority of the associated outbuildings have been demolished since the property was listed in 1982 (see notes).

Description Façade (north elevation) and west elevation of main building looking southeast; West elevation of main building looking east
