CULTURAL RESOURCE SURVEY
PROPERTY IDENTIFICATION FORM

1. HISTORIC NAME/FUNCTION: Marie Elizabeth Moore House
2. ADDRESS/LOCATION: 56 Lark Avenue, Bear, Delaware, 19701
3. TOWN/NEAREST TOWN: Bear vicinity?
4. MAIN TYPE OF RESOURCE: building structure site object
 landscape district
5. MAIN FUNCTION OF PROPERTY: Single Dwelling
6. PROJECT TITLE/ REASON FOR SURVEY (if applicable): SR1 Lane Widening

1. ADDRESS/LOCATION: 56 Lark Avenue, Bear, Delaware 19701
2. FUNCTION(S): historic Single Dwelling current Single Dwelling
3. YEAR BUILT: 1950 CIRCA?: ARCHITECT/BUILDER: Unknown

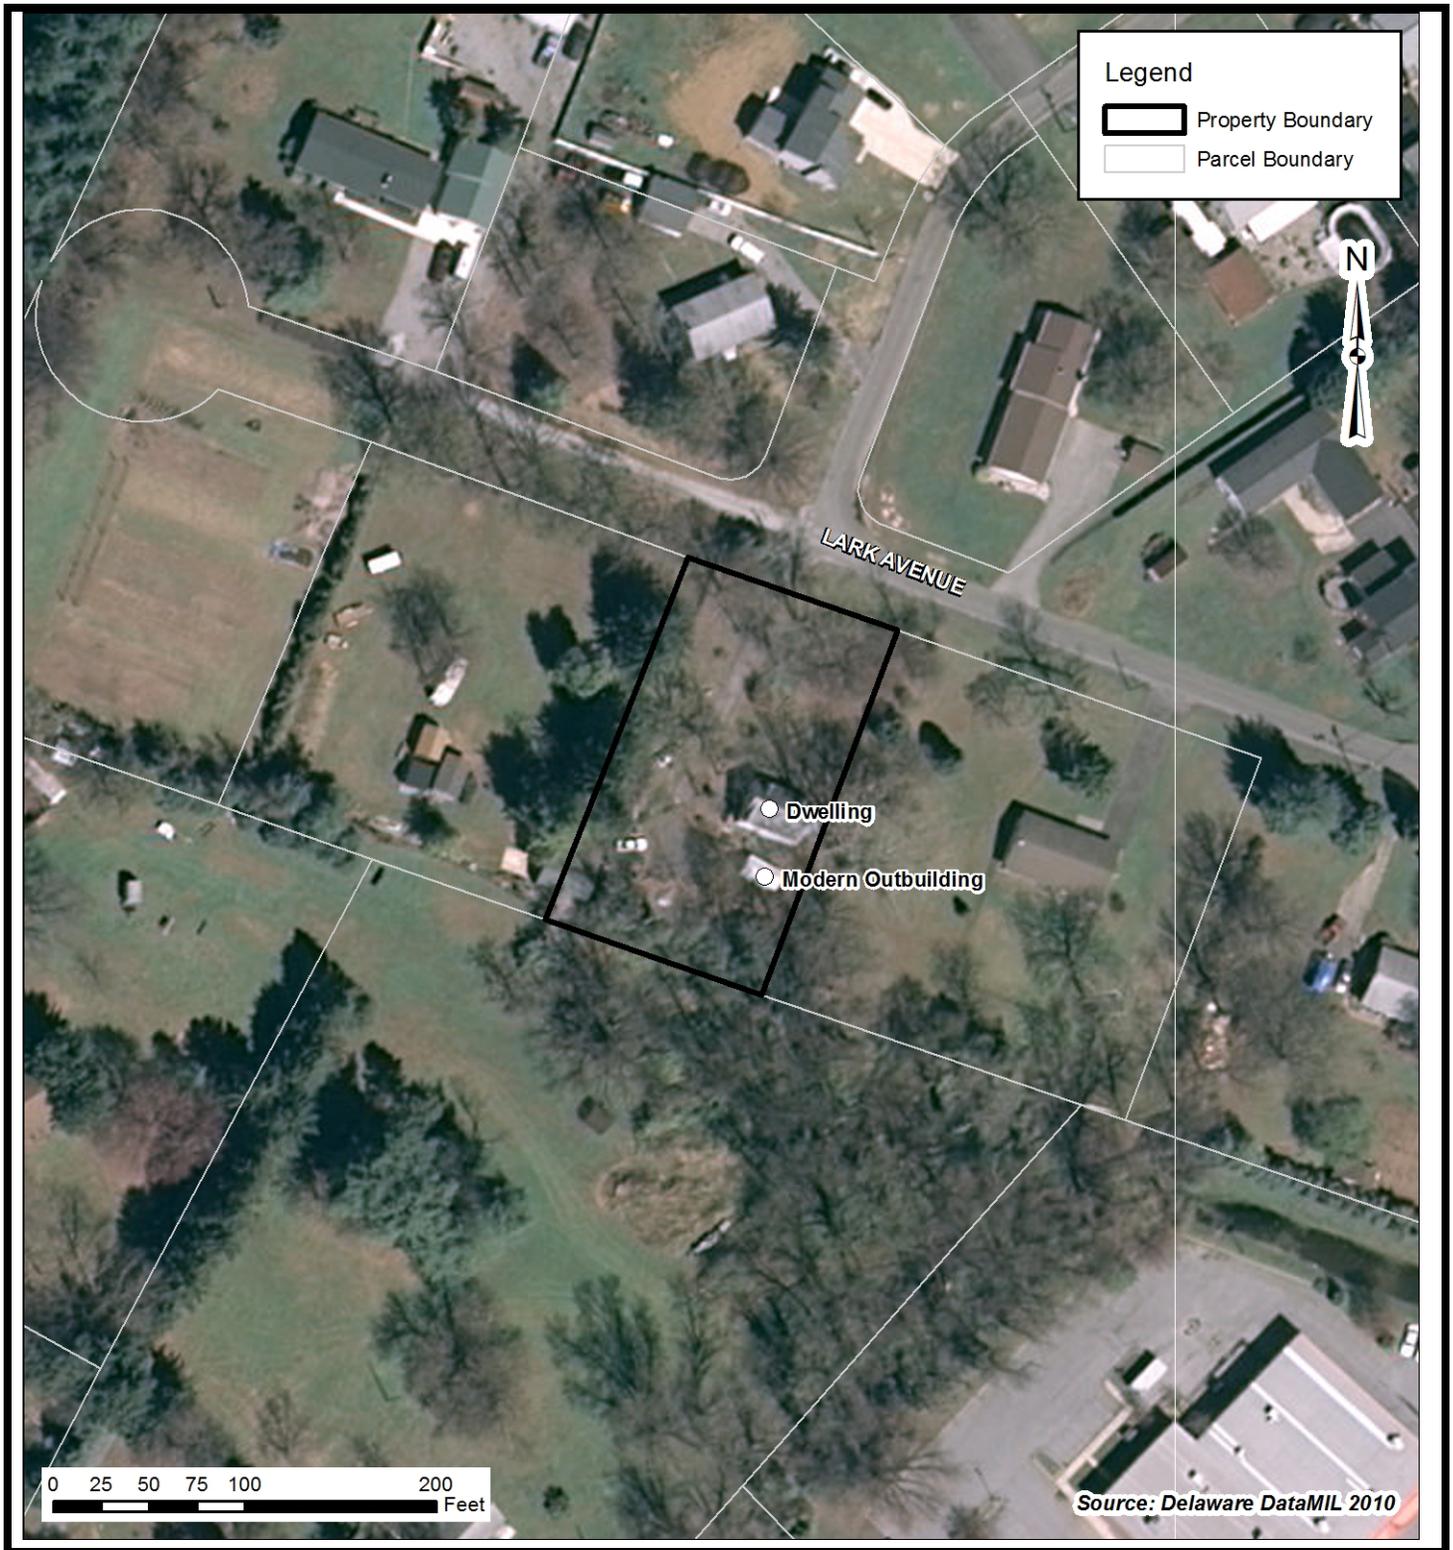
4. SITE PLAN:

10. **LANDSCAPING:** The house is set back from the road on a level, grassy lot that is shaded by mature trees. A paved driveway leads to the house along its northwest side. Large foundation plants line the façade of the house.

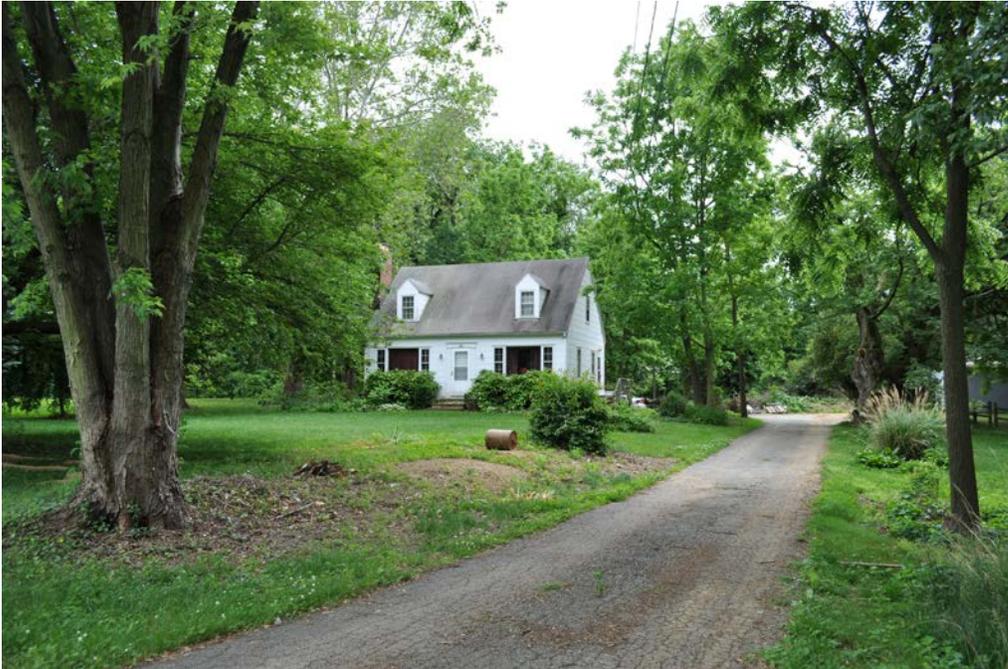
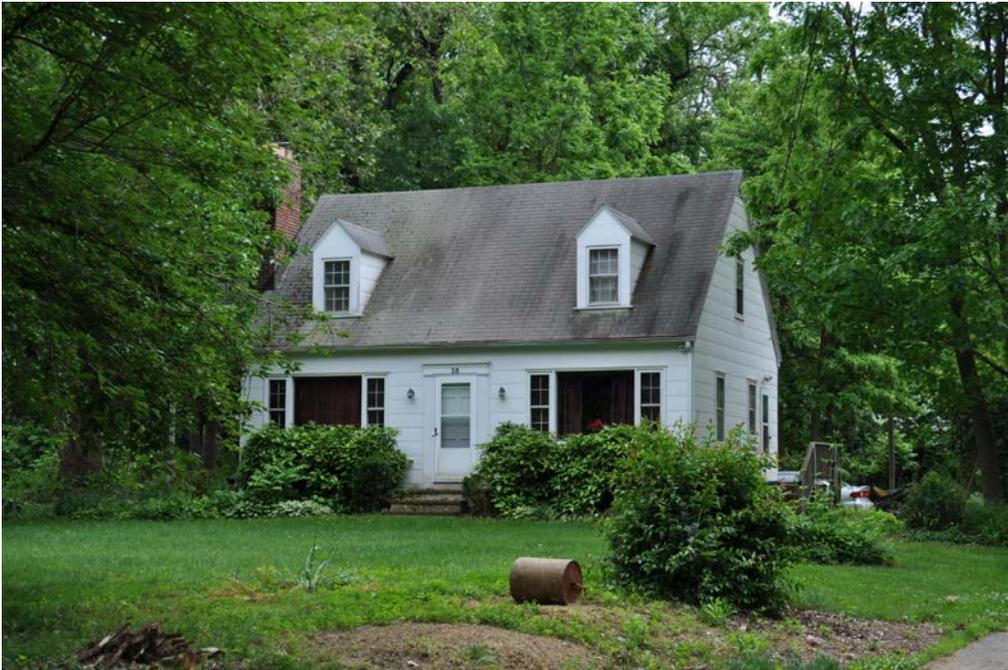
Description View of property from road looking southeast; Main (north) and west elevations looking southeast
