S-11467. Dwelling, 12689 U.S. 113
(PIN: 230-26.00-104.00)
(Detail Map #2)

**S-11468. Dwelling, 12675 DuPont Highway
(PIN: 230-26.00-103.00)
(Detail Map #2)**

S-11469. Dwelling, 18381 Deer Forest Road
(PIN: 135-5.00-39.00)
(Detail Map #5)

**S-11471. Redden Furniture, 18293 DuPont Highway
(PIN: 135-6.00-4.00)
(Detail Map #6)**

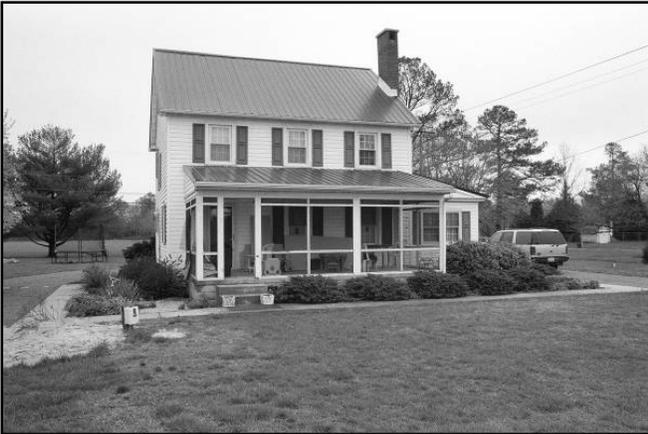
This two-story, side-gabled, three bay, c. 1930s, wood-framed house has a projecting, full-width, shed-roofed, front screened porch and a shed-roofed side ell. The front porch, probably an addition, has a concrete floor, concrete-block foundation, modern metal-clad wood posts, and screening. The entry, placed at the left side of the façade, contains a modern half-wheel and four-panel fiberglass door. The south side features a shed-roofed enclosed side porch that is nearly full width. The porch, probably built in the 1950s, has six-over-six, double-hung wood sash windows. Fenestration of the remainder of the house includes six-over-six, double-hung vinyl sash windows. The rear entry is placed in a shed-roofed, full-width, partially enclosed, partially screened porch. The entry, centered on the wall, consists of a modern nine-light, two-panel fiberglass door. The house is clad in vinyl siding and its roof is sheathed in standing seam metal. A half-engaged brick chimney adjoins one gable end.

main building (.001) façade, view to E

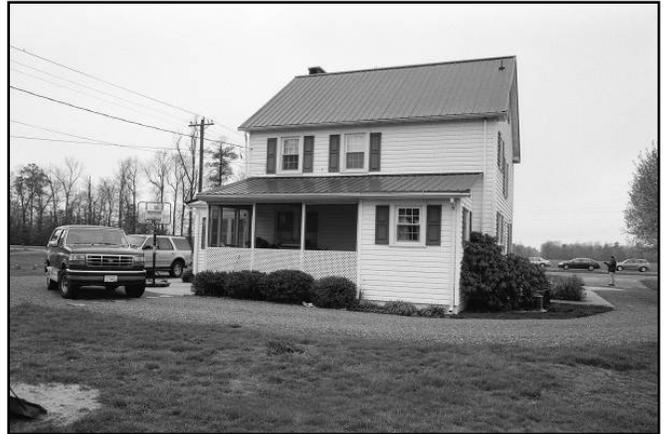
main building (.001) rear, view to W

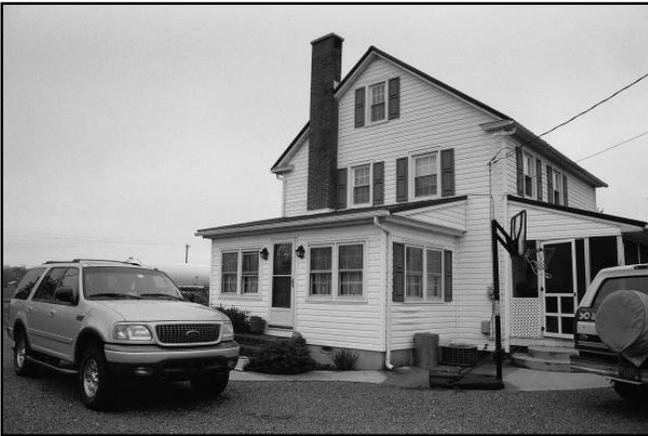
main building (.001) rear and south side, view to NW

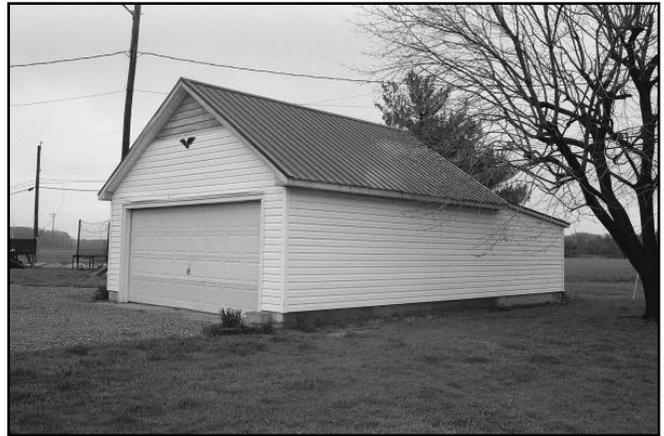
The wood-framed, c. 1930, gabled front garage (.002) is placed southeast of the house. It sits on a concrete-block foundation, is sheathed in vinyl siding over horizontal wood siding, and has a metal-clad roof. The west façade contains a modern, 32-panel, double-size, roll-down garage door. The remaining sides are blank. The rear is obscured by a full-width, lean-to addition.

garage (.002), view to NE

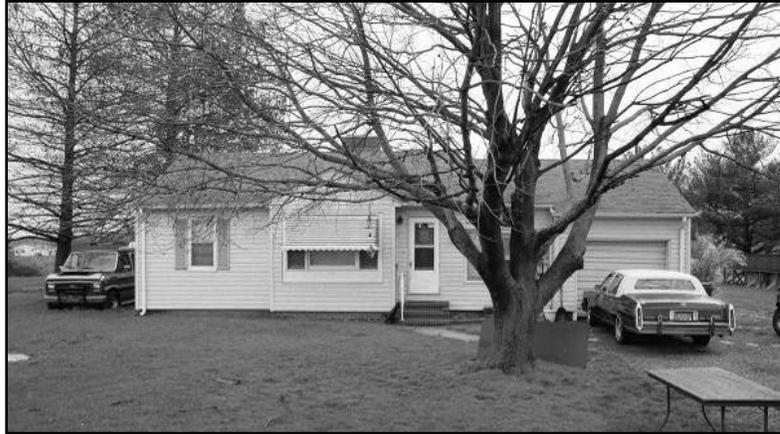
This single-story, c. 1940, side-gabled, wood-framed house with a central cross gable has two front entry doors, a six-panel and a jalousie panel with jalousie sidelights. A brick stoop with wrought-iron balustrade adjoins the first-mentioned door. Another entry is placed in the south wall of a rear extension. This half-wheel and four-panel wood-and-glass door adjoins a concrete stoop with wrought-iron balustrade. The rear wall features a central jalousie door with jalousie sidelights. Fenestration consists of replacement one-over-one, double-hung sash windows, two-over-two, double-hung sash windows with horizontal muntins, and a tripartite window with central fixed single light window flanked by one-over-one, double-hung sash windows. This house sits on a concrete-block foundation and is sheathed in vinyl siding. A brick chimney rises from near the center of the rear roof slope.

main building (.001) façade, view to E

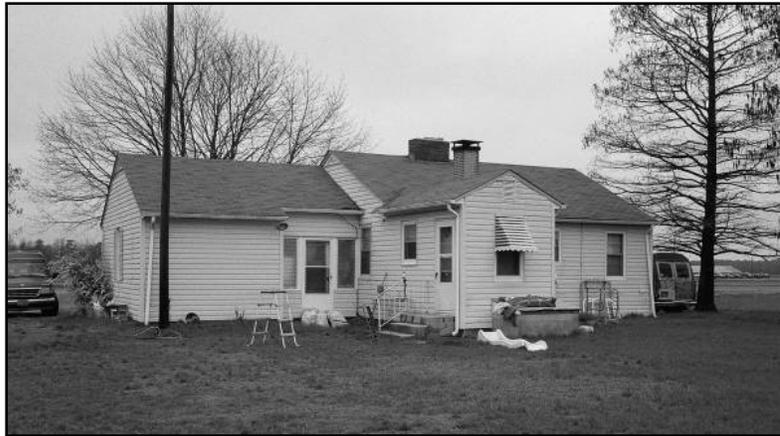
main building (.001) rear and south side, view to NW

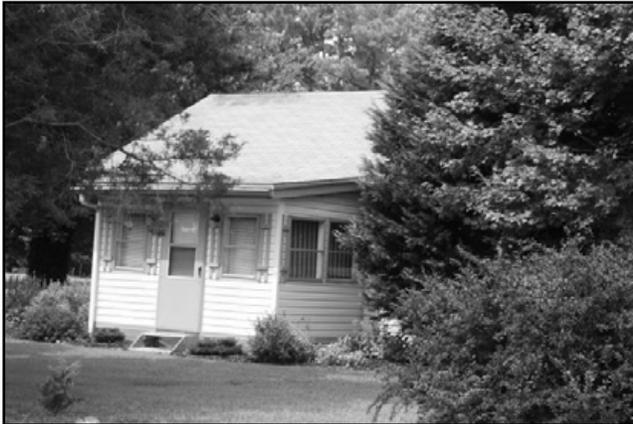
This c. 1940 rectangular-shaped, wood-framed house stands one-story in height and measures three bays wide by two bays deep. A shed-roofed enclosed entry extends from the center of the façade and shelters the main entrance. A full-width, shed-roofed addition extends across the rear wall and is pierced by a secondary entrance located at the east corner of the northeast sidewall. Fenestration throughout consists of single one-over-one, double-hung wood sash windows. The bays along the façade and two sidewalls are flanked by vinyl, non-functional shutters. Metal hood awnings hang above the bays along the sidewalls and rear openings. The house sits on a panel-faced concrete-block foundation and is clad in vinyl. A side-gabled roof sheathed in asphalt shelters the interior. A brick chimney rises from the roof ridge of the northeast gable-end.

main building (.001) façade, view to NW

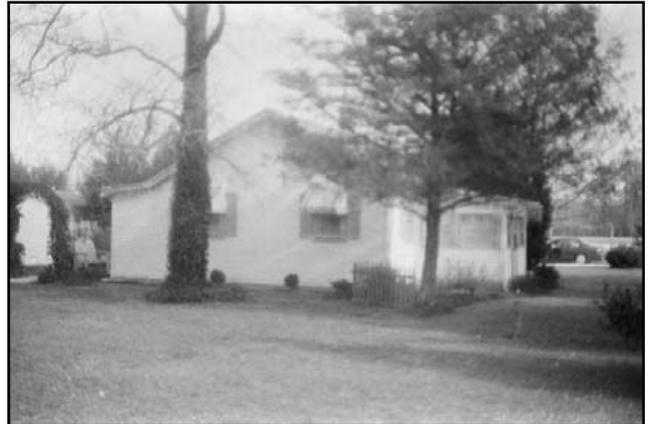
main building (.001) façade and southwest side, view to NE

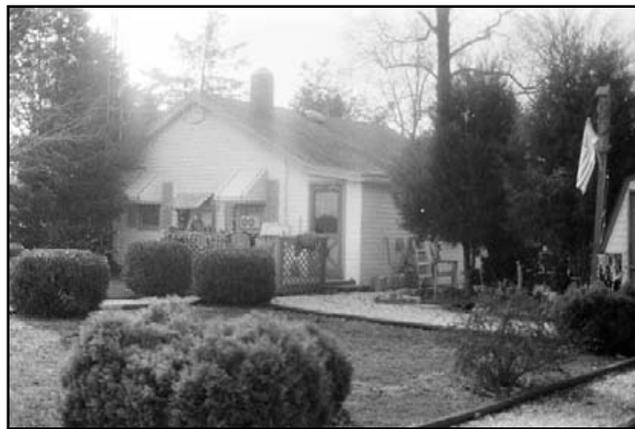
main building (.001) rear and northeast side, view to SW

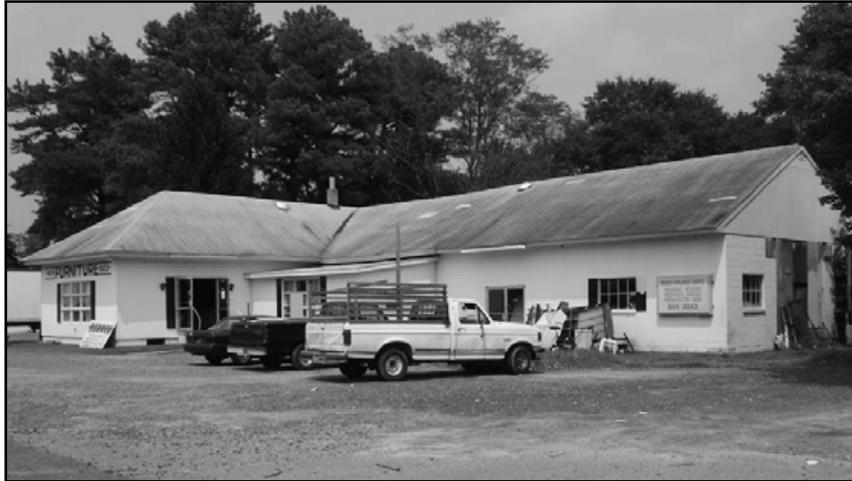
This c. 1940, wood-framed, hipped-roof building stands one-story in height. A hipped-roofed addition spans the north side of the main block, and a one-story, gabled concrete-block addition extends from the southeast side, creating an L-shape plan to the building's overall formation. A shed-roofed, one-room enclosure extends from the north corner of the southeast side of the concrete-block addition, and a shed-roofed addition extends from the rear. Fenestration is irregular throughout the building. A combination of multi-pane bays and single, two-over-two and four-over-one, double-hung sash windows light the interior. The building sits on a concrete-block foundation and features cement-asbestos siding and exposed concrete block on the exterior. The roof is sheathed in asphalt. Two concrete-block chimneys rise from the building, one from the center, interior, and one from the exterior of the northwest side.

main building (.001) façade and southeast side, view to N

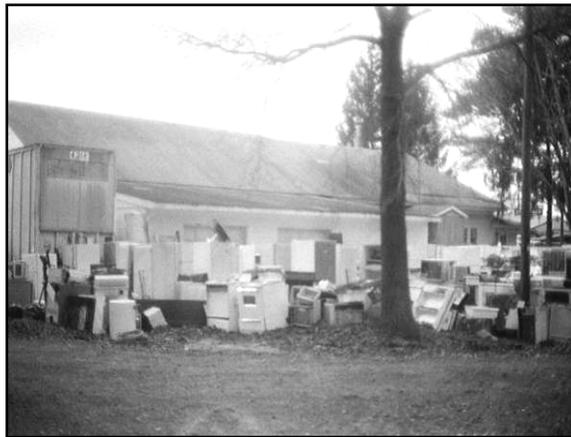
main building (.001) rear, view to NW

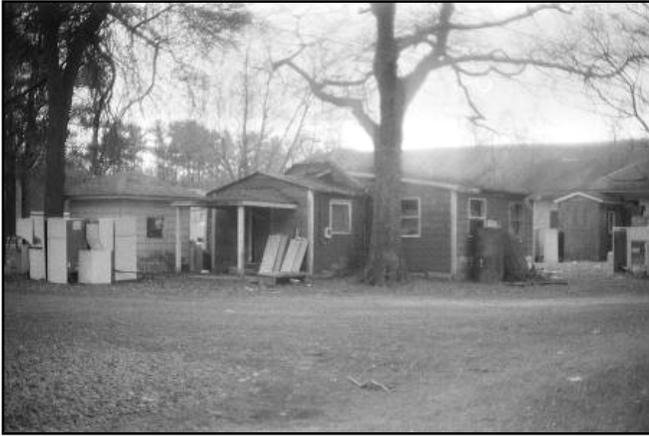
To the rear of the main building stand five mid-twentieth-century former outbuildings (.002-.006). The first outbuilding (.002), placed to the rear of the main building, is of wood-framed construction with a jerkinhead gable roof with shed-roofed side ells. Its three-bay, northeast façade has a center two-light, four-panel door flanked by one-over-one, double-hung sash windows. A gabled stoop projects from its façade. Remaining sides are fenestrated with one-over-one, double-hung sash windows. Its walls are sheathed in asbestos and asphalt shingles.

The second outbuilding is a hipped roof, wood-framed building with a square footprint (.003). The southwest gable end has a central, four panel door. A fixed window is placed in the northwest wall, while the remaining two sides are blank. The roof is sheathed with asphalt shingles.

storage building (.002, .003), view to S

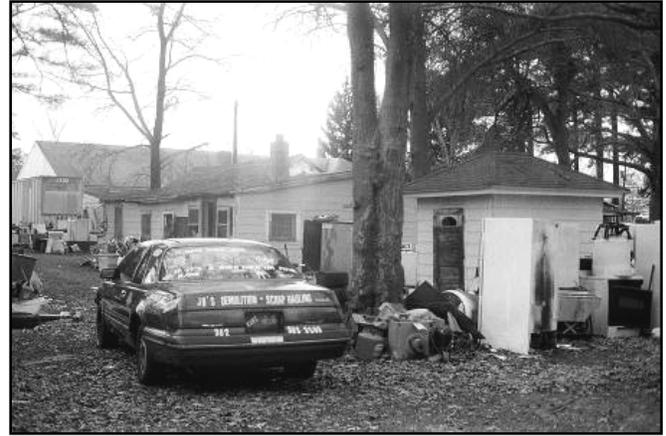
The third outbuilding, wood-framed in construction, side-gabled in orientation, has two doors each placed at the end of the wall (.004). Fenestration of the façade consists of one-over-one and six-light, fixed windows. A variety of window types are placed on the other sides. The walls are sheathed in cement-asbestos siding.

The fourth outbuilding is square in footprint, of wood-framed construction with a hipped roof (.005). Its southeast façade features a solid, central, five-panel door. The southwest side has a fixed wood window, while the remaining two sides are blank. The walls are sheathed in cement-asbestos siding.

storage buildings (.004, .005), view to SW

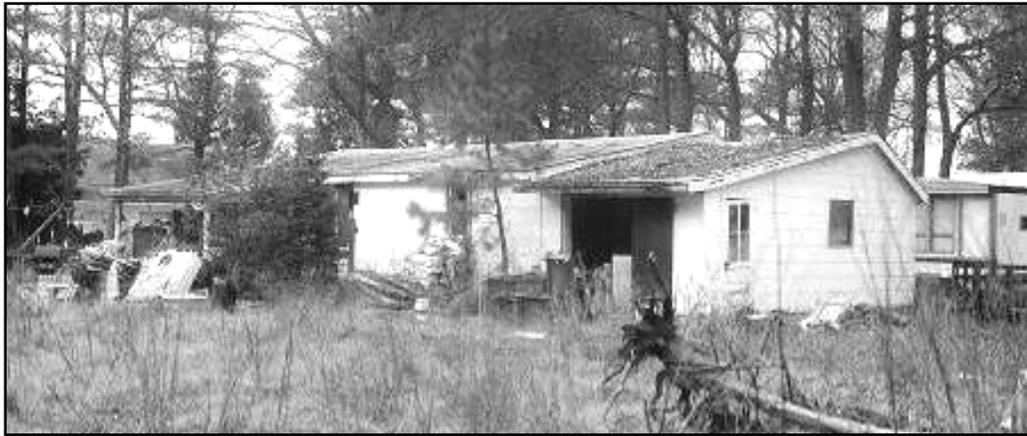
The last outbuilding, is a single-story, oblong structure (.006). Its southeast façade is three bays wide and is pierced by one-over-one, double-hung sash windows and a four-light, four-panel door. The two side walls are pierced by one-over-one, double-hung sash windows, while the rear wall has a four-light, four-panel door.

storage building (.006), view to N
