3.0 MOUNT PLEASANT TO PORT PENN RAILROAD

3.1 As-Built Conditions

3.2 Current Conditions

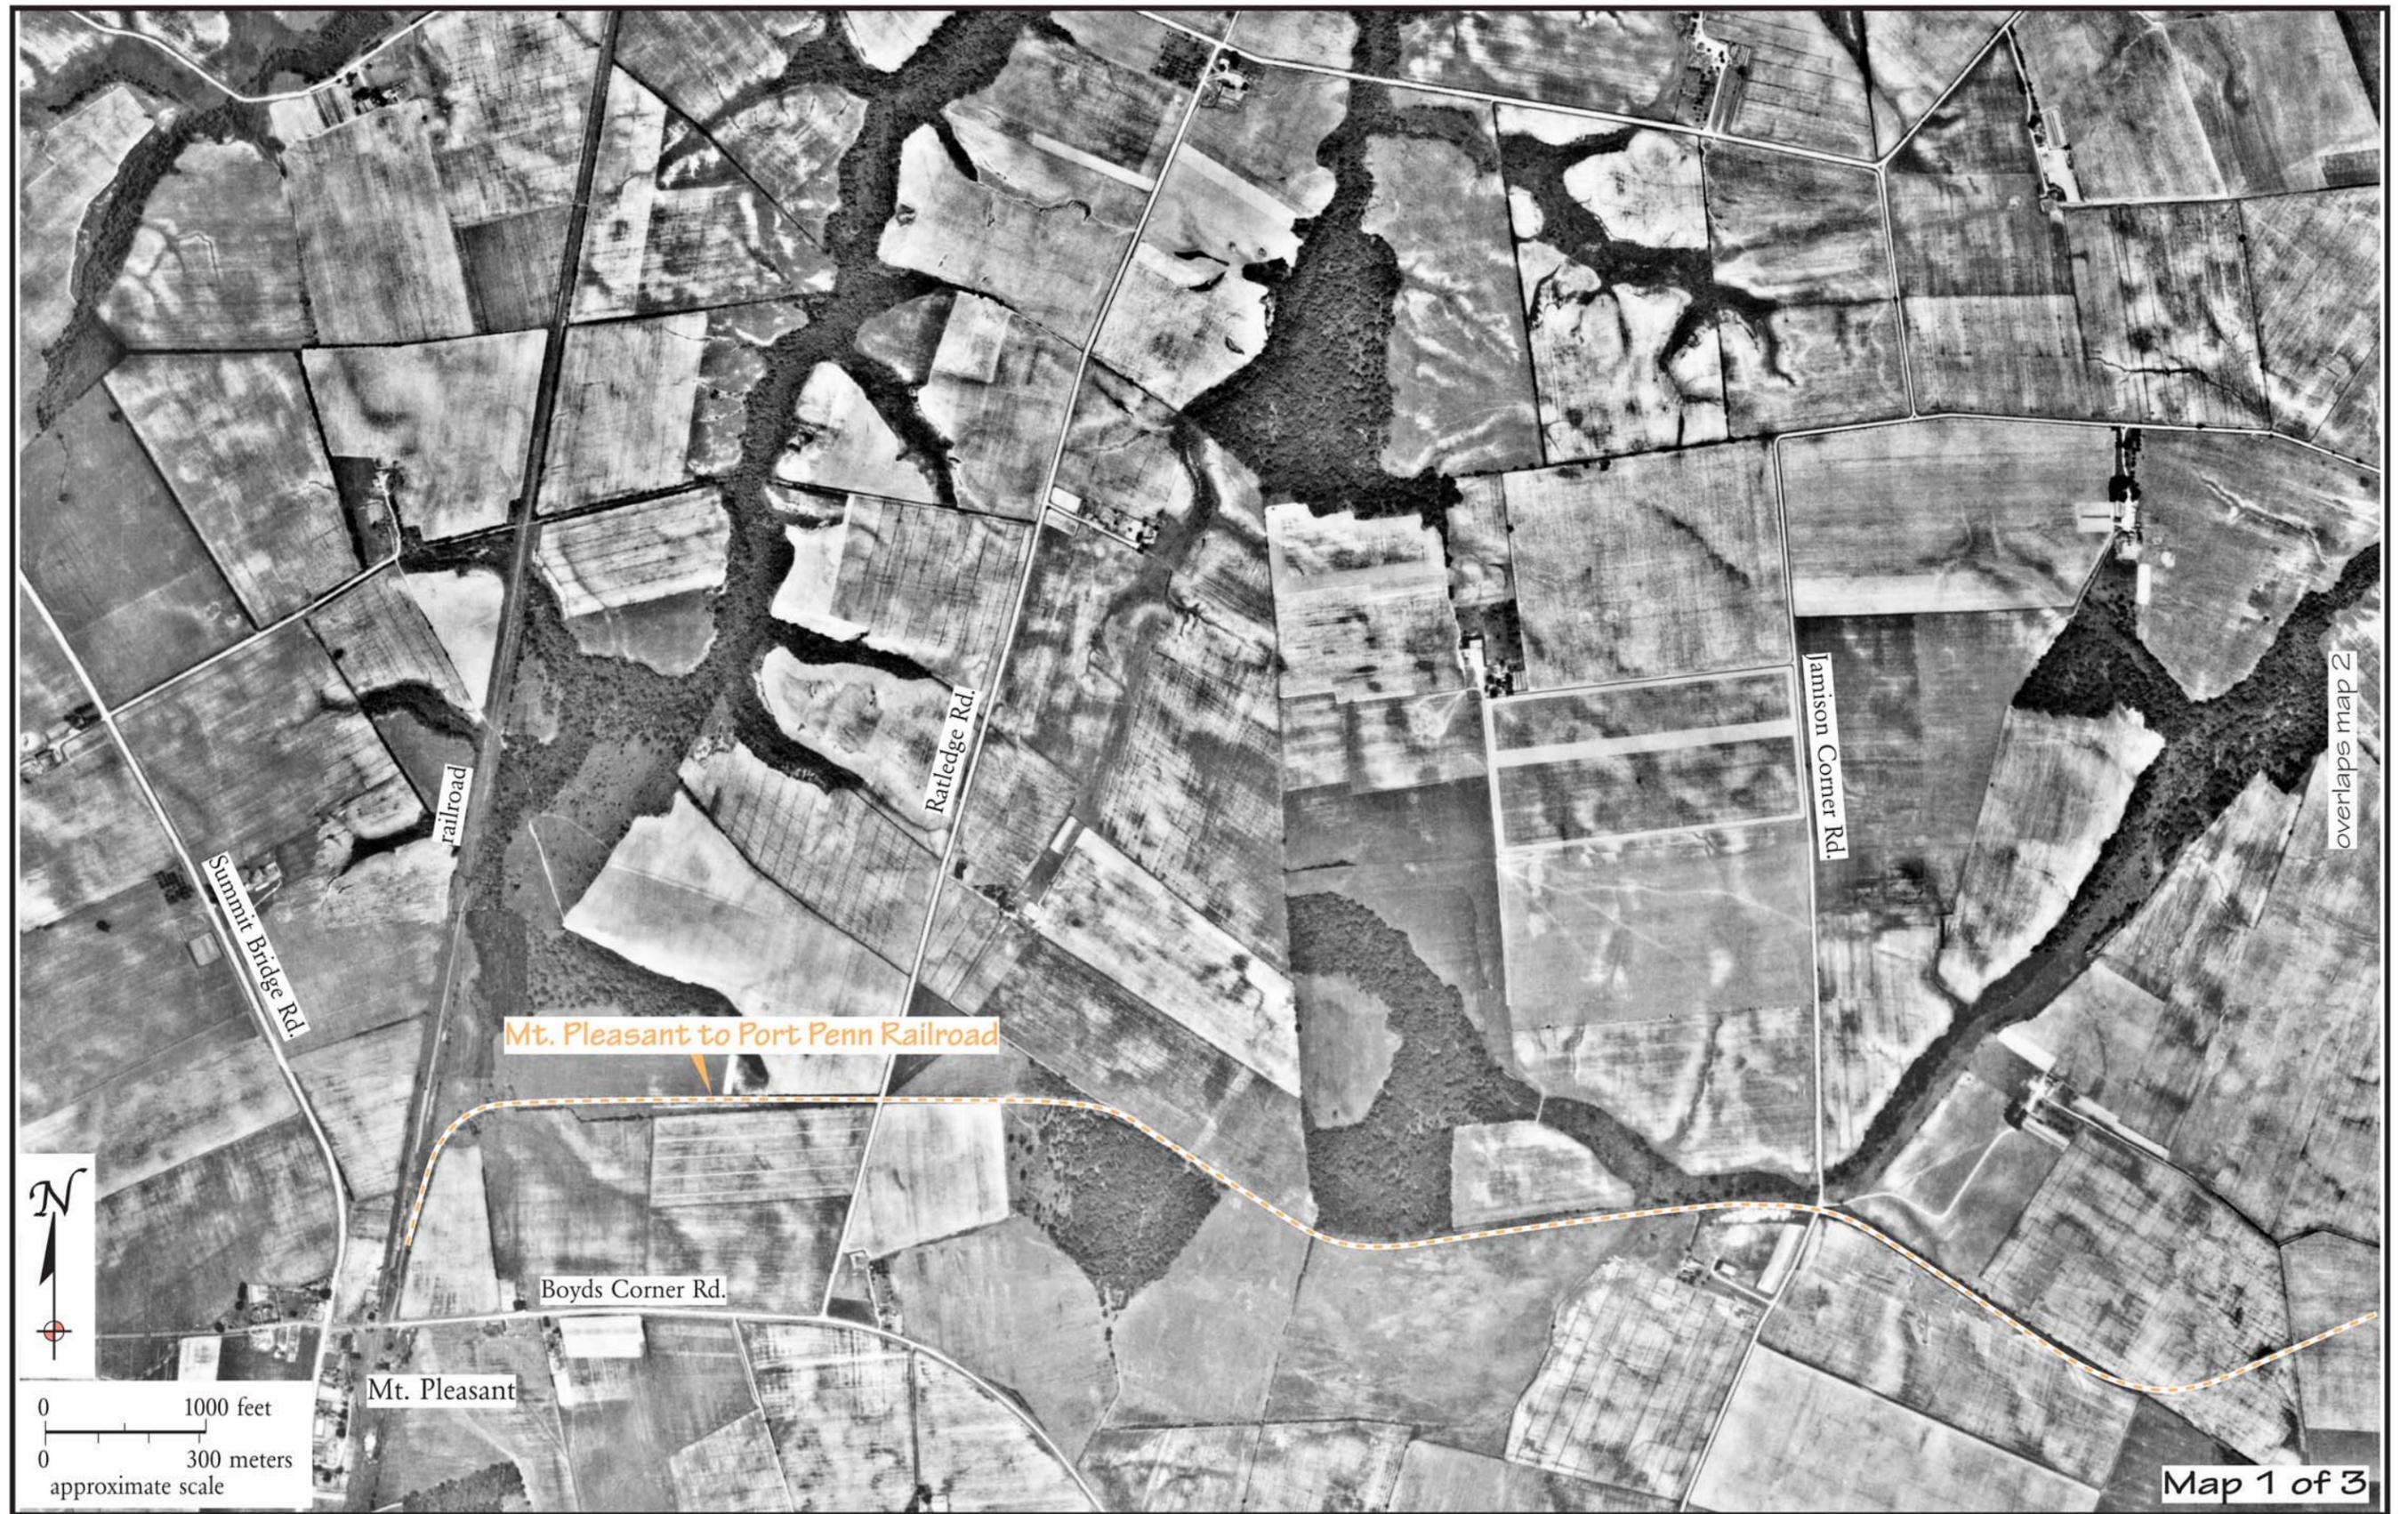
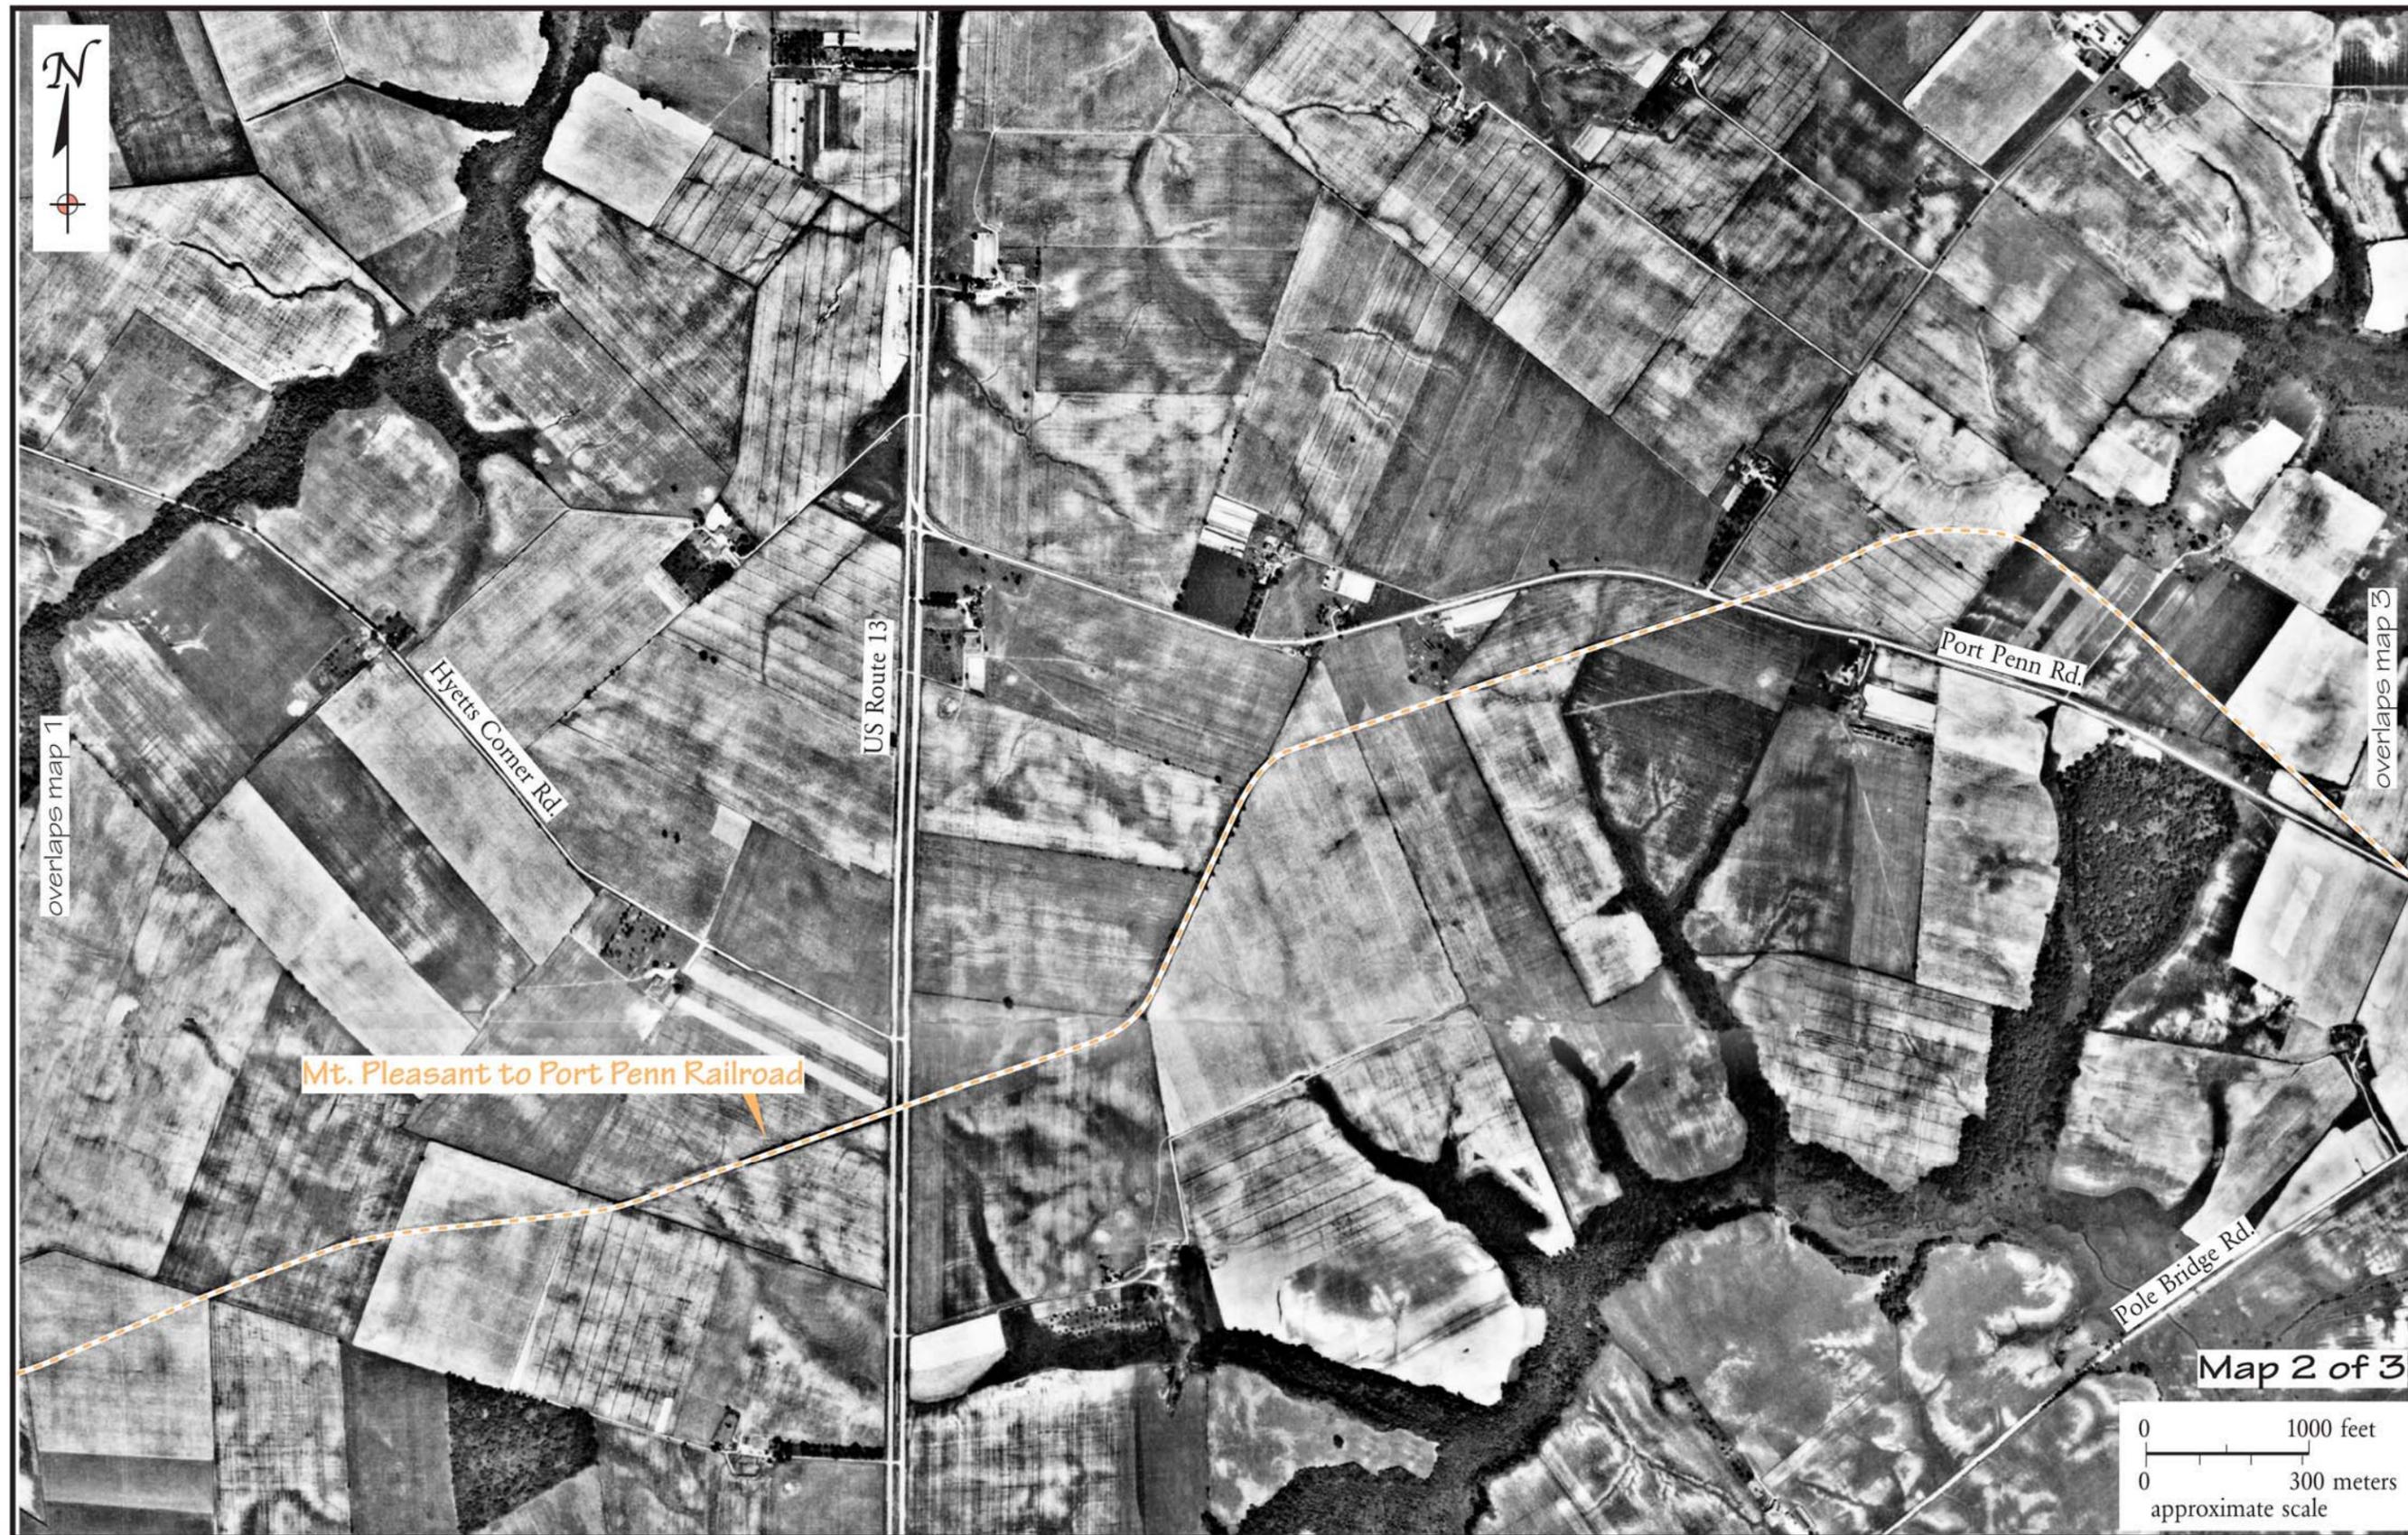
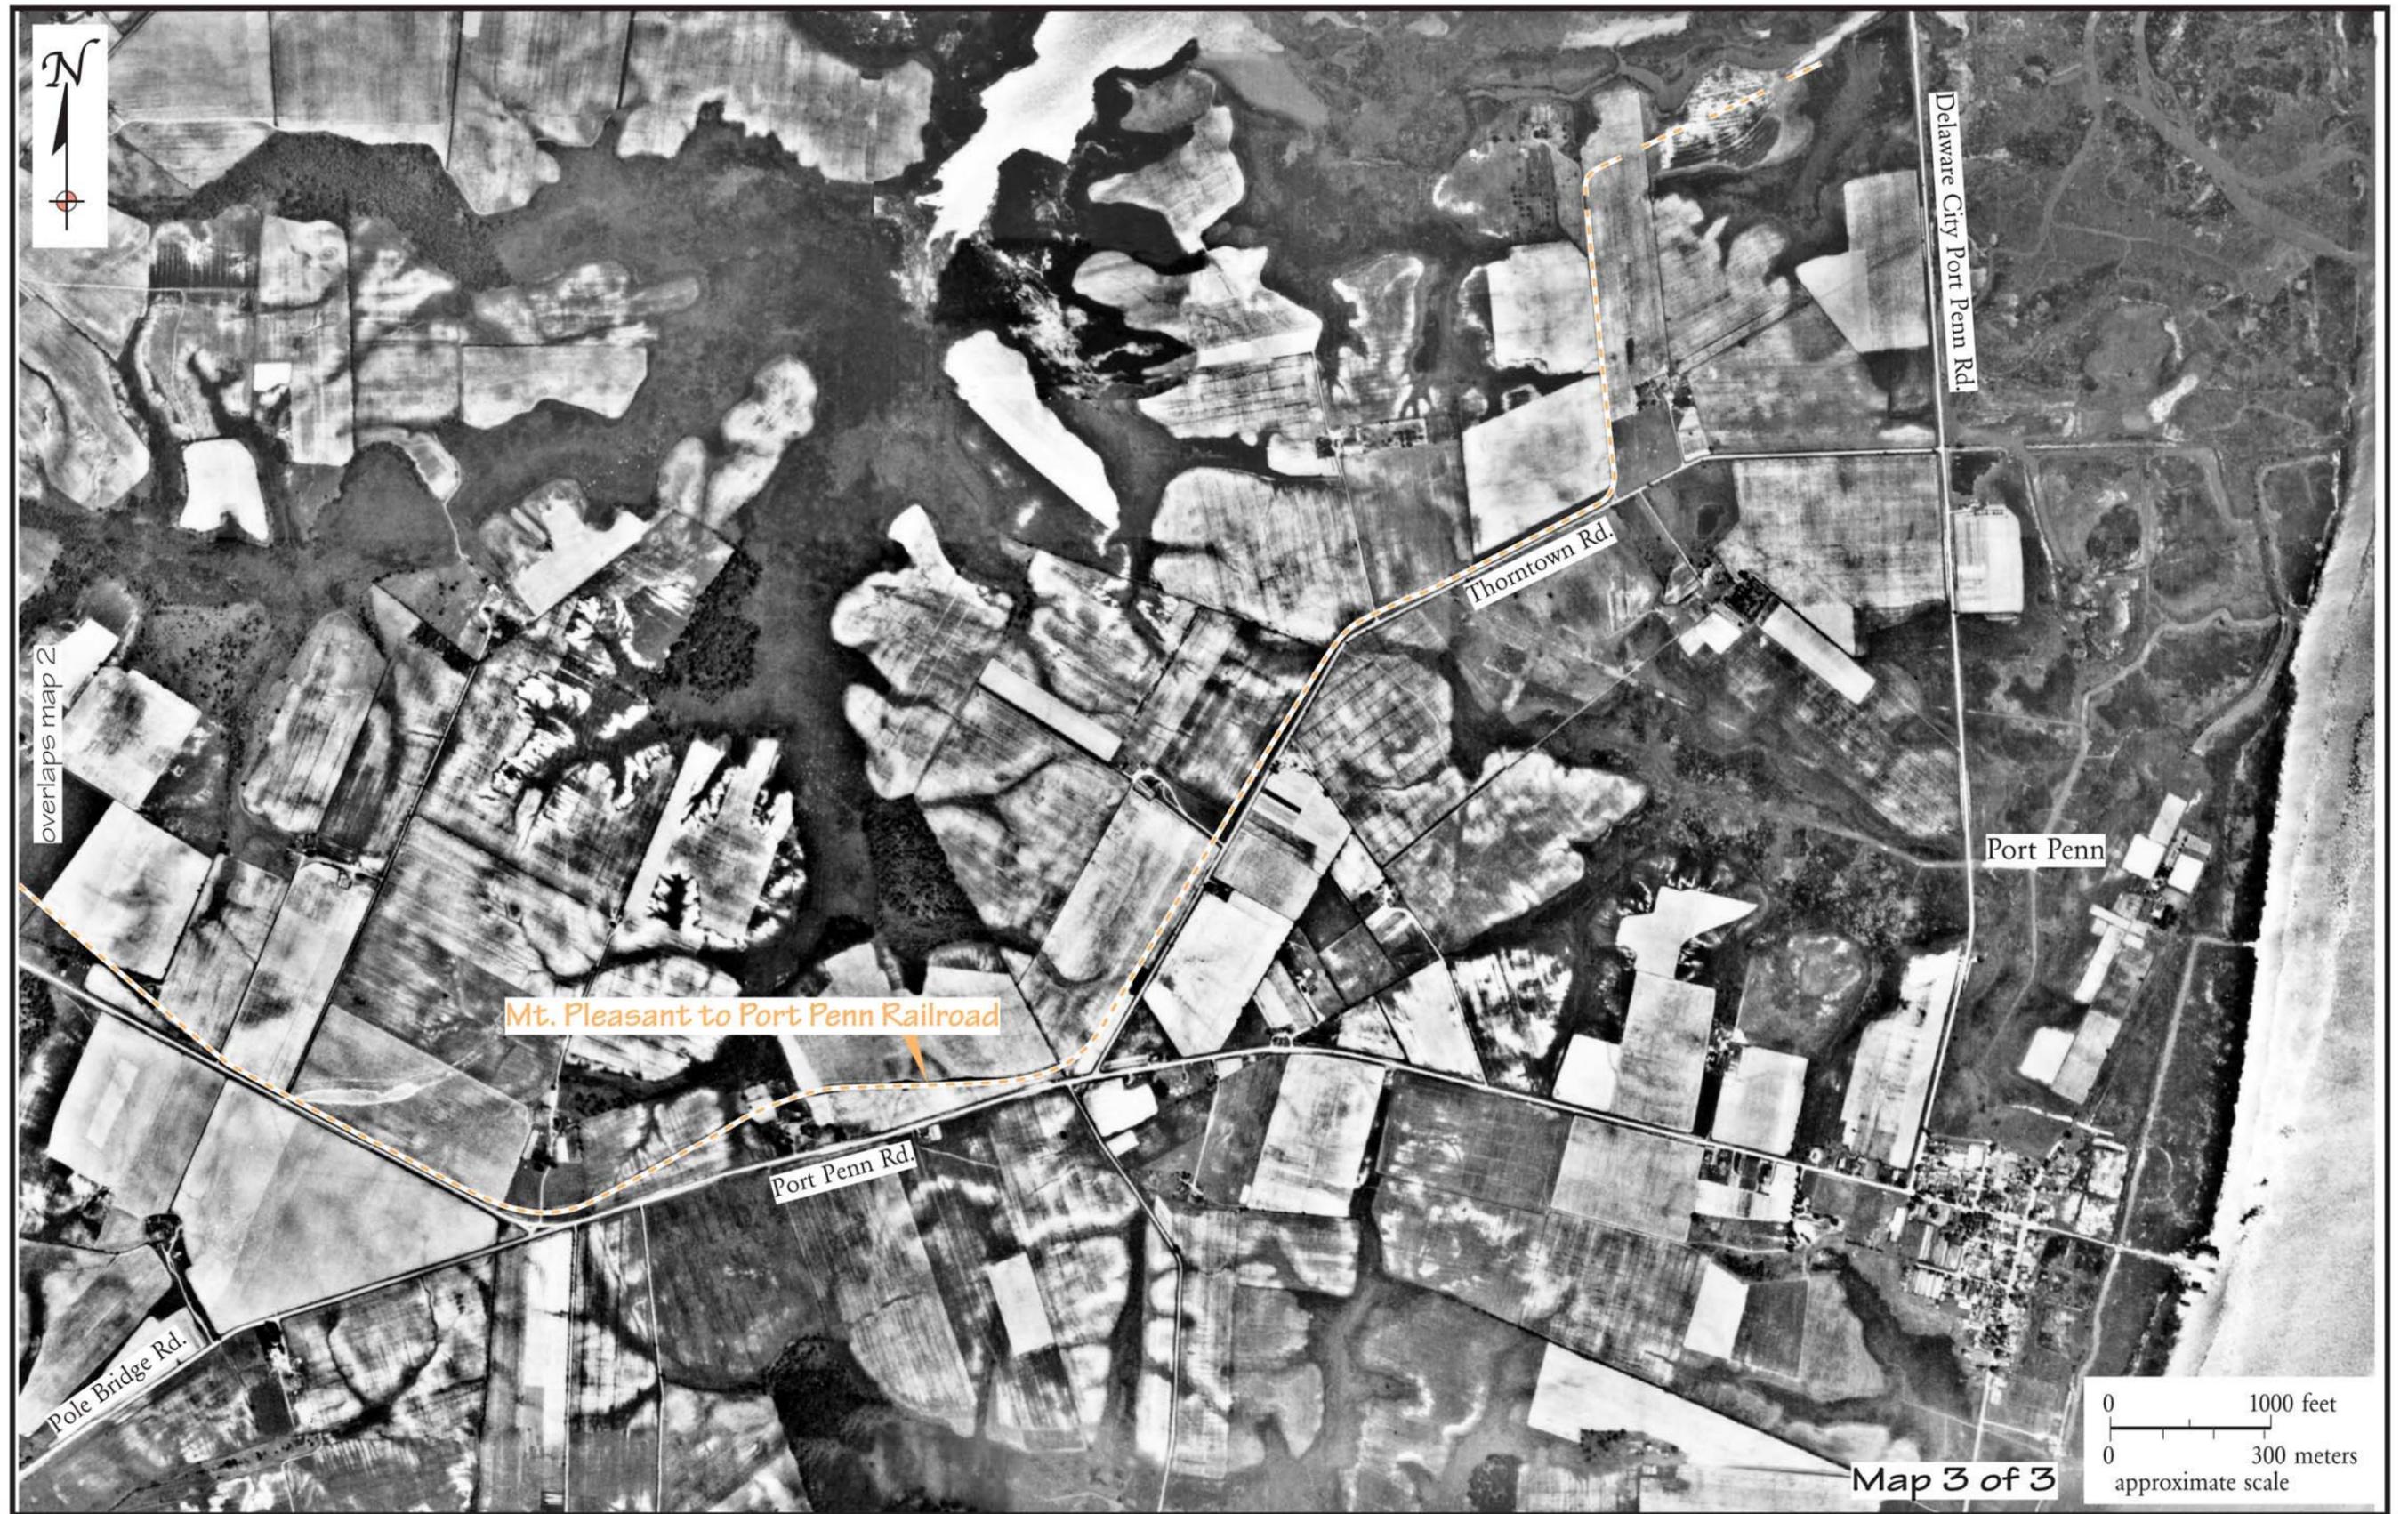
Figure 2: 1937 Aerial photography showing the former corridor of the Mt. Pleasant to Port Penn Railroad. The railroad route was clearly visible on the landscape on these aerials, despite having been dismantled over a decade earlier. Aerials accessed on Delaware's DataMIL.

The route of the Mt. Pleasant to Port Penn Railroad is discernable on 1937 aerial photographs, despite the tracks having been dismantled over a decade earlier (Figure 2). It appears as a linear feature in some portions with the appearance of a road or farm lane, and in other places as a field boundary. In several cultivated fields the line is absent altogether, the corridor having been returned to agricultural use by the owner after removal of the line.

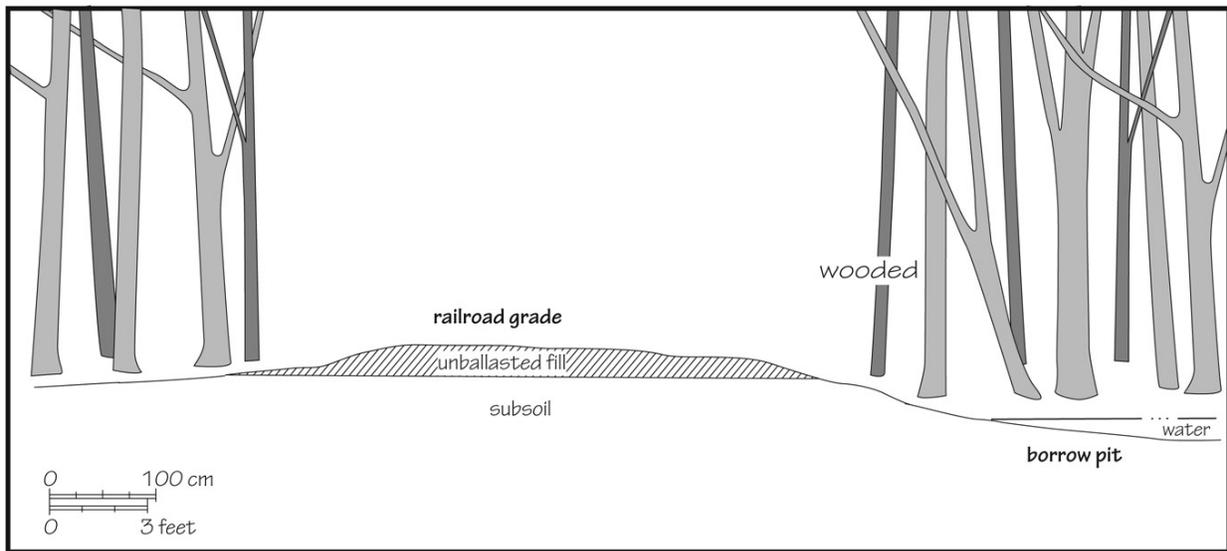
Figure 3: General cross-section of the former grade of the Mt. Pleasant and Port Penn Railroad, looking east along corridor within the U.S. 301 Project APE.

A shovel test, excavated in January 2011, indicated that this remnant section of the railroad grade consisted of unballasted mixed fill to a depth of 30cm below the surface, with no ties or rails (Photo 9). Field survey verified that the earthen grade was composed of material taken from the borrow pit running along the north side of the grade. Digital photographs taken during this field survey illustrated the condition of the remnant, its vicinity, and the adjacent borrow pit.

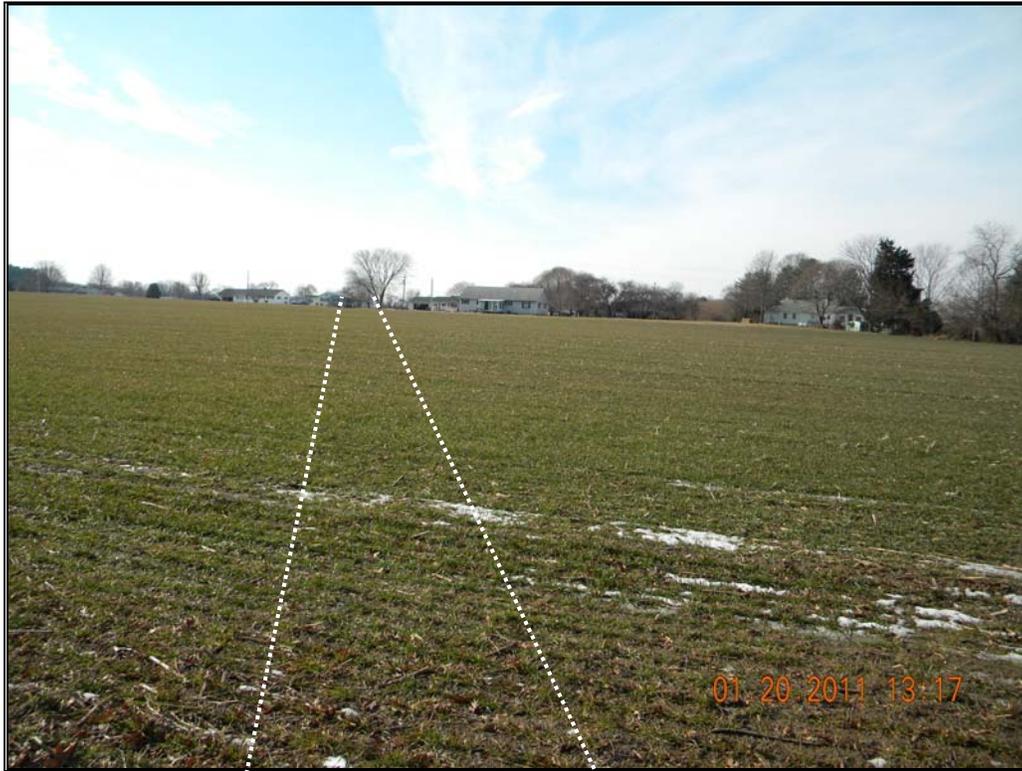
Photo 1: View along the approximate route of the railroad spur-line, looking west toward the modern residential construction along Ratledge Road. This section, which is outside the APE, has been returned to farmland.

after dismantlement of the railroad prior to the mid-1920s, or built upon by modern developments (Photos 1 & 2). However, there are a few areas in which grade remnants are still in evidence, mostly located in undeveloped woodlots scattered along the length of the corridor (Photos 3 & 4). One of these remnants was observed during Phase Ib field survey of AHC Survey Segment 14 of Section 1 as a linear landscape feature crossing the APE in an east-west direction. The area through which the line passed was wooded, and the corridor was discernable as an elevated grade with relatively few trees (Photos 5 & 6). Measurements taken of the grade's cross section indicated that the grade consisted of a slightly raised earthen berm approximately one-and-a-half feet in height and 22 feet in width (Figure 3). A water-filled borrow pit extended along the north side of the corridor; this resulted from the fill excavated to build the railroad's grade (Photo 7). This extant portion of the grade extended approximately 1,500 feet (0.28 miles) through the wooded area only and disappeared in the agricultural fields to the east and west of the woodlot (Photo 8). Approximately 200 feet of remaining grade was located within the APE.

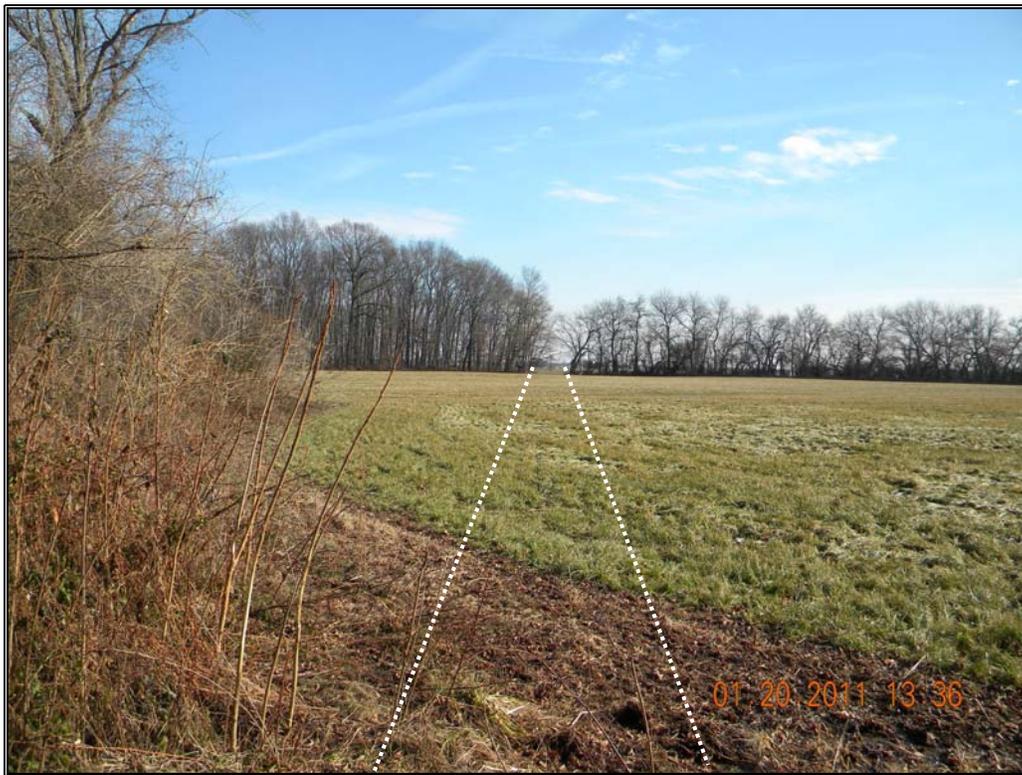
Photo 2: View southeast along the former railroad corridor from within the APE. There is no trace of the grade within the cultivated field, but its route is visible as the gap in the treeline at the edge of the field.

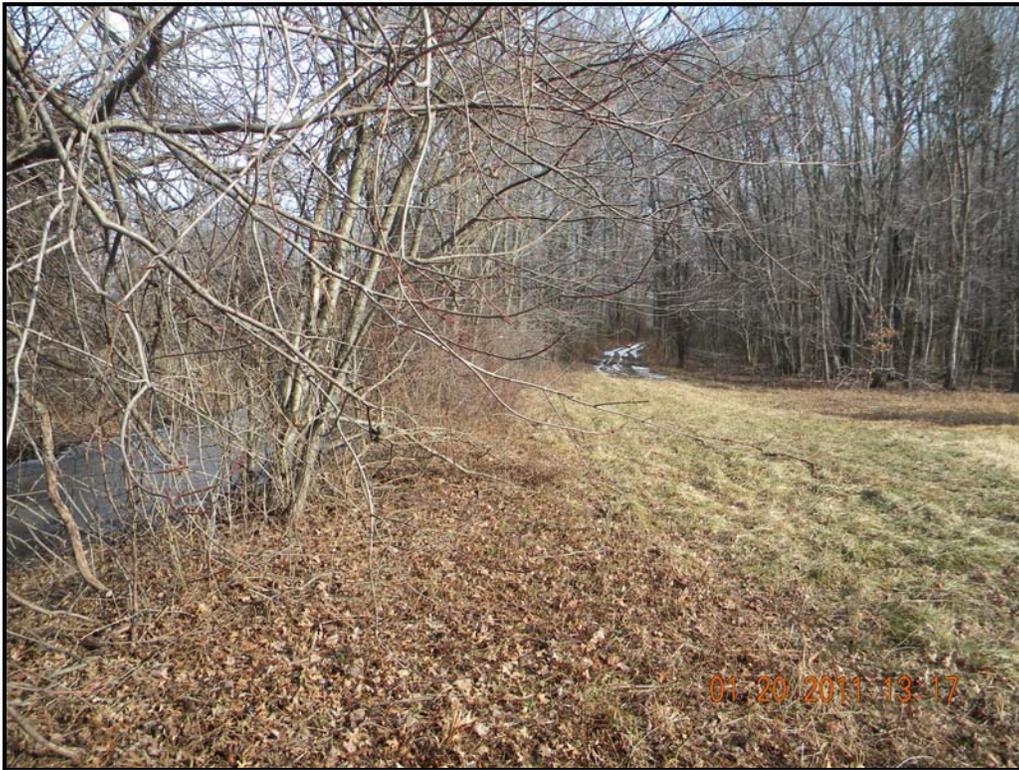
Photo 3: The railroad grade is visible heading southeast into a woodlot, just west of the APE.

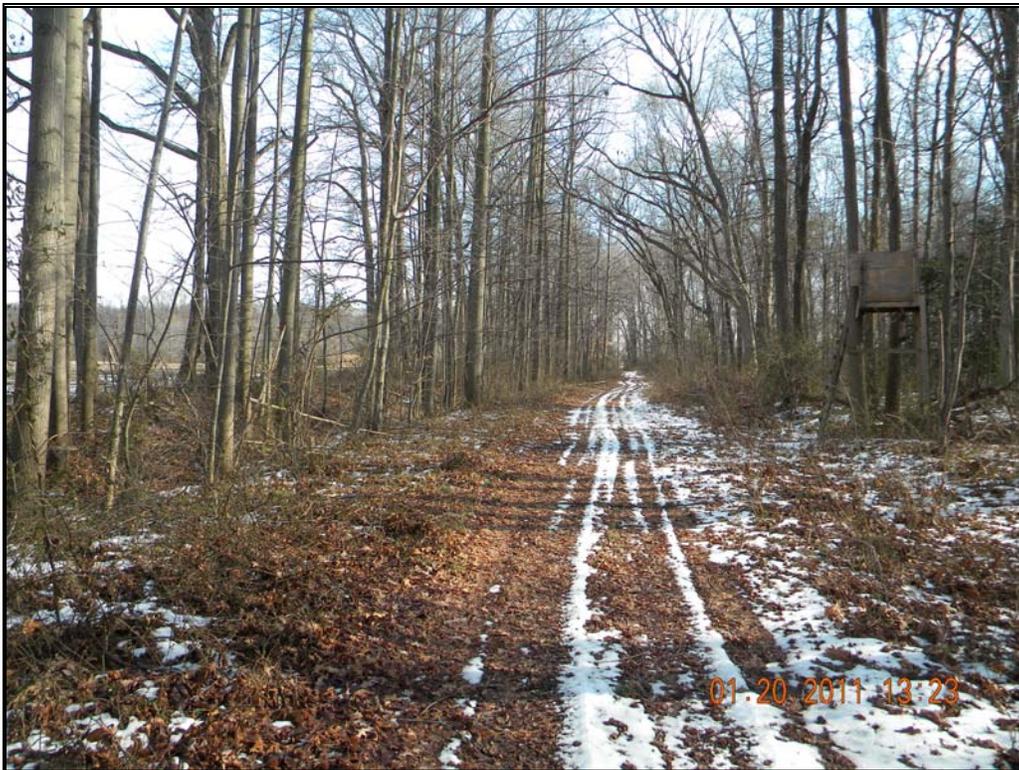
Photo 4: The railroad grade is clearly intact within this woodlot, which is just west of the APE. View looking southeast along the former corridor.

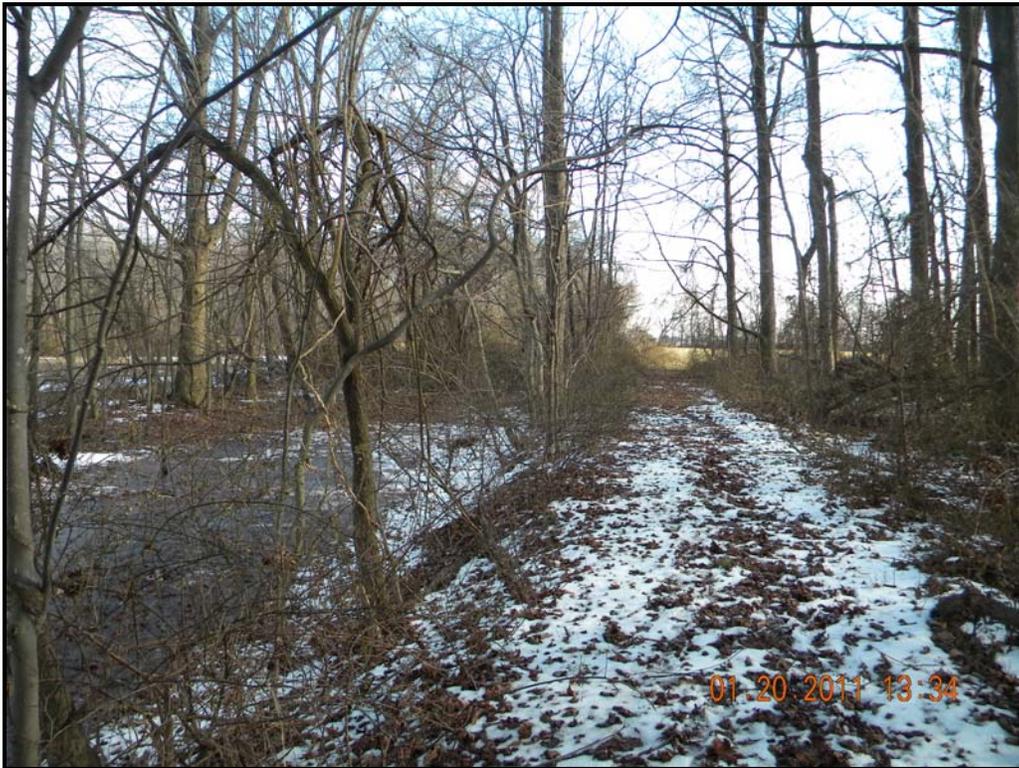
Photo 5: View of the railroad grade within the APE, looking southeast. The grade is slightly raised with a water-filled borrow pit on the left (north) side.

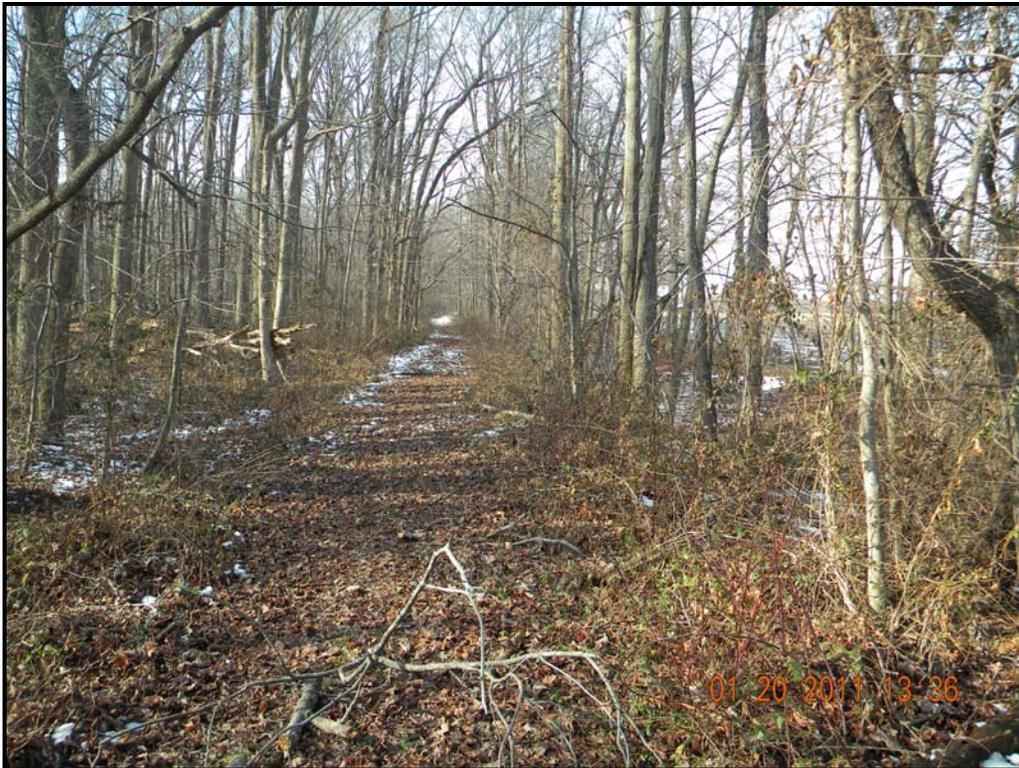
Photo 6: View northwest along the railroad grade segment within the APE.

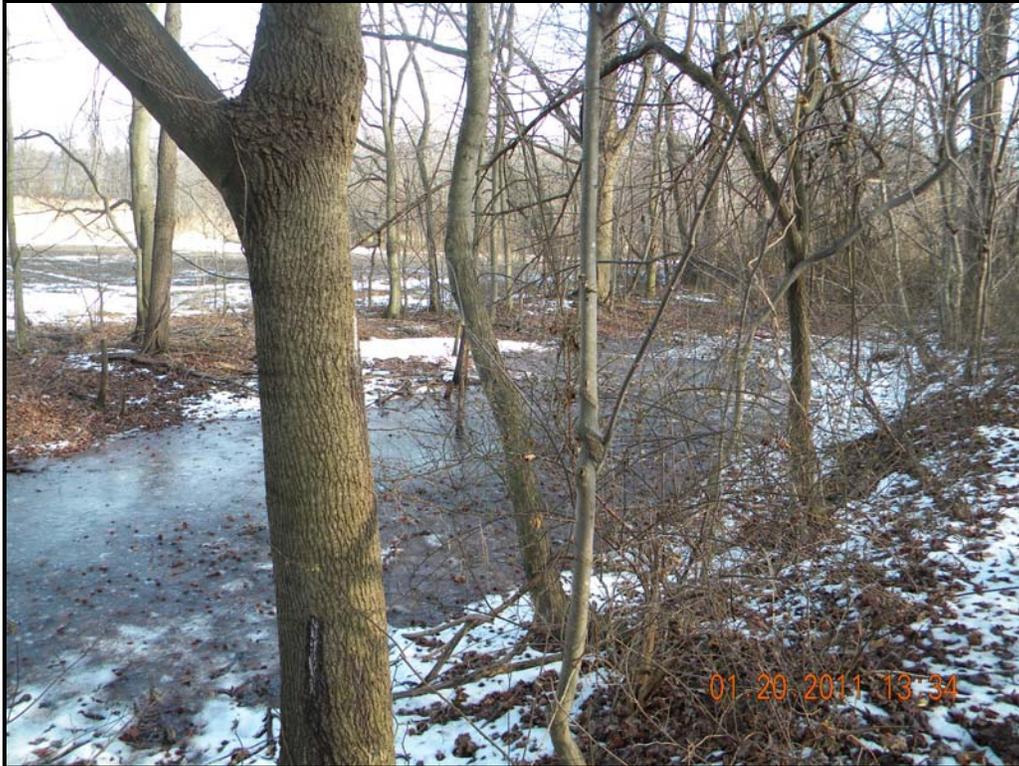
Photo 7: View of an ice-covered borrow pit along the north side of the former railroad corridor within the APE. Looking east from the grade.

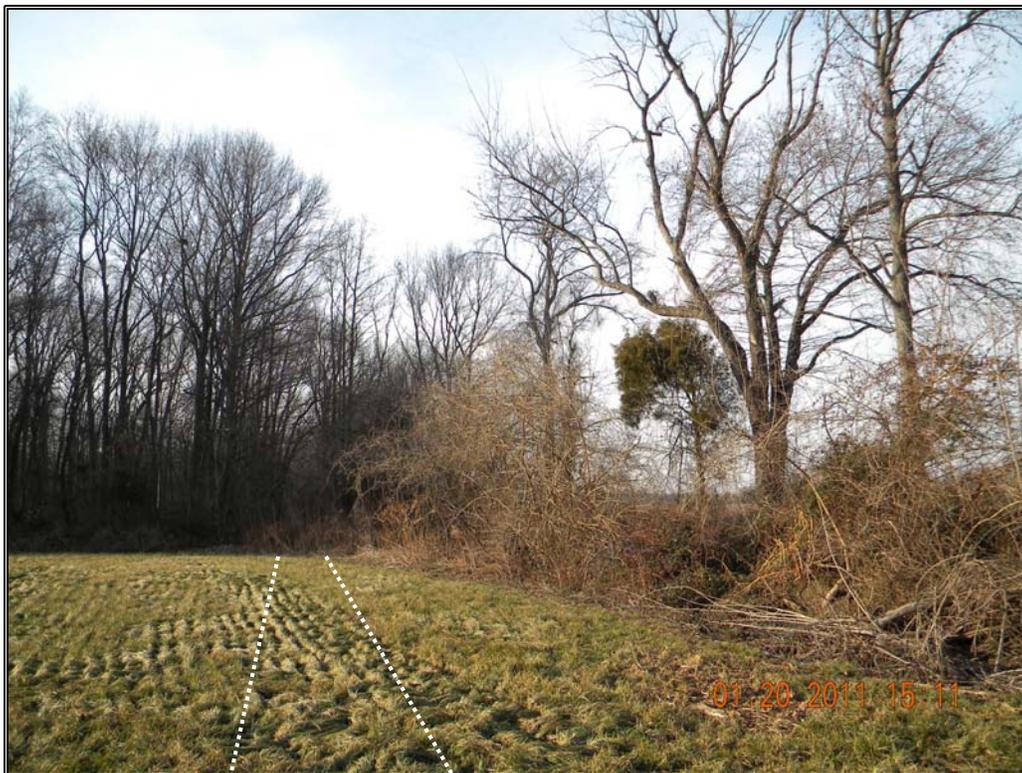
Photo 8: Looking west towards the woodlot where railroad grade is preserved, showing approximate location of the corridor. Taken from the cultivated field within the APE.

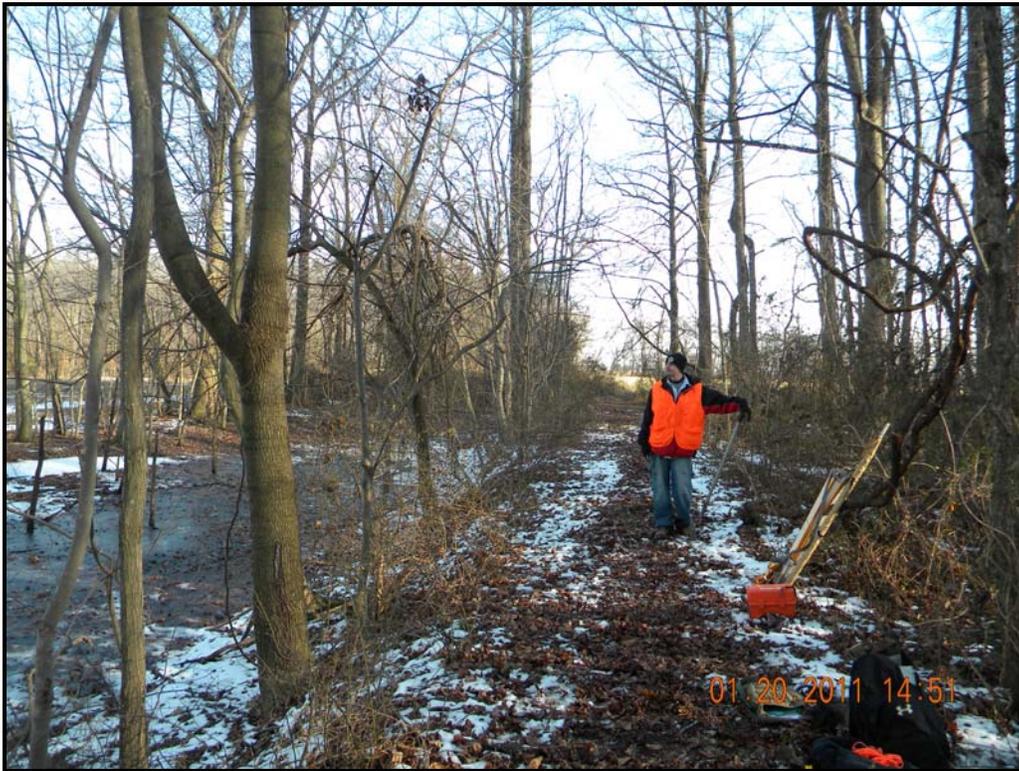
Photo 9: This view shows the approximate location of the shovel test and cross-section measurements. Looking east near the west end of the APE.
