INTRODUCTION AND STATEMENT OF PURPOSE

The purpose of this report is to present results and recommendations based upon archaeological investigations of the Route 4 Schoolhouse site, locally known as the Welsh Tract Schoolhouse, District No. 54 (Map 1, Plate 1 and Appendices I & II). Intensive excavations were undertaken by the Department of Transportation, Division of Highways archaeologists, and included pre-demolition survey, testing in the yard, and post-demolition survey under the driveway and garage. The survey was conducted as part of the widening and upgrading project of Delaware Route 4.

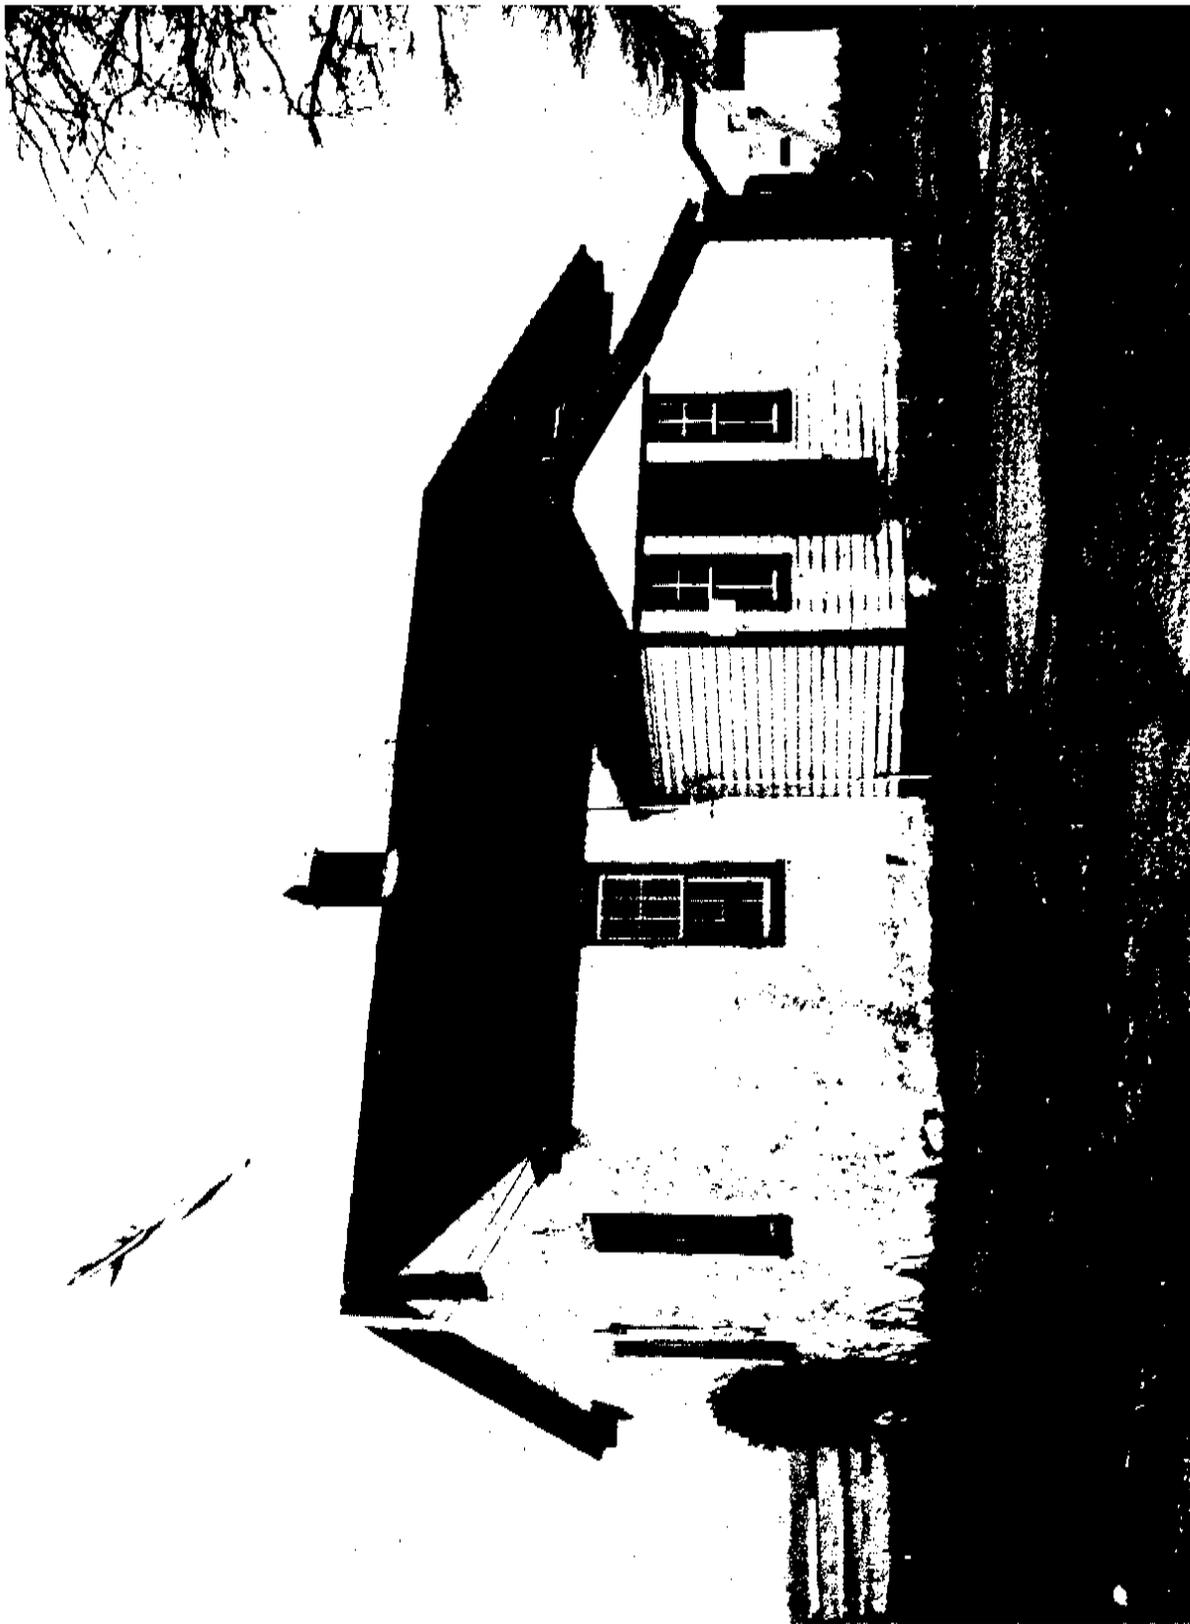
PLATE 2

WELSH TRACT SCHOOLHOUSE 54, 1932

VIEW FROM ROUTE 896 AND ROUTE 4 CROSSROADS, LOOKING NORTH

The Welsh Tract Schoolhouse fits the above description only partially (Plate 2). The structure was 27 feet x 34 feet, constructed of cut stone - gabbro obtained from nearby Chestnut Hill and the Christina Creek. The walls were whitewashed and were approximately 1.5 feet thick. There were six windows with deep sills - two each in the east, south, and west walls, but none in the north wall. The front door was located in the center of the south wall, with a small frame vestibule for coats, hats, and lunches extending from the doorway. The building was oriented south towards the crossroads. Inside, the windowless north wall was covered by a slate blackboard. The teacher's desk was located up front, in the center of the room. Furniture by the end of the 19th century consisted of rows of double desks and benches. Cooch (1936:190) indicates that there were no chairs in 1851. The desks were arranged from the smallest in the front to the largest in the back, or from the younger to the older pupils, respectively. Six oil lamps were located on the walls, and a pot-belly stove was located in the center of the room. The floor was wooden.

Much of this information was confirmed through the archaeological investigation and from a photograph of the schoolhouse in 1932 (Plate 2).

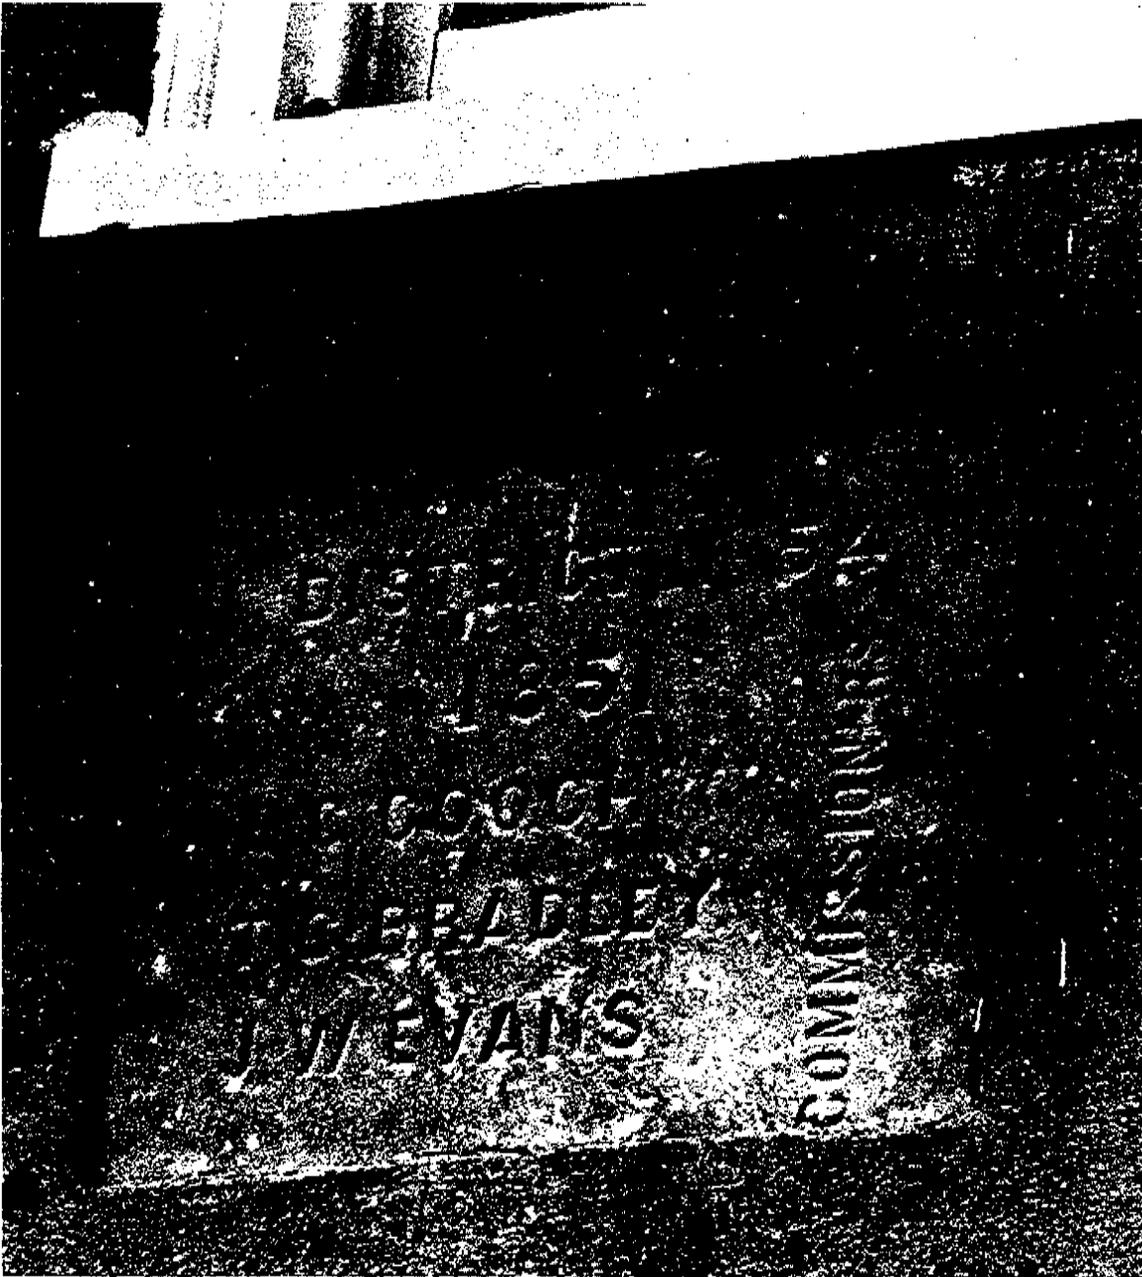
PLATE 3

DATE STONE, EAST WALL, 1981

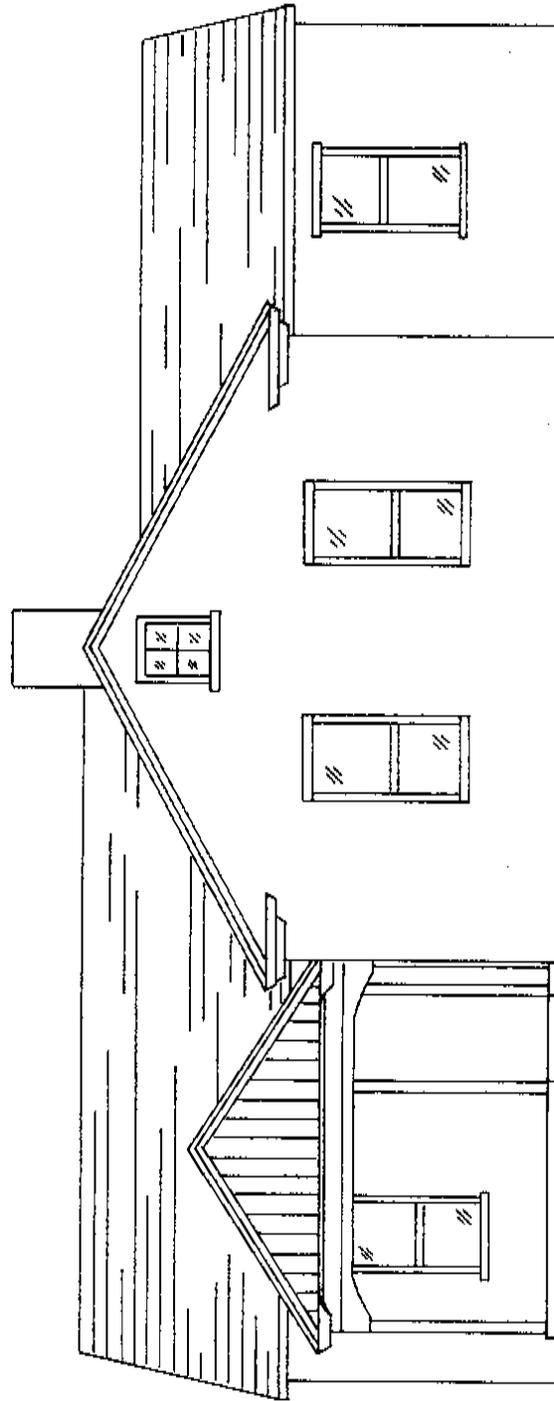
FIGURE 1

ELEVATION OF WEST FACADE

NOTES: THE CENTRAL TWO BAY

SECTION IS THE ORIGINAL SCHOOLHOUSE.
THE WINGS ON EITHER END ARE
ADDITIONS, CIRCA, 1930-1940. THE
PORCH AND CHIMNEY WERE ALSO ADDED AT
THIS TIME.

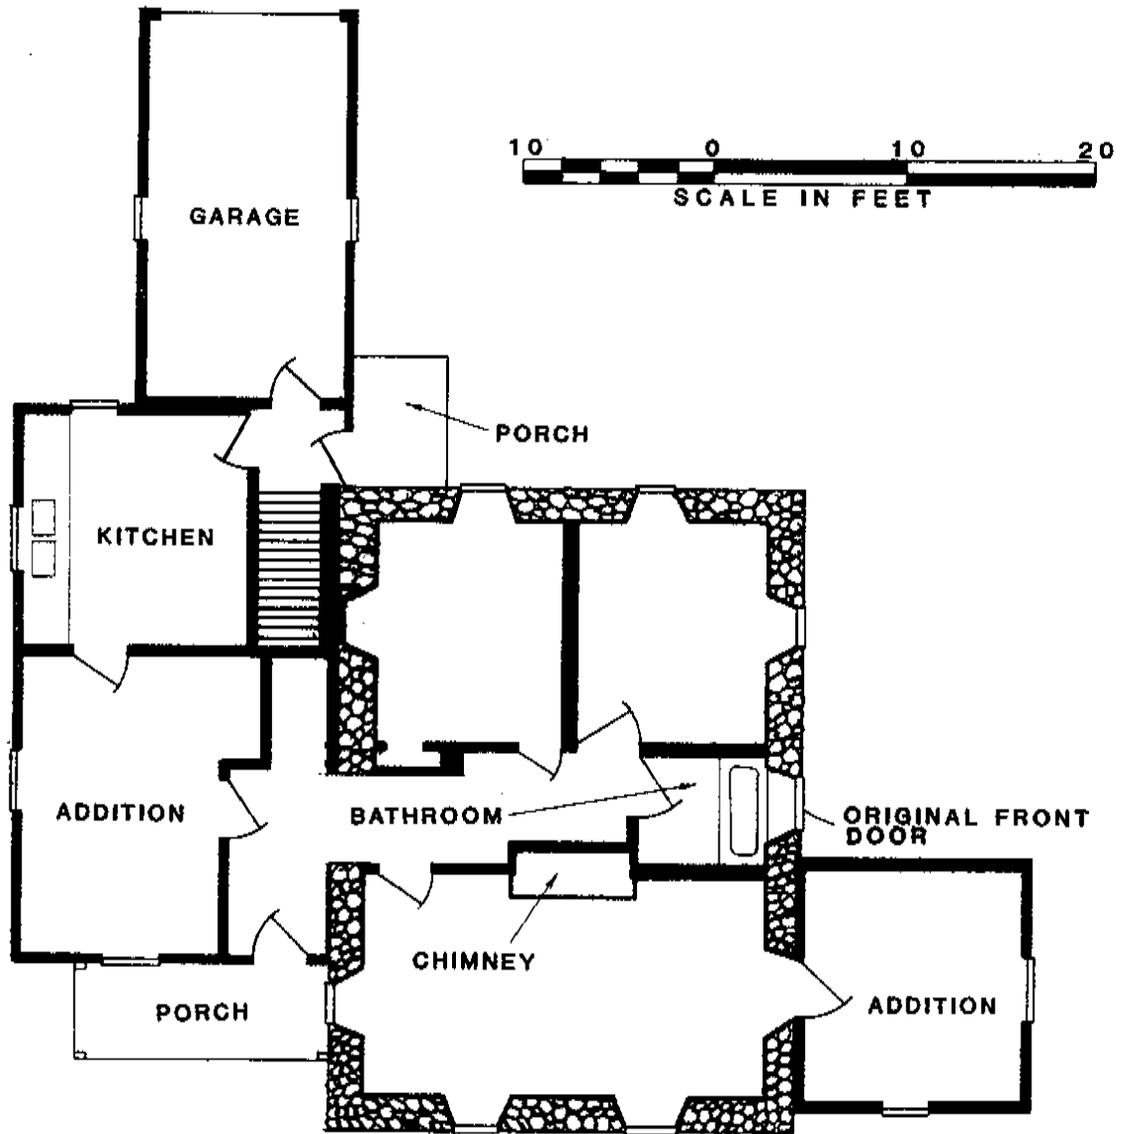
FIGURE 2 WELSH TRACT SCHOOLHOUSE NO. 54

FLOOR PLAN

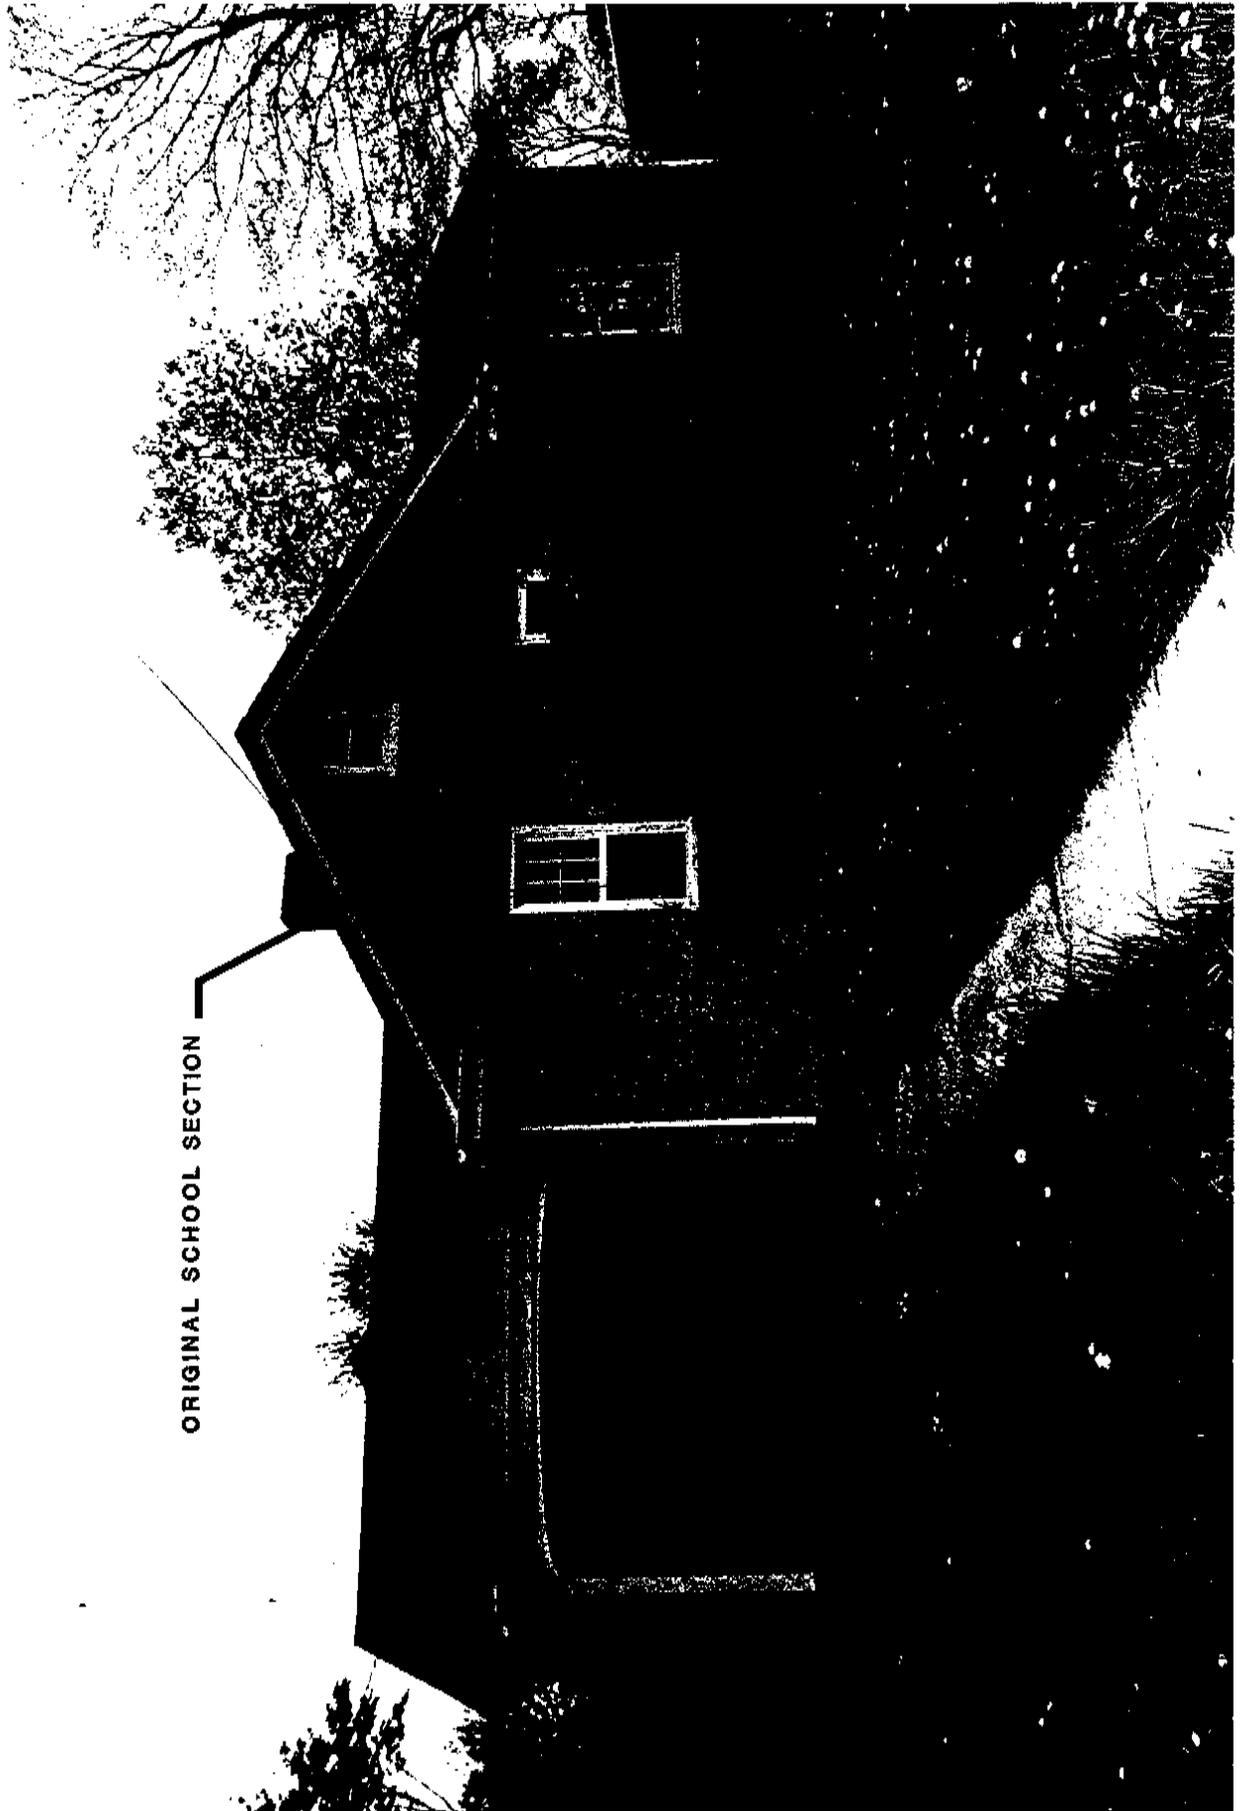
PLATE 4

WEST WALL SHOWING FRONT DOOR
AFTER POST 1939 ADDITIONS, 1981

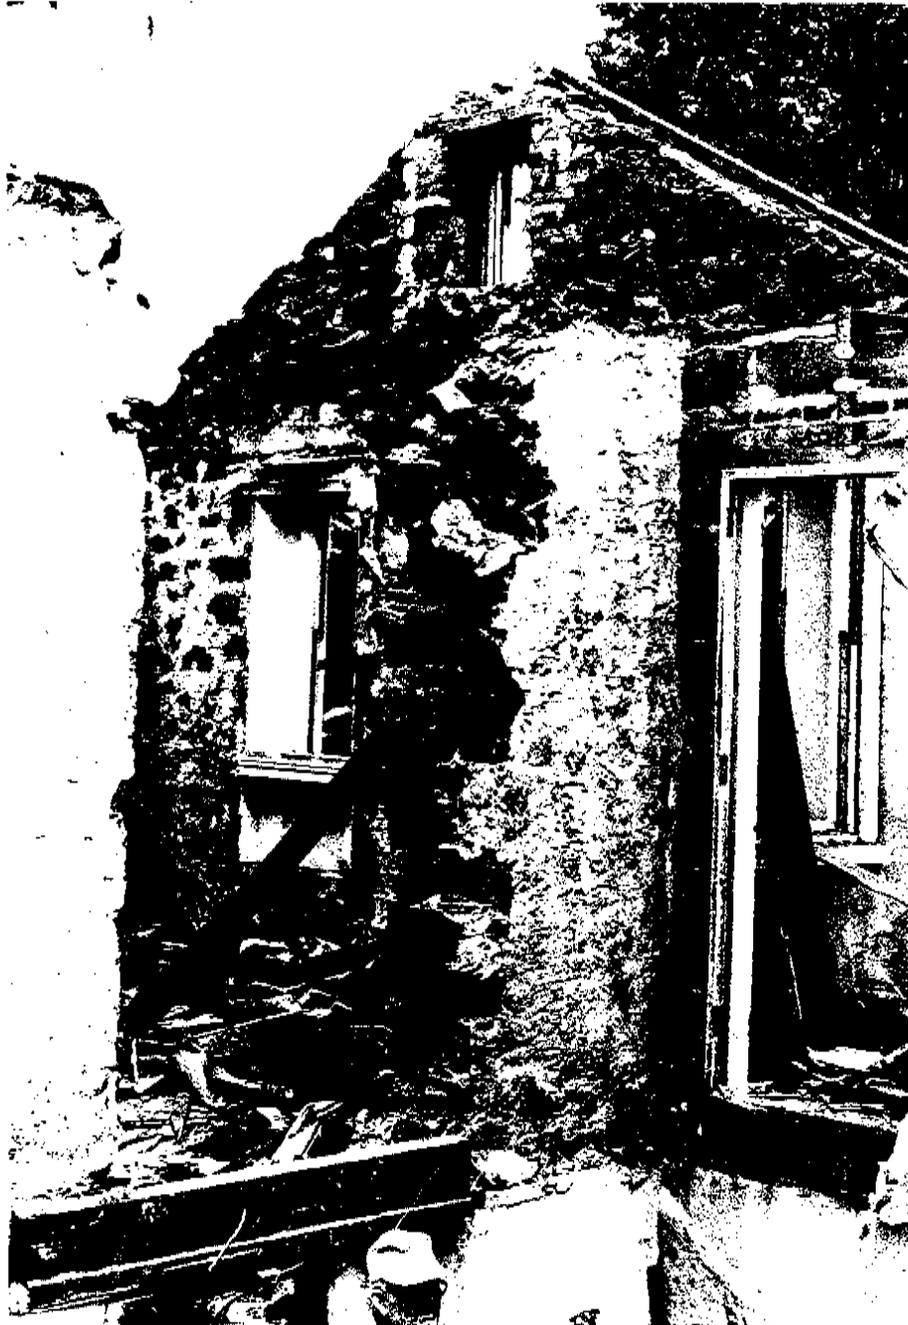
PLATE 7

**WEST WALL INTERIOR DURING DEMOLITION;
SHOWING ORIGINAL SCHOOLHOUSE (STONE ON LEFT)
AND LATER ADDITION (CONCRETE BLOCK ON RIGHT)**

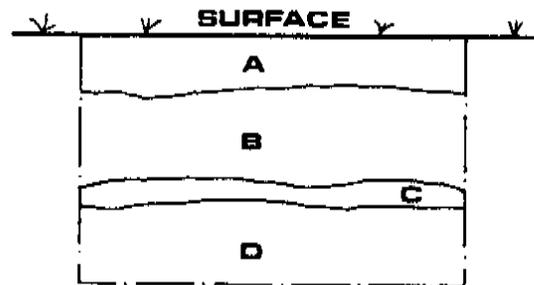
FIGURE 3

PROFILE OF THE EAST WALL TEST UNIT NO. 6

TYPICAL OF ORIGINAL PROPERTY SECTION

- A-TOPSOIL, DARK BROWN SILT LOAM
- B-YELLOW BROWN SILT LOAM
- C-BROWN SILT LOAM (BURIED TOPSOIL)
- D-YELLOW BROWN SILT CLAY (SUBSOIL)

The first testing consisted of eight 2 foot x 2 foot test squares placed selectively throughout the project right-of-way, to provide stratigraphic information for all areas. Two of these units, No. 1 and No. 6, contained undisturbed stratigraphy of the original schoolhouse property area (Figure 3). This consisted of a thin layer of buried topsoil (level C) about 1.0 feet below the surface, underlain by a brownish yellow silty clay subsoil (Level D).

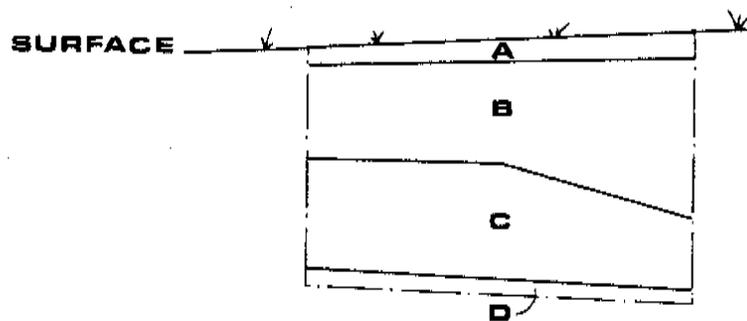
FIGURE 4
WELSH TRACT SCHOOLHOUSE NO. 54
PROFILE OF TEST PIT NO. 7
TYPICAL OF THE PASTURE SECTION

- A-TOPSOIL, DARK BROWN SILT LOAM**
- B-YELLOW BROWN SILTY CLAY**
- C-BROWNISH YELLOW SILTY CLAY**
- D-MOTTLED SILTY CLAY (BROWN, YELLOW GRAY) (SUBSOIL)**

Units 2, 3, 4, 5, 7, and 8 were all representative of the landscaped area. The typical stratigraphy of that area (Figure 4) is as follows:

Level A	Topsoil, dark brown Silt Loam	0	-	0.30	feet below surface
---------	----------------------------------	---	---	------	-----------------------

Level B	Yellow brown silty clay (fill)	0.30 - 1.0	feet below surface
Level C	Brownish yellow silty clay	1.0 - 1.5	feet below surface
Level D	Mottled gray and brown silty clay	1.5 - 1.6	feet below surface

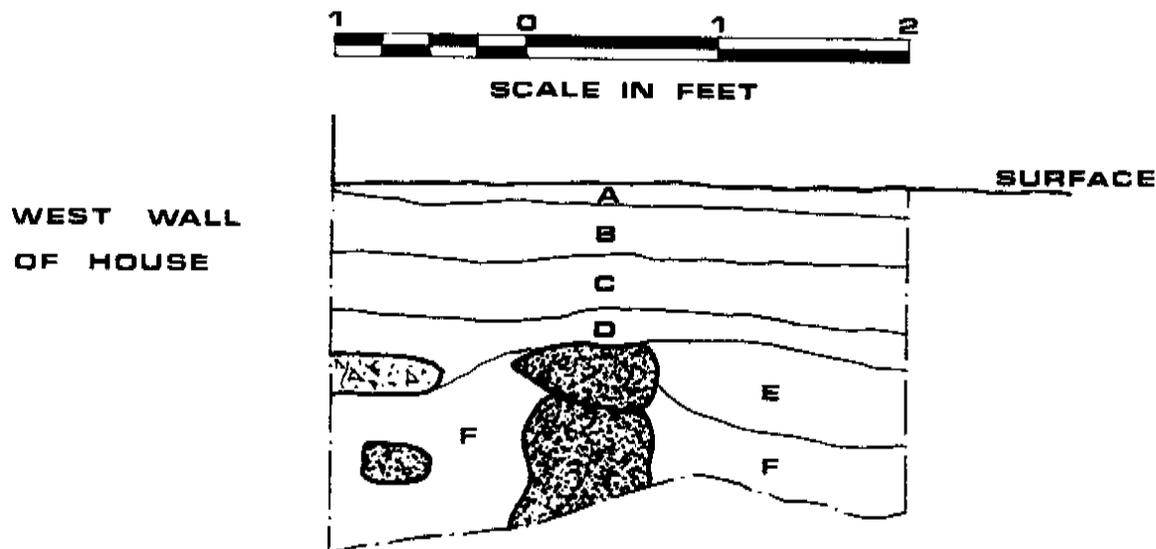
FIGURE 5

PROFILE OF SOUTH WALL, UNIT NO. 10

- A - TOPSOIL, DARK BROWN SILT LOAM
- B - DARK BROWN SILTY CLAY
- C - YELLOW BROWN SILTY CLAY
- D - MORTAR MIXED WITH SAND, GRAVEL AND CLAY
- E - DARK GRAY ASH
- F - YELLOW BROWN SILTY CLAY (SUBSOIL)

Units No. 9 and No. 10: These units (both 3 feet x 3 feet) were placed along the south and west side of the original stone structure. Debris from stuccoing the exterior walls was encountered but no builder's trench was found. Artifacts, mostly bottle glass, nail fragments, and occasional ceramic sherds, were recovered from all levels and were similar to those found throughout the yard. In addition, three clay marbles were recovered from levels D and E. Recorded stratigraphy (Figure 5) is as follows:

Level A and B	Dark brown silty clay	0.0 - 0.50 feet below surface
Level C	Yellow brown silty clay	0.50 - 0.75 feet
Level D	Mortar mixed with sand, gravel, and clay	0.75 - 1.05 feet
Level E	Dark gray ash	1.05 - 1.50 feet
Level F	Subsoil	1.50 - 1.75 feet

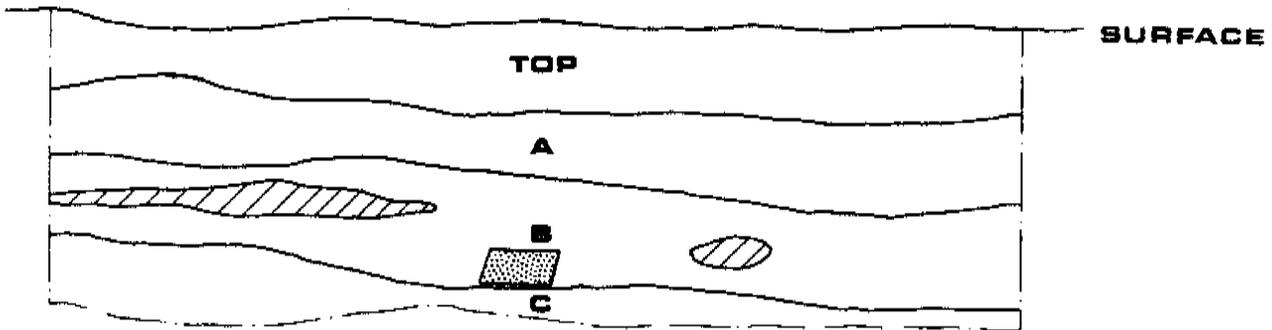
FIGURE 6

PROFILE OF WEST WALL, UNIT NO. 11

TOP - SELECT FILL & YELLOW BROWN SILTY CLAY

A - BROWNISH YELLOW SANDY CLAY WITH PEBBLES, ROCKS AND COAL

B - DARK BROWN SANDY LOAM WITH COAL AND ROCK

C - YELLOW BROWN SILTY CLAY (SUBSOIL)

school's wood/coal shed (Elwood Wilkins, pers. comm. 1981). After removal of the gravel and rubble fill layer, a dark brown buried topsoil was found approximately 0.8 feet below surface (Figure 6). The topsoil level had large amounts of coal chunks and chips embedded in it. A coal layer found below the topsoil had been deposited in a rectangular concentration bounded by the organic rich buried topsoil. At a depth of 1.5 feet below surface, a feature (Feature 1; Appendix 6, Figure 7 and Plate 8) was located at the interface of levels B and C, was excavated, and was found to be a soft circular dark brown mottled stain. It extended into level C approximately 0.5 feet in depth. Glass, metal, and ceramic were found within the feature. In the rest of test unit No. 11 artifacts were like those found throughout the property in other units, with a high proportion of window glass and nail fragments from levels A and B.

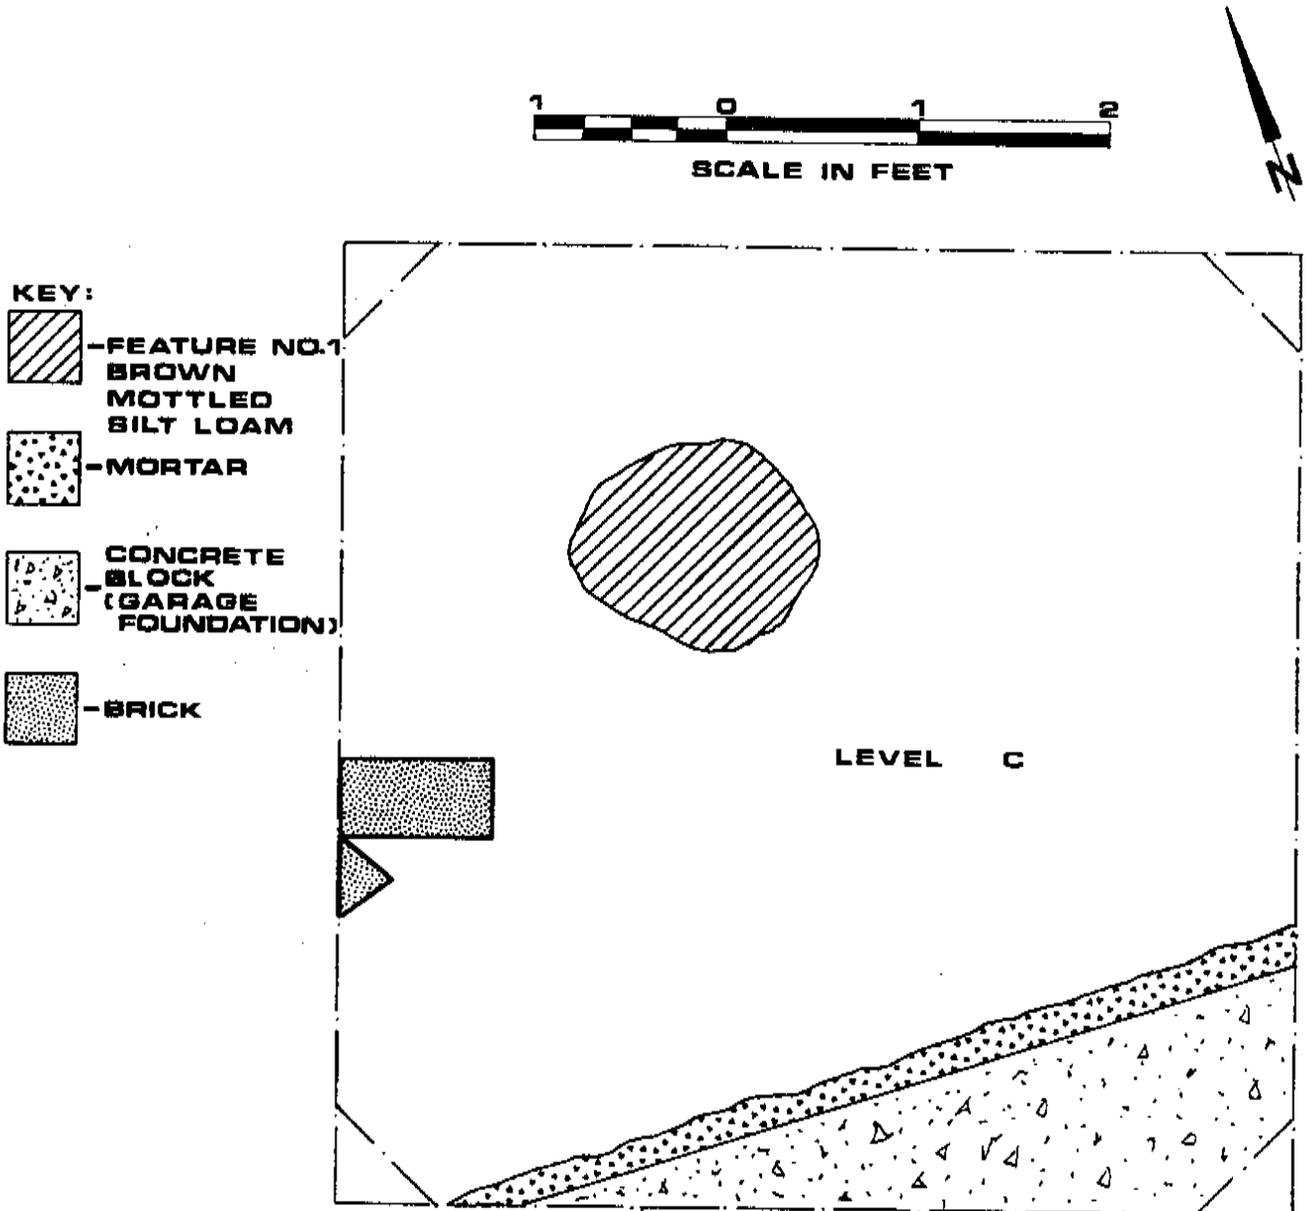
FIGURE 7

PLAN UNIT NO. 11,

TOP OF LEVEL C SHOWING FEATURE NO. 1

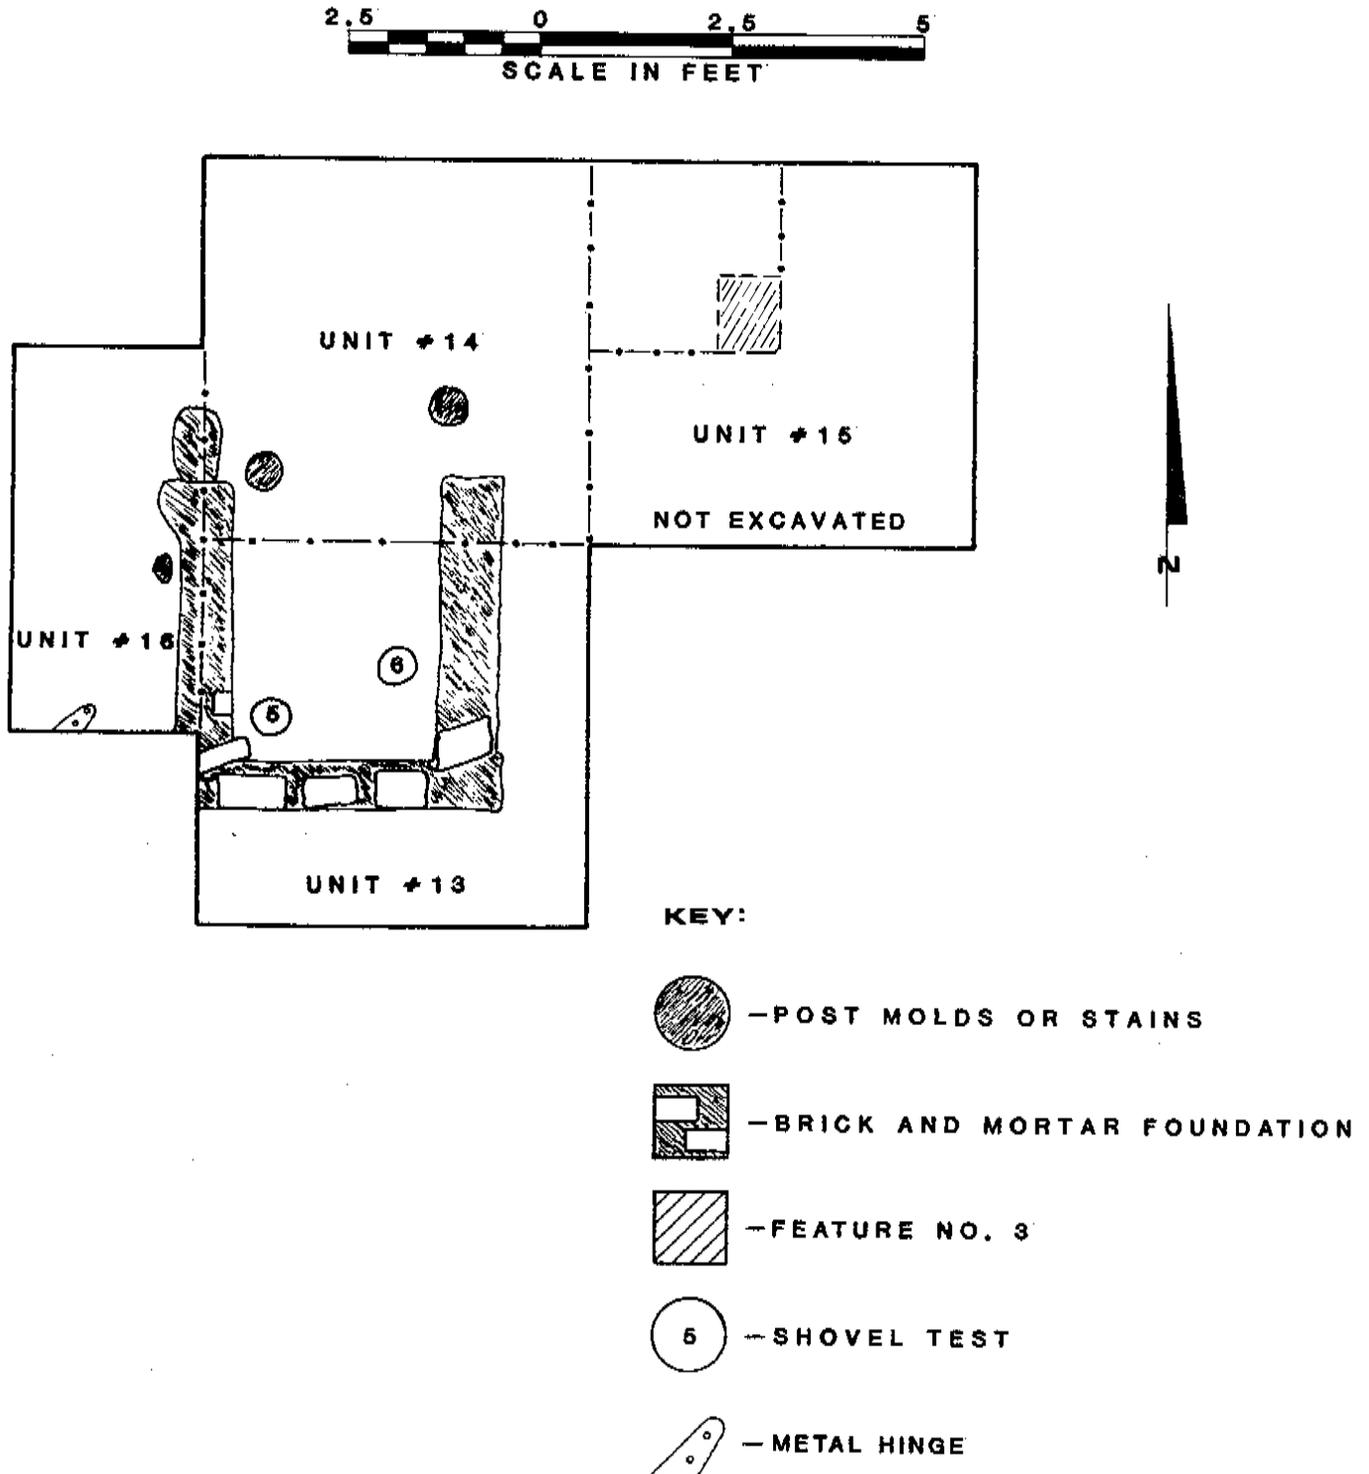
FIGURE 8

PLAN UNIT NUMBERS 13, 14, 15, 16

SHOWING LOCATION OF GIRL'S PRIVY

Unit No. 13: This 5 foot x 5 foot unit (Figure 8) was excavated after testholes 5, 6, 21 and 22 had revealed a brick and mortar feature in the vicinity (Map 7). An informant indicated this area was where the girls' privy was located during the schoolhouse occupation. Removal of the gravel base for the macadam driveway exposed a brick scatter in the configuration of a reverse L (from west to east), about 0.4 feet below the surface (Feature No. 2;

Unit No. 14: This 5 foot x 5 foot unit, (Figures 8 and 11) was excavated directly north of Unit No. 13 to continue the excavation of the foundation (Feature No. 2). The foundation extended into Unit No. 14 approximately 1.1 feet horizontally, and reached a depth of 2.0 feet. In addition to the foundation, two post molds were found in the unit. Both reached a depth of approximately 2.1 feet. The angle of the post holes suggests that the posts were positioned to cross at the top (northern) side of the foundation. These post molds may have been the remains of the posts that were part of the wooden screens which reportedly surrounded the privies (Wilkins, personal communication, 1981 and Plate 2). A large amount of window and bottle glass

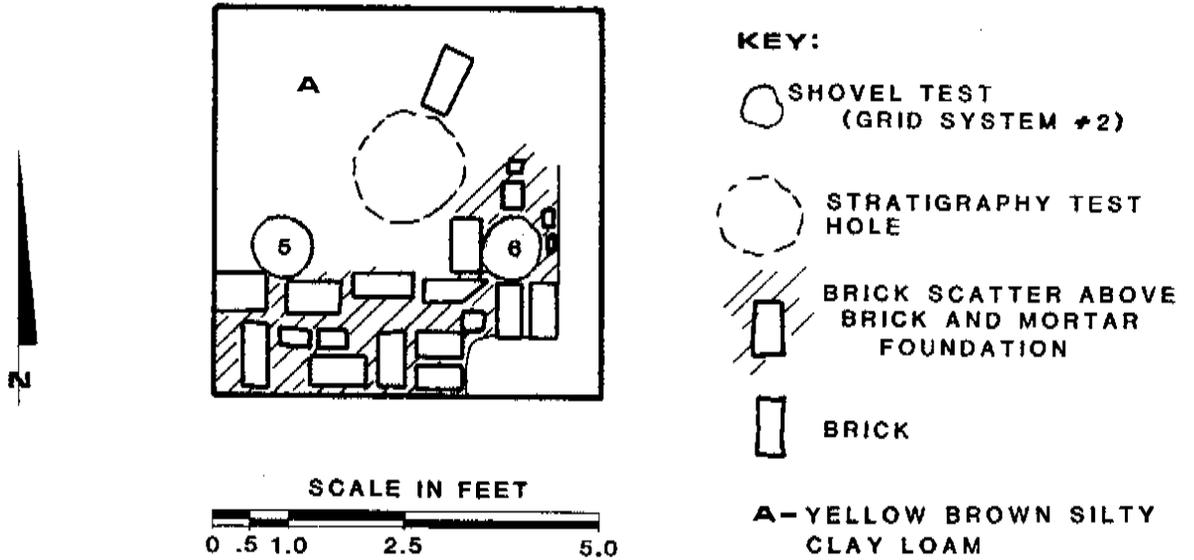
FIGURE 9

PLAN UNIT NO. 13,

BOTTOM OF LEVEL A SHOWING FEATURE NO. 2

Appendix VII, Plate 9 and Figures 9 and 10). Below the brick scatter was a brick and mortar U-shaped foundation with the open end facing northward. Soil stratigraphy within the foundation was a yellow brown silty clay loam (Level A) extending to the vertical limits of excavation, approximately 2.0 feet below surface. Outside of the foundation, the soil stratigraphy consisted of a buried topsoil (Level B) beneath the gravel base underlain by subsoil. It was noted that the foundation continued to the north (the open wings of the 'U'), extending beyond the limits of Unit No. 13. Artifacts were recovered from Levels A and B, or above, and in association with the brick foundation, but none came from within the limits of the U-shaped foundation. Artifacts included three stoneware sherds, several pieces of bottle glass, and a large amount of nail and metal fragments below the top of the foundation. As one of the primary project objectives was to locate subsurface features, it was decided to open up Unit No. 14 to the north of Unit No. 13 in order to determine the extent of this feature. Figures 9 and 10 show Feature No. 2 and the floor plan of Unit No. 13.

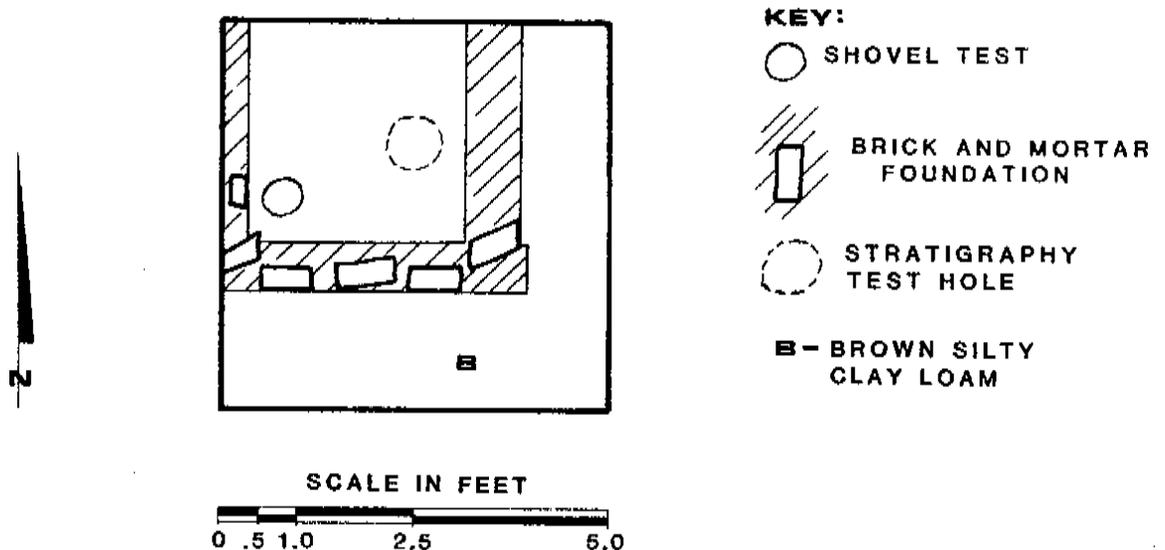
FIGURE 10

PLAN UNIT NO. 13,

BOTTOM OF LEVEL B SHOWING FEATURE NO. 2

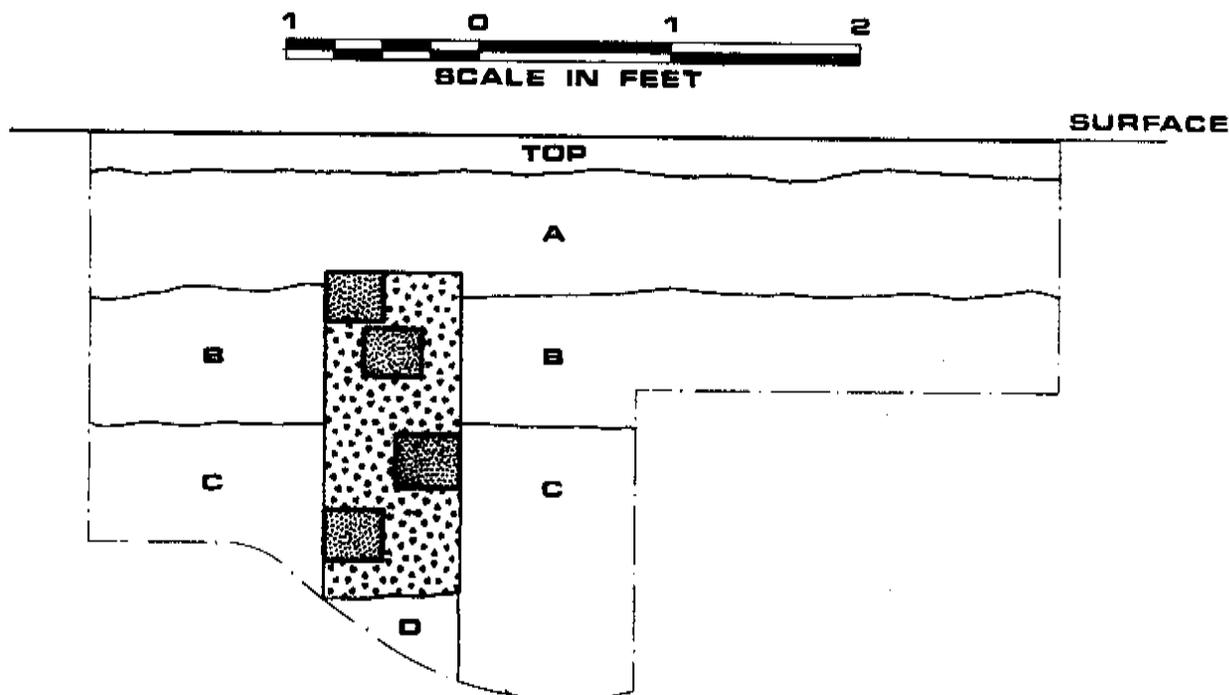
FIGURE 11

PROFILE OF SOUTHWEST WALL, UNIT NO. 14

- BRICK AND MORTAR FOUNDATION (SCHEMATIC)

TOP - SELECT FILL WITH GRAVEL

A - RUBBLE

B - YELLOW BROWN SILTY LOAM

C - YELLOW ORANGE SILTY CLAY (SUBSOIL)

D - COARSE BROWN SAND

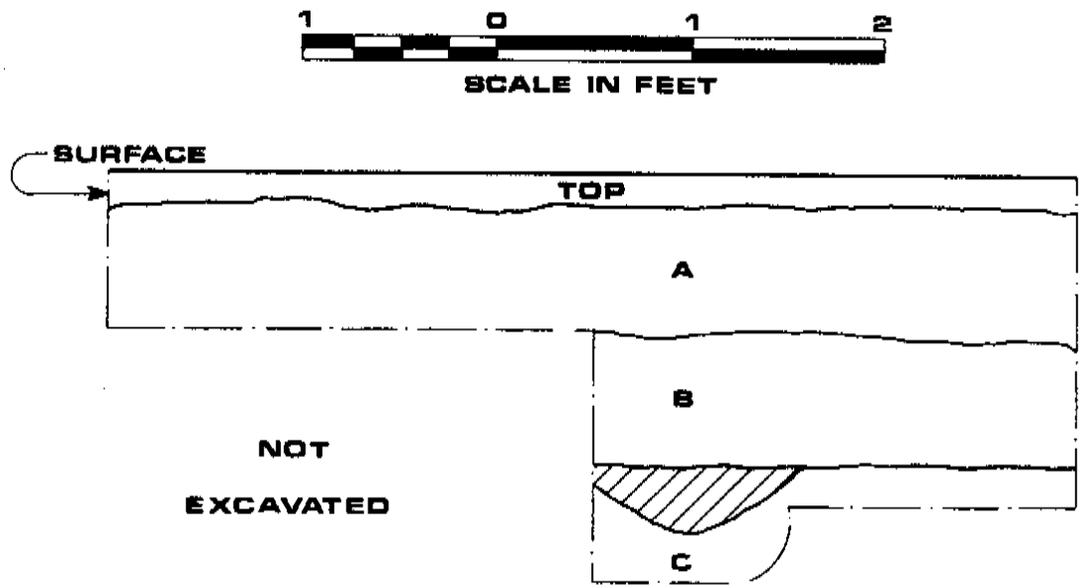
FIGURE 12

CROSS SECTION OF UNIT NO. 15, SOUTH WALL

SHOWING DEPTH OF FEATURE NO. 3

- KEY:**
- TOP - GRAVEL BASE FOR MACADAM DRIVEWAY**
 - A - RUBBLE LAYER**
 - B - YELLOW BROWN SILTY CLAY**
 - C - YELLOW ORANGE SILTY CLAY (SUBSOIL)**
-

Unit No. 15: Located to the east of Unit No. 14, this 5 foot x 5 foot unit (Figures 8 & 12) was placed to determine the extent of the subsurface features discovered by Units No. 13 and 14. Excavations to a level below the gravel base for the macadam driveway (approximately 0.5 feet) indicated that the soil stratigraphy was similar to that in previous units. For this reason, part of the 5 foot x 5 foot unit was discontinued at this depth (Figure 12). Excavation was continued in a 2.5 foot x 2.5 foot quadrant in the northwest corner of Unit No. 15 with the intention of locating additional post molds along the northeast trending line extending from Unit No. 14. A dark brown organic stain with many associated artifacts (predominantly clear bottle and window glass, plus a complete six-sided perfume bottle) was located in the south-east quadrant of this smaller unit approximately 0.7 feet below surface (Feature No. 3, Appendix VIII, Figure No. 8 & 13, and Plate 10). The feature's dimensions were 1.0 feet x 0.8 feet, and it extended to a depth of 1.2 feet below surface. It was a shallow depression. A 1927 "Wheat" penny was recovered from Level B.

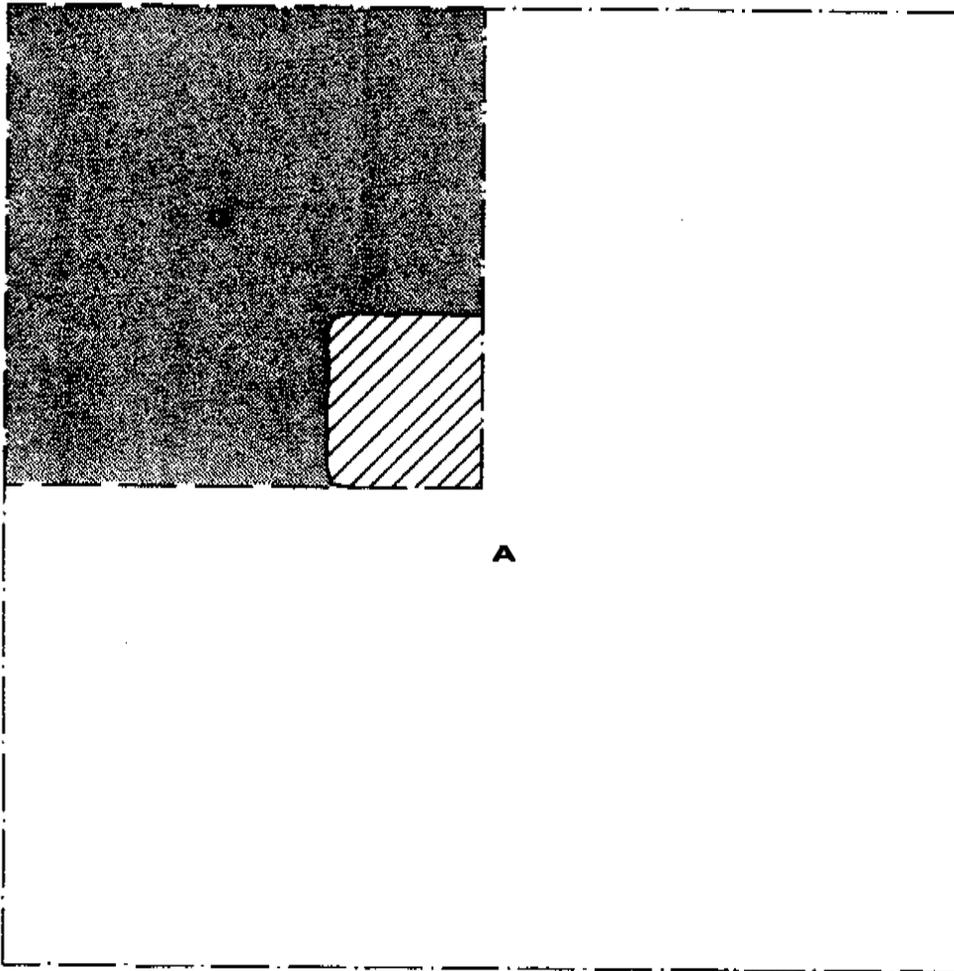
FIGURE 13

UNIT 15, TOP OF LEVEL C, FEATURE NO. 3

- FEATURE NO. 3, BROWN SILT LOAM

- RUBBLE LAYER

- YELLOW ORANGE SILTY CLAY (SUBSOIL)

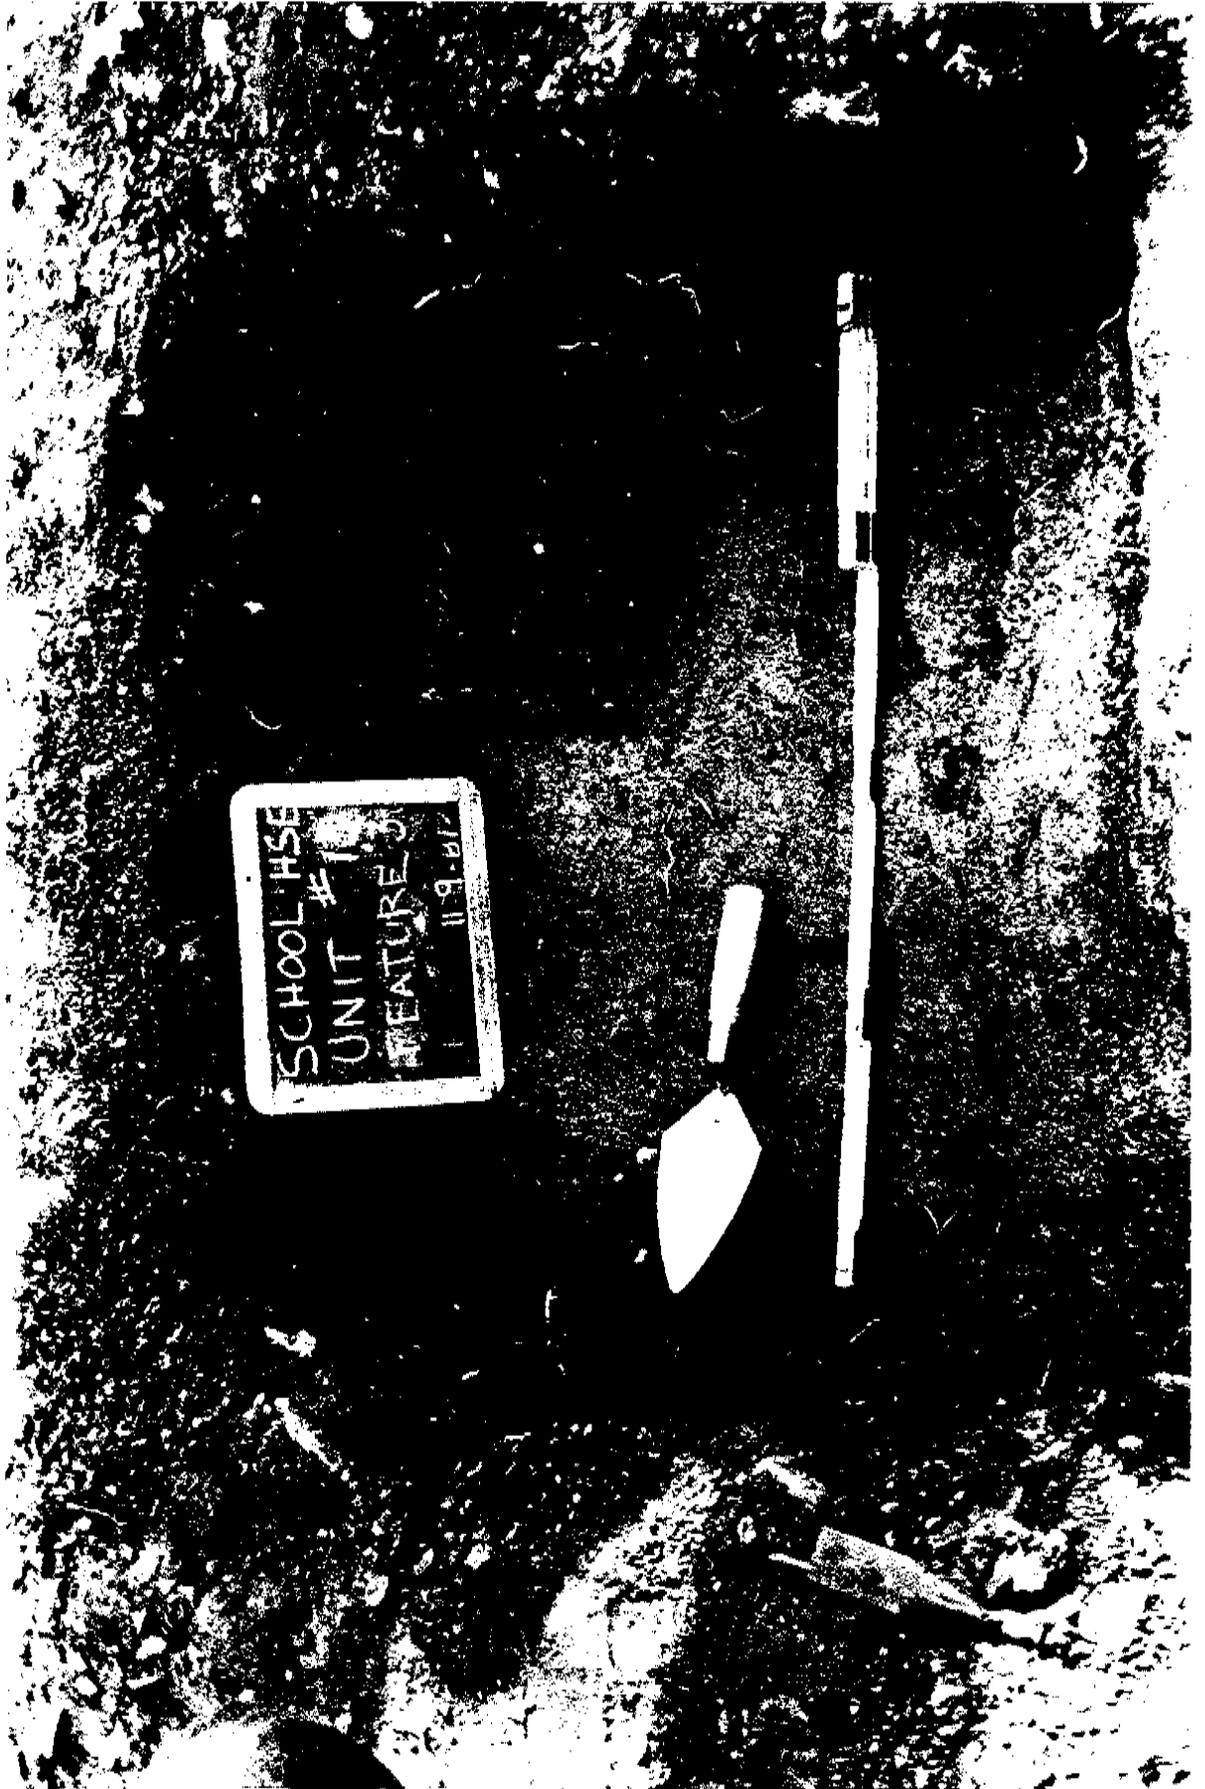
PLATE 10

TEST UNIT NO. 15 SHOWING FEATURE NO. 3
