INTRODUCTION AND STATEMENT OF PURPOSE

The purpose of this report is to present results and recommendations based upon archaeological investigations of the Route 4 Schoolhouse site, locally known as the Welsh Tract Schoolhouse, District No. 54 (Map 1, Plate 1 and Appendices I & II). Intensive excavations were undertaken by the Department of Transportation, Division of Highways archaeologists, and included pre-demolition survey, testing in the yard, and post-demolition survey under the driveway and garage. The survey was conducted as part of the widening and upgrading project of Delaware Route 4.

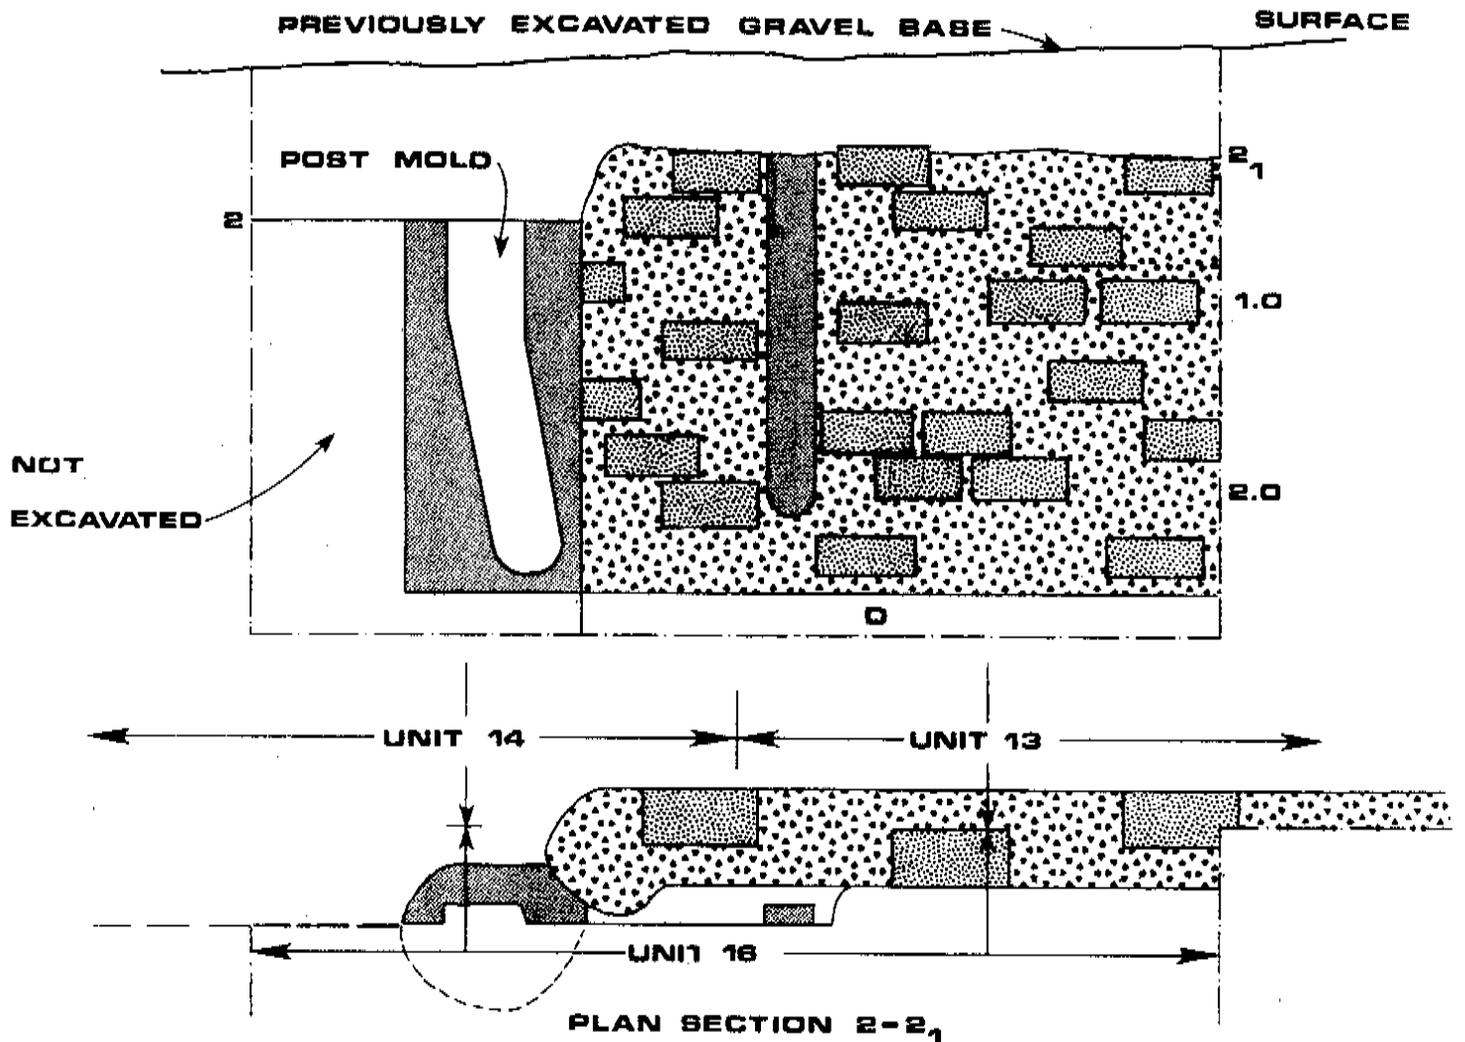
FIGURE 14

PROFILE PLAN OF EAST WALL, UNIT NO. 16

BRICK AND MORTAR WALL
-

-MOTTLED YELLOW ORANGE SILTY CLAY (SUBSOIL)
-

-POST HOLE
-

D - BROWN SAND

Unit No. 16: This final 2.5 foot x 5 foot unit was laid out along the west side of units No. 13 and No. 14. The purpose of its placement was to uncover the western wall of the girl's privy foundation (Feature No. 2) and to locate further post molds (Figure No. 8). The recorded soil stratigraphy was as follows: gravel base to about 0.2 feet (Level A); buried topsoil to 1.3 feet (Level B); a yellow orange silty clay to 2.5 feet (Level C); and below that a strong brown coarse sand at the limit of excavation (Figure No. 14, Plate 11). The brick and mortar foundation extended 3.4 feet along the east wall of Unit

No. 16. Approximately 2.6 feet from the southeastern corner of the unit was a post hole, 0.2 feet in diameter and 2.1 feet in depth. Beyond the northern terminus of the western foundation wall there was a second larger post mold, 0.5 feet in width and 1.9 feet in depth, surrounded by a brown organic post hole stain 0.9 feet wide and 2.0 feet deep. This stain was located adjacent to the northern end of the foundation. The foundation extended to a depth of 2.5 feet below surface and ended abruptly on a strong brown coarse sand level (Level D).

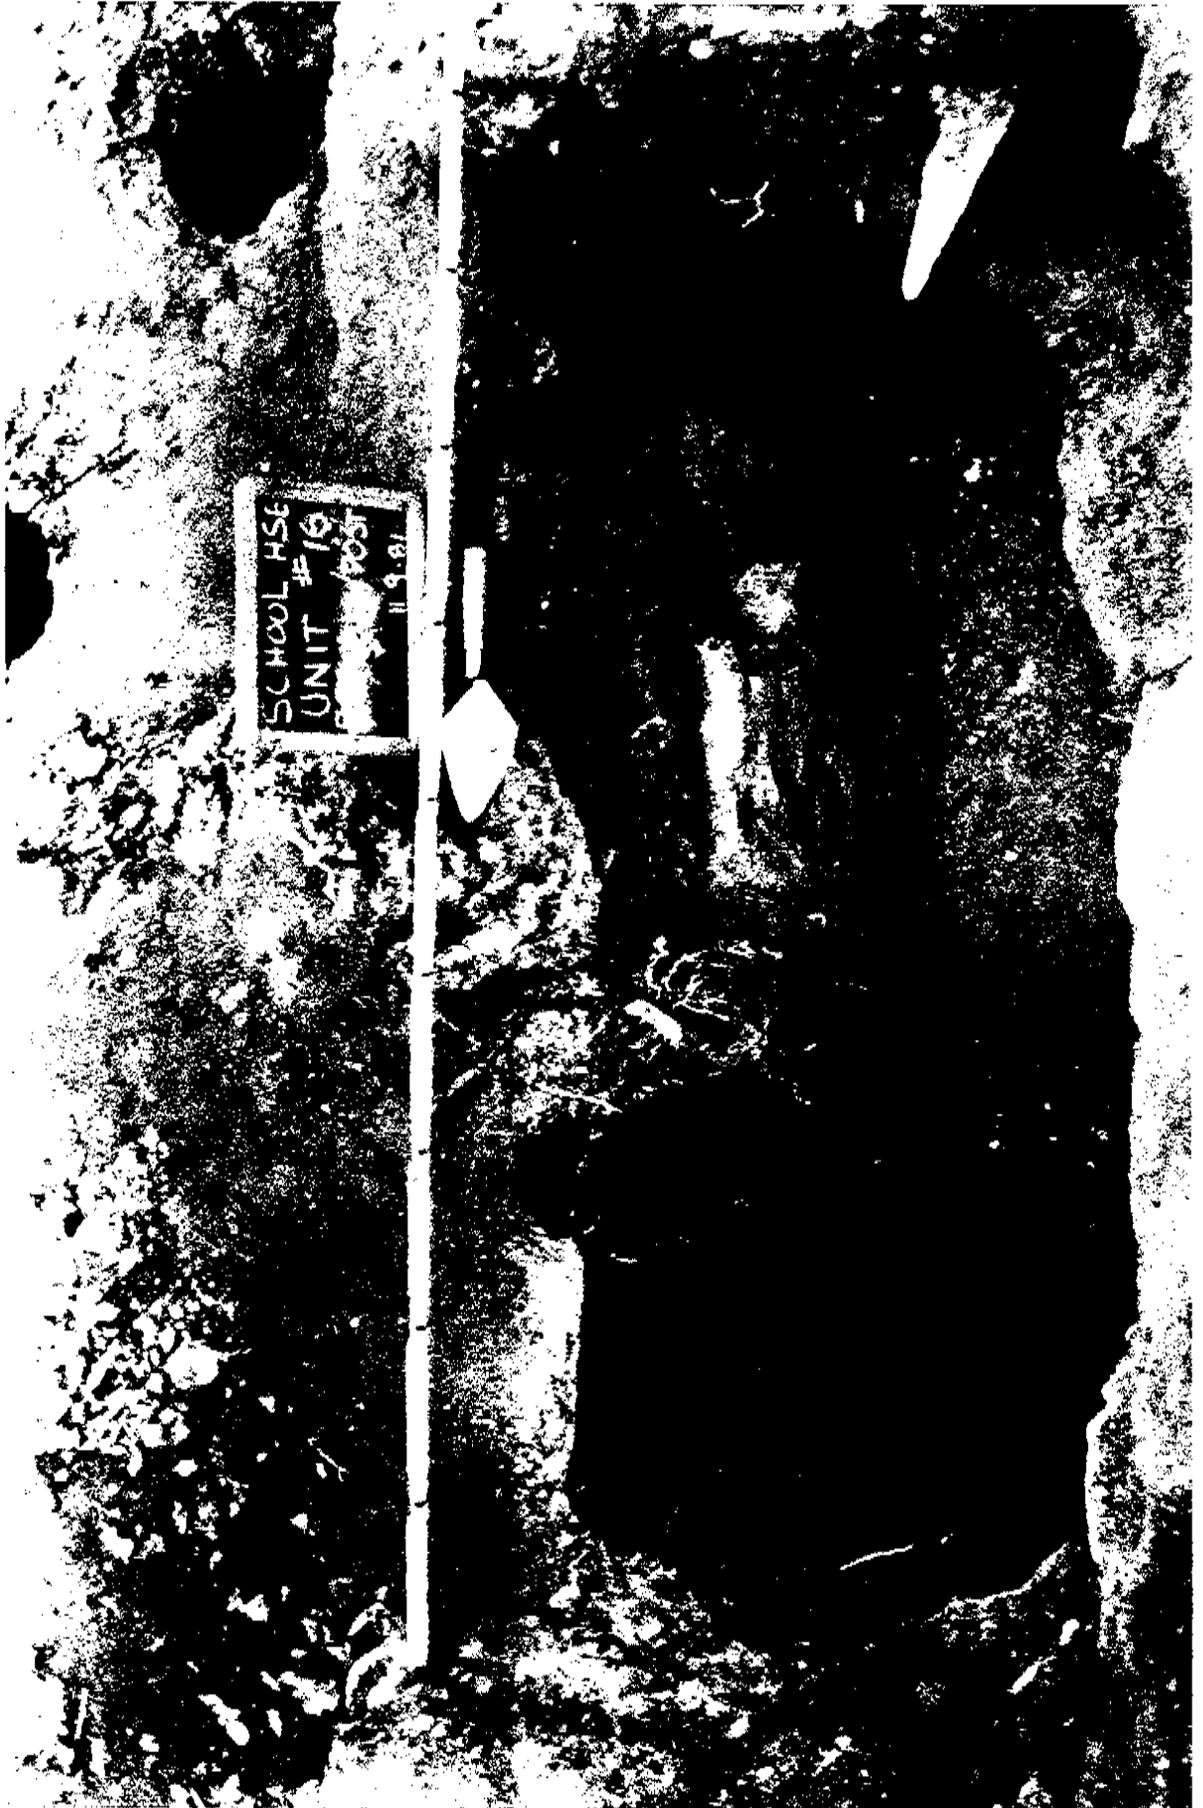
PLATE 11

TEST UNIT NO. 16 EAST WALL PROFILE

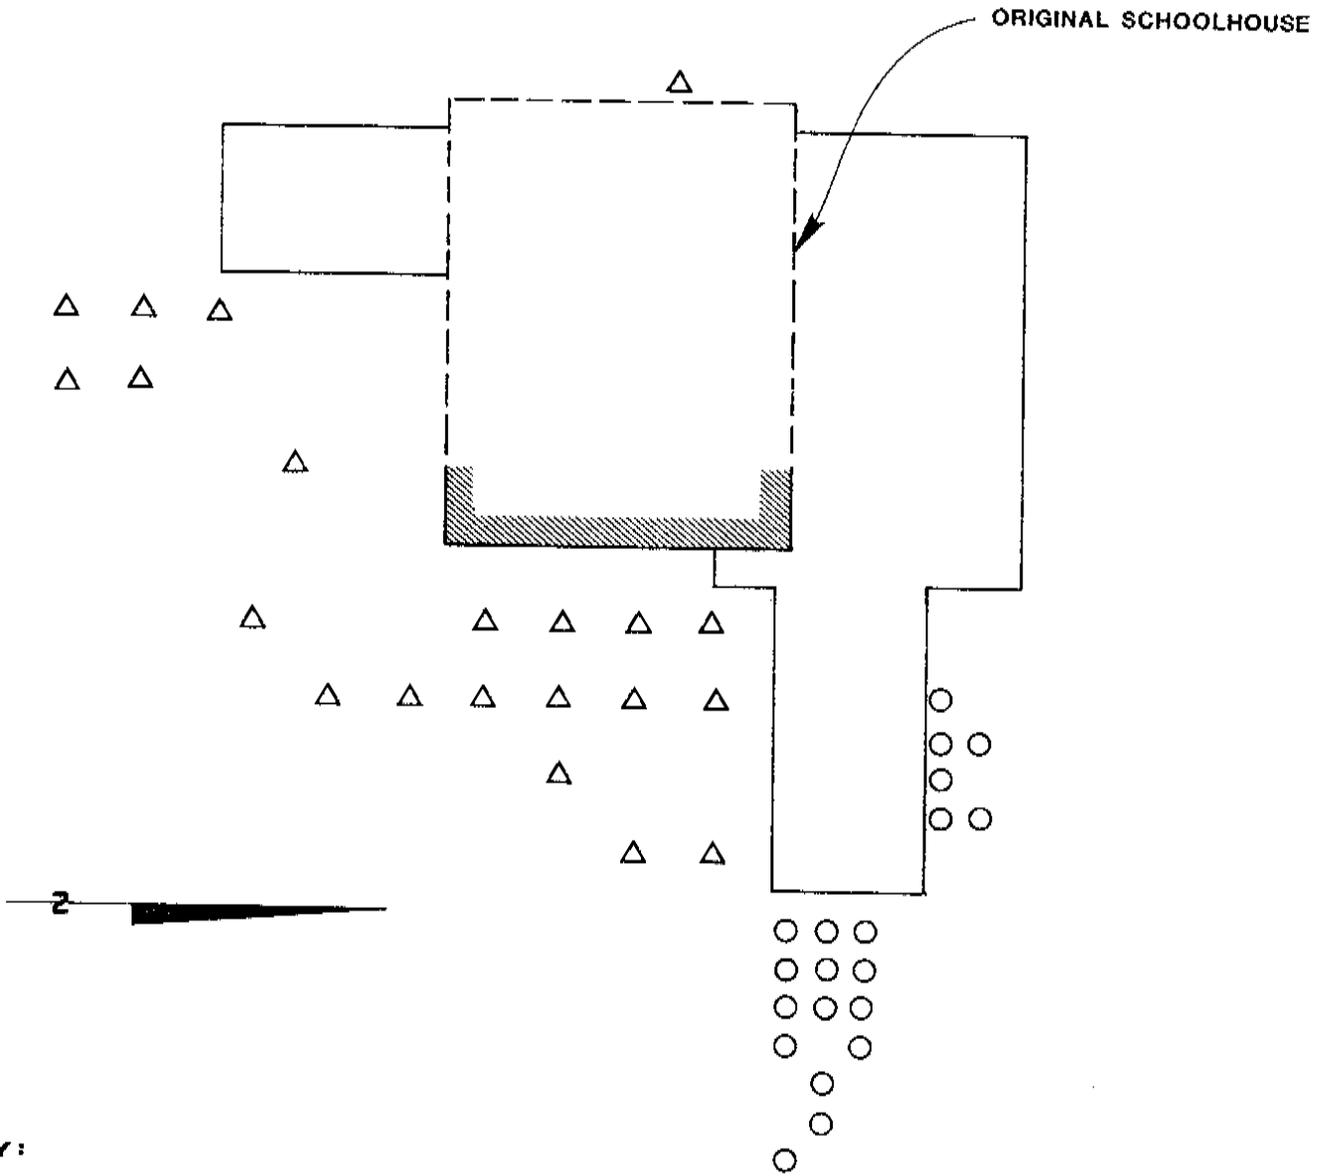
MAP 8

DISTRIBUTION OF ASH, CINDER, AND COAL CONCENTRATIONS AS REVEALED BY SHOVEL TESTING

- AREA ON WALLS THAT SHOWED FIRE SCARRING

- ASH AND CINDER

- COAL

was also constructed (see Map 8). This revealed a large area to the south and east of the original schoolhouse to have concentrations of ash and cinder. Several of the test units (No. 9, 10, 11, and 12) also had ash and cinder levels in them. This level is indicative of the fire that gutted the schoolhouse circa 1906, and thus can be accurately dated. Of interest are the locations of these ash and cinder concentrations found predominantly in the yard area to the south and east of the structure. This could indicate the direction of the prevailing wind at the time of the fire, and fits well with the fire-scarred rocks found in the east wall and at the southeast and northeast corners of the structure. Deposits of coal are also shown on Map 8. These locations, particularly to the north and rear of the original structure, coincide with the area where the wood and coal shed was located.
