CULTURAL RESOURCE SURVEY
PROPERTY IDENTIFICATION FORM

CRS # S-12255
SPO Map 14-15-15
Hundred Cedar Creek
Quad Milford
Other 330-15:00-59.00

1. HISTORIC NAME/FUNCTION: Louis and Shirley Renzi House (storage sheds/ barn)
2. ADDRESS/LOCATION: 7296 Cedar Creek Road
3. TOWN/NEAREST TOWN: Milford Vicinity _____
4. MAIN TYPE OF RESOURCE: building structure site object
 landscape district
5. MAIN FUNCTION OF PROPERTY: Agricultural
6. PROJECT TITLE/ REASON FOR SURVEY (if applicable): State Route 1 and Route 30 Grate Separation Intersection Project: State Contract T2008-122-01 and Federal Aid Number NH-S014(12)

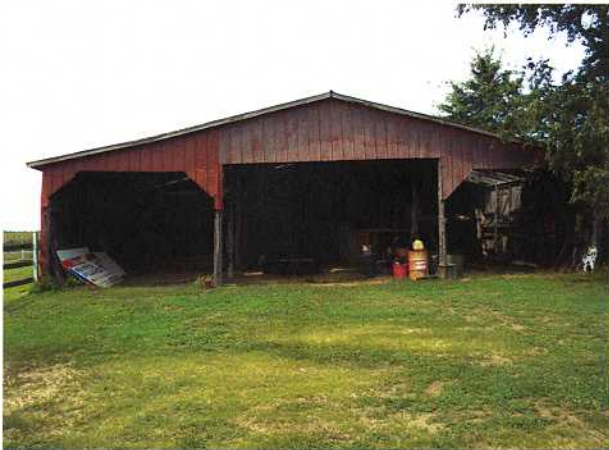
Insert photographs; note file name and brief description of view: 1: Storage Barn N Elevation, 2. NW Elevation, 3: N Elevation, 4:SW Elevation, 5: Storage Shed NW Elevation, 6: Modern Barn SE Elevation, 7: Modern Dwelling E Façade. PECT RATIO – DO NOT STRETCH PHOTO)
