FINAL
U.S. 113 Milford Architectural Supplement
and/or
Supplement Material for Intersection Improvements Cedar Neck Road, State Route 1 and
State Route 30 for Cultural Resource Evaluations

Prepared by Michael C. Hahn, AICP and Nathaniel Delesline
Delaware Department of Transportation
800 Bay Road, P. O. Box 778 Dover, Delaware 19903
September 2010

**S-12254 Key Properties Group, LLC (Vreeland House)
7272 Cedar Creek Road
(Tax ID: 3 30 15. 00 58.01 or 1.01 Acres)**

**S-12255 Louis and Shirley
Renzi (Vreeland Outbuildings)
7296 Cedar Creek Road
(Tax ID: 3 30 15. 00 59.00 or
1.26 Acres)**

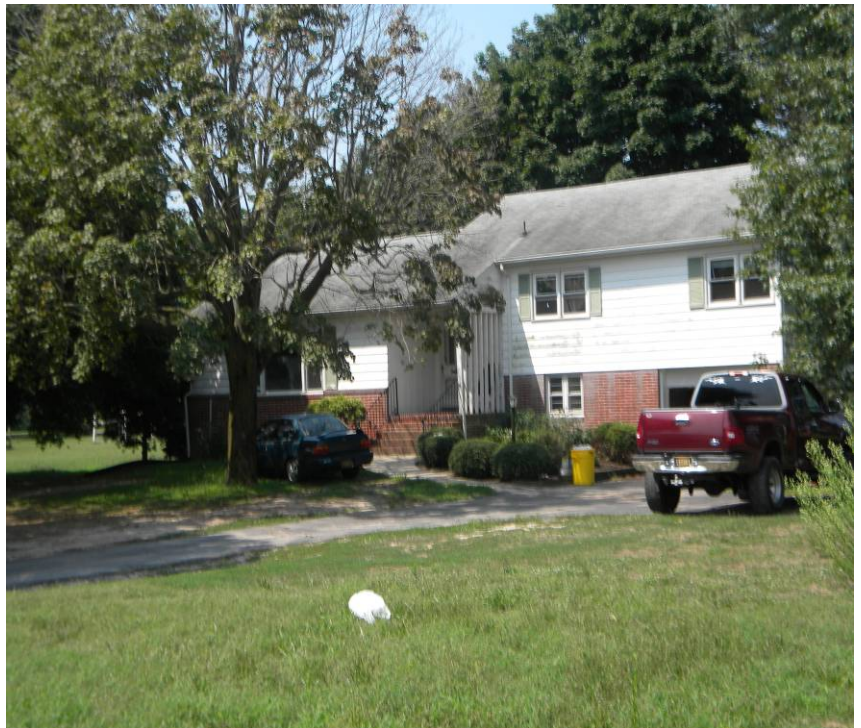
The two story split-level dwelling is topped with a side gable roof covered with asphalt shingles. On the west elevation, a brick chimney rises from the middle of the dwelling towards the rear. The lower level of the house is constructed of concrete blocks and stucco, while brick veneer covers the lower level of the east facing façade. The remaining dwelling is constructed of timber. The upper level of the façade as well as the north, south and west elevations are all sheathed with aluminum siding. A partial basement is located on the southern end.

The east facing façade is punctuated with four bays with the southern end consisting of a Chicago style bay window. By a series of ascending brick steps and a metal hand rail, the central entrance is covered by the overhang gable. It is partially supported by a series of timber vertical planks on the north end. Entrance into the front of the house is through a half light door sheltered by a half light aluminum storm door. The façade is also marked with a pair of smaller 1/1 double hung sash windows at ground elevation and two pairs of 1/1 double hung sash windows on the upper floor. Green metal shutters highlight the Chicago style bay window and the paired set windows on the upper level.

Throughout the dwelling, most window units have been replaced. In addition, various shutters have been removed and any additional metal awnings are missing. Siding is aged and faded that conveys an overall stressed appearance.

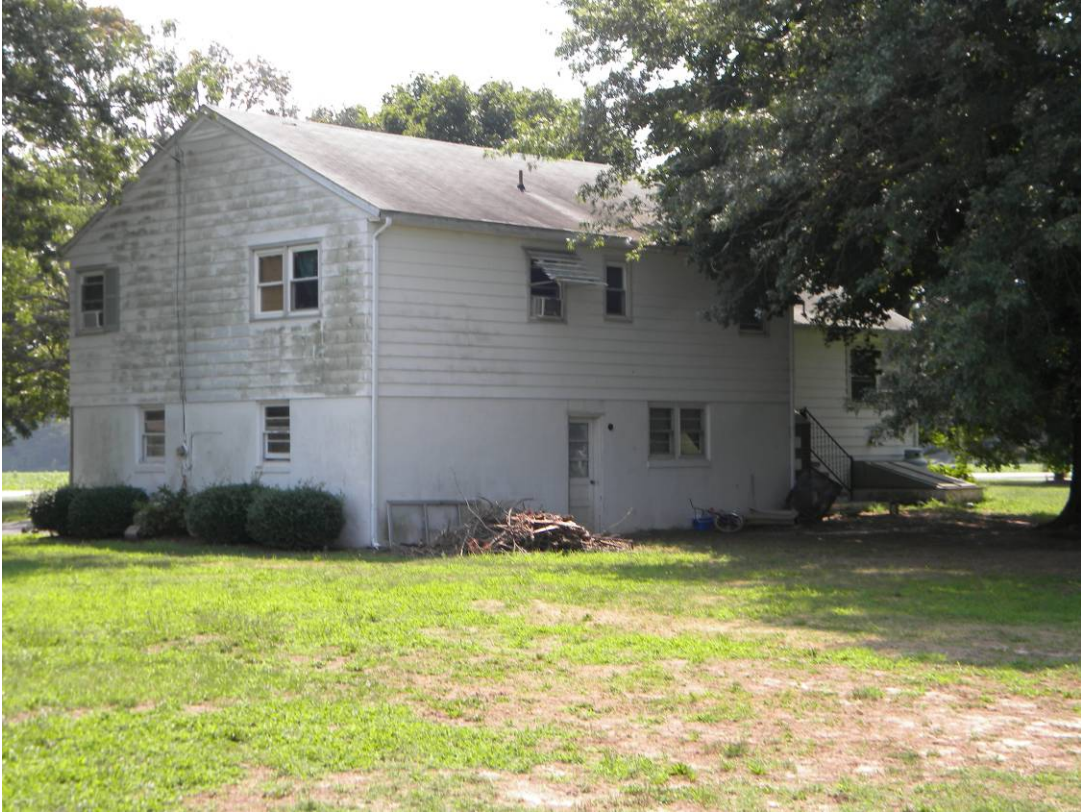
North end and rear of dwelling looking southeast

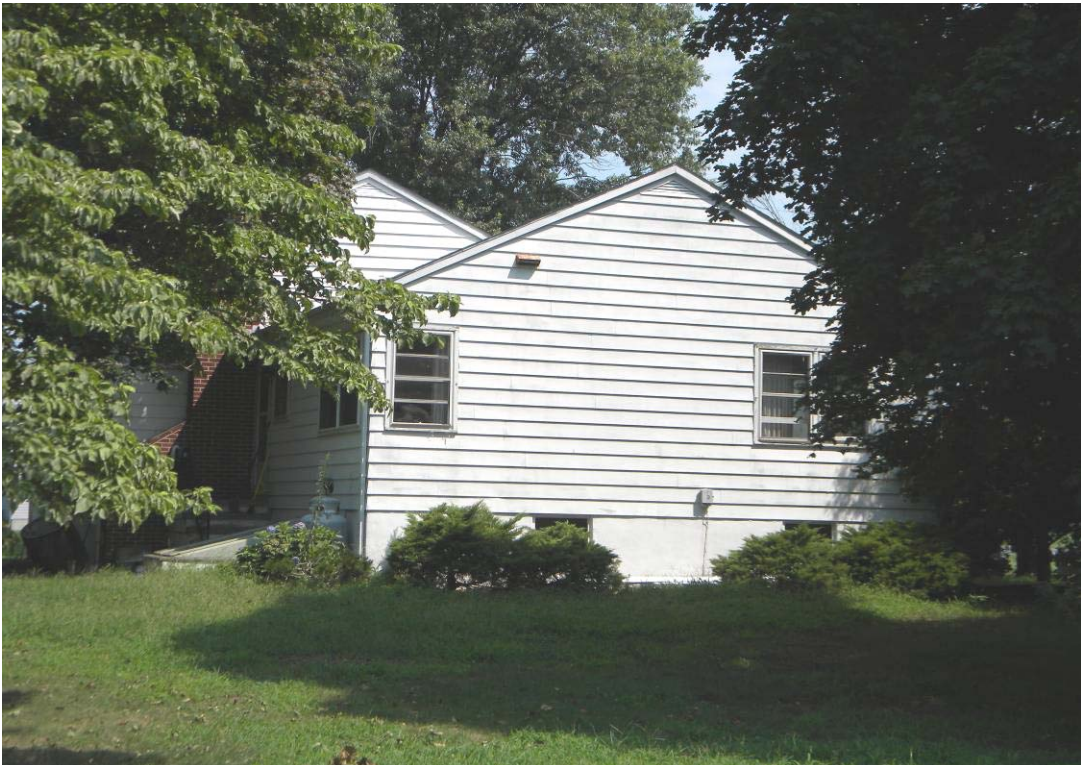
South end looking north

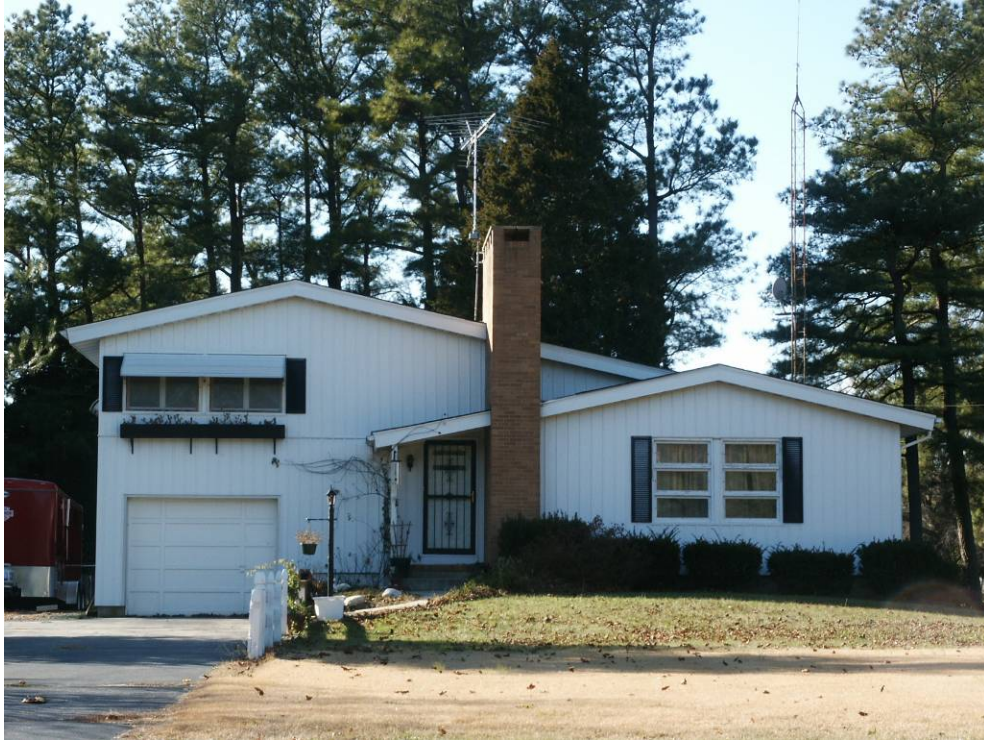
S-10564, Haight House @ 314 South DuPont Highway exists in the Milford area and provides a better comparative example of a split level in the outskirts of town.

In addition, another example of this style (S-10564. Haight House @ 314 South DuPont Highway), exists in the area and may provide a better example of a split level in the outskirts of town. The Haight House also embodies more distinctive characteristics of a type or period of construction. The dwelling at 7272 Cedar Creek Road is another example of a split-level, but with less character, alterations, and is recommended not eligible under Criterion C.

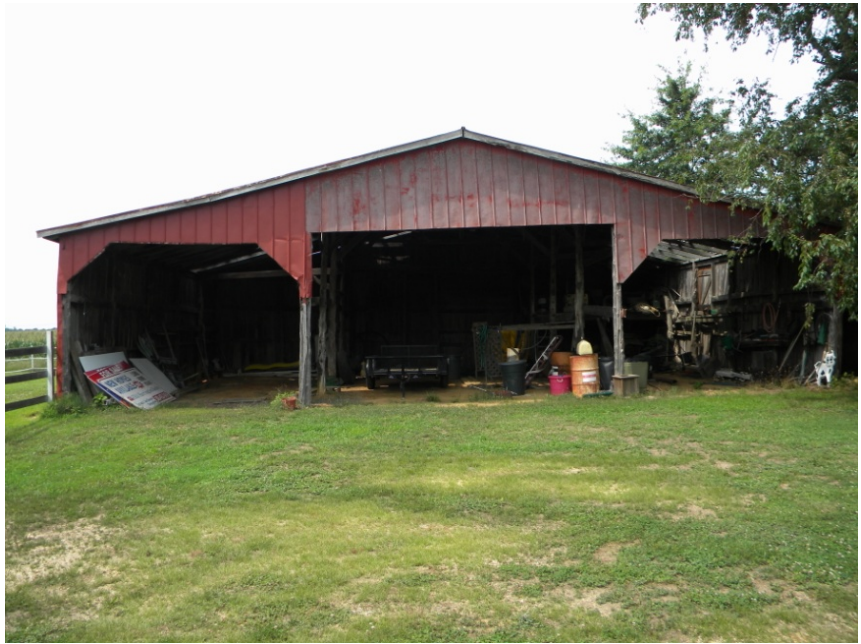
Description: The circa 1930 three bay machine shed storage barn is located on the west side of Cedar Creek Road nearly ¼ mile south of Wilkins Road. Despite being another tax parcel that appears landlocked, access is provided from the eastern lot off Cedar Creek Road. A U-shaped access way (now modified) provides access to the site location.

The machine shed storage barn measures approximately 50' by 40' and rests on a series of heavy timber posts/trees (un-cut) set directly in the ground. The flooring is dirt. The central rafter support system is supported on a series of Queen Posts. Un-cut timbers consist of a combination of trees (stripped of bark) and mechanically saw cut lumber. The roof framing consists of common rafters.

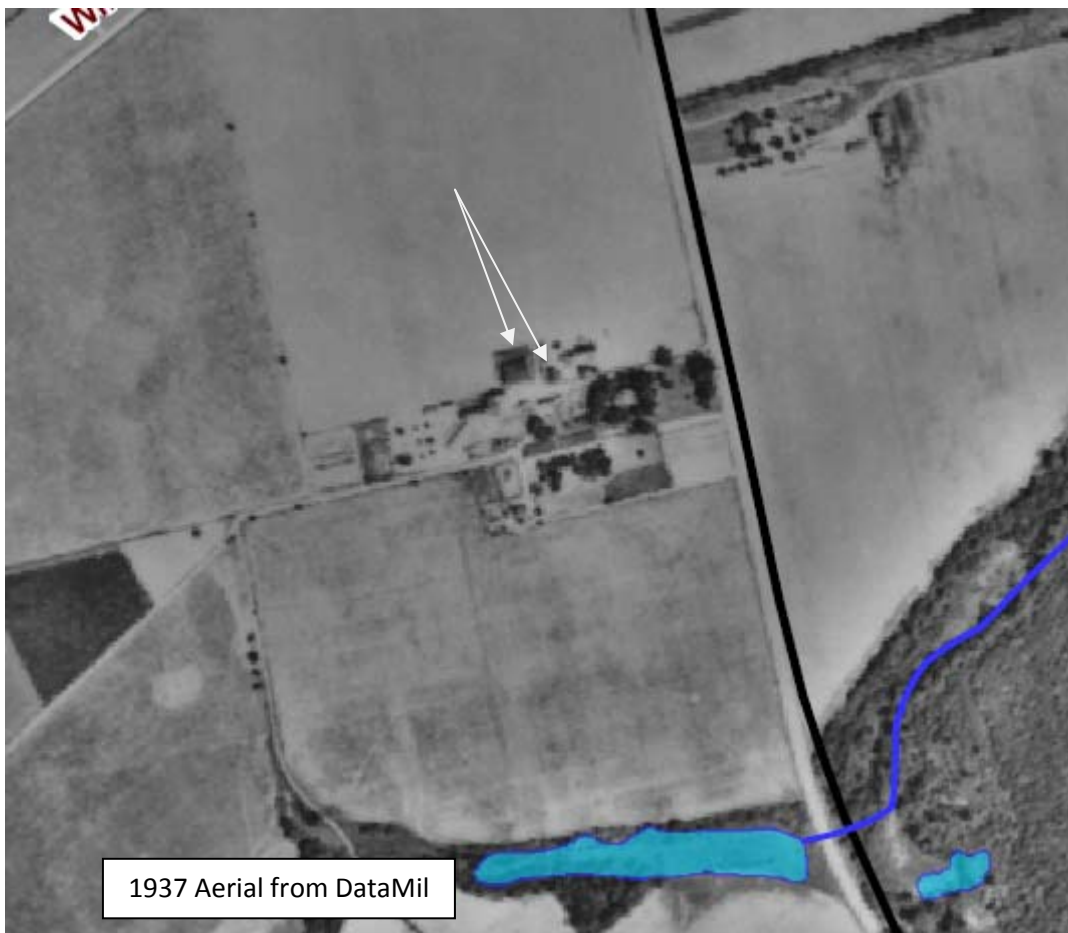
Historic Overview: Under deed search and a site visit to the property it was revealed that the property was subdivided off the larger Vreeland farm that had been in the family since 1862. The property consisted of a much larger farmstead in which numerous outbuilding and fields were situated behind the main farm house. Aerial photographs from 1937 DataMil (below) seem to situate the machine shed storage barn and storage shed at their current location. Based on this 1937 aerial observation and others, it appears that other agricultural buildings and arrangement of fields and circulation patterns were evident behind the main farmhouse.

Current owner Louis Renzi indicated to DelDOT staff that the original farmhouse dwelling footprint had been facing Cedar Lane Road just behind the area in which he has his modern circa 1980 brick ranch dwelling. Outbuildings were situated towards the rear and were accessed by a separate travel U-shaped access way. A farm lane, which is still current today, continues south into the fields. The 1937 above aerial confirms that assessment.

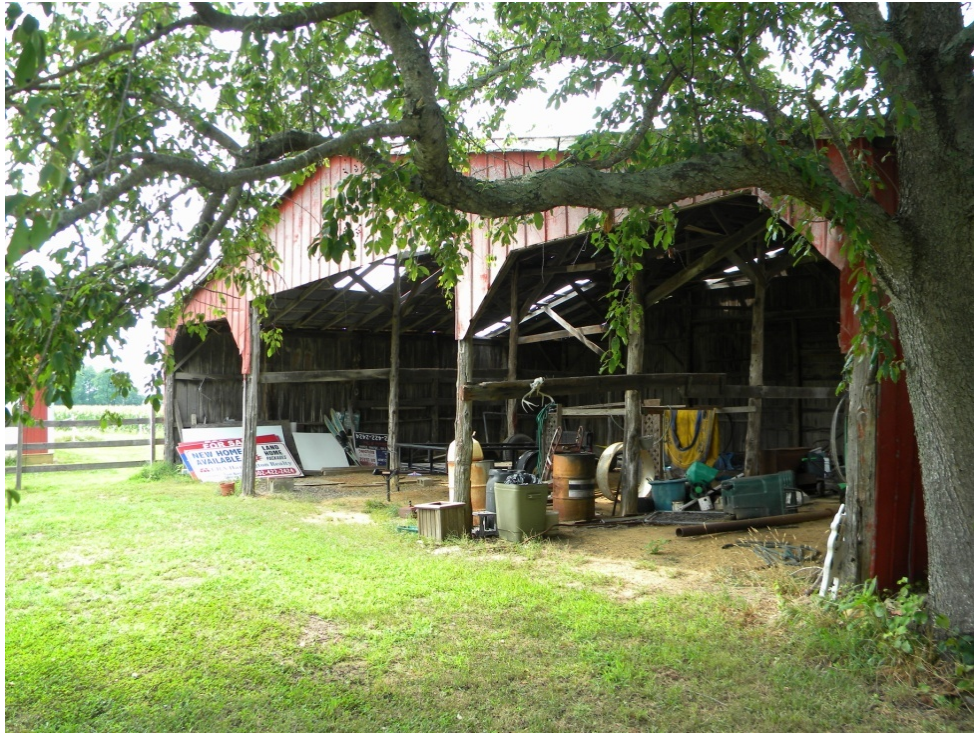
Three bay Machine Shed Storage Barn looking northwest

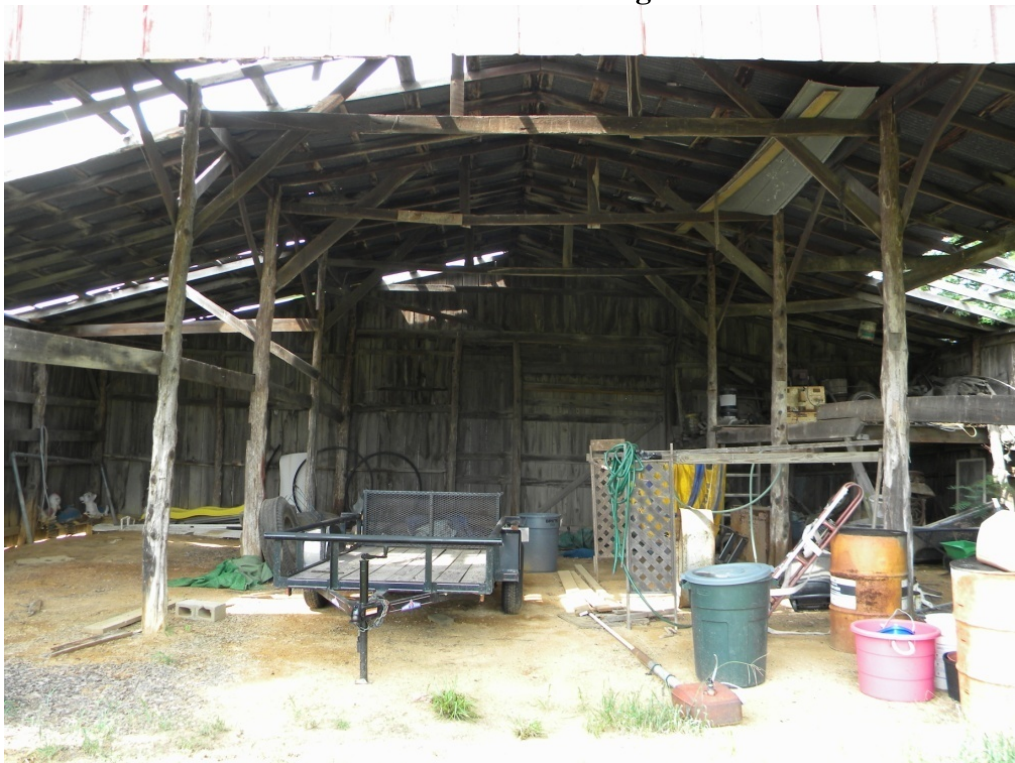
Interior detail looking north

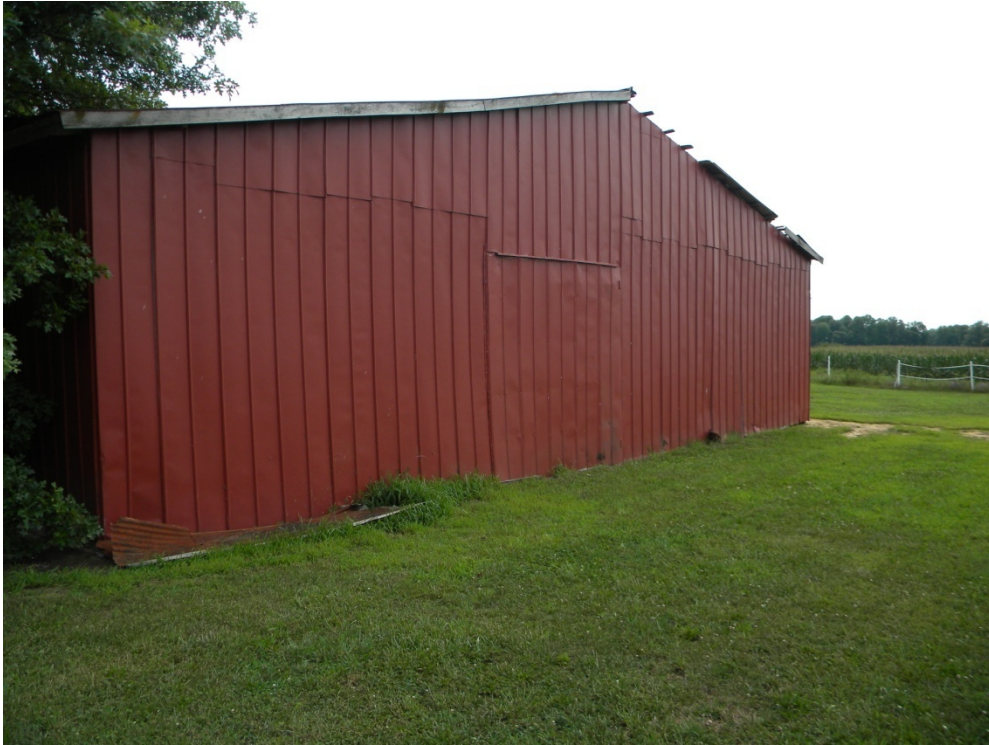
The building is completely sheathed in seamless metal sheets on all three sides and at the upper gable of the open bay. Vertical planking for side and rear walls has been covered over and can only be detected from the interior. The front gable is low pitched and the roofing is covered in corrugated metal sheets. Sections of the roofing have been damaged and are missing. Some timber framing along side walls has been sistered and braced for added support or repair. Various farm equipment remains in the building, but this is limited to chains, conventional yard tools, and other mechanical belts. Nothing of substantial interest or rarity appears to remain reflected in past or current agricultural practices. Larger farm equipment such as combines, tractors, trucks, wagons or fixtures for mechanical equipment would have been stored in this “barn-like” storage outbuilding.

Machine Shed Storage Barn looking southwest – note metal sheathing

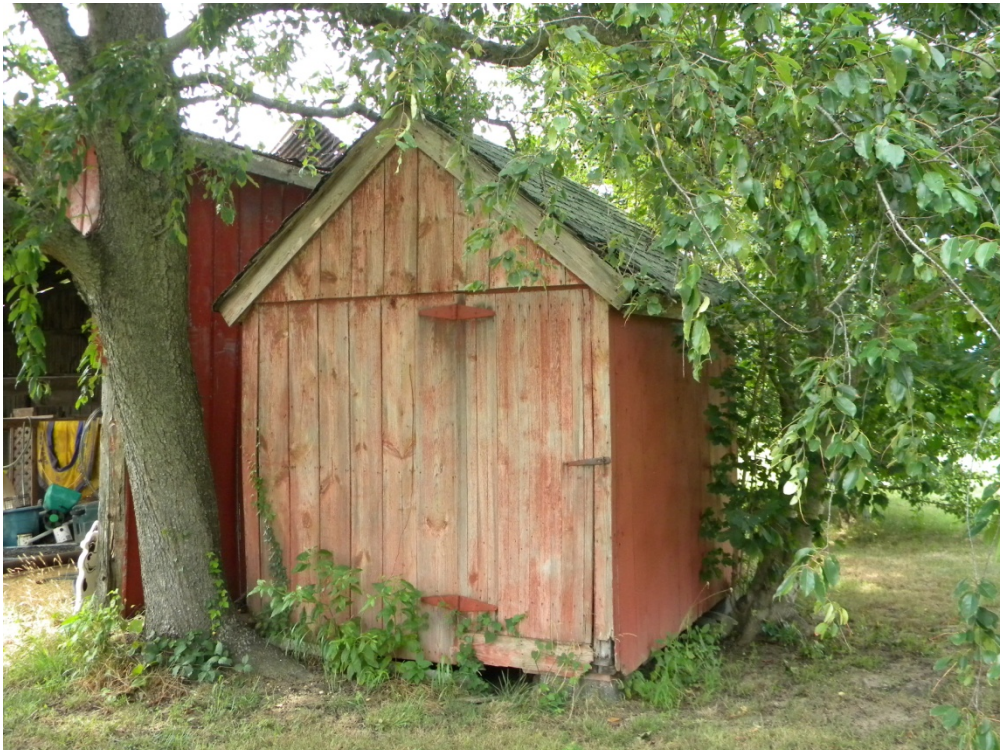
Also evident on the lot is a circa 1930 front gable storage shed with a central wood panel entrance door. The smaller building measures approximately 8' by 12' and rests on concrete cinder blocks. It has probably been moved to its present location immediately east of the machine shed storage barn.

Beyond the front entrance, the remaining vertical timbers on this storage shed outbuilding are sheathed over with the same seamless metal sheets. The roof is covered over with asphalt shingles. Evidence suggests that cedar shakes covered the roof at one time. The roof structure is in poor condition, so different roofing layers are visible.

Storage Shed – second and remaining outbuilding on this lot

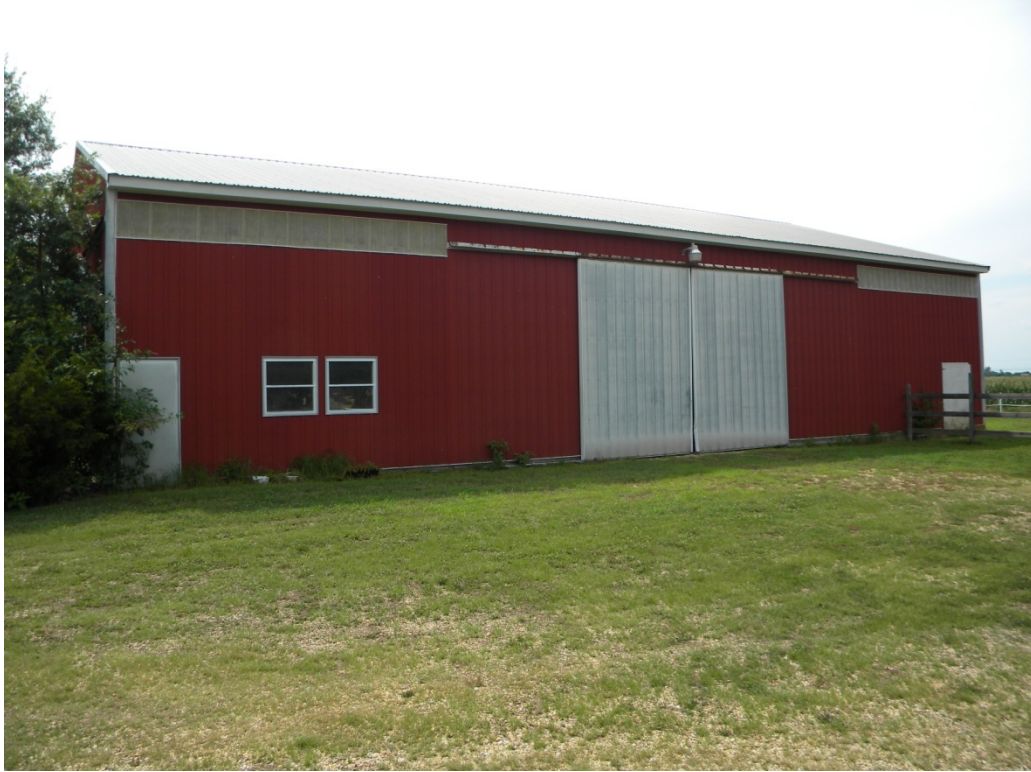
A larger contemporary pole barn is evident towards the central rear of the parcel. Like the two older outbuildings, its use is limited to contemporary residential storage and not agricultural use. The owners of the current lot have even slightly altered the machine shed storage barn and larger pole barn by converting some areas into pleasure horse or equestrian use.

Modern Pole Barn – circa 1980
