# S-11477. Abbott-Compton-Lake Cemetery, Old State and Robbins Roads (PIN: 135-3.00-6.00) (Detail Map #4)

S-11896. Dwelling, 10749 DuPont Highway (PIN: 230-19.00-84.00) (Detail Map #7)

## S-11897. Roadside Stand and Garage, 18078 Beach Highway (PIN: 230-26.16-1.00) (Detail Map #2)

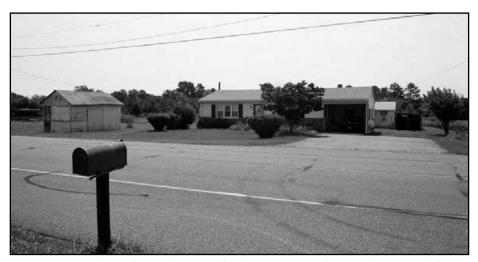
**Description:** The property includes a modern house and two older outbuildings. The first, gabled roof, outbuilding, is placed east of the house and adjoins a gravel driveway, while the second is located south of the modern house and adjoins a fenced garden.

property overview with modern dwelling in center, roadside stand (.001) to left, and garage/storage shed (.002) behind, view to SE
