S-08582. Robert Gray House, 12743 U.S. 113
(PIN: 230-26.00-109.00)
(Detail Map #2)

S-08583. Alvin Niebert House, 12749 U.S. 113
(PIN: 230-26.00-110.00)
(Detail Map #2)

**S-08584. Robert Mulholland House, corner U.S. 113 and Sharons Road
(PIN: 230-26.00-111.00)
(Detail Map #2)**

**S-08588. Robert Short Property, 16848 Beach Road
(PIN: 230-26.00-98.00)
(Detail Map #2)**

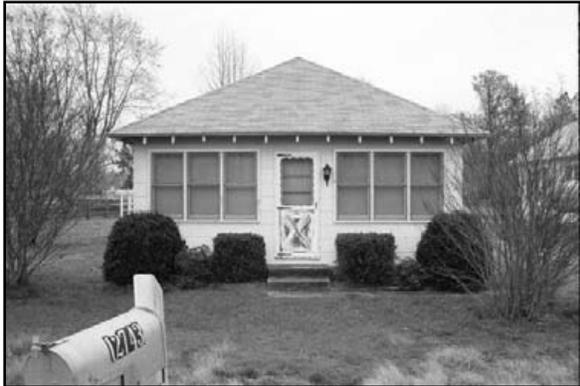
S-08582

This c. 1930, one-story, wood-framed bungalow has a hipped roof ornamented with exposed rafter ends. Its main entry is centered in a recessed screened porch and is reached by concrete steps. The house is fenestrated with three-over-one, double-hung sash windows, typically arranged in pairs with flat wood frames. The house sits on a rusticated concrete-block foundation and is sheathed in cement-asbestos siding. A brick chimney with corbelled cap rises from the middle of the roof ridge.

main building (.001) façade, view to E

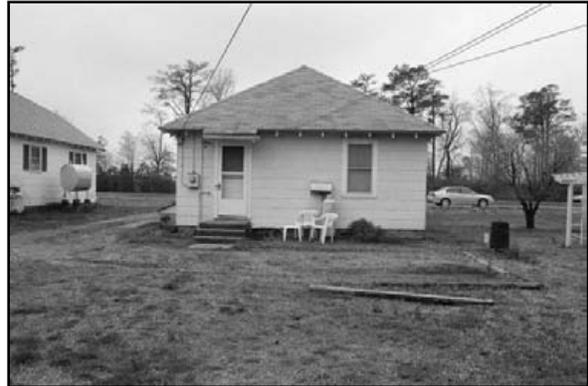
main building (.001) rear, view to W

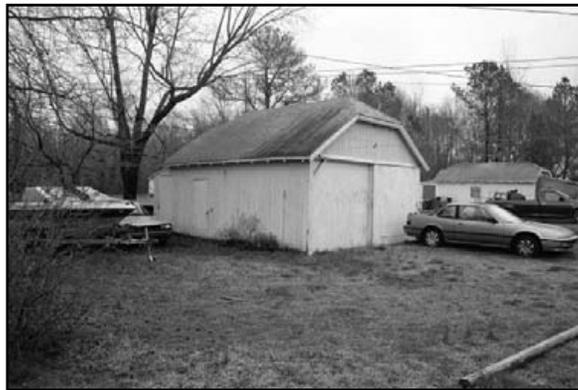
The c. 1930, jerkinhead gable front, wood-framed garage (.002) is located southeast of the house at the end of the driveway. It sits on a concrete block foundation and is sheathed in vertical board wood siding. The west façade is marked by an original, sliding, wood, beadboard garage door. The north side includes two doors, one at the center and one at the left end. Both are original beadboard doors. The remaining two walls are blank. The roof is sheathed in asphalt shingles.

garage (.002), view to ESE

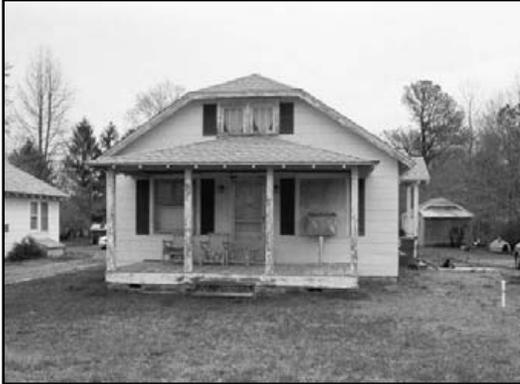
S-08583

This jerkinhead gable front, wood-framed, c. 1930 bungalow has a hipped porch extending most of the width of the front gable. This three-bay porch, set on concrete-block piers, has wood posts, square in cross section, a wood deck, and exposed rafter ends. It shelters a central front door flanked by double-hung sash window openings. The doorway contains an original, Craftsman style, wood-and-glass door. One of these openings contains an original five-over-one, double-hung sash window, while the other has been boarded over. Two smaller, three-light casement windows are placed in the gable peak. A second entry is placed in the center of the south side wall and is sheltered by a gabled stoop with a brick-and-concrete foundation, wood posts, and wrought-iron railings. The stoop shelters a wood-and-glass, Craftsman-style door similar to the first. A third entry, with a central four-light, two-panel, wood-and-glass door is placed in the east wall. Fenestration consists primarily of single and paired three-over-one, double-hung sash windows. The house sits on a concrete-block foundation and is sheathed in cement-asbestos siding. The eaves are marked by exposed rafter tails. A brick chimney protrudes from the rear of the roof ridge.

main building (.001) façade, view to E

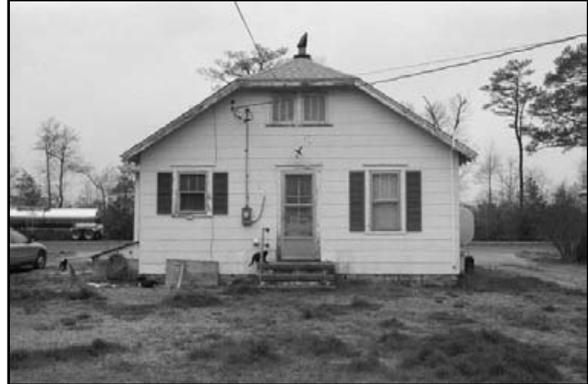
main building (.001) rear, view to W

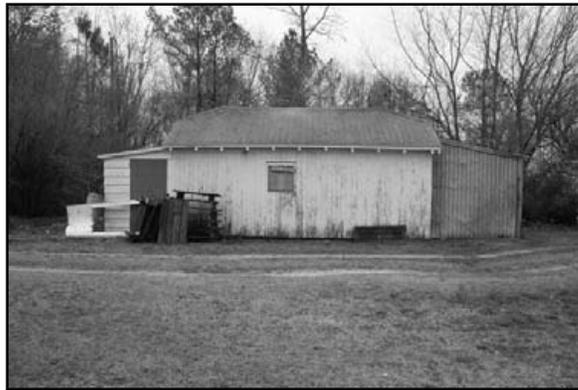
The c. 1930 garage (.002) is contemporaneous with the house. This wood-framed garage sits on a concrete-block foundation, is sheathed in vertical wood siding, and has a front jerkinhead gable. Its west wall, which originally had a double door, is obscured by a shed-roofed addition. The north wall contains a single, three-light fixed window that may have been salvaged from another building. The south wall has a single, one-light, fixed window, while the east wall also has a single, one-light, fixed window. Its roof is sheathed in asphalt shingles.

garage (.002), view to S

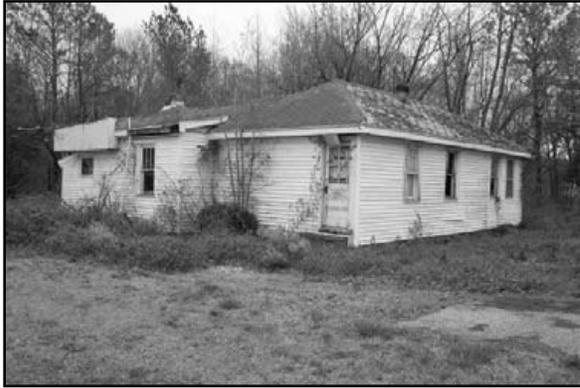
S-08584

This abandoned, c. 1930s house consists of a single-story, hipped-roof main block and a gabled roof rear addition. The main entry is placed at the front end of the north side elevation and consists of a four-light, three-panel, wood door that adjoins a concrete stoop. Fenestration of the main block consists of three-over-one, double-hung sash windows, several of which have partially or completely broken sashes. The rear addition has a flat roof with a cornice boxed in aluminum, while the walls are sheathed in cement-asbestos siding. Most of the rear addition is obscured by overgrown foliage. Visible portions include an enclosed porch and a rear wall fenestrated with one-over-one, double-hung aluminum sash windows. The main portion of the house sits on a concrete-block and poured concrete foundation and is sheathed in vinyl siding. Its roof is sheathed in composition shingles, in poor condition, and a chef's hat ventilator rises from the front roof slope of the main block.

The building is an altered vernacular bungalow whose integrity has been severely compromised by abandonment and subsequent deterioration and an earlier rear addition. The building is far from the best example of a vernacular bungalow in the study area, and JMA concurs with LeeDecker et al.'s recommendation of not eligible under Criterion C.

main building (.001) façade and west side, view to SE

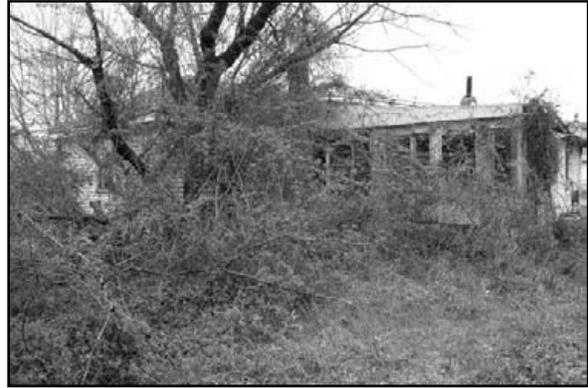
main building (.001) rear, view to NW

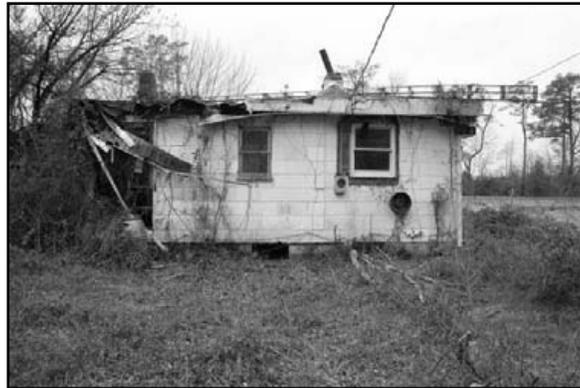
main building (.001) east side, view to W

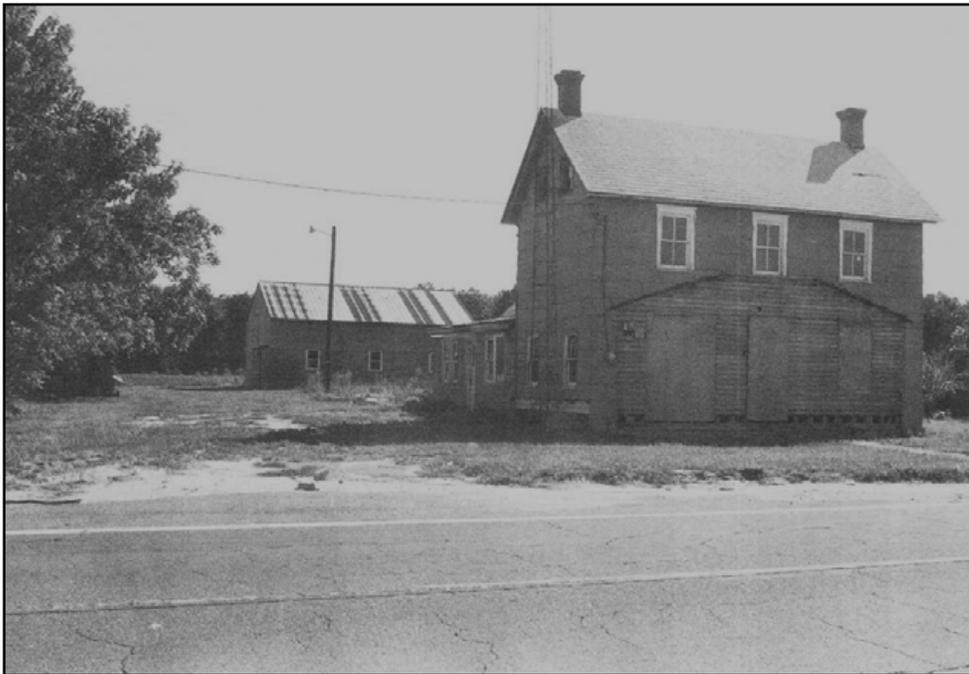
The house has undergone substantial alterations, many of which have occurred since the LeeDecker et al. (1992) survey. Alterations to the original house include removal of a full-width front porch, fenestration changes to the façade and side walls, replacement of windows and doors, resheathing in modern materials, removal of the end chimneys, and construction of at least one addition. In form, it appears to be a late three-bay I-house. Far better preserved examples of this house type are present in the study areas. Therefore, the house is recommended not eligible under Criterion C.

Robert Short house in 1992; note the two chimneys, the façade fenestration, the ghost of the full-width porch, and the two attic-level windows in the gable end (LeeDecker et al. 1992:122)

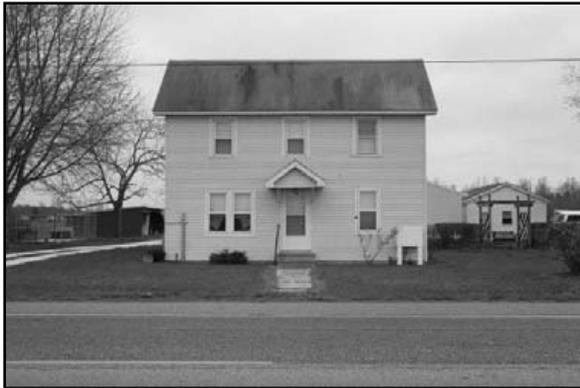
S-08588

The c. 1900, two-story dwelling has a three-bay, side-gabled main block with a one-and-one-half-story rear ell with side lean-to addition. The main entry is sheltered by a gabled hood and is centered on the front wall of the house. The door is of the modern fiberglass half-wheel and four-panel type. The east wall has a modern door placed in a modern shed-roofed side porch in the rear ell. The west wall has a mid-twentieth century, four-light, three-panel, wood-and-glass door. First- and second-story fenestration consists of replacement, one-over-one, double-hung vinyl-clad sash windows. The house is sheathed in vinyl siding.

main building (.001) façade, view to S

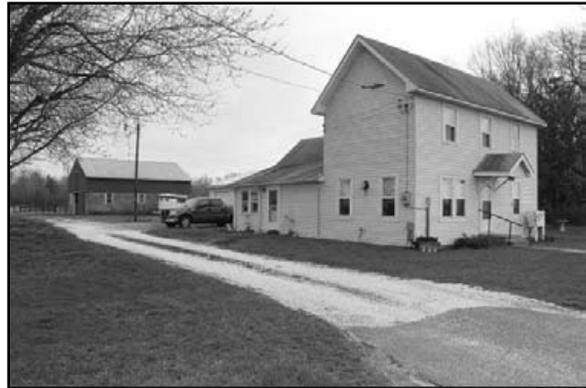
main building (.001) façade and east side;
barn (.003) in background, view to SW

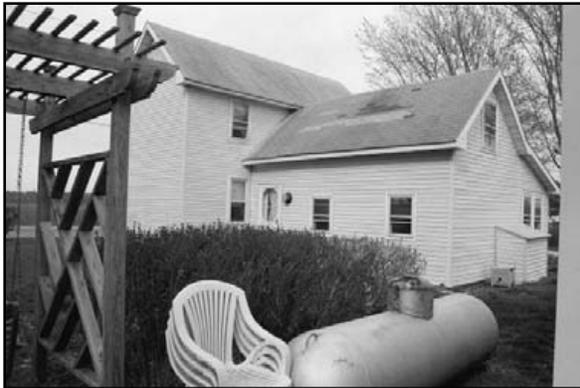
main building (.001) rear and west side, view
to NE

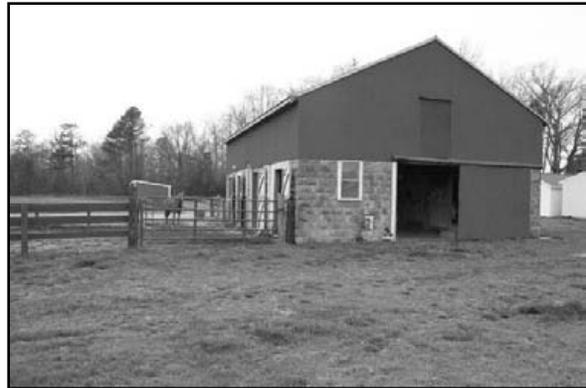
The second outbuilding, a c. 1910-1930 horse barn (.003), is placed at the northeast corner of fenced horse fields south of the house. The gabled front barn, sits on a rusticated concrete-block foundation, is sheathed in metal, and has a roof sheathed in metal. Its east façade is fenestrated with two one-over-one, double-hung sash windows. A sliding metal door is placed at the center of the wall. The north wall is fenestrated with three, one-over-one, double-hung sash replacement windows, while the south wall has four Dutch doors marking horse stalls and three one-over-one, double-hung sash windows. The rear wall is pierced by a one-over-one, double-hung aluminum sash window and central sliding metal door.

barn (.003), view to NW

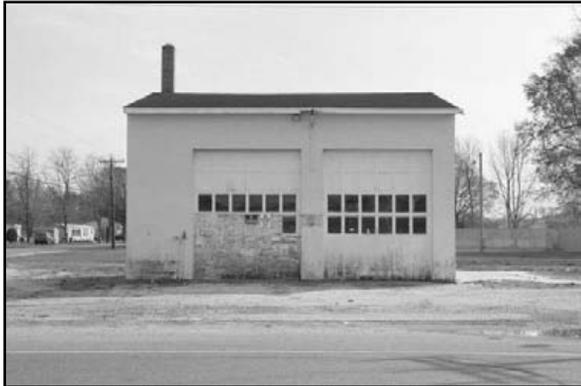
S-08733.047

The building on this property was formerly used as a commercial garage. The garage door openings have been closed up and patched with plywood. Rear restroom doors and windows have been boarded up, and a side lean-to addition removed. A dwelling that stood on the property at the time it was surveyed in 1999 has since been removed.

The c. 1950s, side-gabled, wood-framed building has a façade that faces north. The north wall is marked by two, 12-light, 24-panel, industrial-sized garage doors, probably original. The east wall has boarded up steel casement windows, and three, three-light, two-panel, wood-and-glass doors, now boarded over. The west side is marked by two steel casement windows, while the rear wall is marked by boarded over casement windows.

main building (.001) facade, view to S

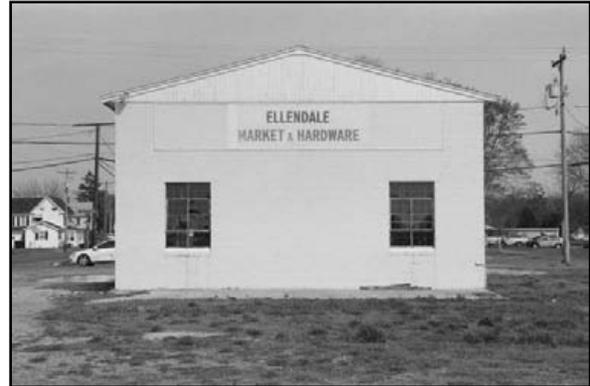
main building (.001) west side, view to E

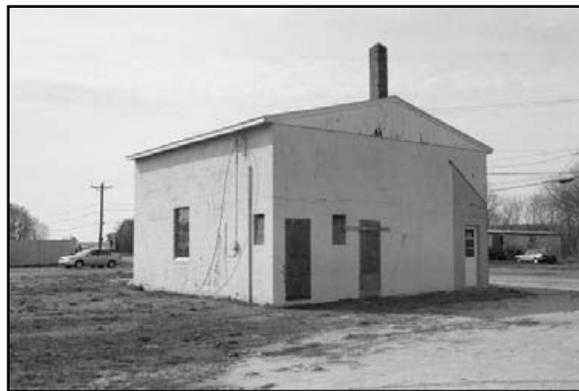
main building (.001) rear and east side,
view to NW
