45. Carleton James House (S-3237)
Route 113 (1-35-9-26.1)
(Plate 56)

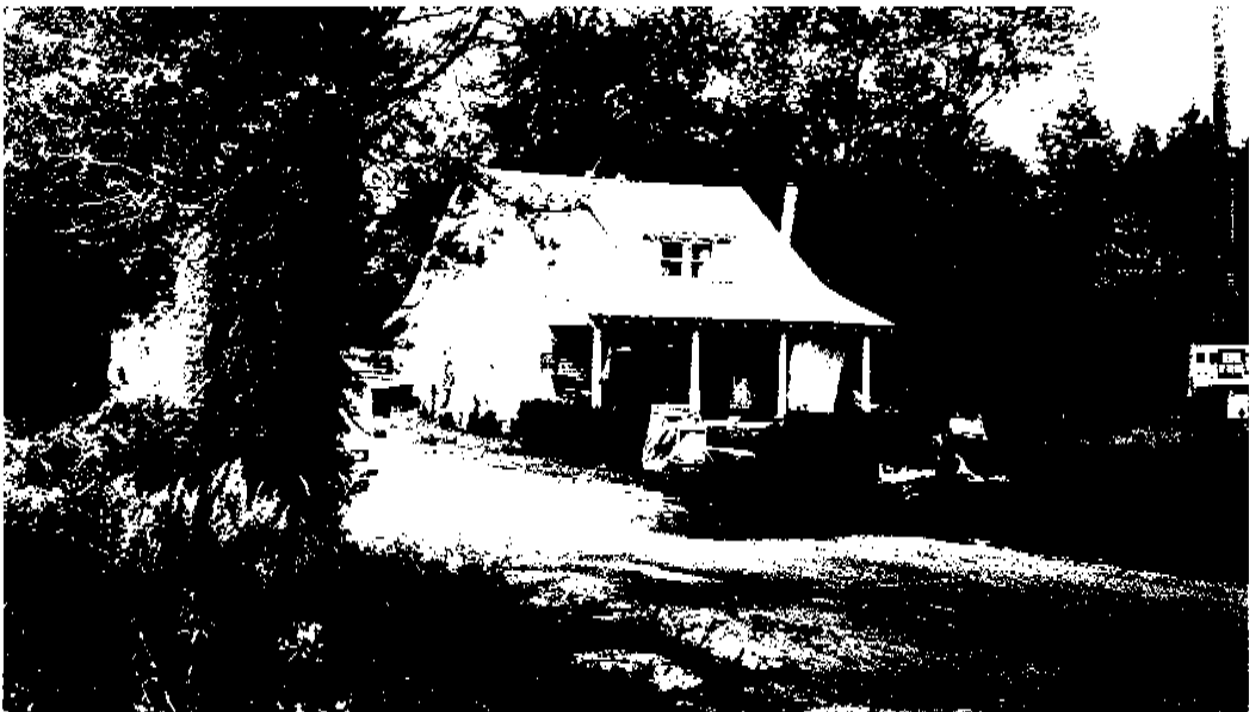
Description: This is a 1 1/2-story frame Craftsman bungalow set on a cast concrete block foundation and clad with recently applied narrow horizontal siding. A broad side-gable roof, originally with exposed rafter ends (now enclosed within boxed eaves) is noticeably flared at front and rear and at the front shelters a full-length porch. This porch originally featured Tuscan Doric columns, which were replaced with thin, square wooden posts sometime between 1988 and 1991. The dwelling retains 3/1 sash in flat frames topped with narrow cornices. A shed-roofed dormer centered above the three-bay facade illuminates the upper story.

PLATE 56: Building 45, Carleton James House, View to West (1988)

Evaluation: When first surveyed in 1988, this house was among the best examples of early twentieth-century bungalow architecture within the project area, notable for retention of original siding and porch detail. However, subsequent alterations, including new siding and removal of the porch posts, have significantly reduced the dwelling's integrity of materials and workmanship, and thus its value as an example of its type. The house does not meet National Register criteria and no further work is recommended.

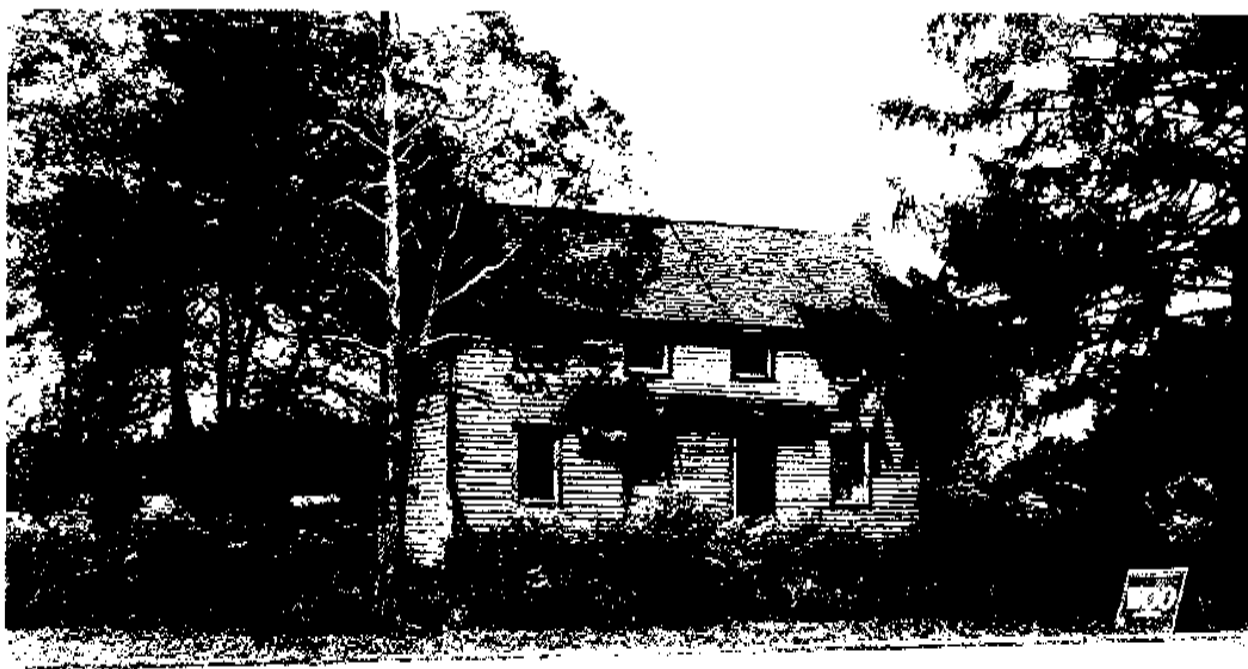
Description: This property consists of an abandoned dwelling situated close to the east side of Route 113, immediately north of a row of mid-twentieth-century ranch-type houses. The dwelling is 1 1/2 stories, with a side-gable main block and slightly lower rear ell. Both sections are of frame construction, but the ell is clearly an addition: (1) the foundation under the main block is of a soft, orange-red brick, while that under the ell is of a darker red, harder brick, with the joint between the two foundations clearly discernible; (2) the clapboarding of the main block is narrower than that of the ell; (3) the roof of the main block has narrow boxed eaves with partial returns, while the roof of the ell is covered with composition shingle and has exposed rafter ends. Exposed areas of the main block at the rear and upper northwest corner reveal hewn sills, upper corner diagonal bracing, and vertical framing consisting of alternative sawed 4x4 and 2x4 members, the larger members tenoned into the sill while the 2x4s are nailed to the sill's upper surface.

The facade is divided into four bays, of which the middle two contain side-by-side entrances. First-story window sash is 2/2; the attic level is illuminated by 3/3 moveable sash set close beneath the eaves, with 4/4 double-hung sash at each gable end. Across the north side of the ell is an enclosed lean-to unit, part of which functions as a bathroom, the rest as a rear porch. Another entrance, and one 6/6 window, are present on the south side of the ell.

Abandoned for some years, the house is in deteriorated condition. Large areas of the brick foundation have been "salvaged" for reuse; where not boarded over, window sash is broken; large areas on both floors show evidence of water damage. There is also substantial evidence of structural deterioration, particularly at the northwest corner due to loss of roof shingles and long-term drainage problems. No outbuildings exist on the

PLATE 57: Building 46, Jacob Sharp House, View to East

The Sharp House possesses integrity of location, as its present location corresponds to that indicated for W. H. Jester in 1911. The house also retains overall integrity of exterior design and materials despite loss of the front porch. Integrity of interior design and materials, however, appears to be diminished: while the hall-parlor plan appears original, the partition wall has been opened for the insertion of French doors, and the awkward placement of the stairs in relation to the stove thimble at the south end suggests that it may represent a later remodeling. The interior has also experienced both natural deterioration and vandalism, diminishing the integrity of original fabric. These factors lead to the conclusion that the Sharp House does not adequately meet National Register requirements for integrity, despite the architectural interest of its locally-unusual proportions and double front entrances.

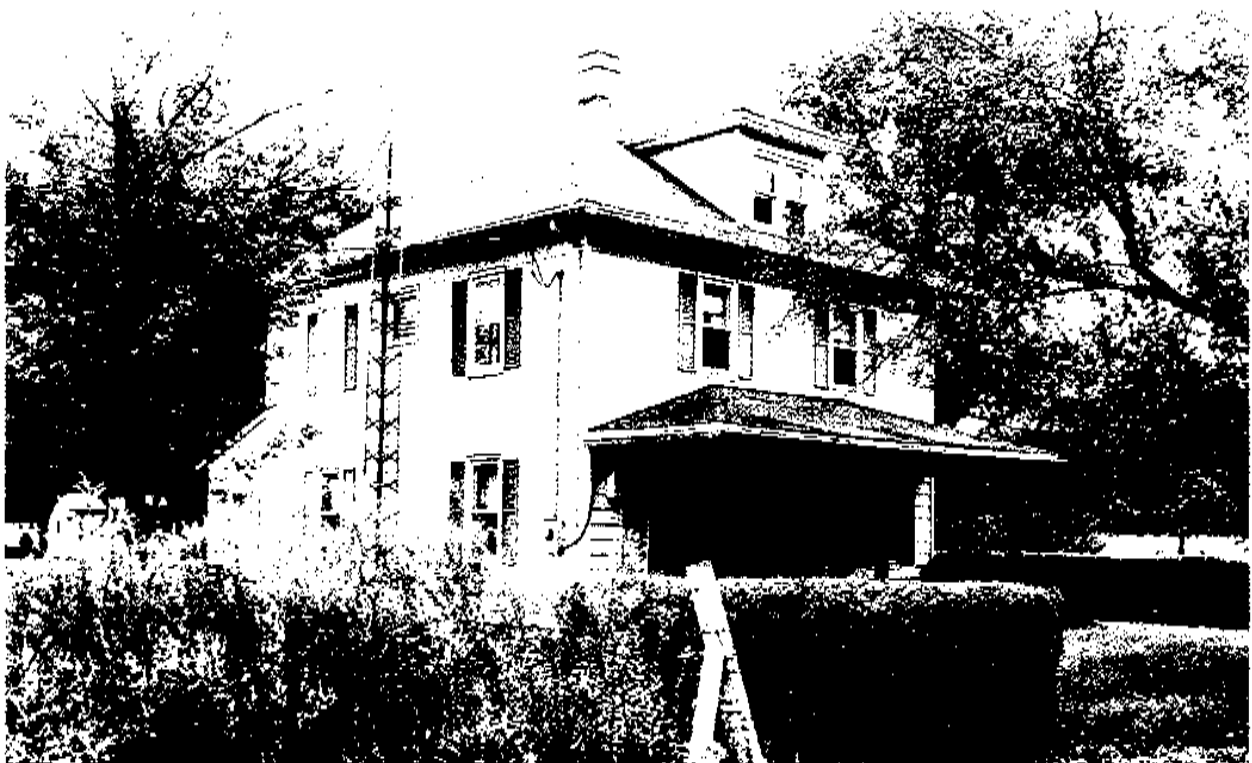
Description: This building is an early twentieth-century "foursquare" type dwelling, characterized by a nearly square plan, 2 1/2 stories, and high-pitched hipped roof. Aluminum siding obscures the trim around the 1/1 sash windows. The side and front elevations are each two bays wide. A hipped-roofed dormer is centered in the front roof slope. The full-length front porch features a hipped roof supported on thin wooden posts of square section, which recently replaced Tuscan Doric columns. The house has recently been moved back on the lot, and is set on a new cinder block foundation. A lean-to unit across the rear contains a kitchen.

PLATE 59: Building 48, Robert E. Betts House, View to South (1988)

Evaluation: Although possessing basic design and massing associated with its type and period, this house lacks demonstrable architectural distinction, and has suffered loss of integrity of materials and workmanship through application of aluminum siding, relocation on a new foundation, and removal of original porch columns. No documentary basis for association with important persons or events has been identified. The property does not appear to meet National Register Criteria for Evaluation, and no further work is recommended.

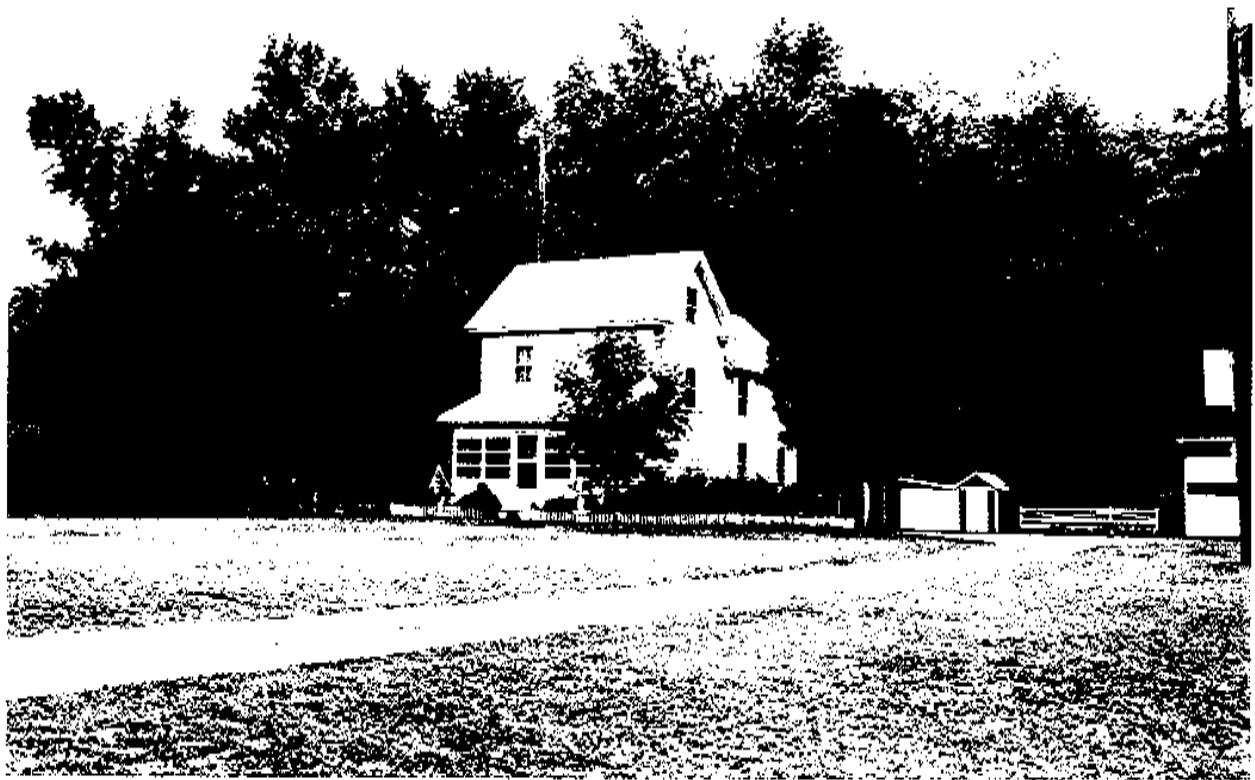
Description: This is a late nineteenth-century frame dwelling, two stories high with side-gable roof, narrow, two-bay facade, and two-story rear ell. The exterior is clad with asbestos shingle, and features 2/2 double-hung sash in flat surrounds framed by wood shutters. The front porch, with a shed roof, is fully enclosed. Associated with the house are a large shed/garage with asphalt roll siding and corrugated sheet metal roof, and a row of small one-room gabled frame sheds. The house is believed to be on its original lot but has been relocated toward the rear of the lot as a result of a previous widening of Route 113 at this location.

PLATE 60: Building 49, Thomas Shimp House, View to West

Evaluation: This house is a representative illustration of late nineteenth- and early twentieth-century hall-plan house construction in the lower Delaware region. However, integrity of materials is diminished by asbestos shingle siding and by the enclosure of the porch with louvered window units. No documentary basis for association with important persons or events has been identified. The property does not appear to meet National Register Criteria, and no further work is recommended.

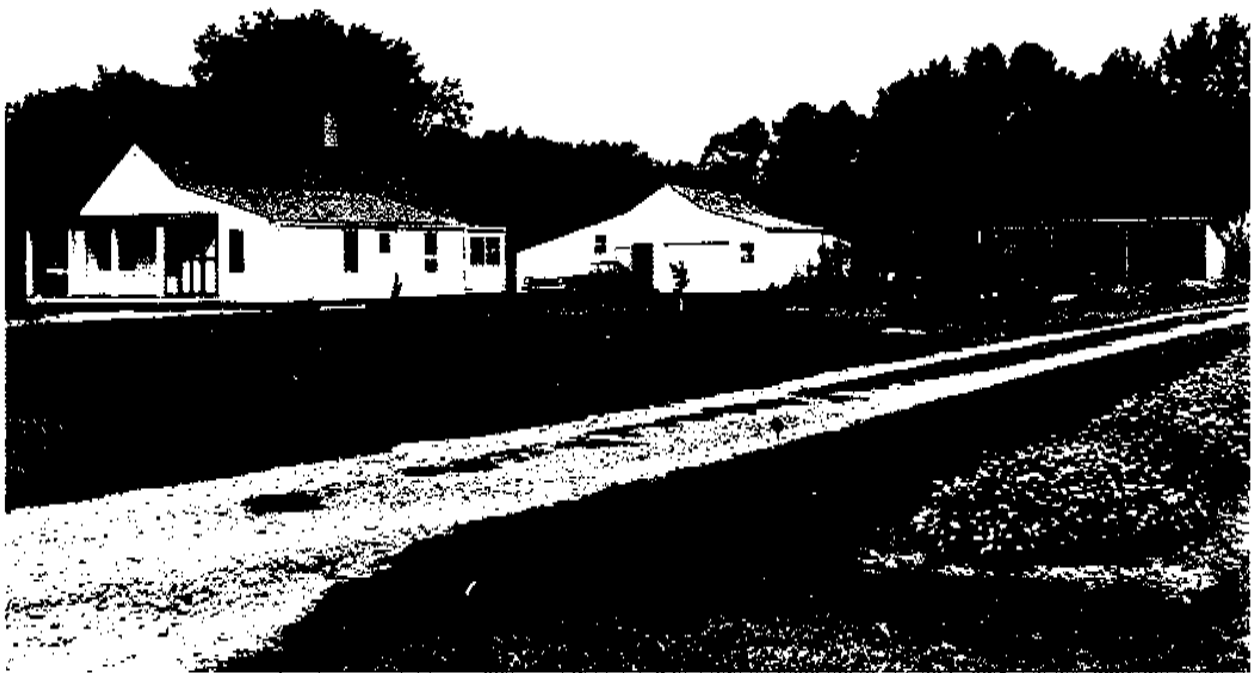
Description: This is a small frame dwelling of indeterminate age set on a concrete slab and covered with wide aluminum siding. The dwelling is one story high with front-gable orientation and lean-to extension on the south side. Across most of the front is a flat-roofed porch with square posts and wood floor. To the rear of the house is a front-gable frame garage with large lean-to side extensions.

PLATE 61: Building 50, Clarence E. Wilson House, View to Southwest

Evaluation: This house appears to have originated as a small front-gable Craftsman-type "cottage", but has been substantially altered through expansion of the plan to the south. It does not possess integrity of design, materials or workmanship. No documentary basis for association with important persons or events has been identified. The house does not meet National Register Criteria, and no further work is recommended.

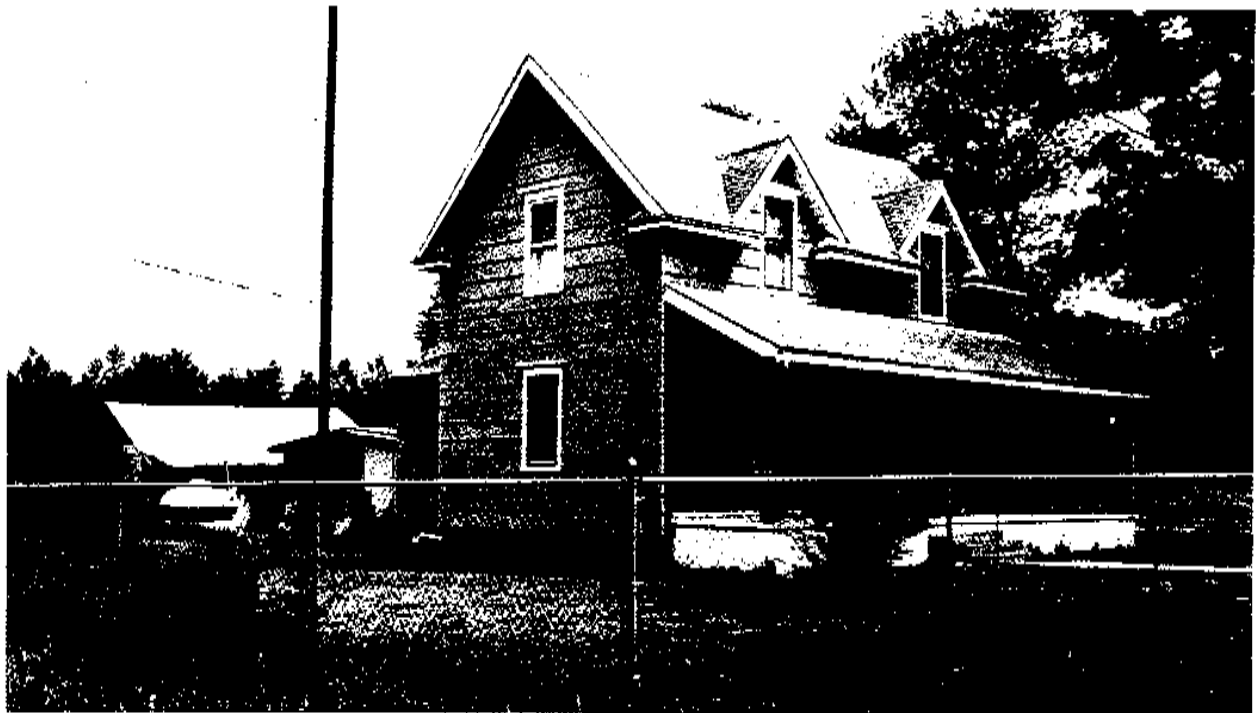
Description: This is a 1 1/2-story frame dwelling massed as a side-gable single-pile main block with full-height rear ell. It was originally set close to the east edge of Route 113, on a brick foundation, but has within the past year been relocated much further back on a cinder block foundation. The exterior is covered with asbestos shingle and aluminum siding, and windows have 1/1 aluminum sash. The composition shingled roof has partially returned cornices and small gabled wall dormers at the front and on the south side. An enclosed lean-to unit is located on the north side of the ell. The front porch, with metal posts and new concrete floor, is extended around the southwest corner where it becomes fully enclosed for the full length of the south side. Two frame sheds, one with a standing-seam metal roof, the other with slightly sloping flat roof, were previously located behind the house but are no longer present.

PLATE 62: Building 51, G. Torbert House, View to Southeast (1988)

Evaluation: This late nineteenth-century vernacular dwelling lacks sufficient physical integrity to retain architectural importance. No documentary basis for association with important persons or events has been identified. The property does not meet National Register Criteria for Evaluation, and no further work is recommended.

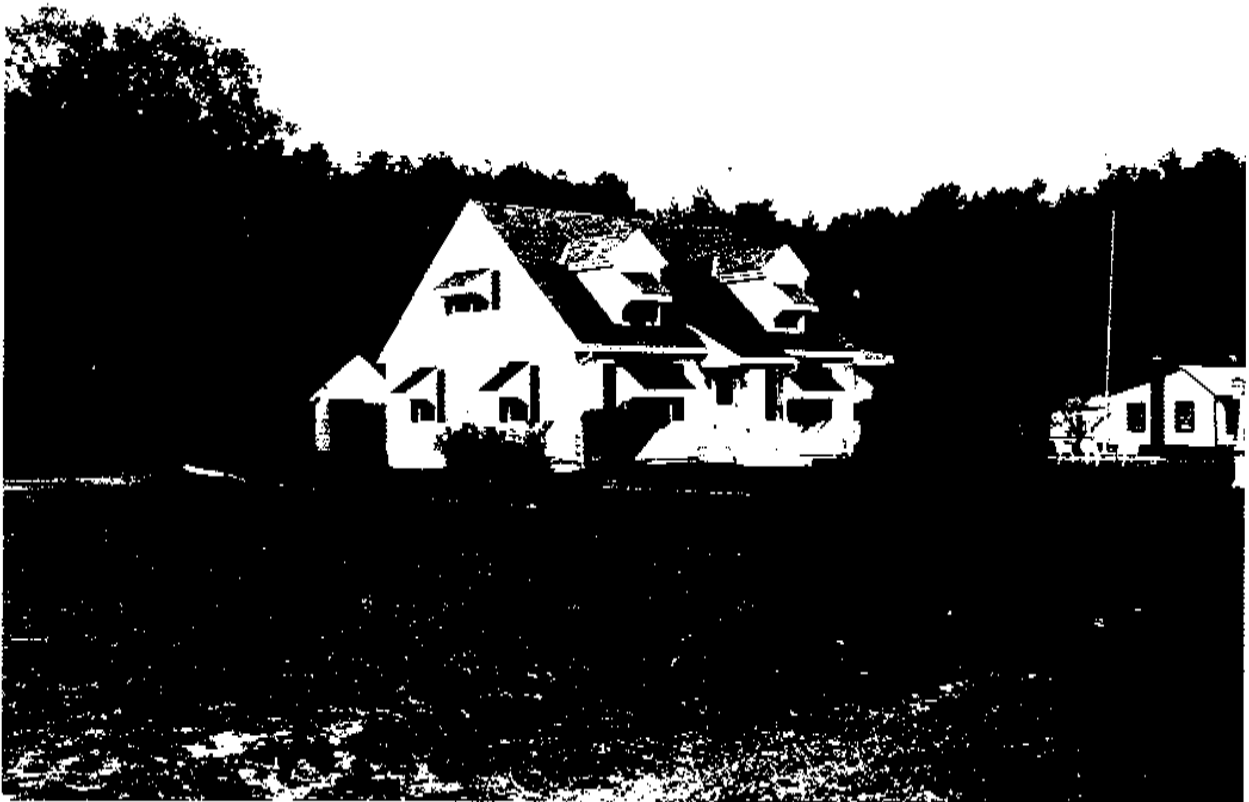
Description: This is a circa 1940s Cape style frame house, aluminum sided on a concrete foundation. The house has a steep side-gable roof with two symmetrically placed gabled dormers on the front slope. The facade is symmetrically arranged with 1/1 sash windows flanking the main entrance, which is sheltered by a short extension of the roof slope above it. All windows are hooded by fixed metal "awnings" and framed by green shutters. To the rear is a one-car gable-roofed frame garage.

PLATE 63: Building 52, Mary V. Donahue House, View to Northwest

Evaluation: Although demonstrating basic characteristics of design associated with its type and period, this house lacks architectural distinction, and has been altered by application of aluminum siding. No documentary basis for association with important persons or events has been identified. The house does not meet National Register Criteria for Evaluation, and no further work is recommended.

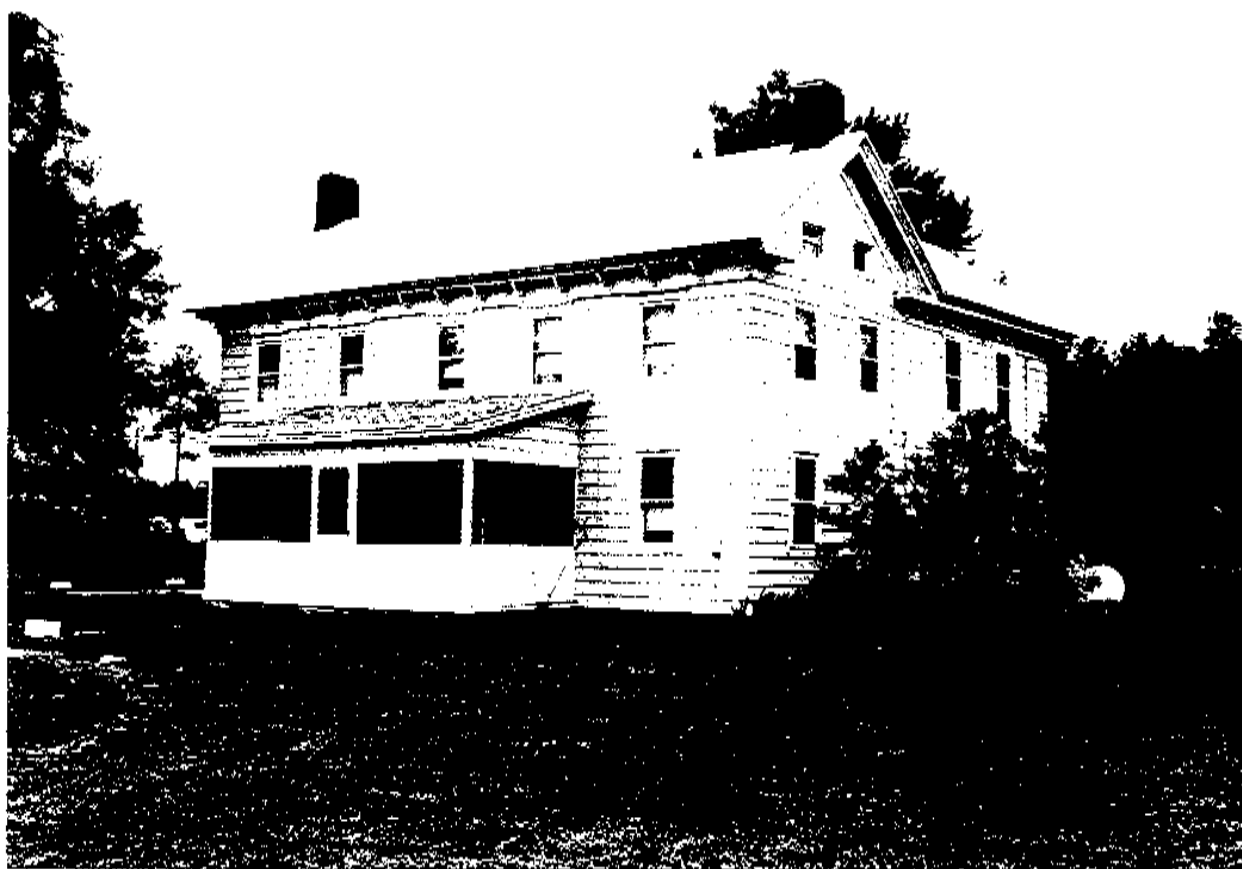
Description: The Bayard Macklin house is a two-story, single-pile frame dwelling with symmetrical five-bay facade and full-height rear ell. Originally set on a brick foundation, the house has recently been moved back on its lot and now rests on a new cinder block foundation. The side-gable roof has pendant brackets at the eaves, partially returned cornices, and is covered with composition shingling. The exterior walls of the house are covered with asbestos shingle siding; the foundation is obscured beneath sheet metal. Window openings are fitted with 1/1 aluminum sash (two original 6/6 wooden sash remain in the ell). Brick chimney stacks are set within the gable ends of the main block, flanked by small square attic windows, and toward the rear (west) wall of the ell. A slant-roofed screened porch on concrete slab extends across the center three bays of the facade. A fully enclosed slant-roofed porch extends across the south elevation of the ell.

The interior plan of the main block originally consisted of a center passage (containing stairs) flanked by one room to each side. Beginning in the 1950s, the present owner and her husband (now deceased) removed the north wall of the stairhall and replaced the then existing staircase with a new wooden element. The two front rooms are finished with wall-to-wall carpet and dark plywood panelling and trim, all installed under the present owner. The paneling also covers the chimney breasts, which are of a size to indicate that they were built to serve stoves (rather than having fireplace openings subsequently filled in and fitted with stove thimbles). On the second floor are three bedrooms, with painted plaster walls and flat trim. In the south bedroom, a partition across the south end encloses the chimney stack between two closets.

PLATE 64: Building 53, Bayard Macklin House, View to Southwest (1988)

The Macklin house is an example of a major rural domestic architectural form built in Delaware from the late eighteenth into the early twentieth century. However, apart from basic exterior form (two stories, one-room depth, rear ell), the house lacks integrity of design, materials, and workmanship. Although the original form and massing remain clearly evident, the house has been extensively remodeled on the interior within the past 35 years, original window elements and front door have been replaced by modern elements, the original exterior cladding is obscured beneath artificial siding, and the building now rests on a modern cinder block foundation. Constructed in the mid-nineteenth century as a dwelling in an agricultural unit, the house also lacks integrity of setting, feeling, and association, as no structures associated with agricultural activities remain on the property. In sum, the Macklin house lacks sufficient integrity to qualify for the National Register.

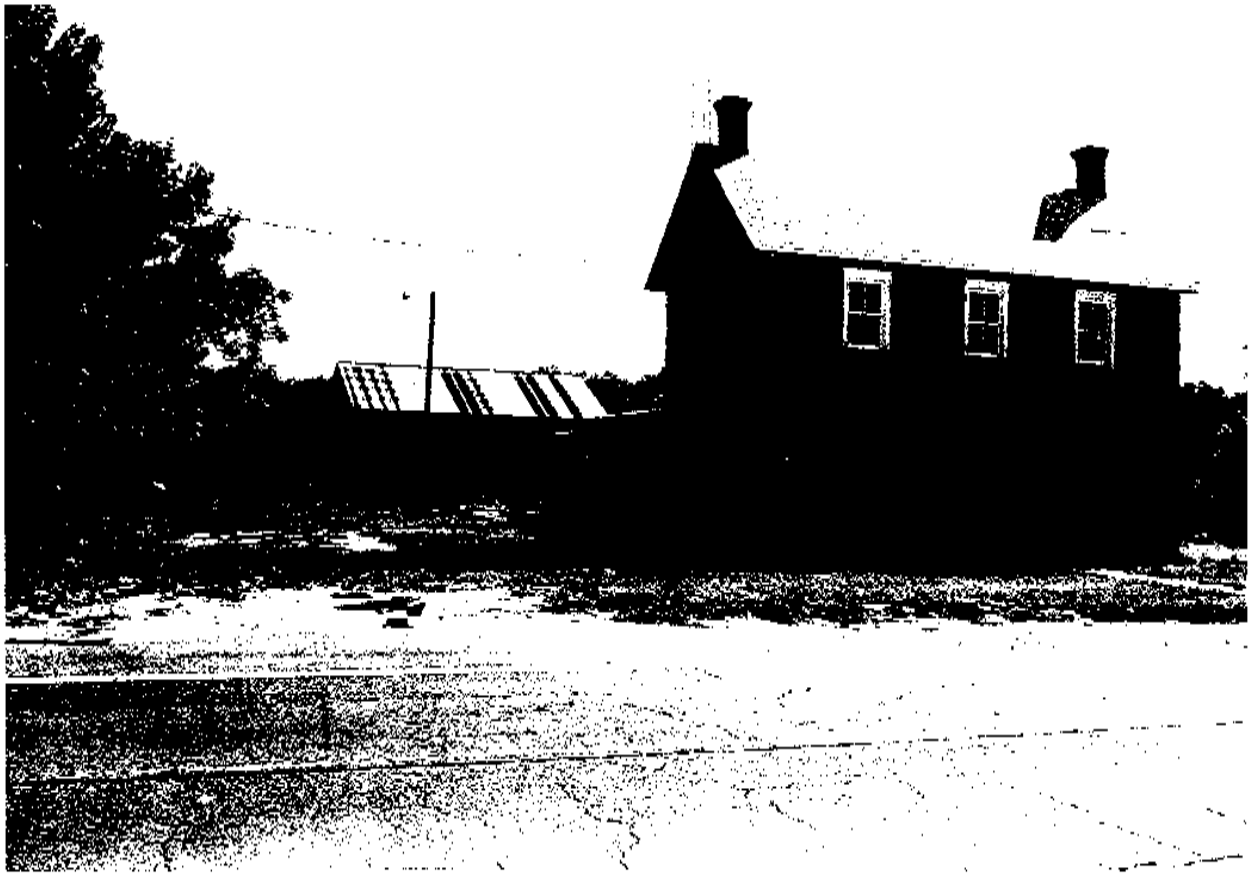
Description: This property consists of a dwelling, barn, garage, and row of attached sheds. The dwelling, set close to the edge of the road, is a frame house with hall-parlor plan, two stories high and one room deep, with three-bay facade, side-gable roof, and 1 1/2-story rear ell. Asphalt shingling covers clapboarding on the exterior. The front and side windows of the main block have 2/2 double-hung sash, while a lean-to unit inserted along the east side of the ell features 6/1 sash. First-floor front openings are covered with plywood, and a porch across the facade has been removed.

Directly behind the house is a front-gable frame garage with vertical beaded board siding and sliding doors. Beyond the garage is a front-gable barn, oriented to face east, constructed of concrete block with a corrugated sheet metal-clad frame loft level. Opposite the barn to the east is a row of attached sheds, including two one-room gabled structures and a multiple-vehicle machine shed open on the west side.

PLATE 66: Building 55, Robert Short Property, View to South

Evaluation: This property appears to be a turn-of-the-century farmstead, containing dwelling, barn, and early garage as well as a small complement of multi-purpose sheds. The dwelling possesses the basic characteristics of the hall-parlor house type regionally common in the late nineteenth and early twentieth centuries, and appears to retain at least some original woodwork (narrow molded stock elements with bull's-eye corner blocks). However, this property does not possess qualities of demonstrable historical or architectural importance, nor has any documentary basis for association with important persons or events been identified. The property does not appear to meet National Register Criteria, and no further work is recommended.

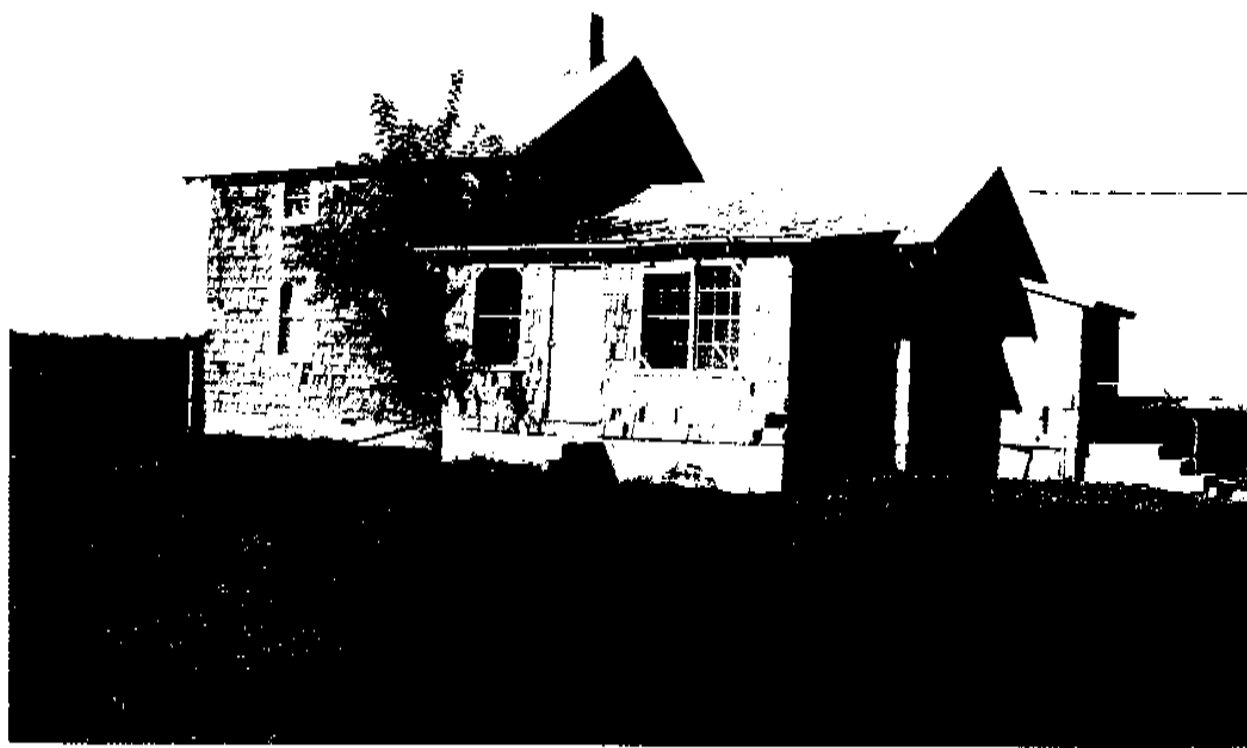
Description: This property consists of a dwelling and barn, located on a six-acre parcel on a lane extending north of Route 16 west of Route 113. The dwelling is of frame construction on a concrete block foundation. Painted wood shingles have been installed over horizontal tongue-in-groove board siding. The house is massed as a 1 1/2-story side-gable two-bay section with a one-story wing on the south end. The roof is covered with composition shingles and has exposed rafter ends. One entrance is contained in an enclosed shed-roofed porch on the west side of the wing, the other in a small vestibule on the south end of the wing. Window openings are fitted with 1/1 double-hung sash of varying dimensions, except in the porch, where 6/6 sash are employed. The barn, located directly south of the house, has a concrete block first story and asbestos-shingled frame loft area beneath a gambrel roof with exposed rafter ends. The principal entrance is in the north elevation, through wide double sliding doors. A double row of steel posts creates a concrete-floored center aisle on the ground level of the barn, with wood planking forming animal pens on the east side of the aisle. A concrete-walled cow yard is located outside the east wall of the barn. Within it is a small animal shed with low concrete-block walls supporting stud framing. Peeled tree trunks are used as posts along the open southern side.

PLATE 67: Building 56, Coleman Farmstead, House, View to Northeast

transportation for poultry and dairy products as well as perishable seasonal crops. The Coleman farmstead, although developed rather late in the period of this historic context, is, architecturally, illustrative of the agrarian environment of the 1920-1940 period, and the barn in particular is a good example of the use of then-"modern" forms and materials, such as the dimension-lumber-framed gambrel roof, concrete block walls and even the asbestos shingles on the upper level. The Coleman Farmstead thus appears to be eligible for the National Register under Criterion C. The house and barn remain integrity of location, and although the property is not in agricultural use, the general setting remains clearly agrarian. Both buildings possess integrity of design, materials and workmanship, and thus also integrity of association and feeling. The boundary of the eligible property comprises only a portion of the legal tax parcel, in order to exclude non-contributing modern buildings to the east.

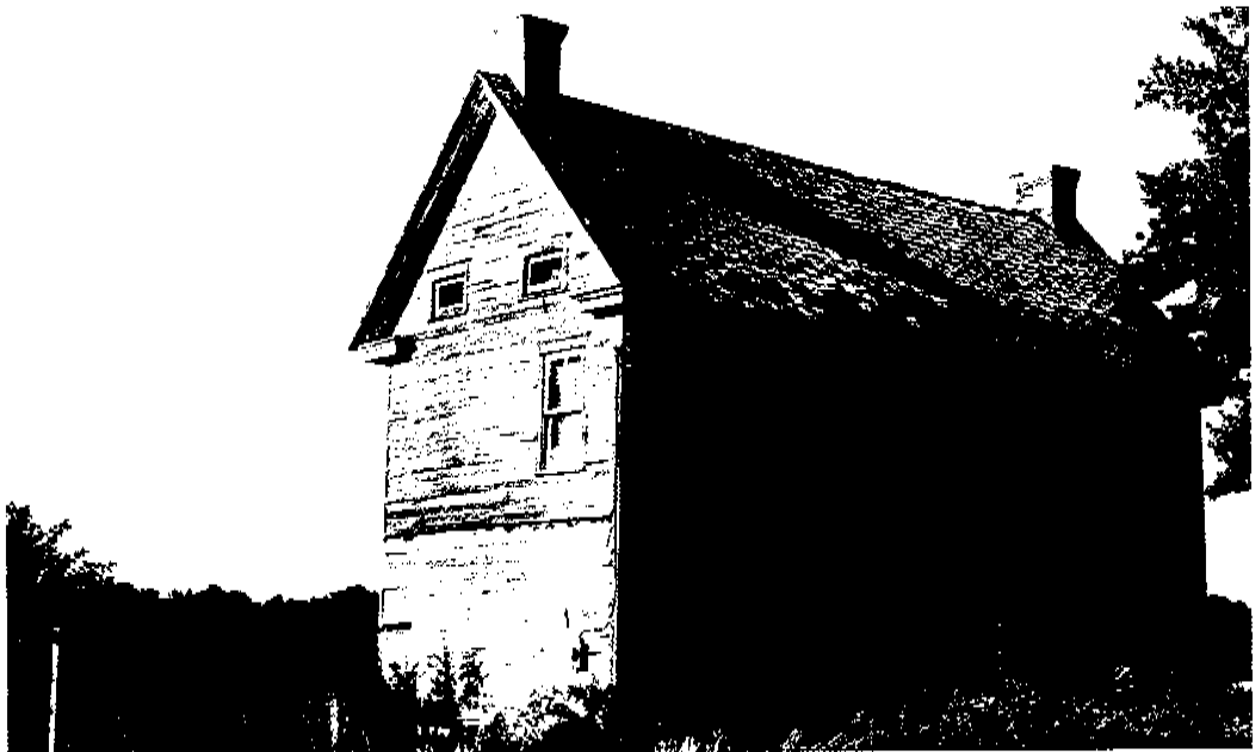
Description: The house that was present at the time of the initial survey for the Route 113 project has since been demolished. The house was set back at the end of a weeded lane several hundred feet north of Route 16. It was a two-story, single-pile, weatherboarded frame dwelling, oriented to face south on a partial brick foundation and brick footings. The side-gable roof had partial returns and short plastered brick chimney stacks within each gable end. Fenestration was extremely irregular, but featured 2/2 double-hung sash in flat plank surrounds, those of the second-story front topped with narrow cornices. The first floor was arranged with one room on either side of a roughly centered passage at the rear of which was a bathroom. The house was originally served by fireplaces, subsequently filled in and the projecting breasts fitted with thimbles for stovepipes. An enclosed winding stair was located at the northwest corner adjacent to the west fireplace in what was the kitchen of the house.

PLATE 69: Building 57, Robert Fisher House, View to Northeast (Non-Extant)

Evaluation: Since the house is no longer extant, the property can no longer be evaluated as an architectural resource under National Register criteria. The property has been included in this report for information purposes only.

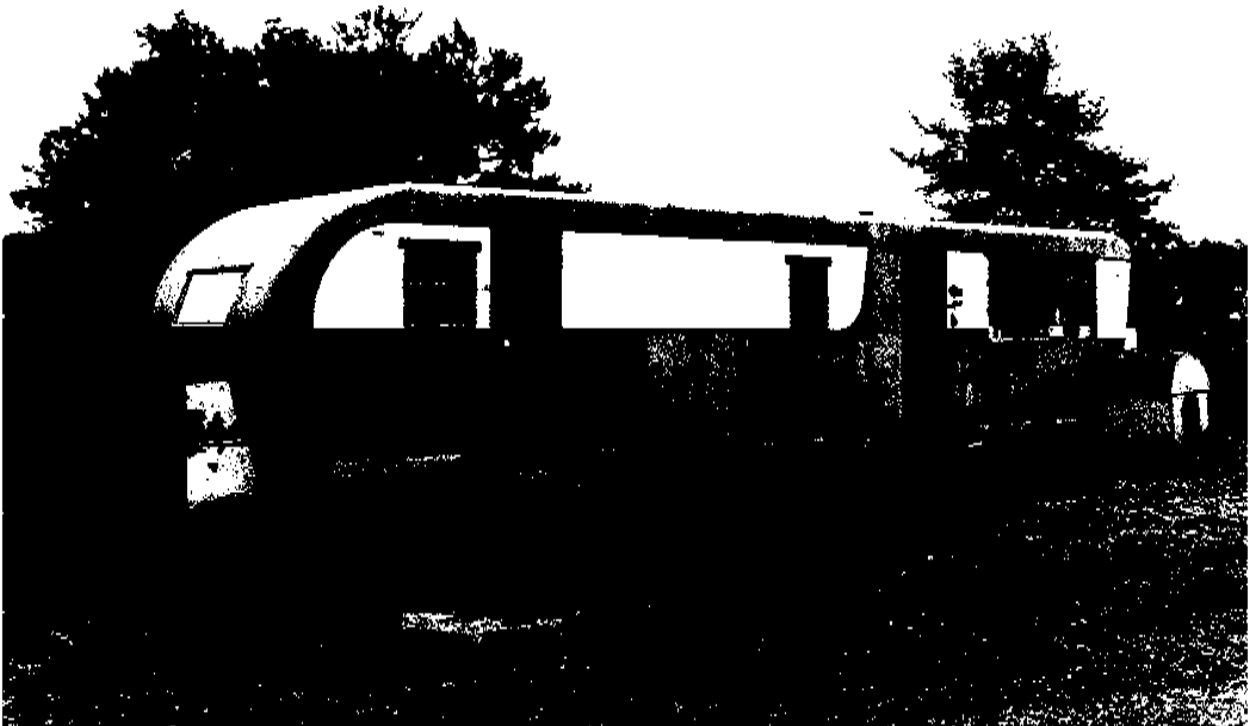
Description: This house trailer is located toward the rear of the lot containing property No. 48 (see above). The metal exterior is robin's egg blue, with white panel strips and green trim. A streamlined effect is produced by the rounded corners, forward-canted front "elevation," and sloping rear. Chicago-type windows illuminate the front end from three sides, and all moveable window elements open like louvers from horizontal hinges. The two doors in one of the side walls have circular windows. The trailer is unoccupied, and is used for storage.

PLATE 71: Building 60, Robert Betts Travel Trailer, View to Northeast

Evaluation: This house trailer offers a representative example of trailer design from the period between the end of World War II and the mid-1950s. The streamlined shape with canted hitch end and sloping rear, as well as the horizontal panels and porthole windows, are classic features (Wallis 1989). However, it does not demonstrate architectural importance sufficient to substantiate National Register eligibility. No further work is recommended.
