**NATIONAL POLLUTANT DISCHARGE
ELIMINATION SYSTEM**

**KENT COUNTY MS4
Permit No. DE 0051144**

**submitted by
DELAWARE DEPARTMENT OF TRANSPORTATION**

ANNUAL REPORT FOR CALENDAR YEAR 2010

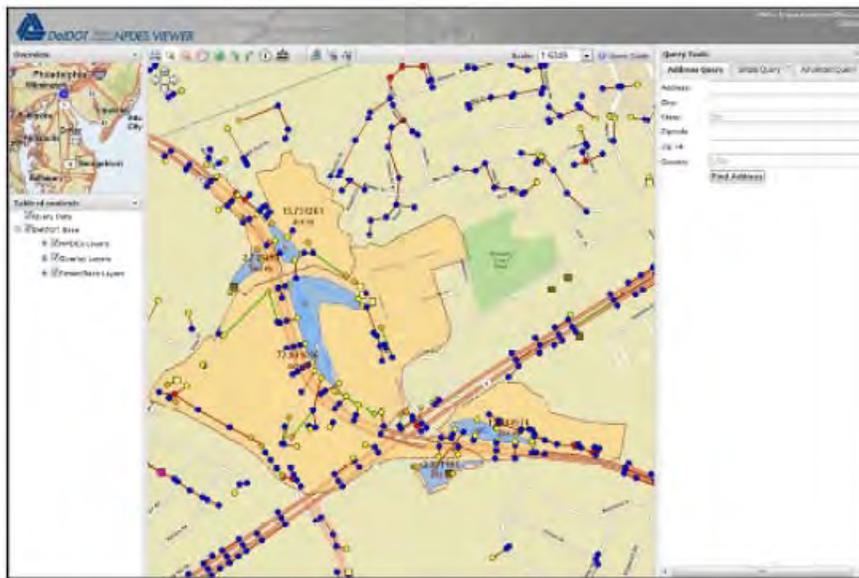
Figure 3-1. Screen shot from DeIDOT's NPDES Map Viewer application, developed by KCI Technologies, Inc.

The mapping requirements of the Phase II Permit are met through an existing GIS viewer originally developed for the storm sewer system inventory in New Castle County (Figure 3-1). The viewer is available to all DeIDOT employees with access to the intranet. This satisfies the requirements of 40 CFR Part 122.21(f)(7) or Part 12.34.(b)(3)(i). This statewide map shows the location of all outfalls, the names and location of all waters of the United States that receive discharges from those outfalls, condition assessment data, and photographs.

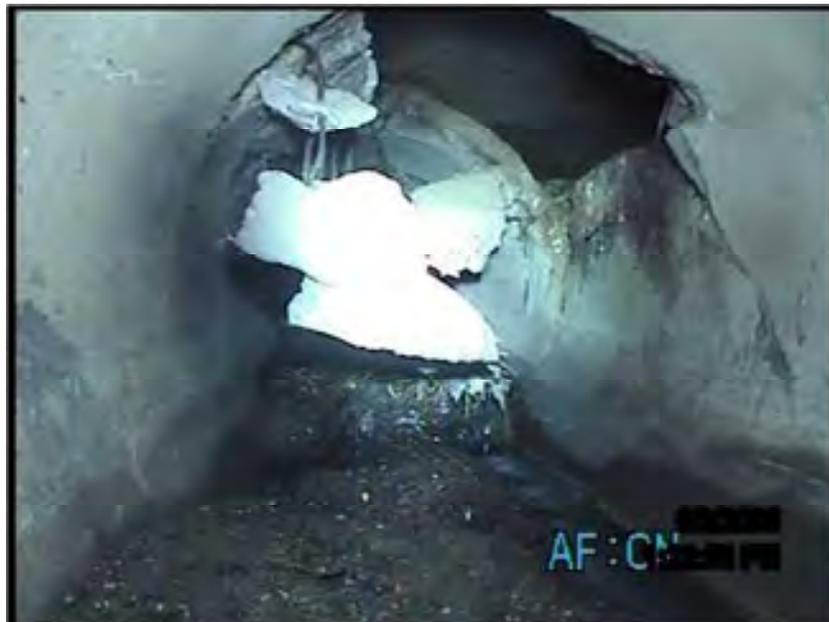
Maintenance Work Order for Conveyance Pipe

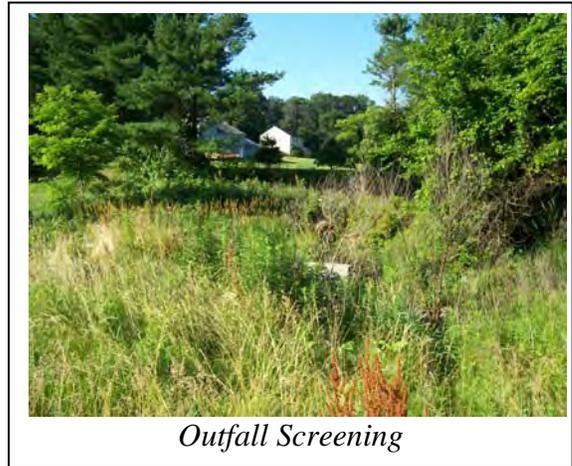
Outfall Screening

In 2010, 1,109 outfalls were screened as part of the inventory, inspection and re-inspection tasks under Agreement 1354.

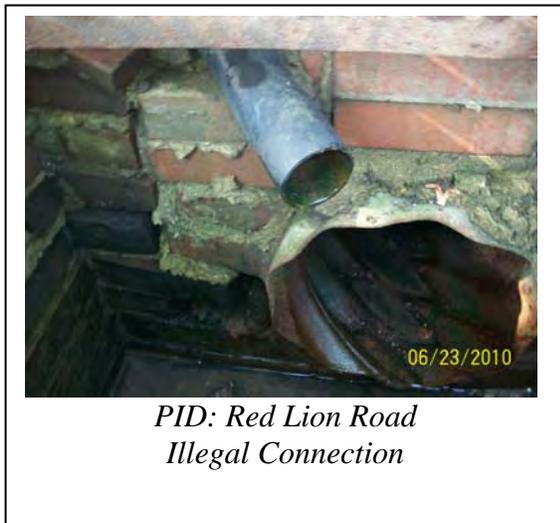
*PID: Red Lion Road
Illegal Connection*

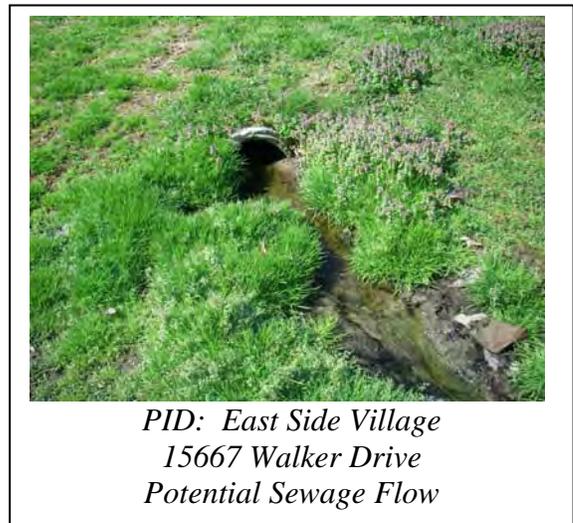
*PID: East Side Village
15667 Walker Drive
Potential Sewage Flow*

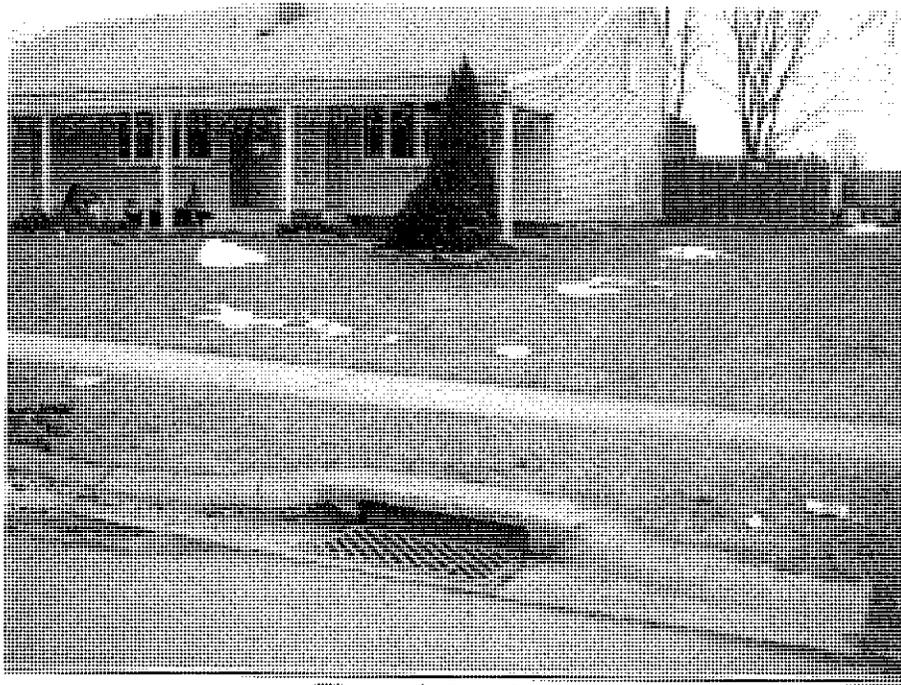
Figure 1. Landscape

Upon inspection of the catch basin on March 2, 2010 it was noted that the structure had pet waste on the grate and in the basin. The pet waste appeared to be purposely placed in the basin. The closest house to the catch basin, 42 Lynchfarm Drive, had signs on the fence warning of a dog on the property. Pictures were taken of the PID and other catch basins in the area were inspected. The other basins in the immediate area appear to be clear of pet waste.

On March 11, 2010 KCI distributed 25 door hangers to the residents in the immediate vicinity of the PID on Lynchfarm Drive.

KCI plans to do a follow up investigation of the site to verify all dumping of pollutants has ceased.

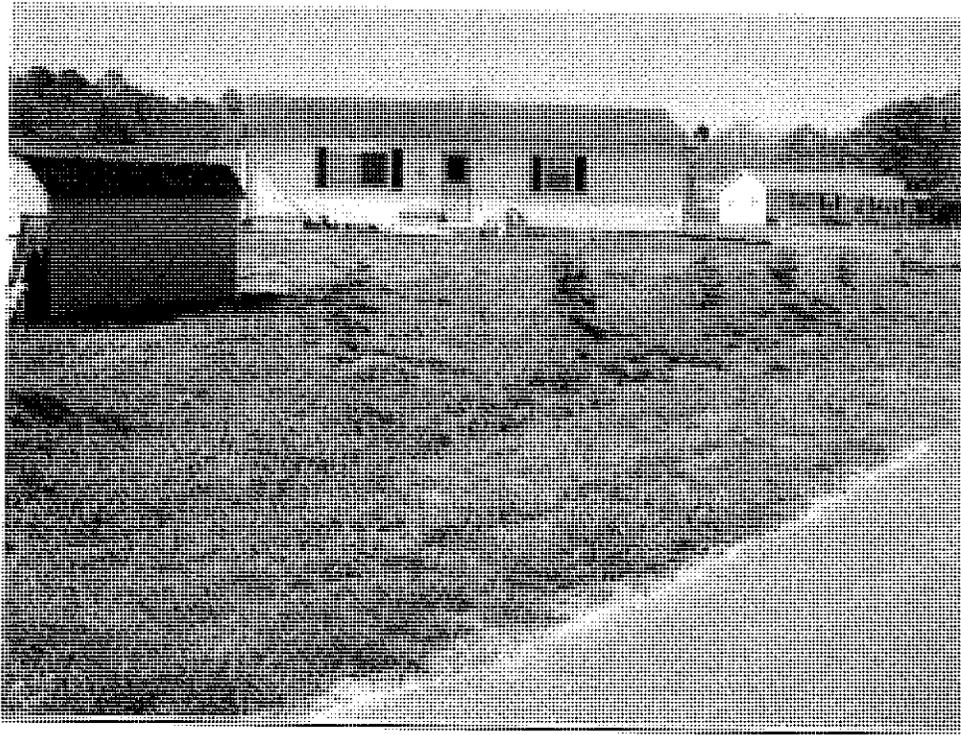
Figure 1. Landscape

The Agreement 1495 KCI field crew inspected the swale on April 1, 2010, and noticed a strong odor of sewage coming from the swale. There was no evidence of active flow in the swale, although there were areas of ponding water in the swale and at the outfall (see attached photographs). The septic mound near the swale was inspected and showed no signs of seepage. The discharge appears to be coming from the residence beside the property that contains the septic mound. The illicit discharge seems to originate near the top of the swale, although no evidence of the source was found. This appears to be a septic issue because no evidence of direct connections or dumping was found in the swale.

A sample was collected from the swale outfall and tested on-site. Parameter levels were above detectable limits for detergents and ammonia. Because of the supporting evidence of an illicit discharge with no obvious source, KCI will discuss the next step(s) to be taken with DelDOT at the April 15, 2010 Project Status Meeting.

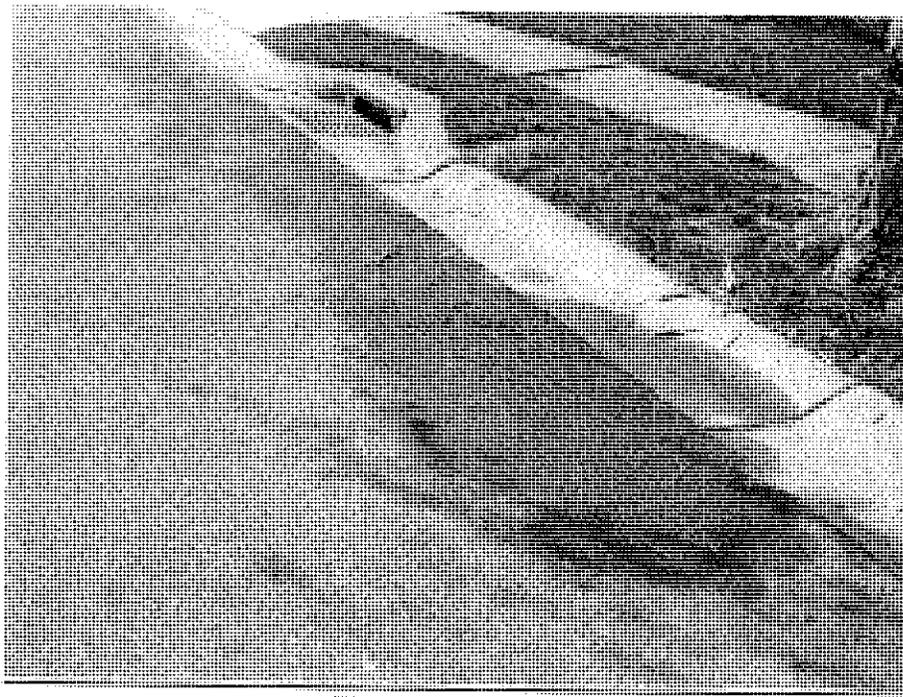
Figure 2. Oil Stain

No action was taken per DelDOT. It was determined during a regular status meeting that this PID could not be linked to a specific individual and was not considered to be direct dumping into the storm system.

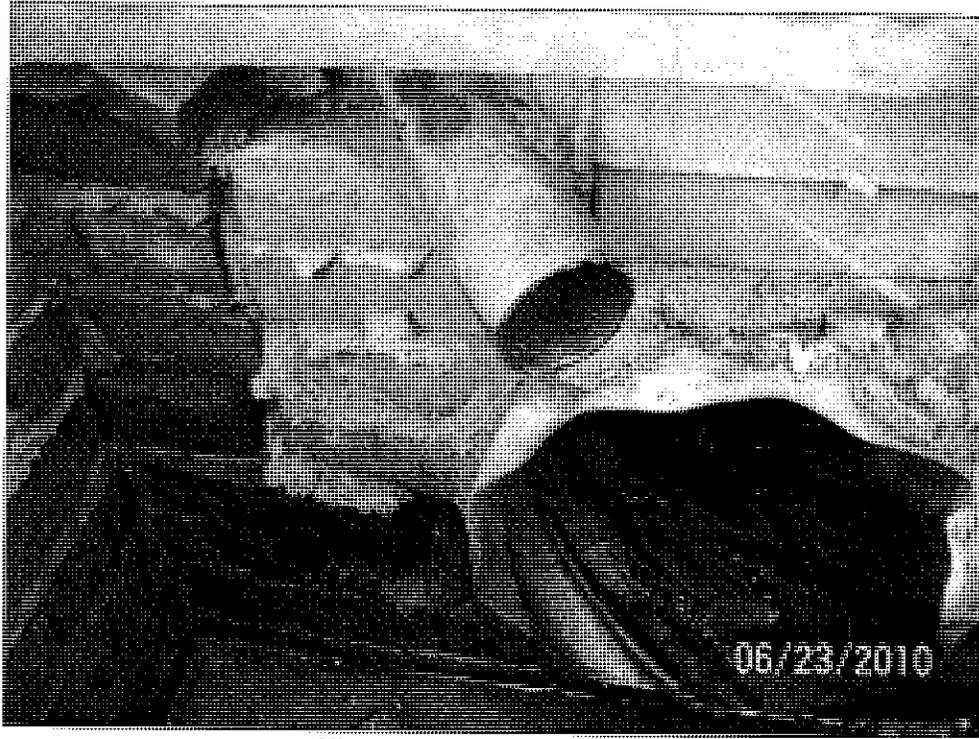
KCI field personnel re-visited the PID on Wednesday June 23, 2010 to inspect the pipes for illicit connections. No illicit connections were found in the pipes during the inspection. A 3 inch PVC pipe was noticed in the wall of catch basin #95458 (**Figure 1**) which could be the source of the illicit flow. Prior inspection information from URS was checked on the DelDOT NPDES Viewer and this illicit connection was noted during their inspection. The pictures from the inspection showed obvious flow with soap suds (**Figure 2**). KCI is not certain which property the pipe connects to, but it is believed to be coming from the residence at 2572 Red Lion Road.

KCI believes that this is an illegal connection because of the evidence found. It is unclear whether sewage is being discharged because of low Ammonia levels but there is a possibility because of the smell and what appeared to be toilet paper in the catch basin. KCI notified Tom Wyatt of KCI Newark office who has contract with the New Castle County for dye testing sanitary flow. Tom will talk to the county about dye testing at this location.

Figure 1. Illicit Connection

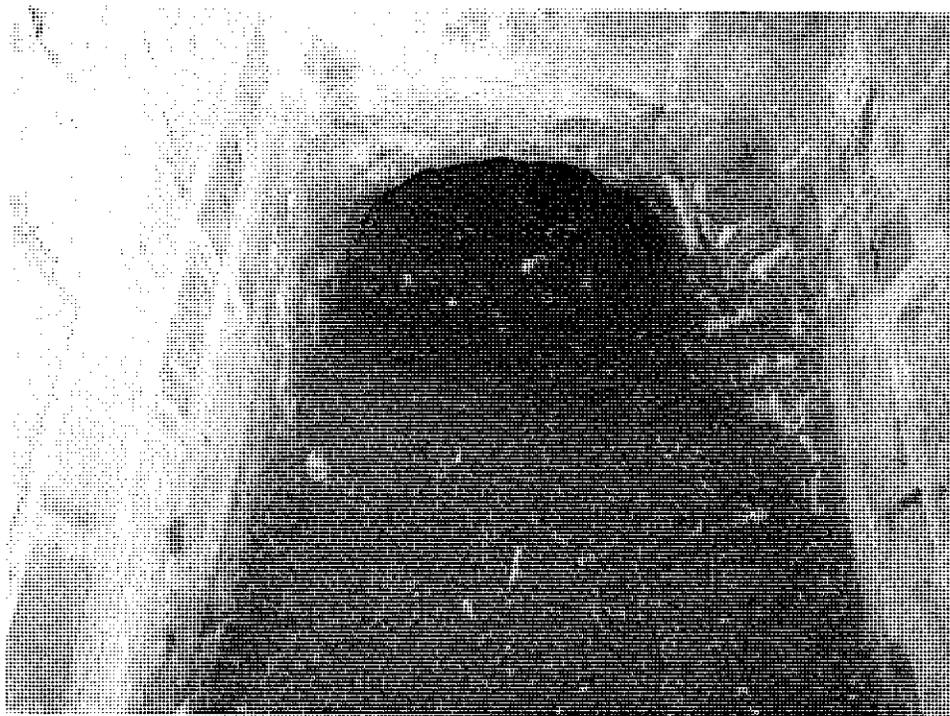
Figure 2 – Removed Hot Mix Pipe Blockage (08/03/10)

KCI removed enough hot mix material from catch basin 77010 to allow positive flow in the storm sewer system, which should alleviate any potential future storm event flooding. However, KCI was not able to remove all the material due to the hot mix compacting and hardening. **See Figure 2.**

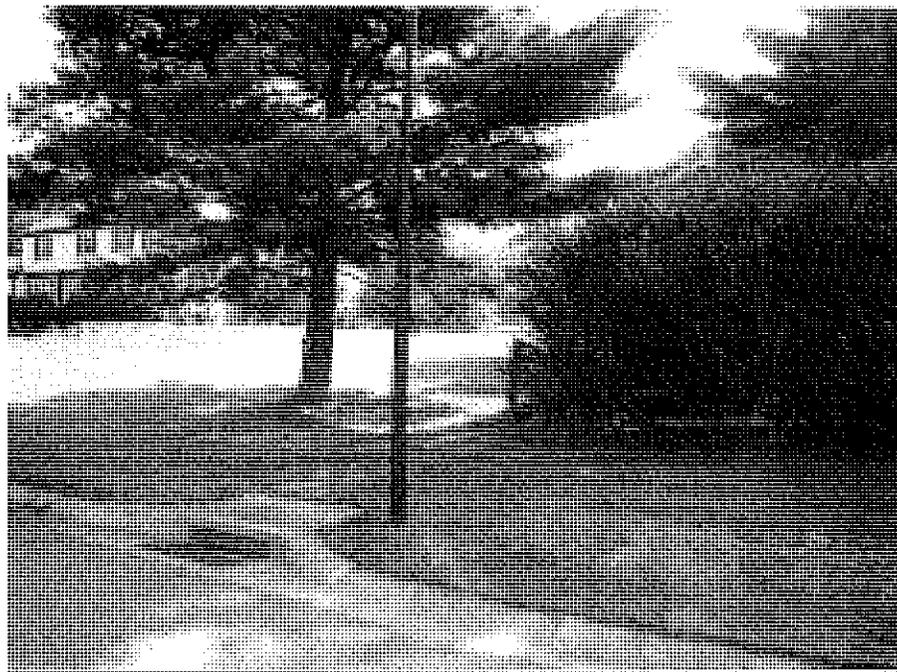
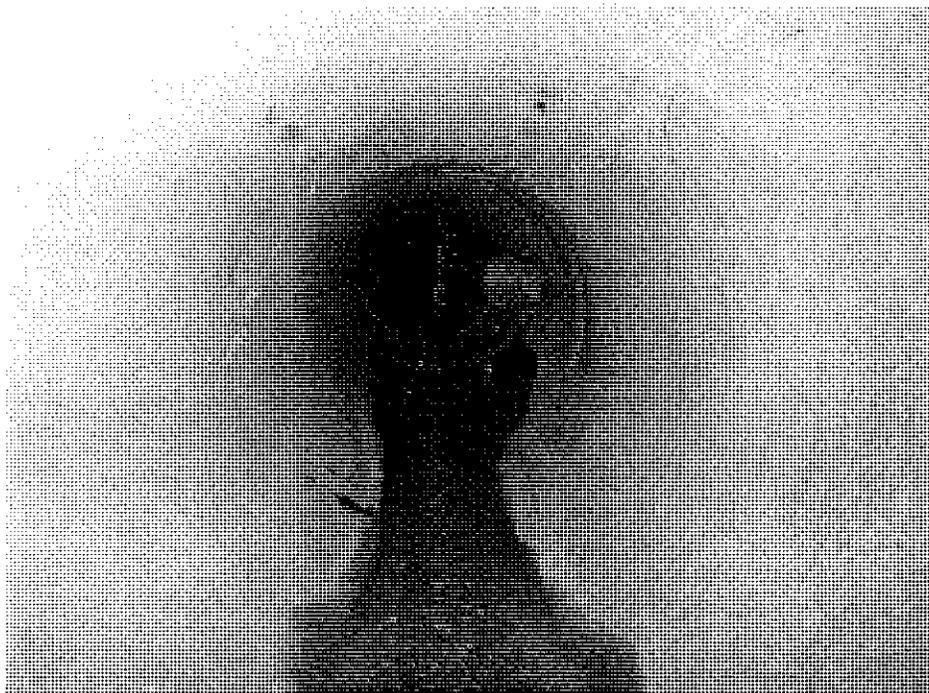
The KCI field crew also inspected Catch Basin Structure #5143 and found a small 4 inch PVC pipe protruding into the side wall of the concrete pipe connecting into the catch basin (**Photo 4**). Water was observed flowing from the small PVC pipe and collecting in the catch basin. Field crews could not immediately determine the source of flow. A water sample was obtained and tested. Results indicated that all parameters were within allowable limits.

Photo 3
Catch Basin #5143

Photo 4
Catch Basin #5143

KCI will periodically re-test this PID in an effort to determine its source prior to concluding that no further action is needed.
