THREATENED BUILDINGS DOCUMENTED IN DELAWARE, 1999-2000

Center for Historic Architecture and Design
University of Delaware
Newark, Delaware

Site Name:	Jehu M. Reed House
CRS Number:	K-137
Location:	420 U.S. Route 113, just west of its intersection with Bowers Beach Road Little Heaven South Murderkill Hundred Kent County, Delaware
Date of Fieldwork:	February 2000
Type of Documentation:	Level II: Partial Intensive Annotated field notes (2 sheets) Measured drawings--CAD (1 sheet) 35 mm color slides (7) Architectural data narrative

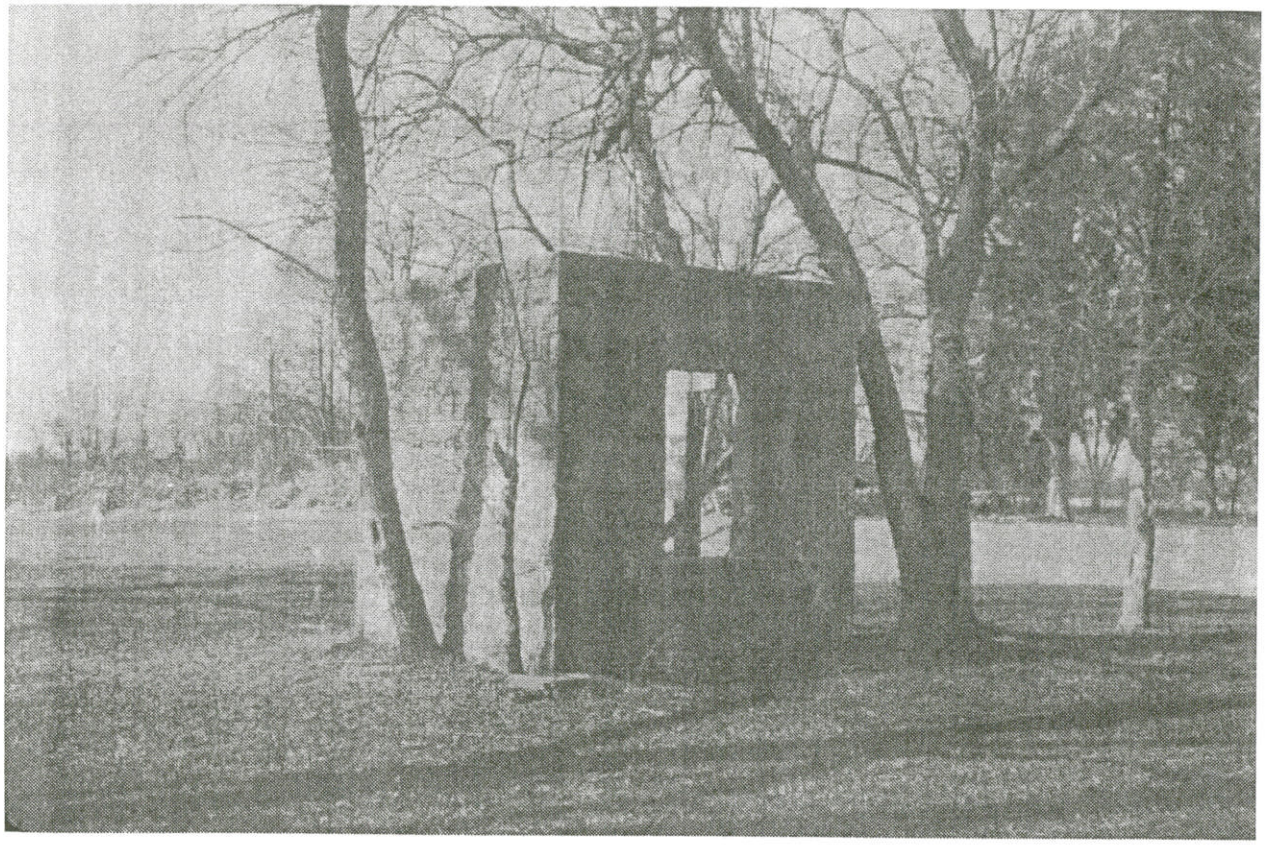
Figure 6: Jehu M. Reed Farm, view of north and east elevations of concrete block outbuilding, looking southwest.

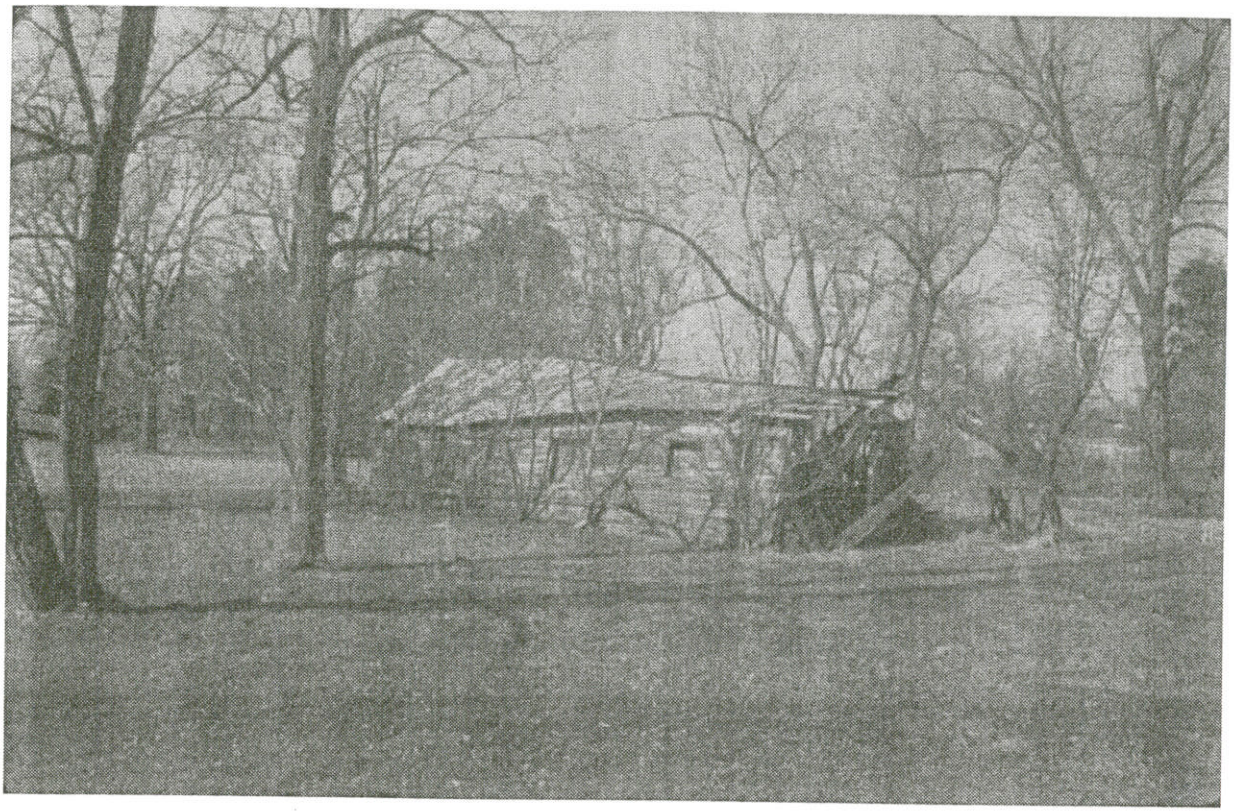
Figure 8: Jehu M. Reed Farm, view of north and east elevations of barn, looking southwest.
