**S-11905. Dwelling, north side of Fleatown Road
(PIN: 230-19.00-99.00)
(Detail Map #1)**

**S-11906. Dwelling, 18126 Fleatown Road.
(PIN: 230-19.00-103.02)
(Detail Map #1)**

**S-11907. Agricultural Complex, Shoemaker Lane, north side of Redden Road.
(PIN: 135-6.00-27.00)
(Detail Map #5)**

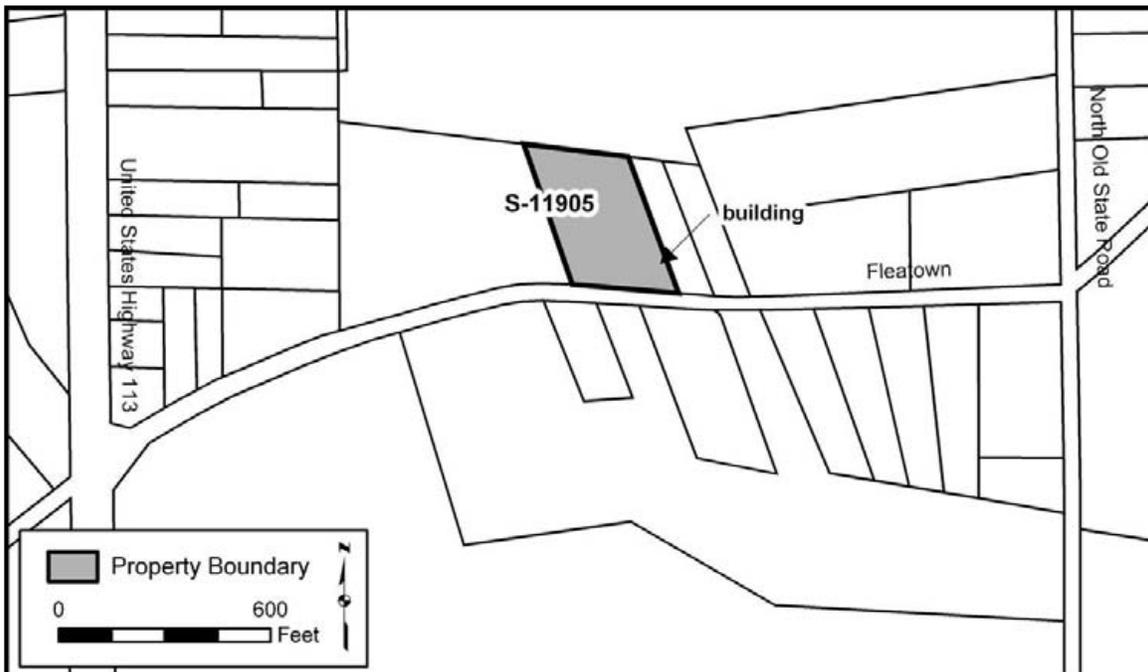
As described and visually evident, this house has undergone substantial alterations. Additions have been added to its façade, southeast corner, and eastern sidewall. The fenestration pattern on each elevation has been altered, in addition to all bays having been replaced with non-sensitive and/or period replacements. Lastly, vinyl siding has been applied to the entire exterior. Altogether these changes have greatly diminished the dwelling's integrity. Therefore, it is recommended not eligible under Criterion C.

main building (.001) rear and west side,
view to SE

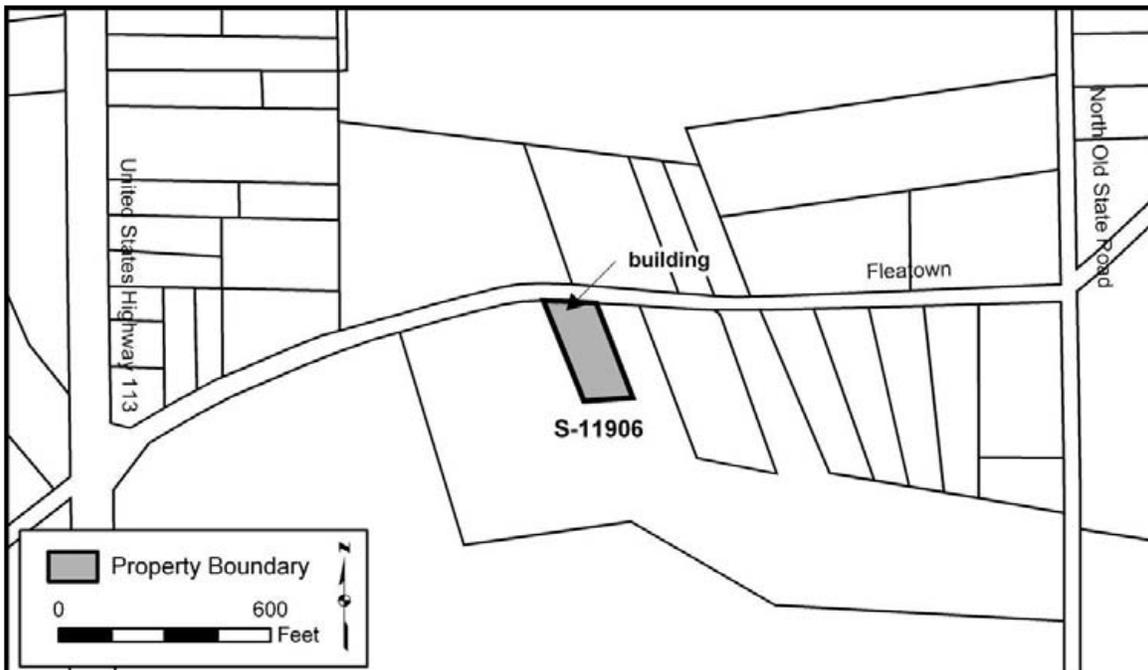
As evident, the house has undergone substantial alterations including the removal of the original front entrance, the addition of a full-width addition both to the façade and rear, the addition of a gabled ell from the eastern sidewall, the replacement of all the windows and doors, and the application of vinyl-siding to the entire exterior. Altogether these changes have greatly diminished the dwelling's integrity of design, materials, workmanship, and feeling. Therefore, it is recommended not eligible under Criterion C.

main building (.001) rear and west side,
view to NE

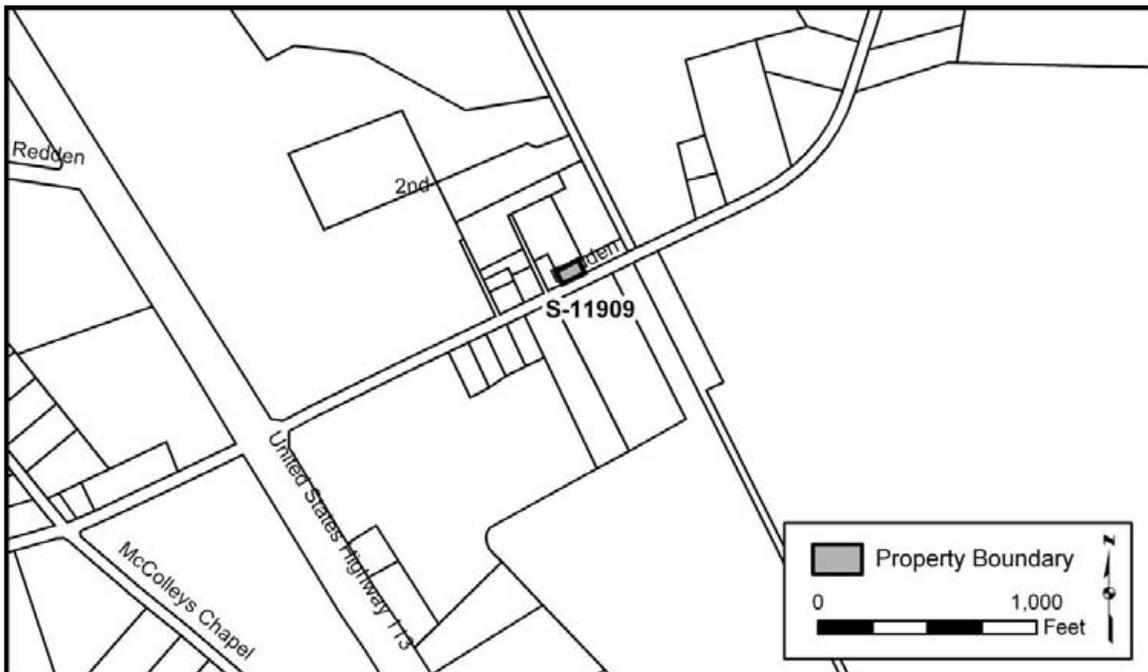
Eligibility under Criterion C for architecture requires that the historic function of a country store be readily discernable and that much of its historic character remain intact. Significance is increased if the store remains associated with an older residence. The historic-period residence on this property is no longer extant, and the building itself has undergone substantial alterations. The full-width, inset entry has been remodeled with new, decorative porch supports and railing, the fenestration pattern on each of the walls has been altered, all the windows and doors have been replaced, modern elements (skylights) have been added to the rooftop, modern siding has been added to the exterior, and an addition has been attached to the rear. Altogether these changes have greatly diminished the building's integrity, and its ability to convey its architectural significance.

main building (.001) rear and west side,
view to SE
